# Inspection Photos

API: 05-071-08860

Operator: PIONEER NATURAL RESOURCES

Inspection Date: 3/1/2019

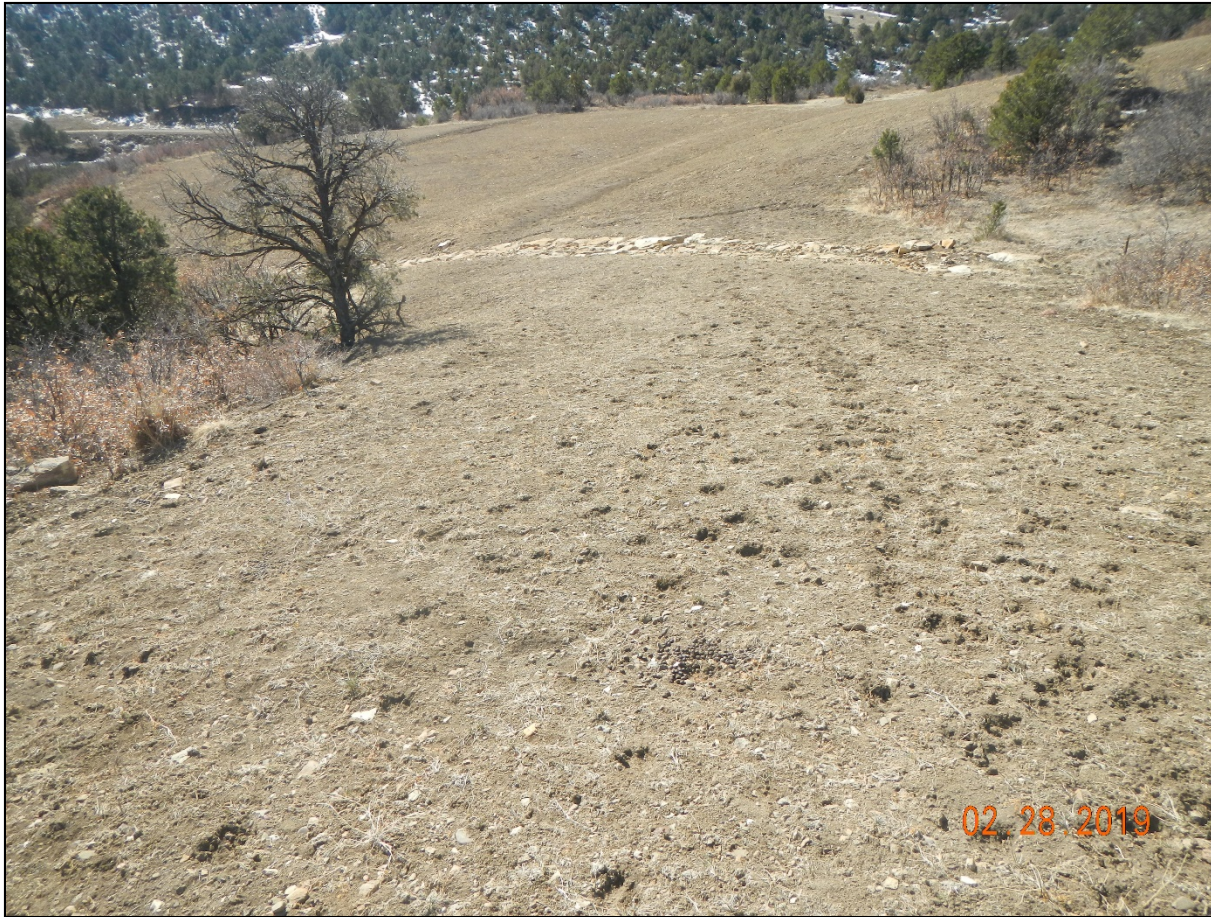
**Photo 1.** Facing south toward the recontoured and reclaimed location.

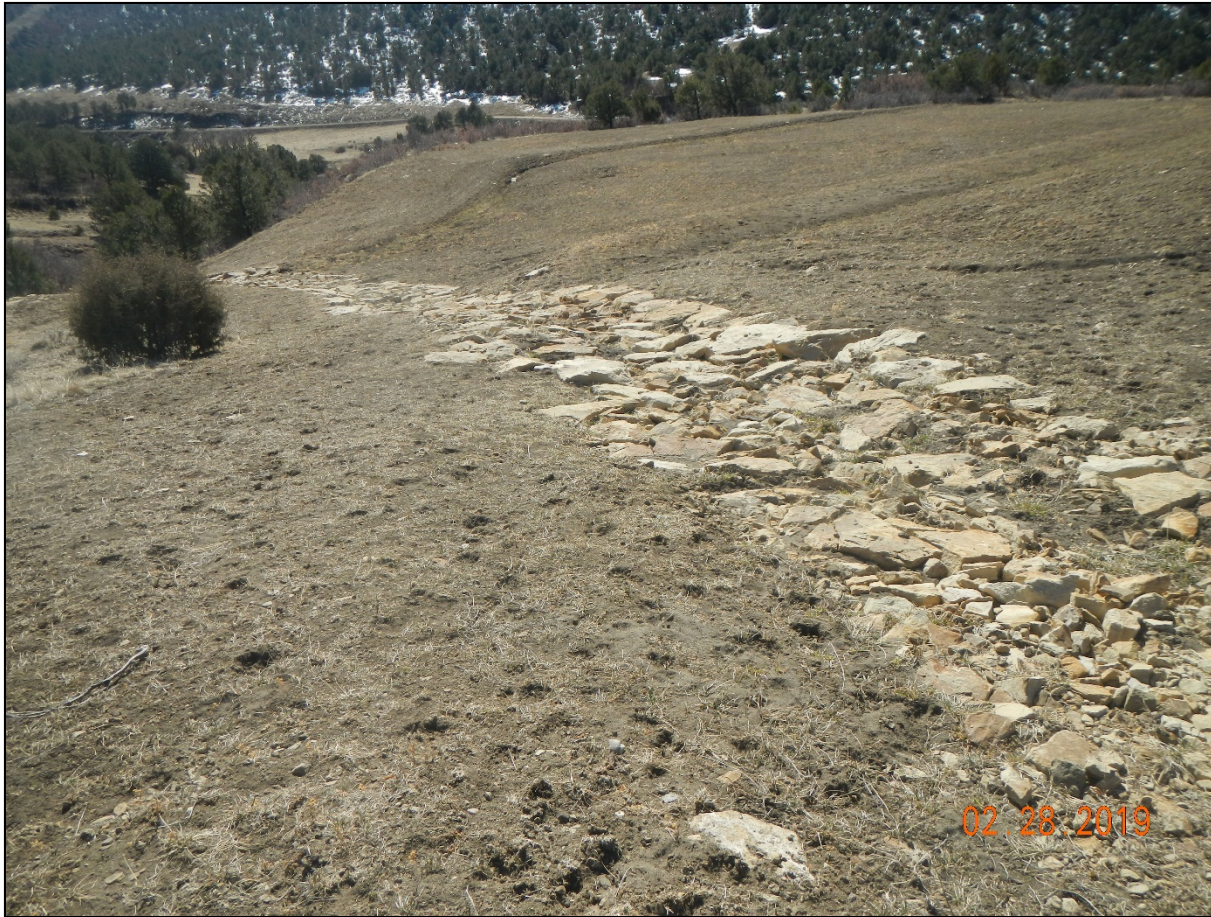
**Photo 2.** Rock rip/rap is placed in the drainage channel.

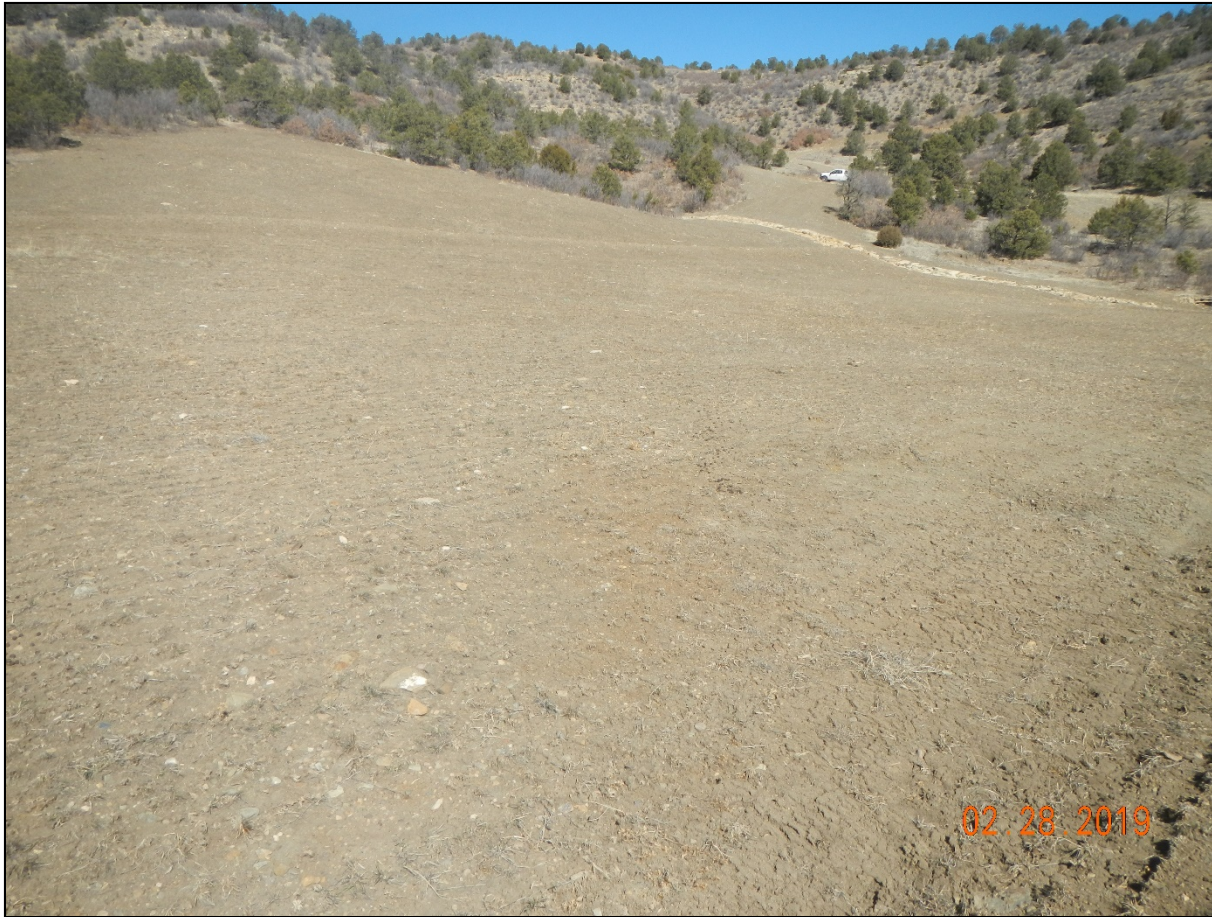
**Photo 3.** Facing back to the north at the location.

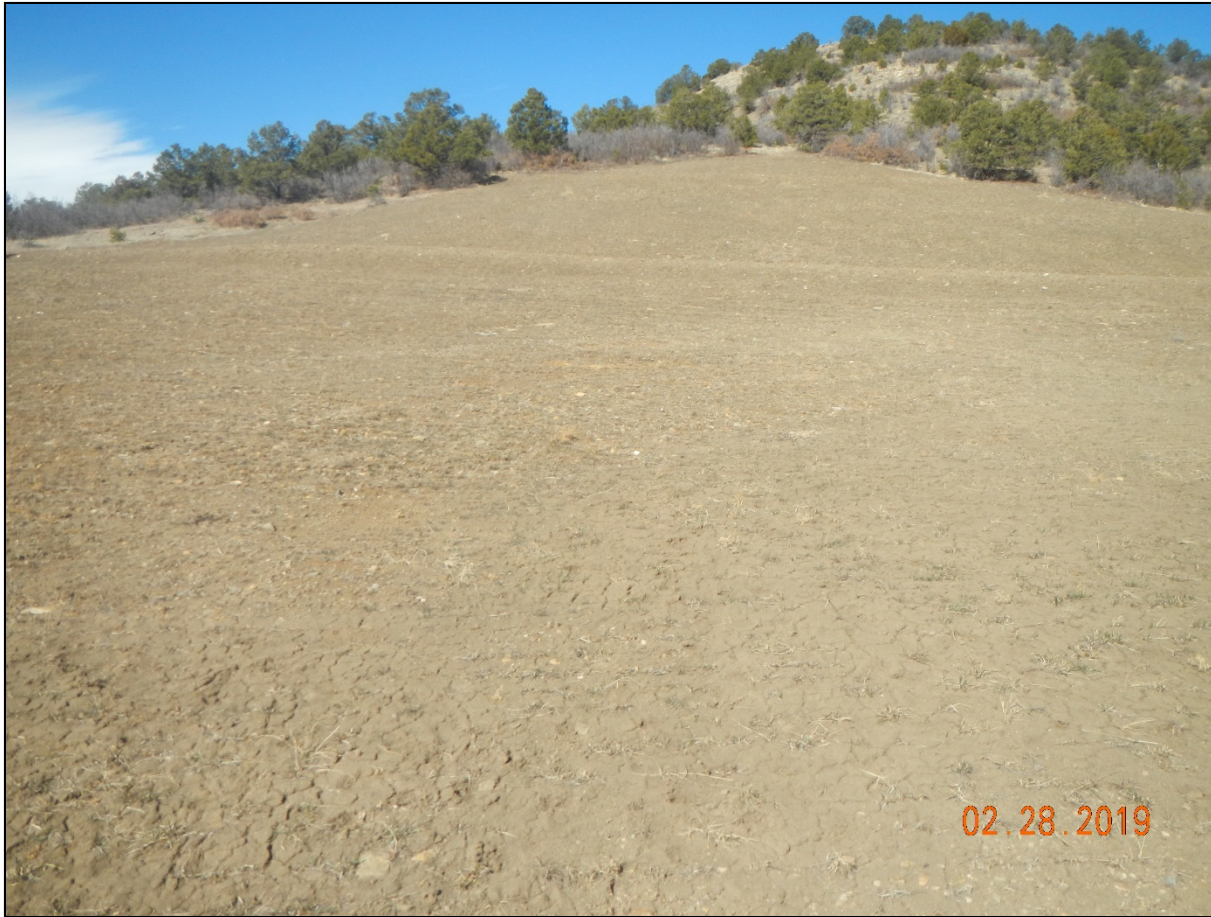
**Photo 4.** Facing west toward the recontoured slope.

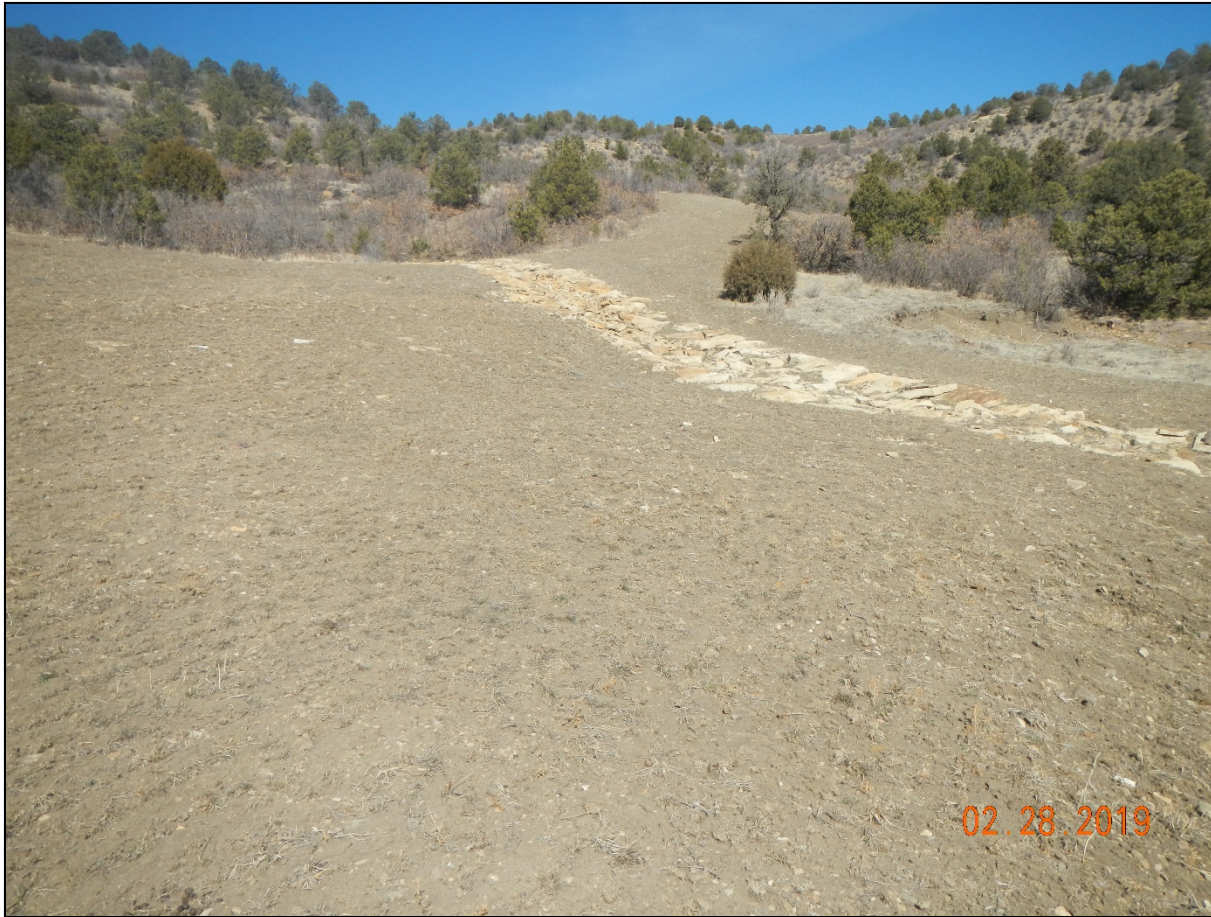
**Photo 5.** Facing north at the location.
