Inspection Photos

API: 05-071-06671

Operator: PIONEER NATURAL RESOURCES

Inspection Date: 3/1/2019

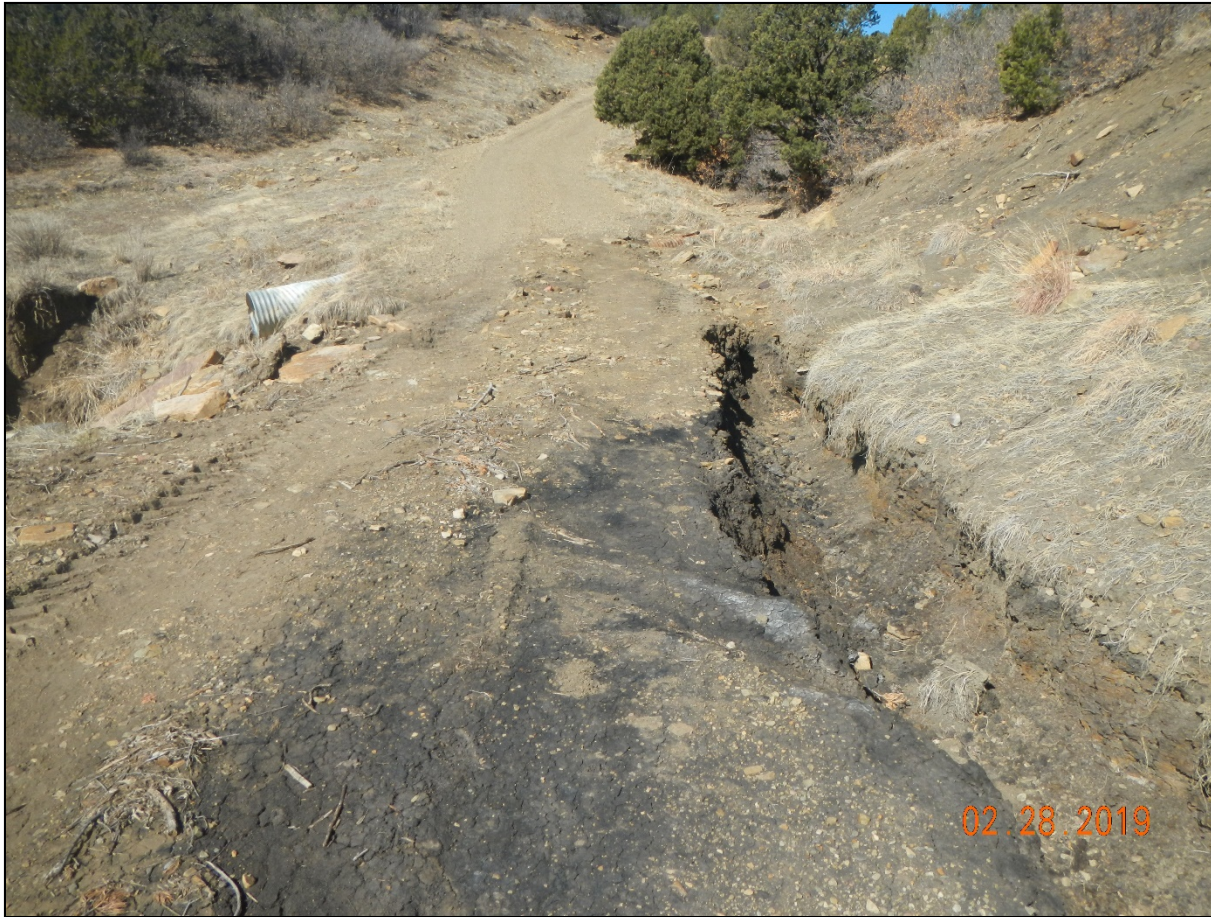
Photo 1. Erosion is occurring along the access road at Lat/Long:37.09966,-104.73441. Facing northwest.

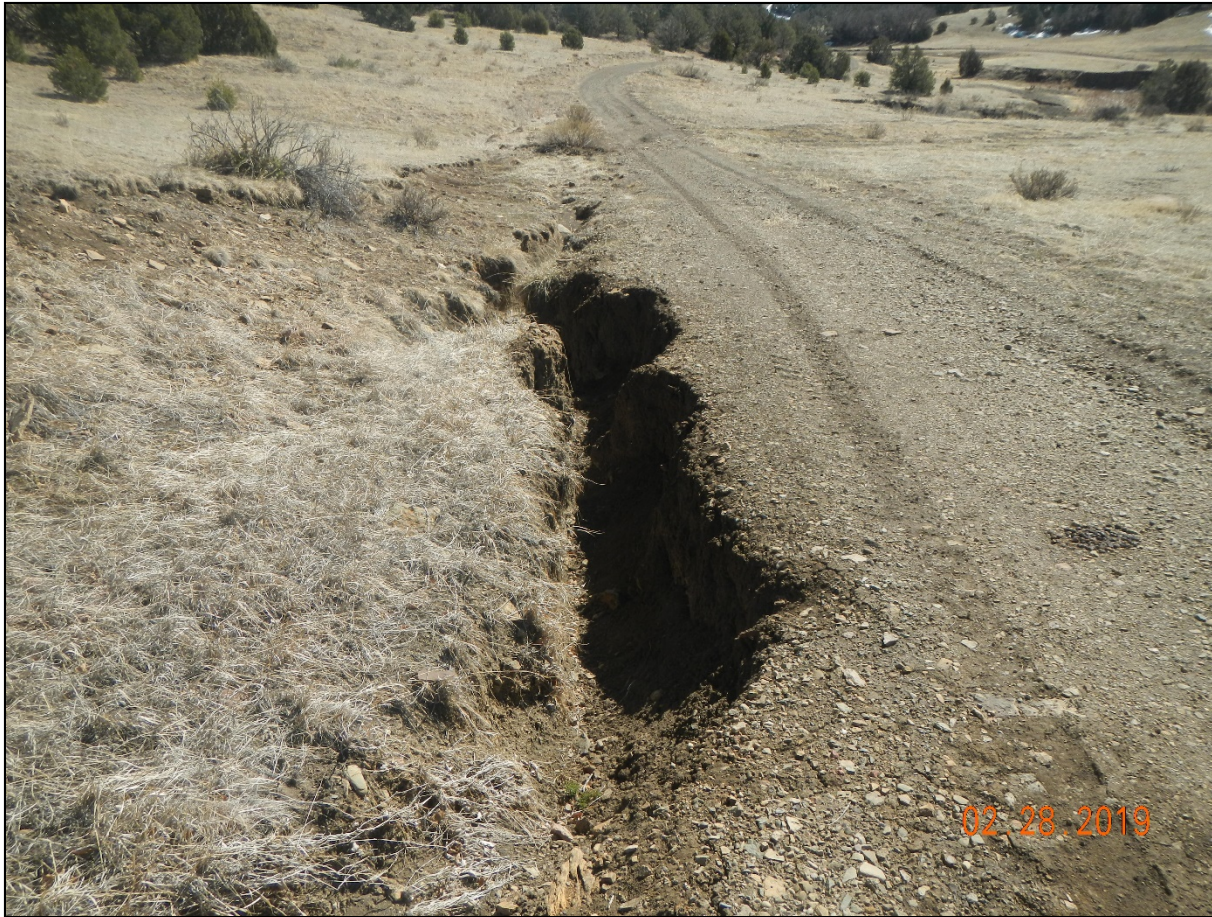
Photo 2. Erosion is occurring along the access road. Facing southeast.

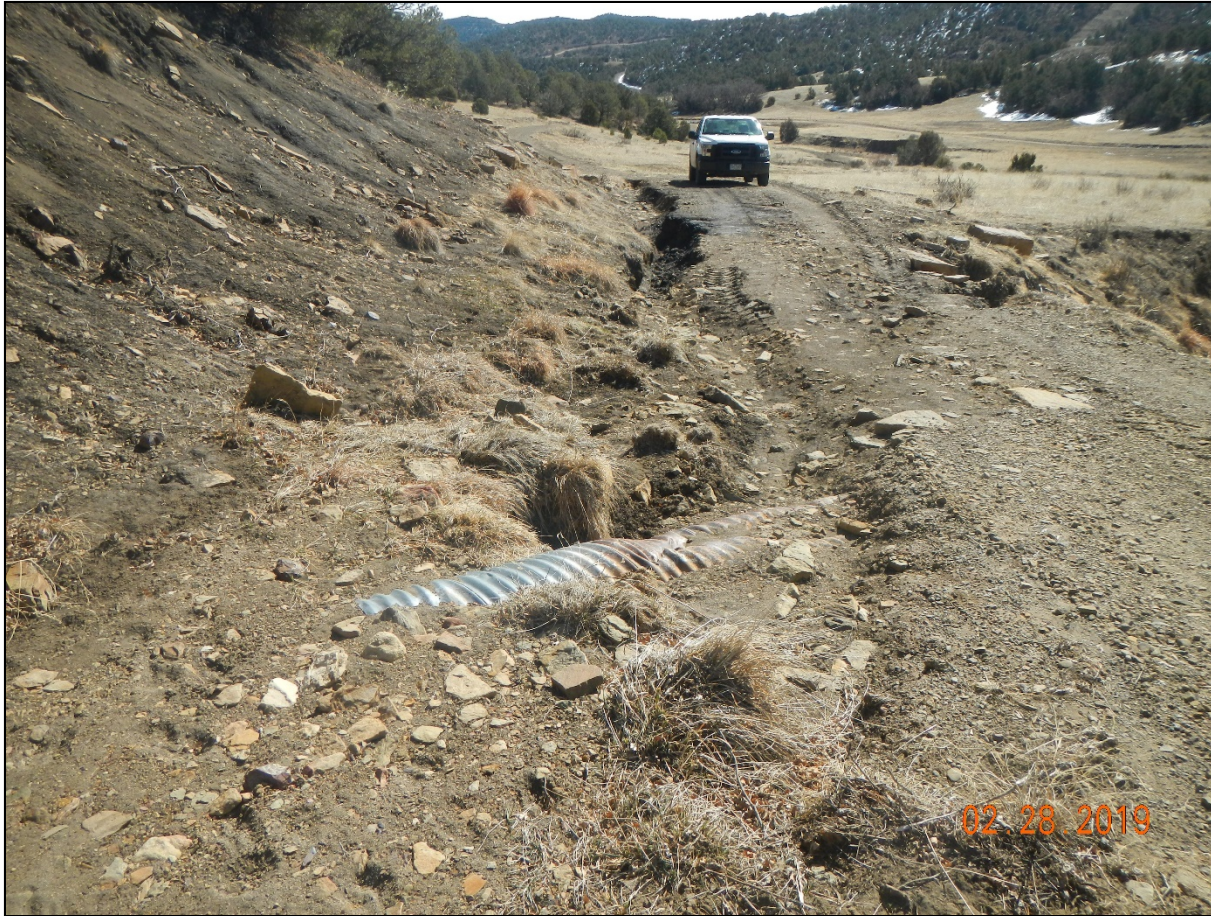
Photo 3. Facing southwest at Lat/Long:37.09966,-104.73441. The culvert is filled in with sediment and erosion is occurring down the road.

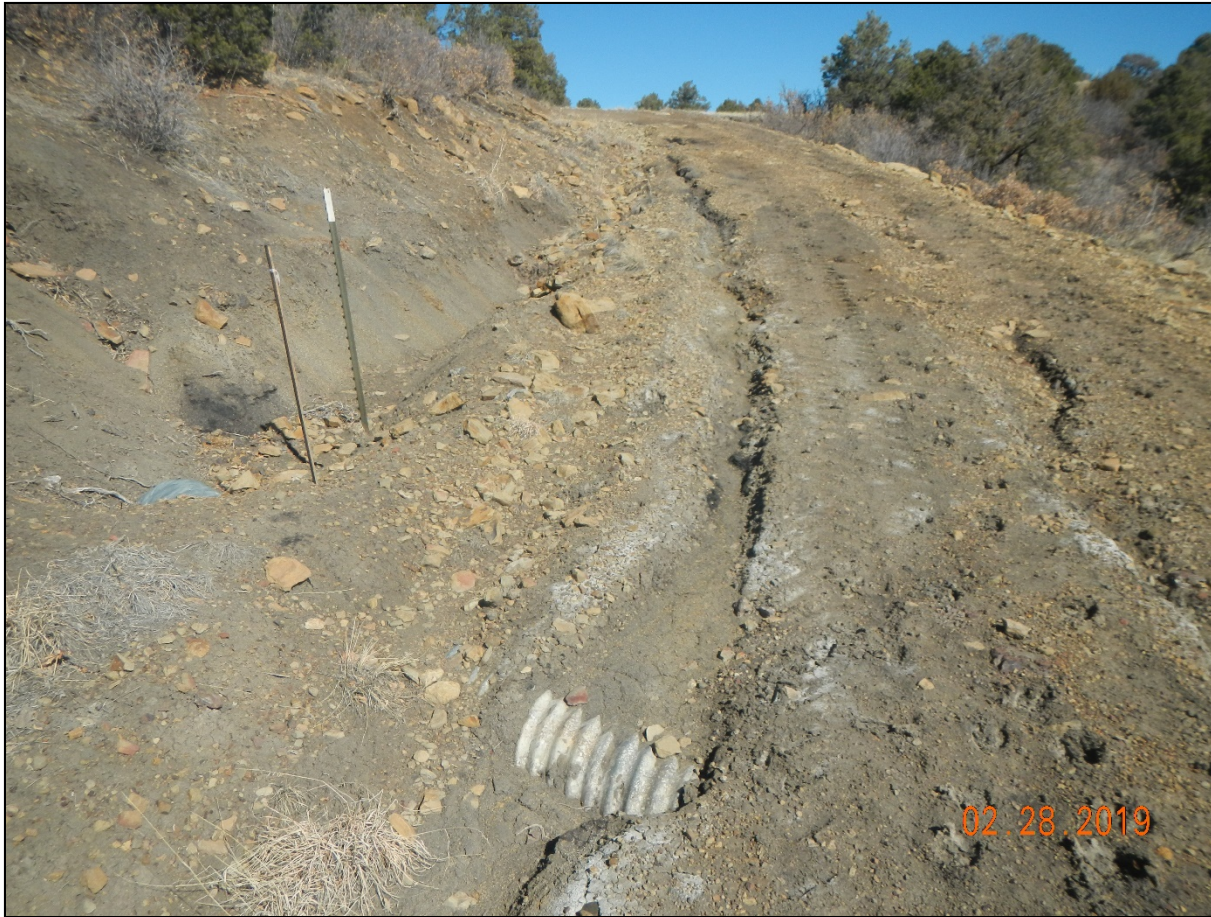
Photo 4. Further along the road traveling toward the top of the ridge near the [TAD POLE #21-12](#) location. Erosion is occurring down the road past the culvert.
