Inspection Photos

API: 05-071-06716

Operator: PIONEER NATURAL RESOURCES

Inspection Date: 3/1/2019

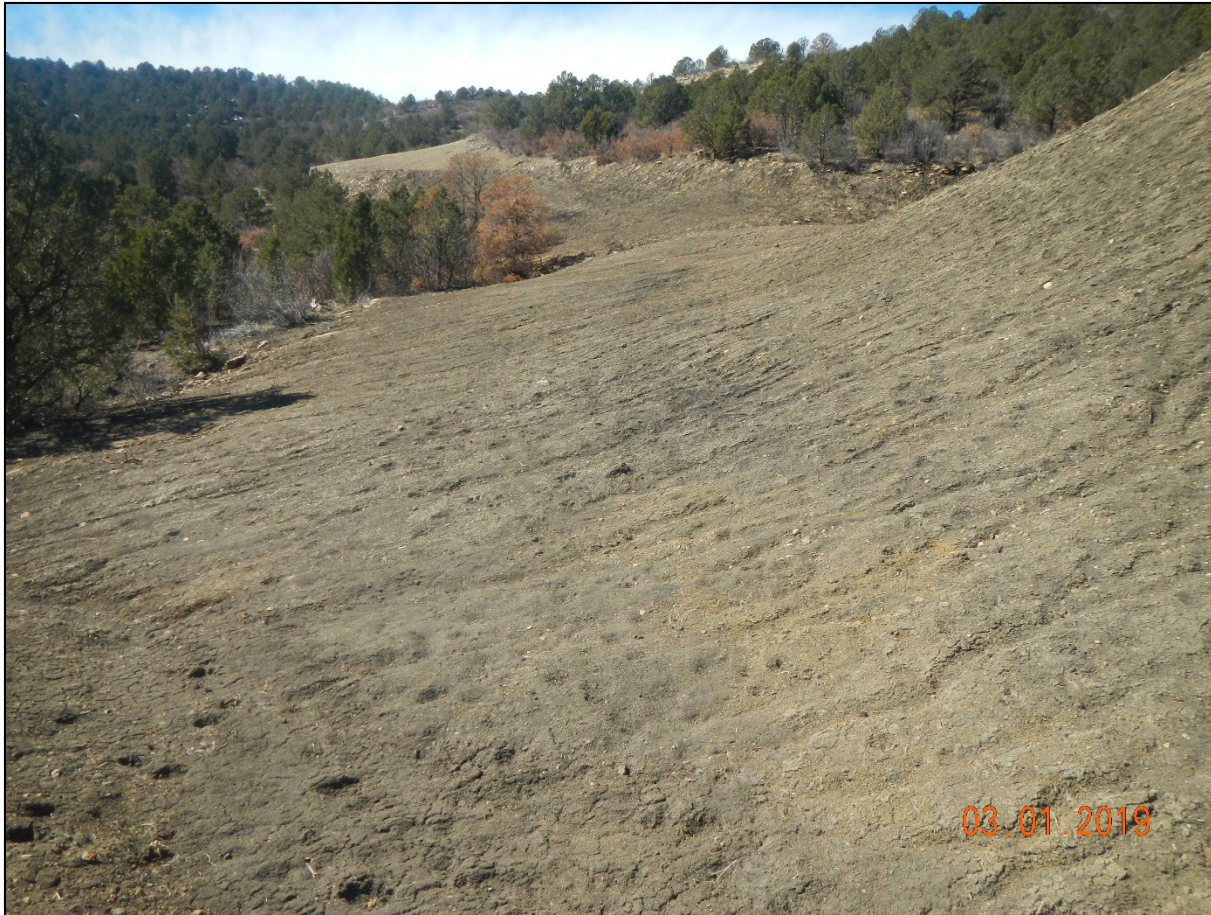
Photo 1. Facing southwest toward the recontoured and reclaimed road.

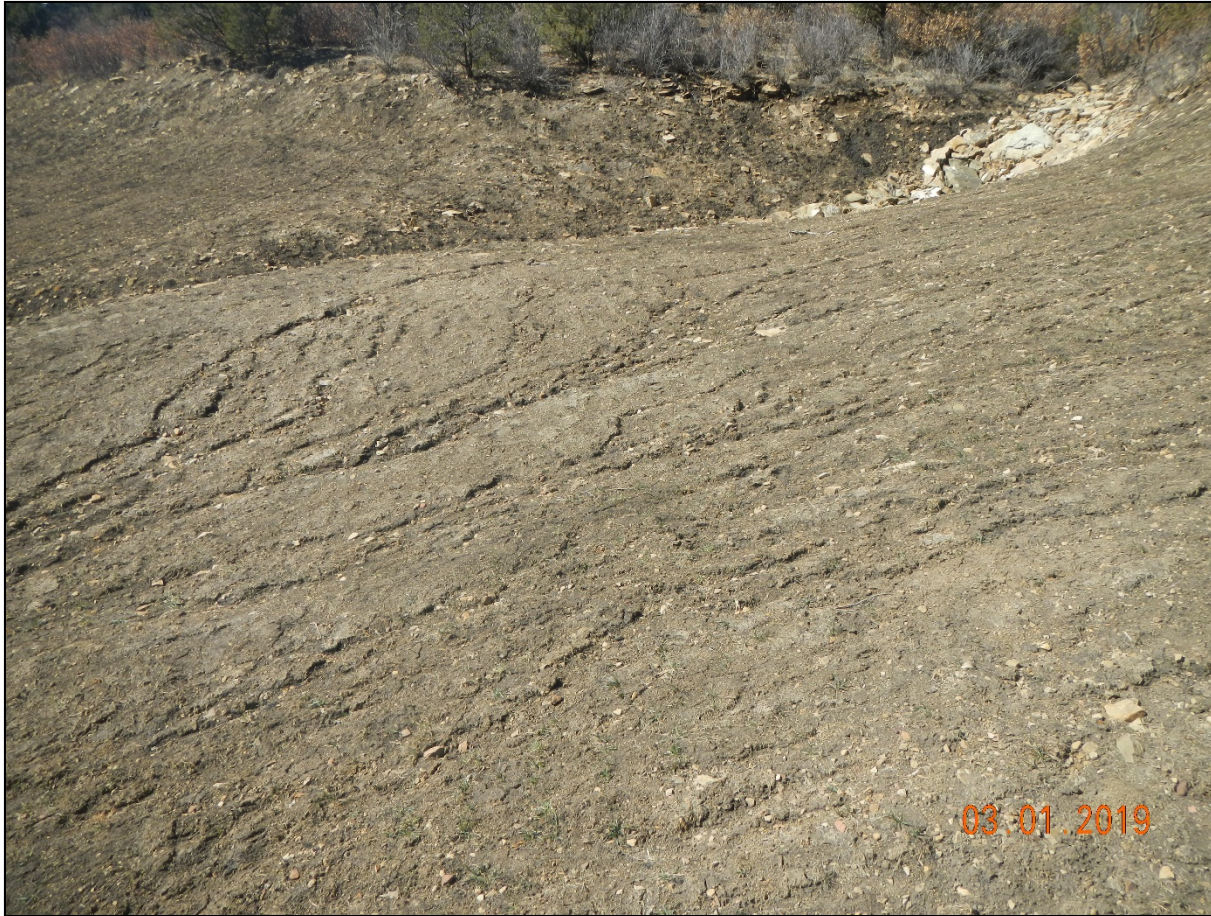
Photo 2. There is little vegetation establishing at the beginning of the reclaimed road. This area may require additional seeding.

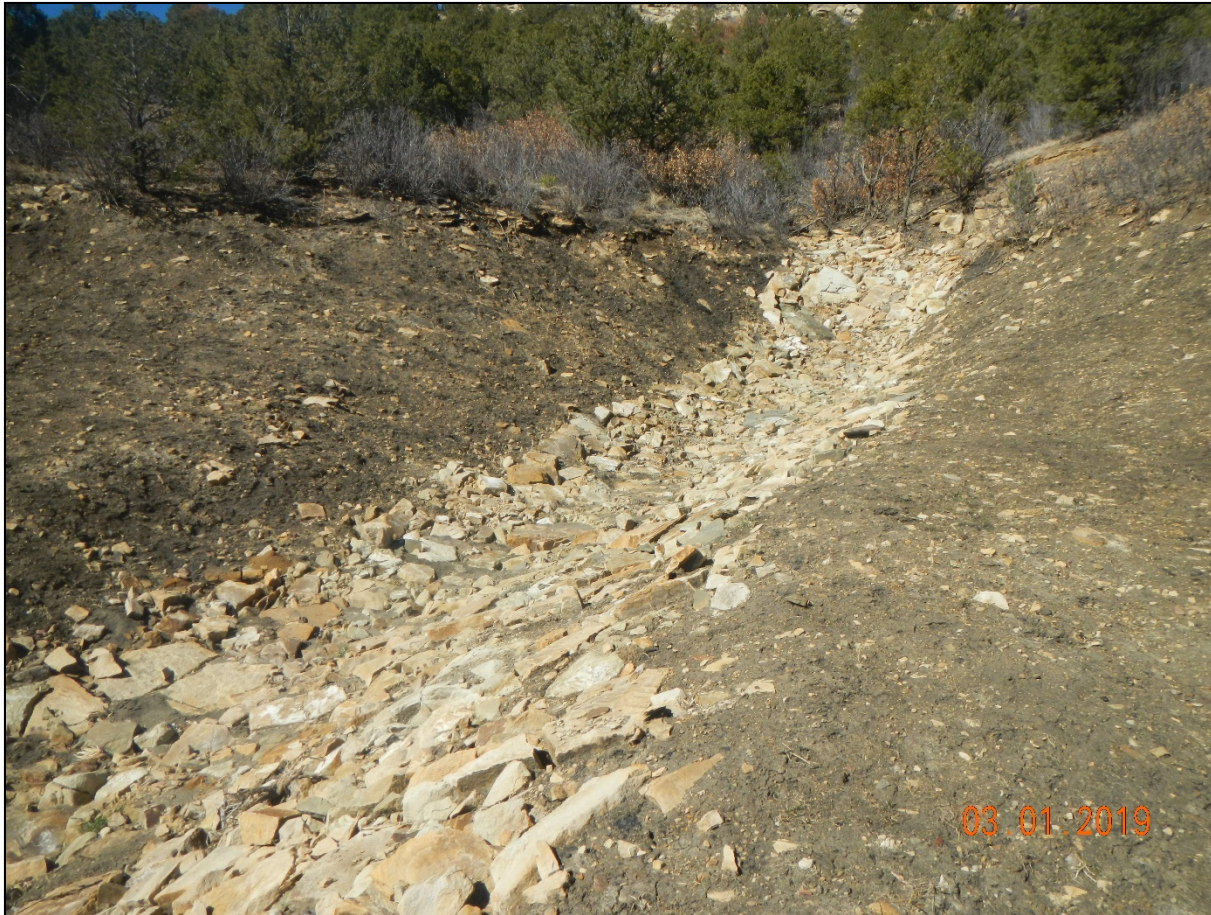
Photo 3. Rock rip/rap is placed in the drainage channel.

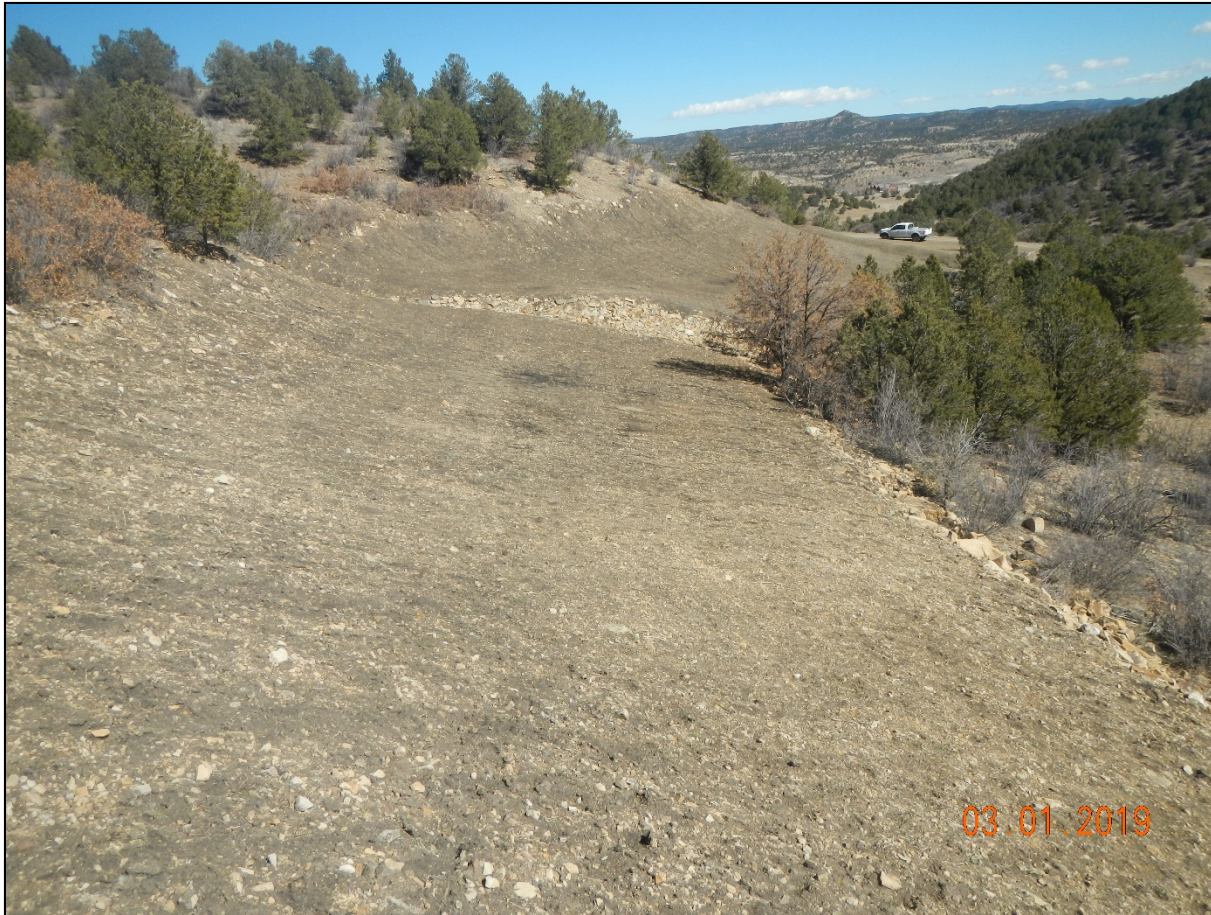
Photo 4. Facing back toward the northeast.

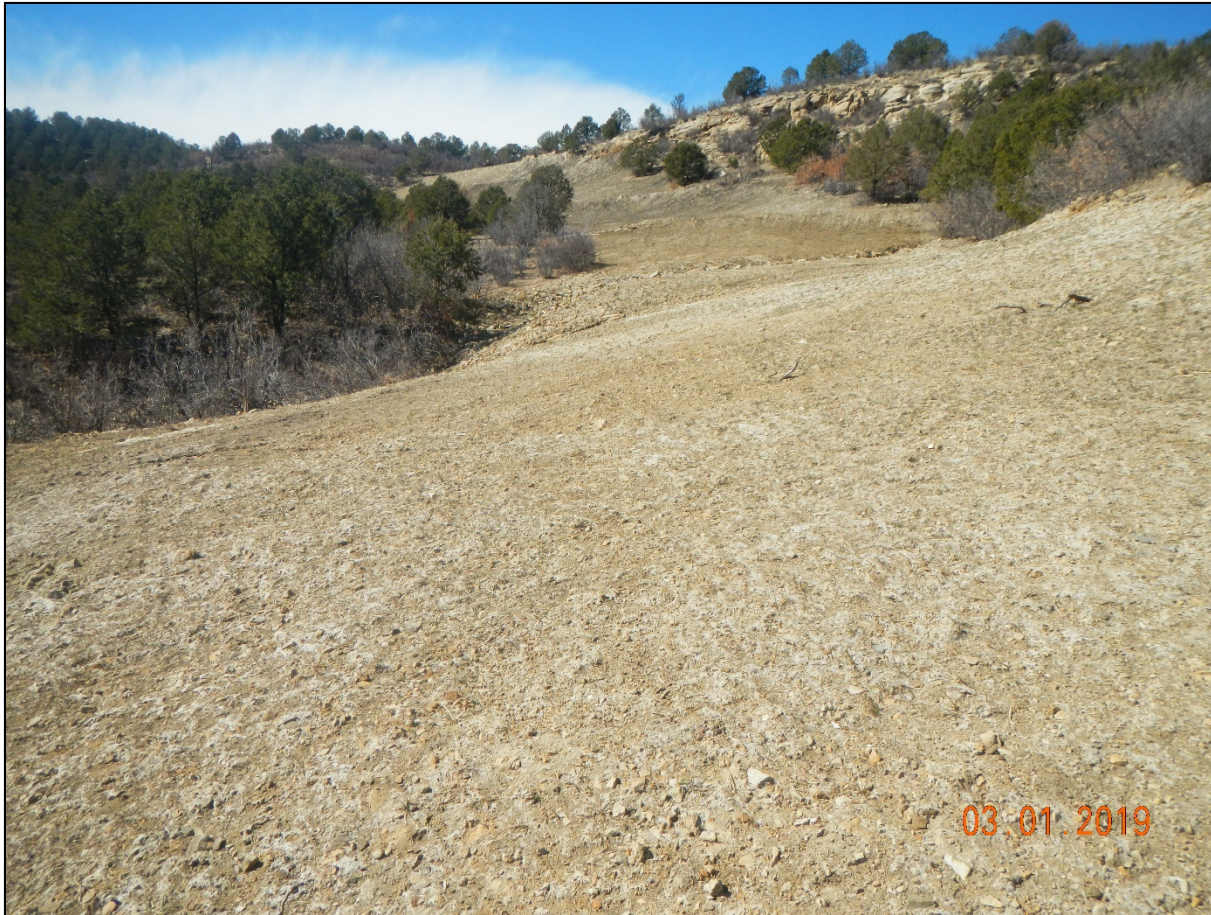
Photo 5. Facing southwest along the recontoured and reclaimed road.

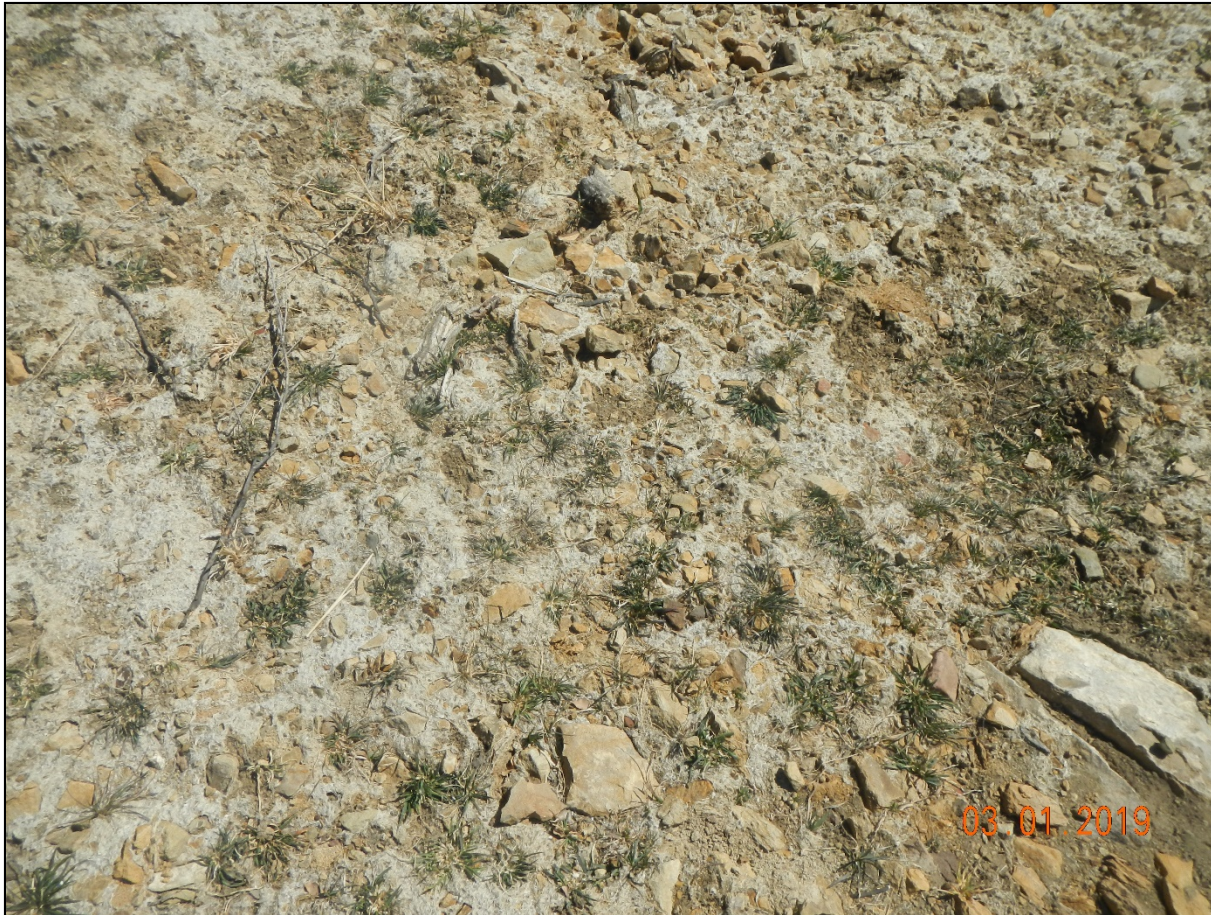
Photo 6. There are signs vegetation is beginning to establish.
