Inspection Photos
Operator: Ausco Petroleum Inc.
Location/API #: 043-06226
Date: 2/27/2019

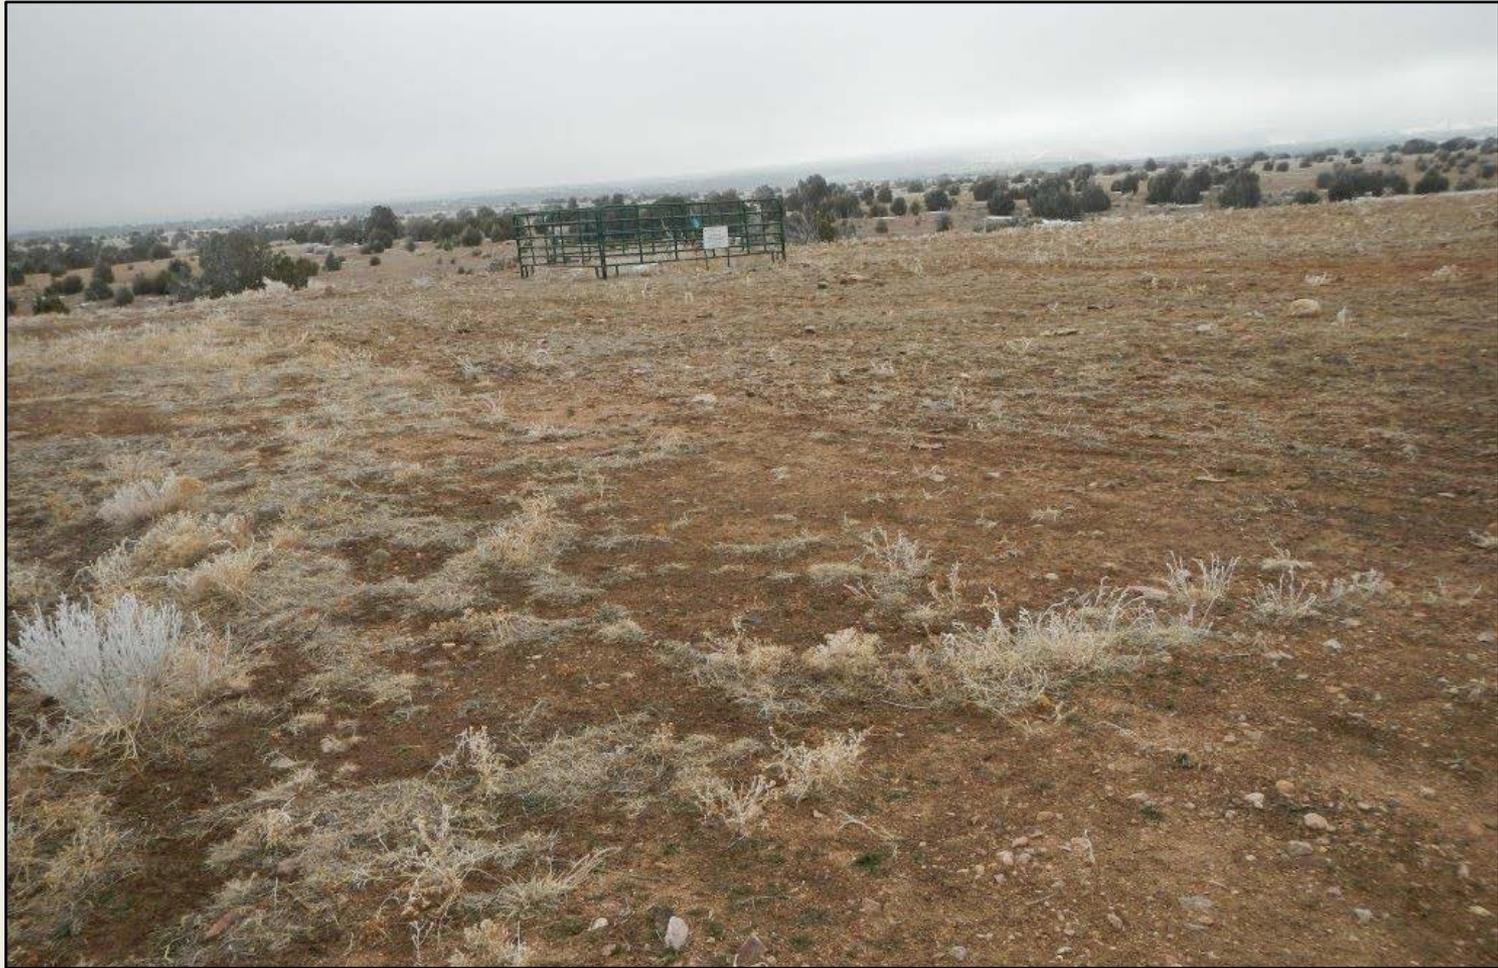
Photo 1. View of the project area from the northeastern corner facing center. Project area appears recently reclaimed.

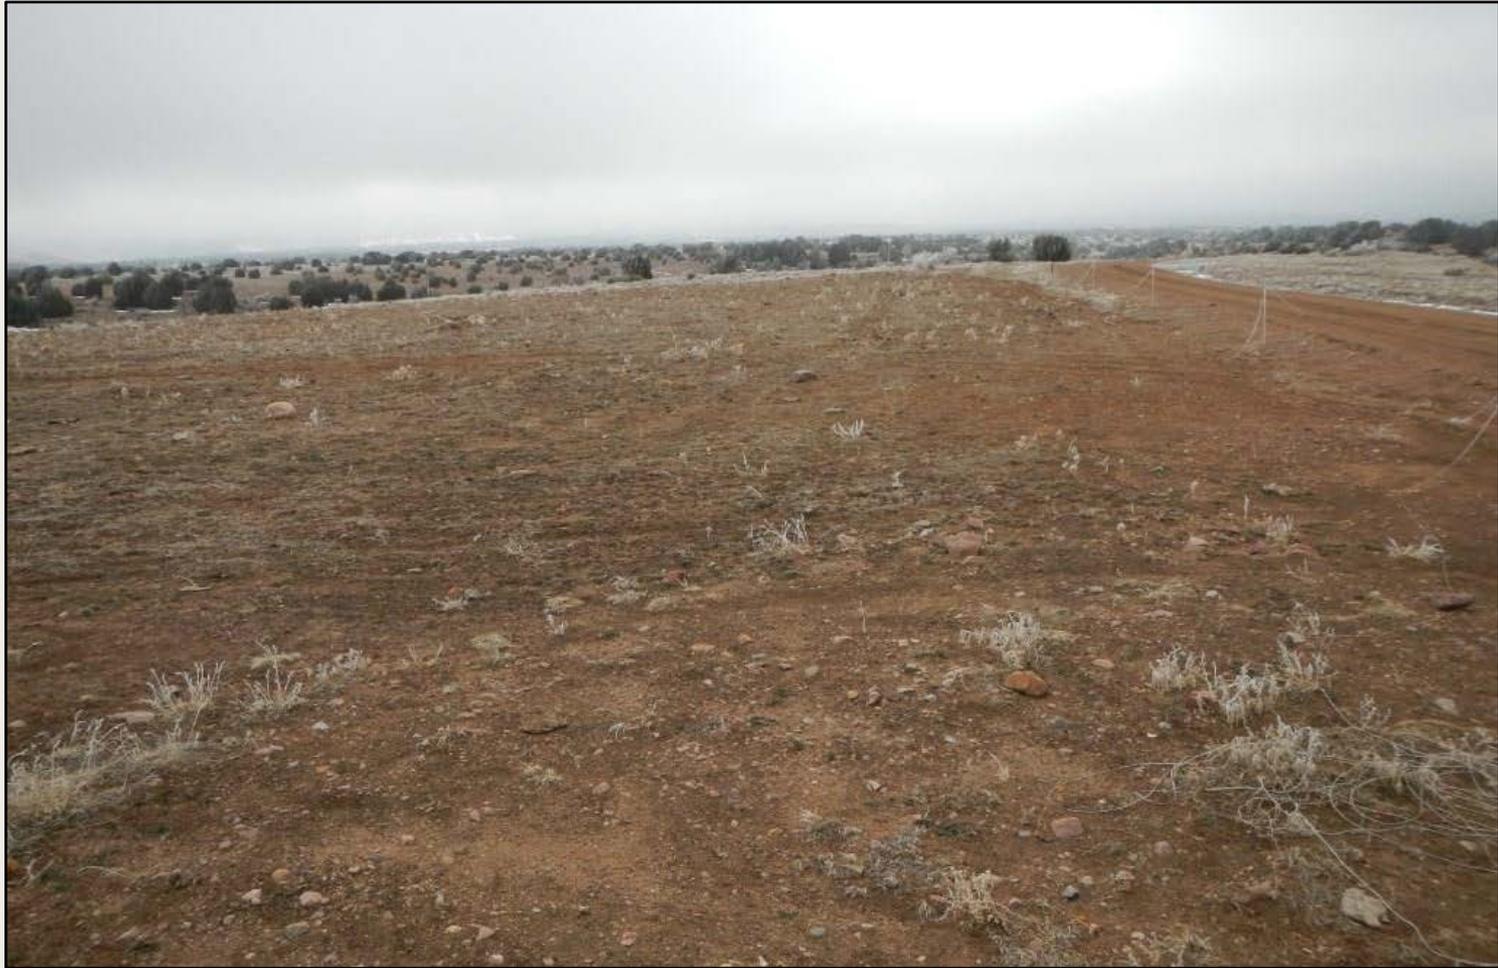
Photo 2. View of the northern portion of the project area from the northeastern edge facing southward. Fencing is not functioning and needs to be repaired or removed. Livestock/wildlife exclusion may be needed for successful revegetation.

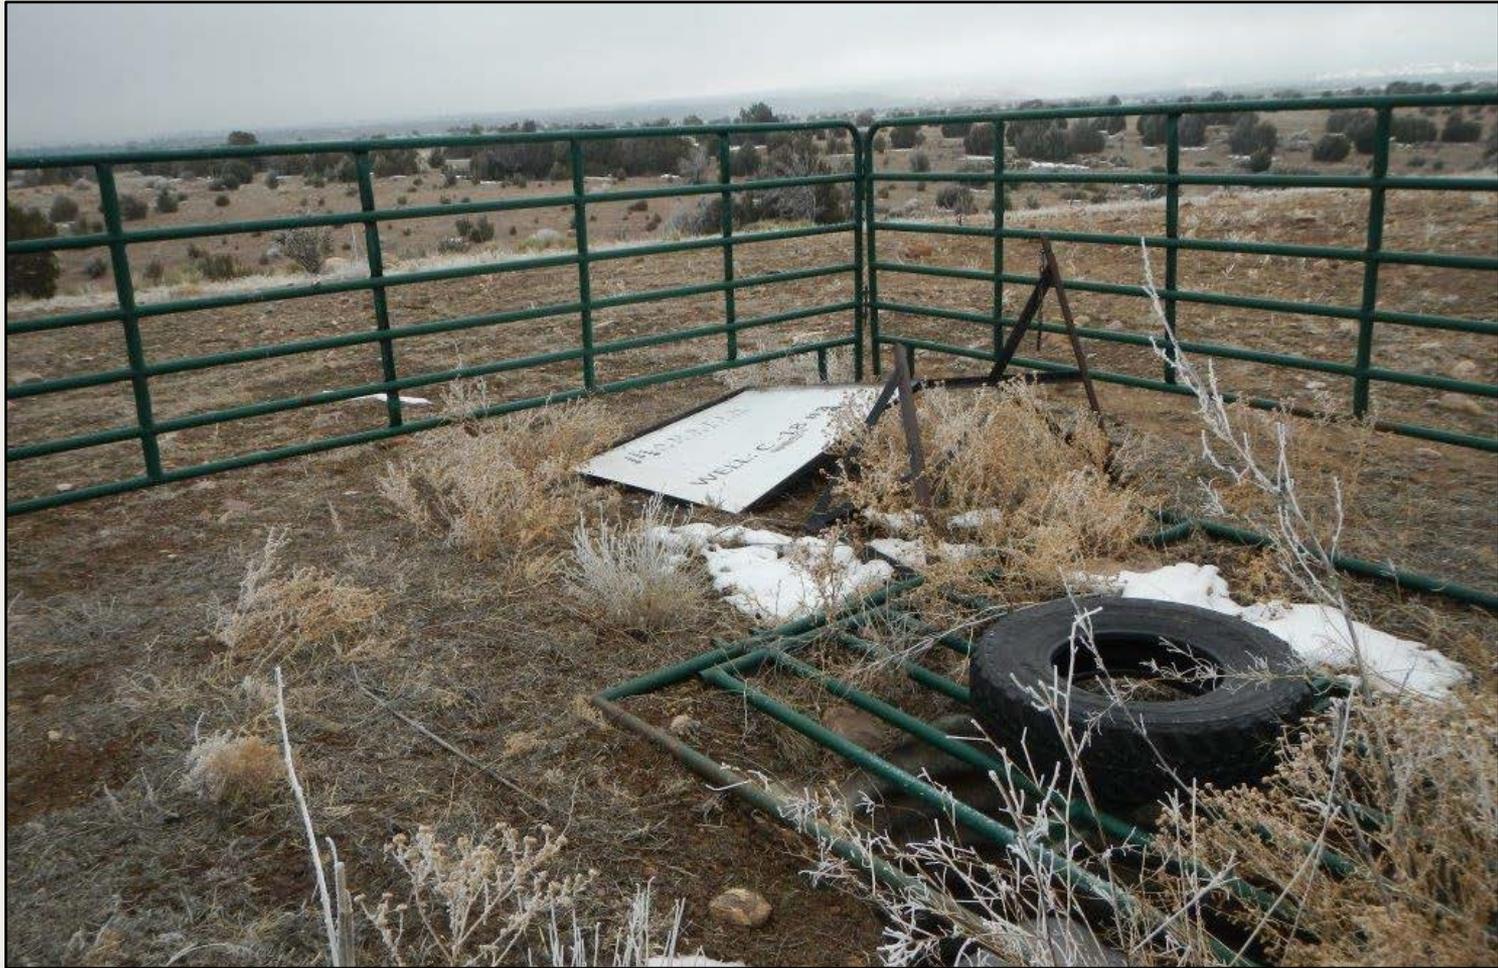
Photo 3. View of debris around well head area. Well cellar should be properly closed to prevent wildlife entrapment.

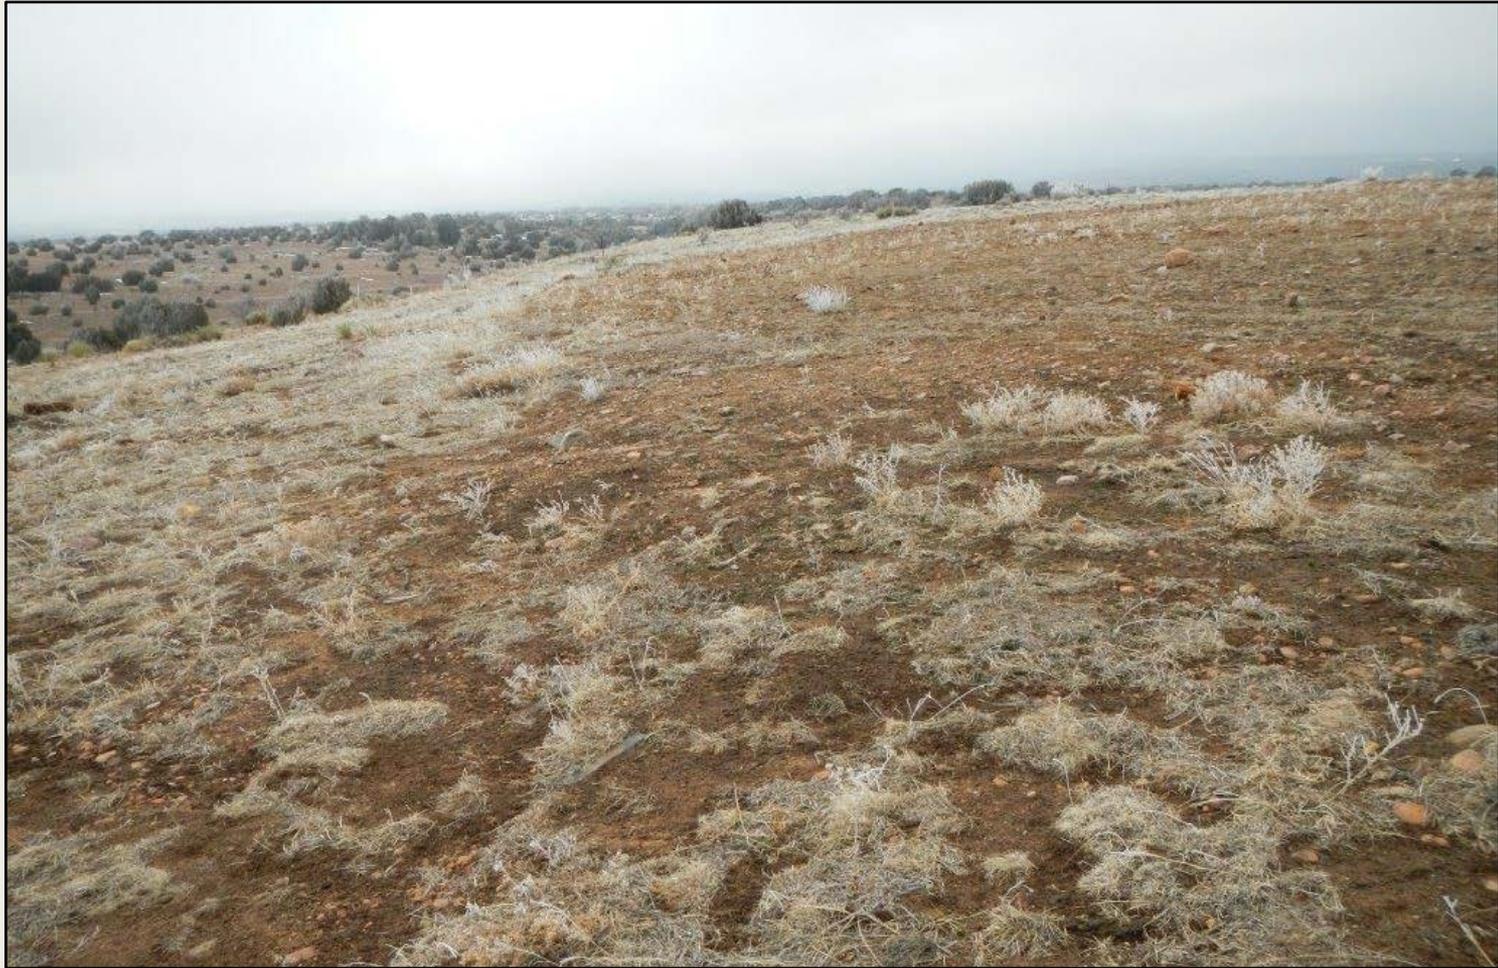
Photo 4. View of the southern project area from the southeastern edge facing westward. Area appears to be recently reclaimed.

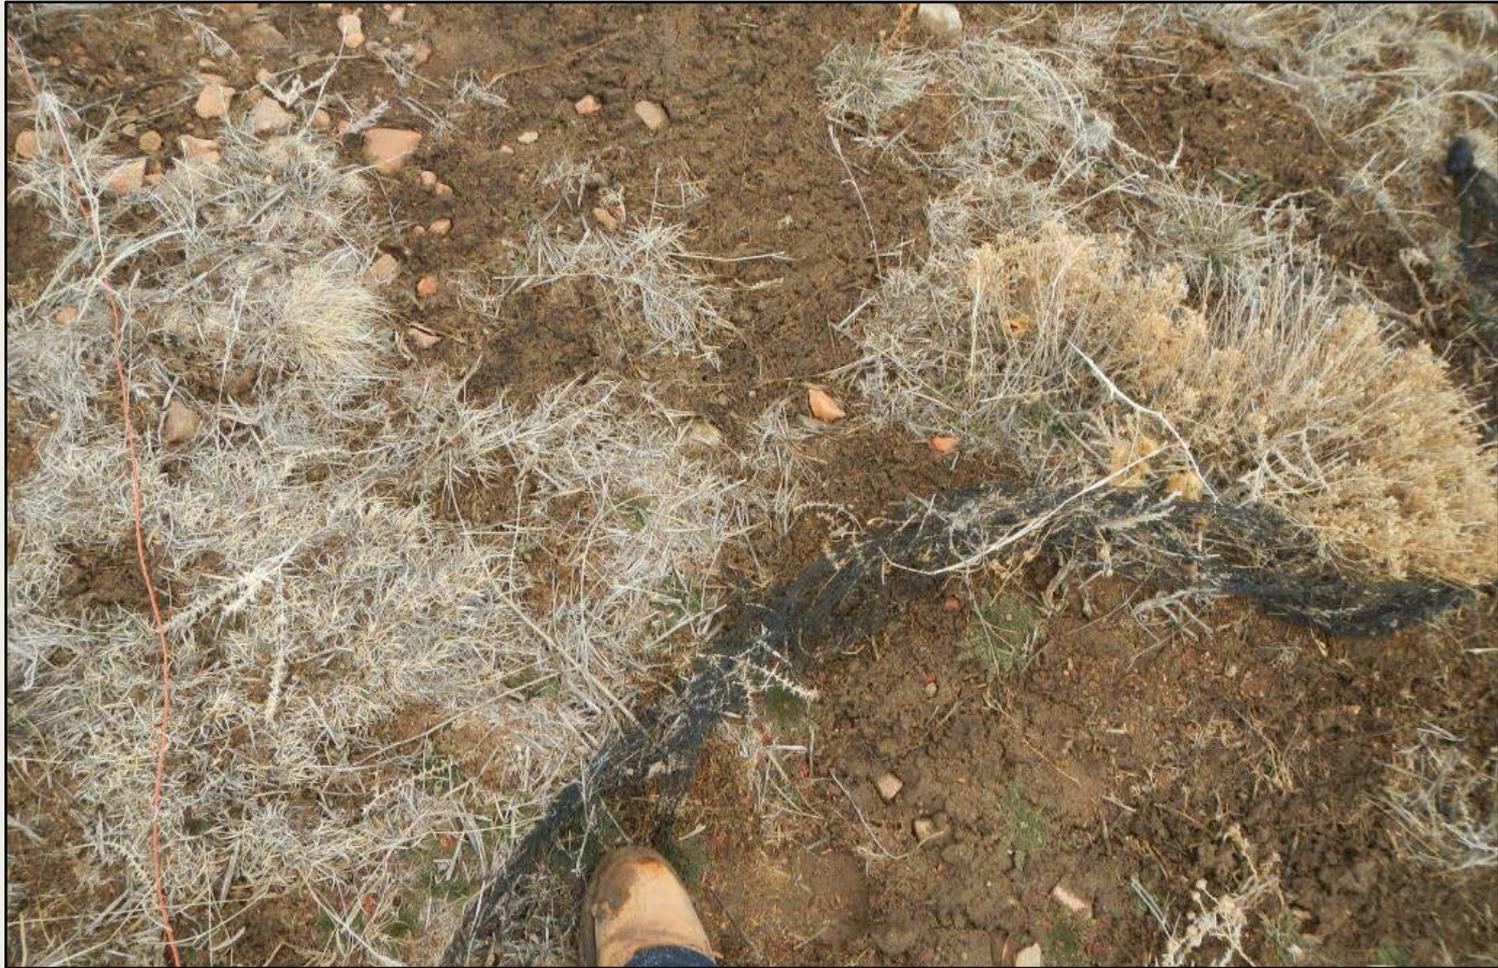
Photo 5. View of plastic netting debris that needs to be removed.

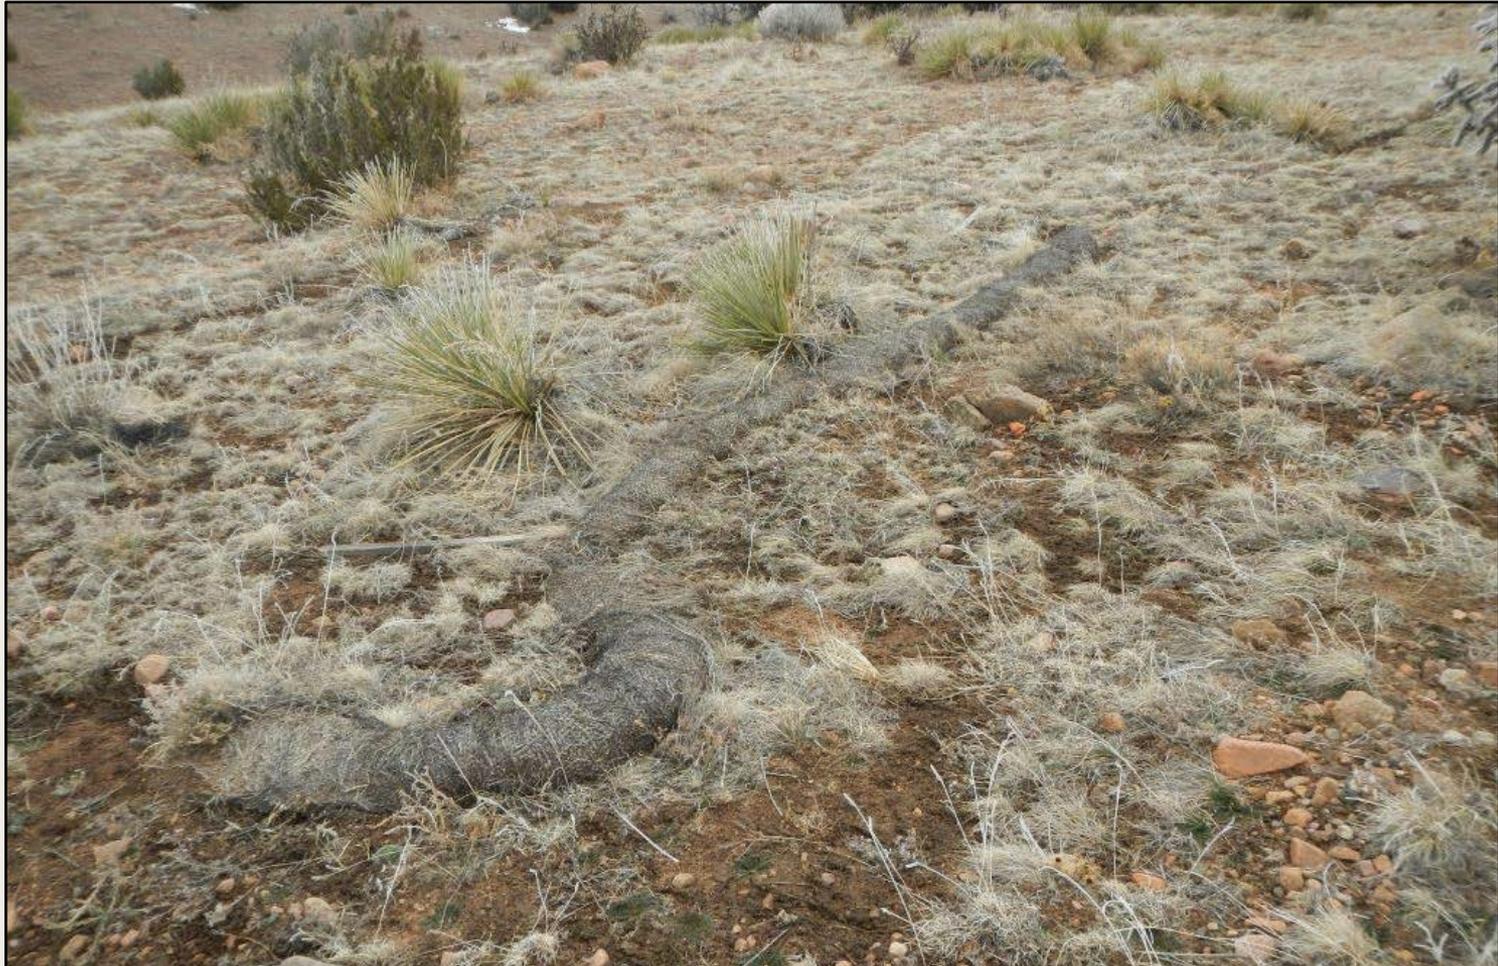
Photo 6. View of wattle debris in the southeastern project area. .
