Inspection Photos
Operator: Ausco Petroleum Inc.
Location/API #: 043-06230
Date: 2/27/2019

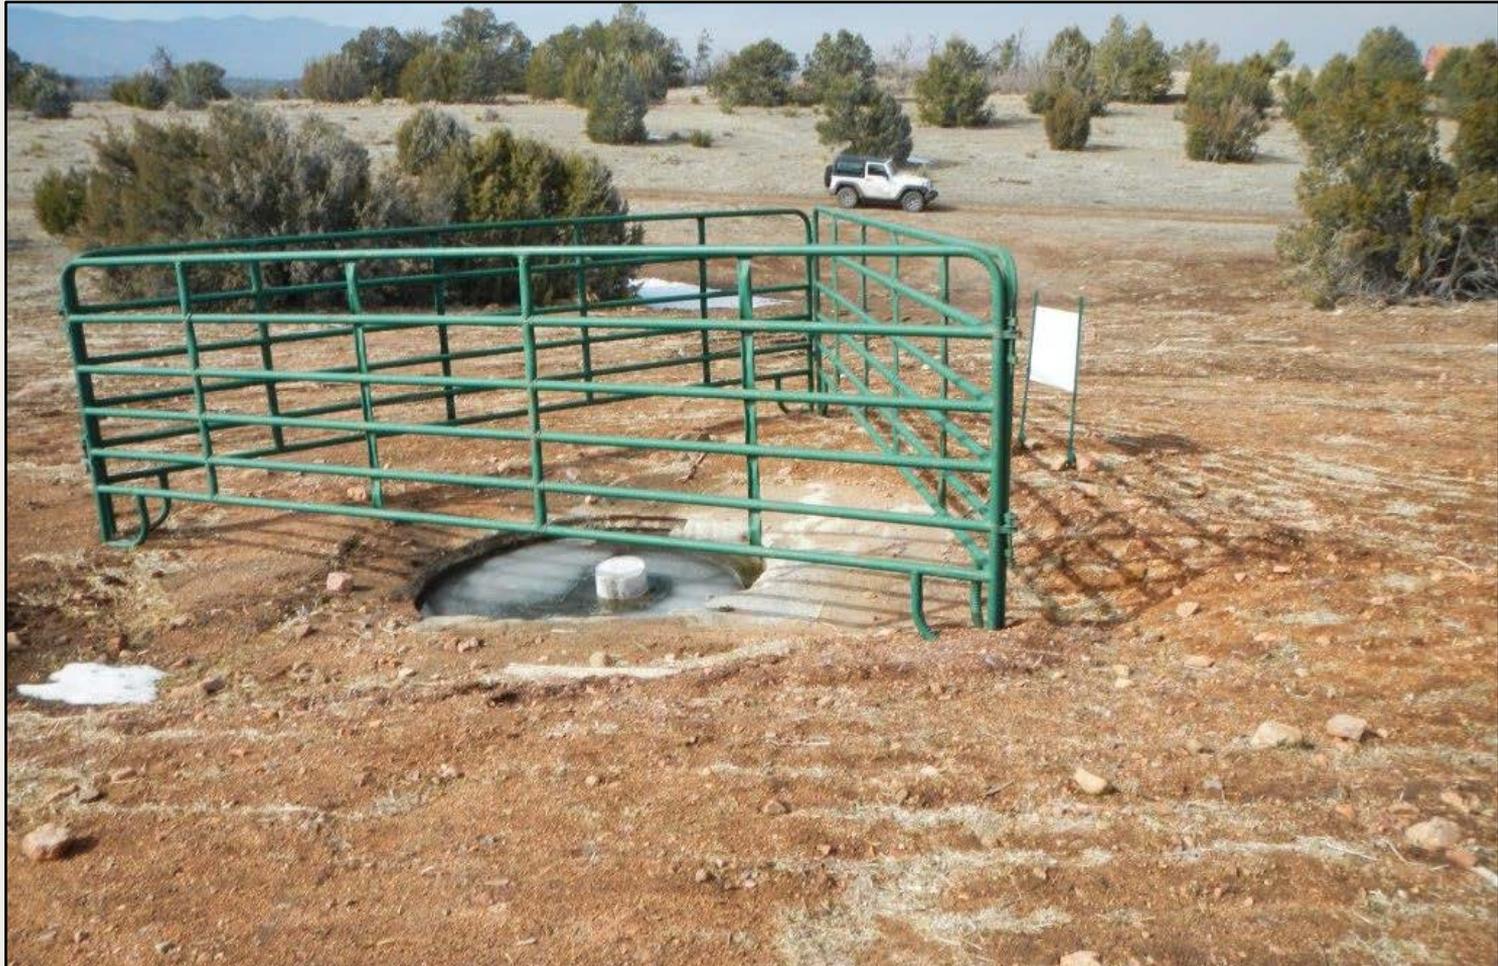
Photo 1. View of the project area from the southern edge facing northward. Project area appears recently reclaimed.

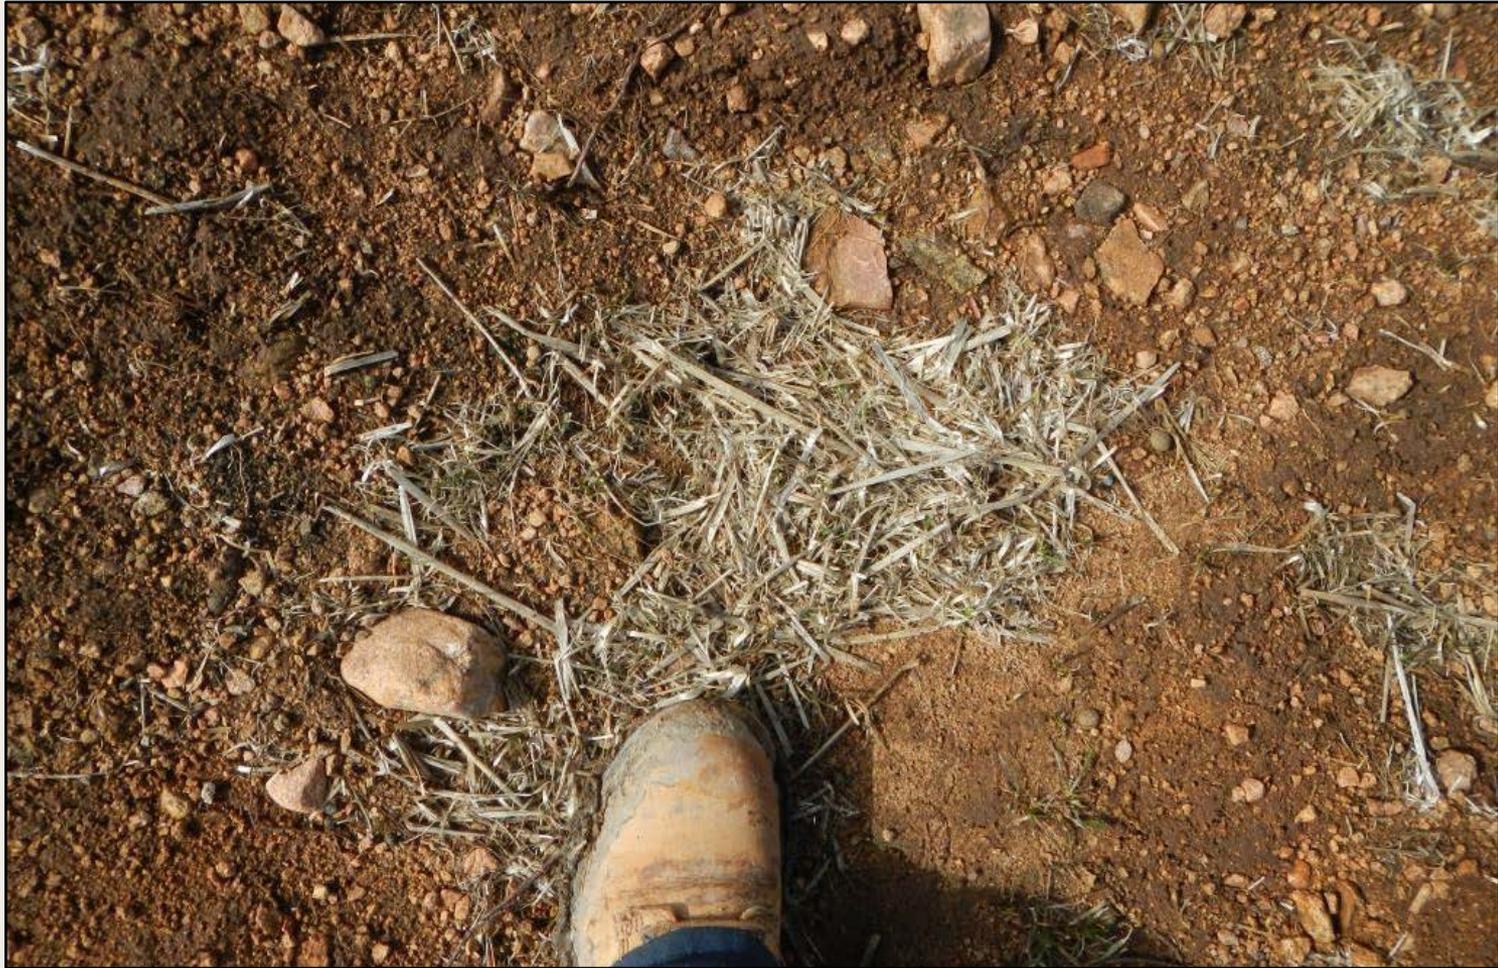
Photo 2. Birdseye view of reclamation within the project area. Small, green grass seedlings are observable within straw mulch.

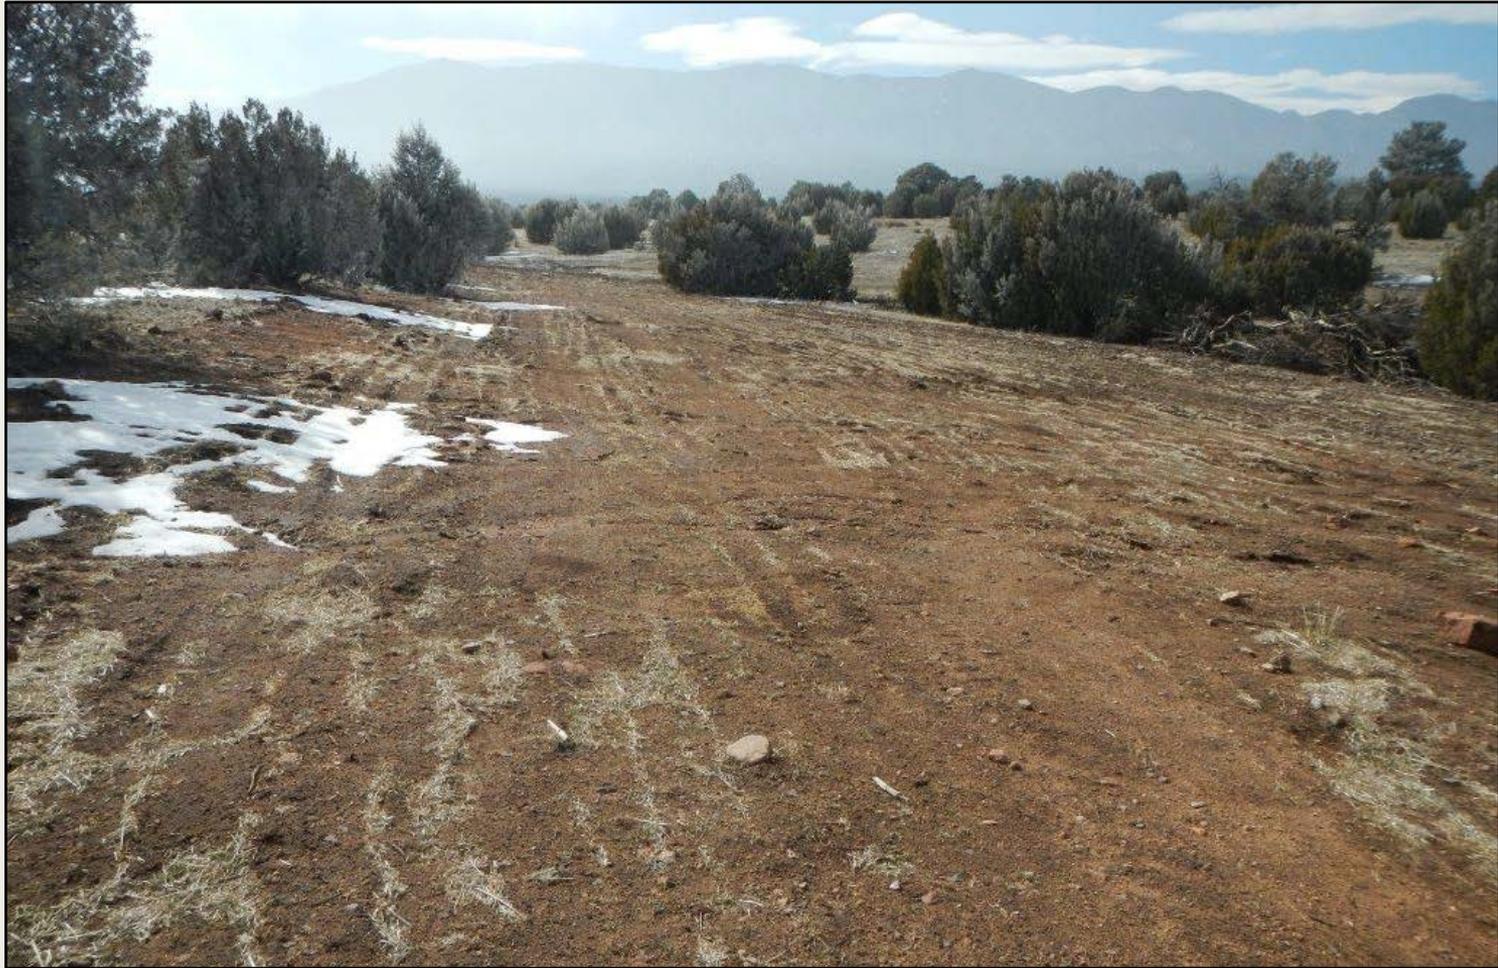
Photo 3. View of the western portion of the project area from the southern edge facing westward.

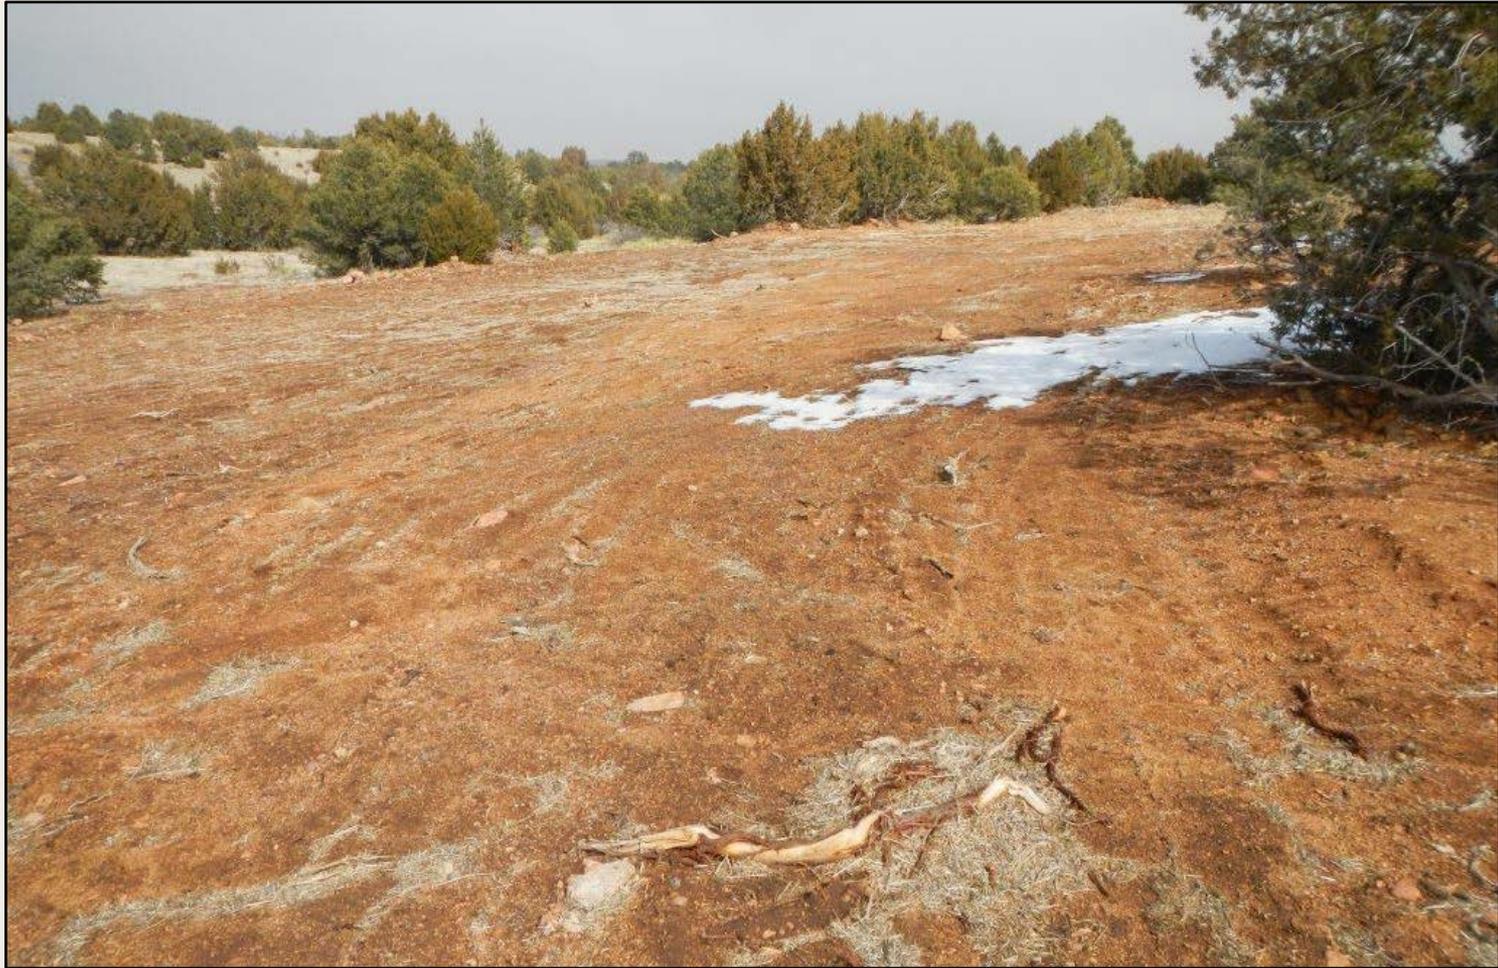
Photo 4. View of the eastern project area from the southern edge facing eastward.

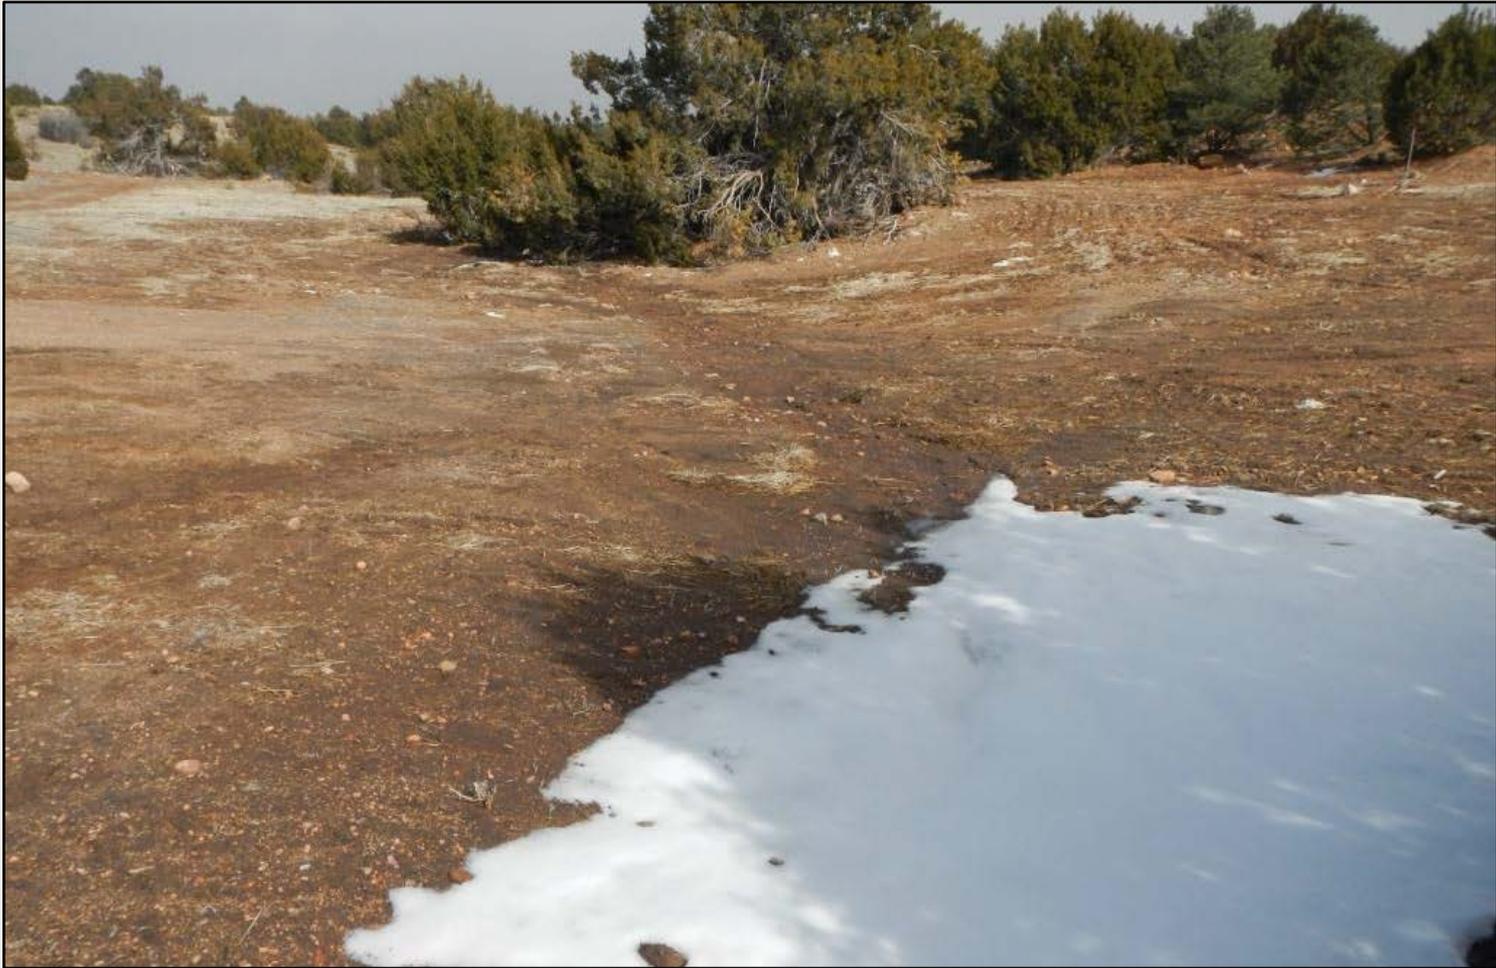
Photo 5. View of swale in the northern project area where snow melt is causing erosion. Stormwater controls are needed to stabilize erosion and sediment run-off from the project area.

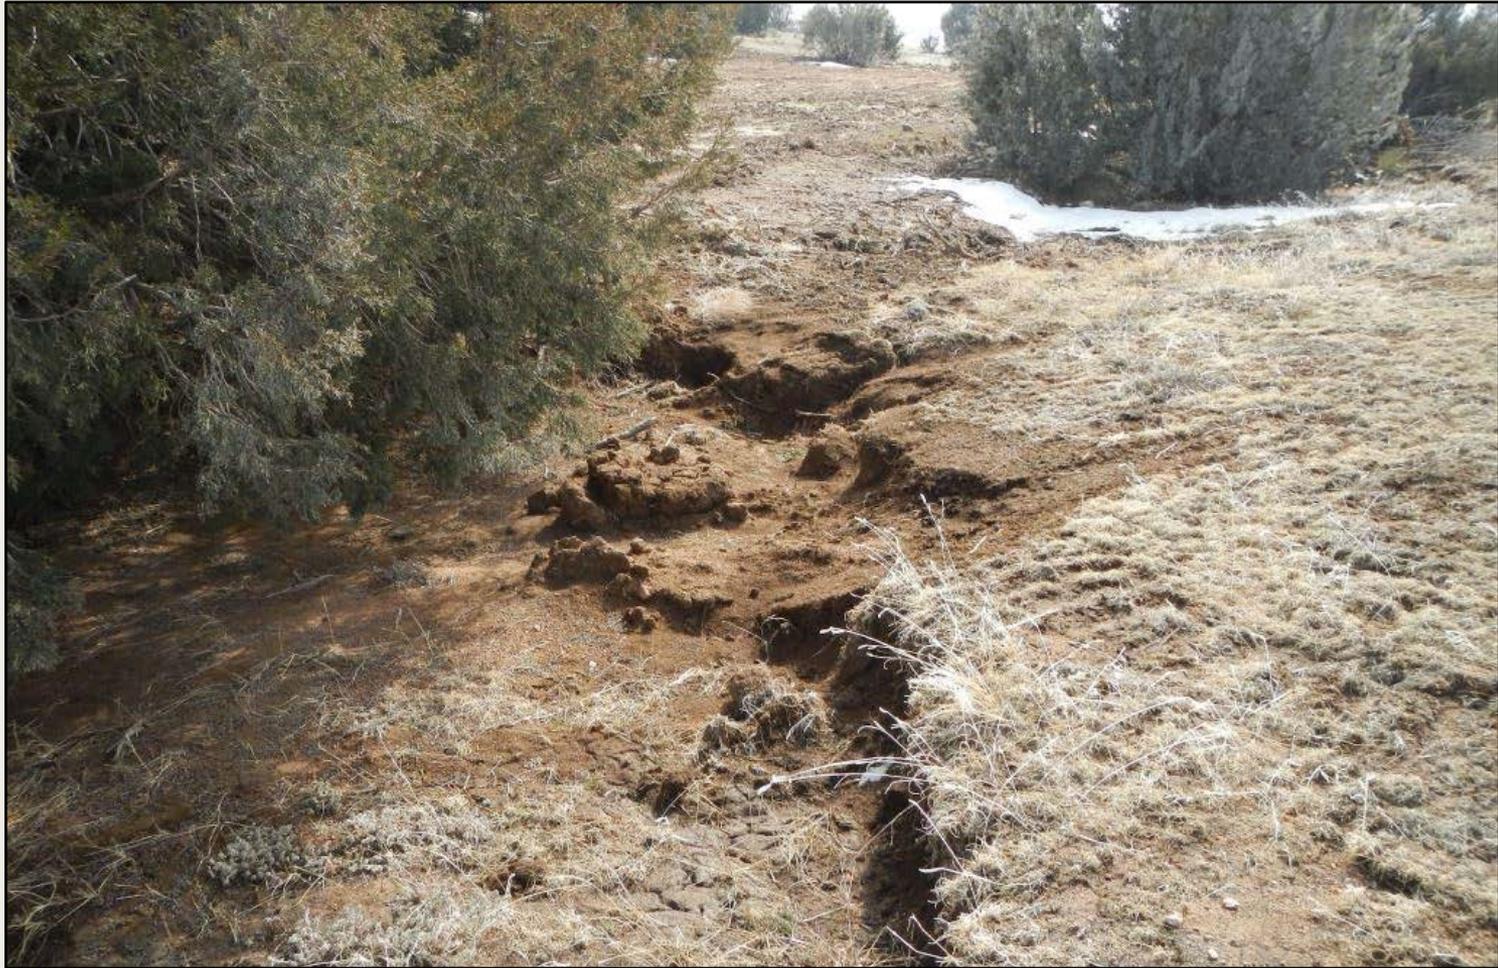
Photo 6. View of headcut erosion within and upstream from the drainage in Photo 4. Stormwater controls are needed to stabilize erosion here.
