# Construction and Stormwater Inspection

February 28, 2019

Operator: HIGHPOINT OPERATING CORPORATION- #10071

Location ID: 444377

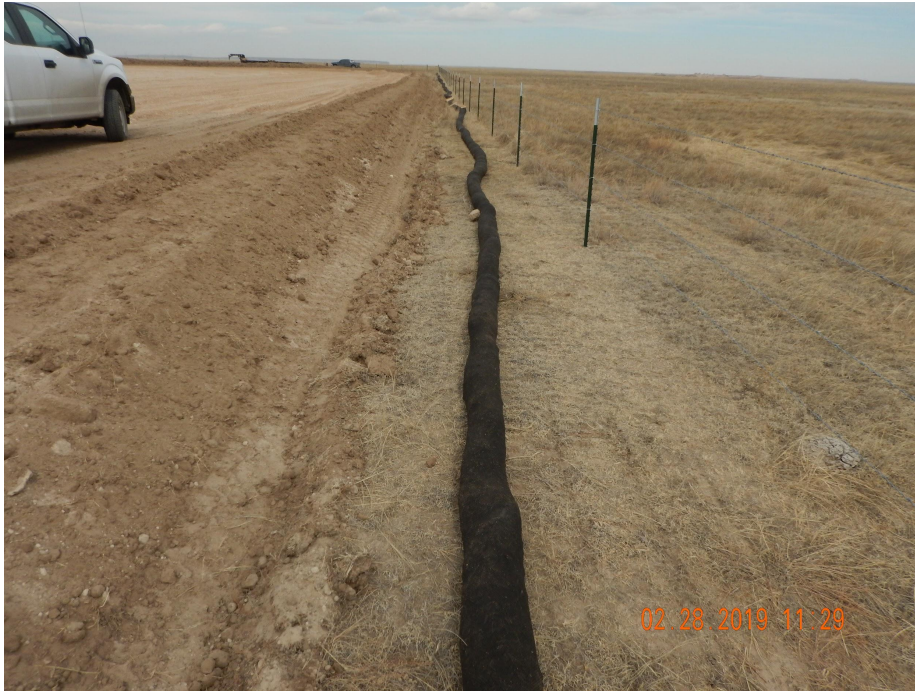
**Photo 1.** Photo taken from the southeastern perimeter of location, facing North. Photo illustrates a ditch and wattle BMP. The ditch does not appear to be constructed to a sufficient depth and wattle BMPs have not be staked.

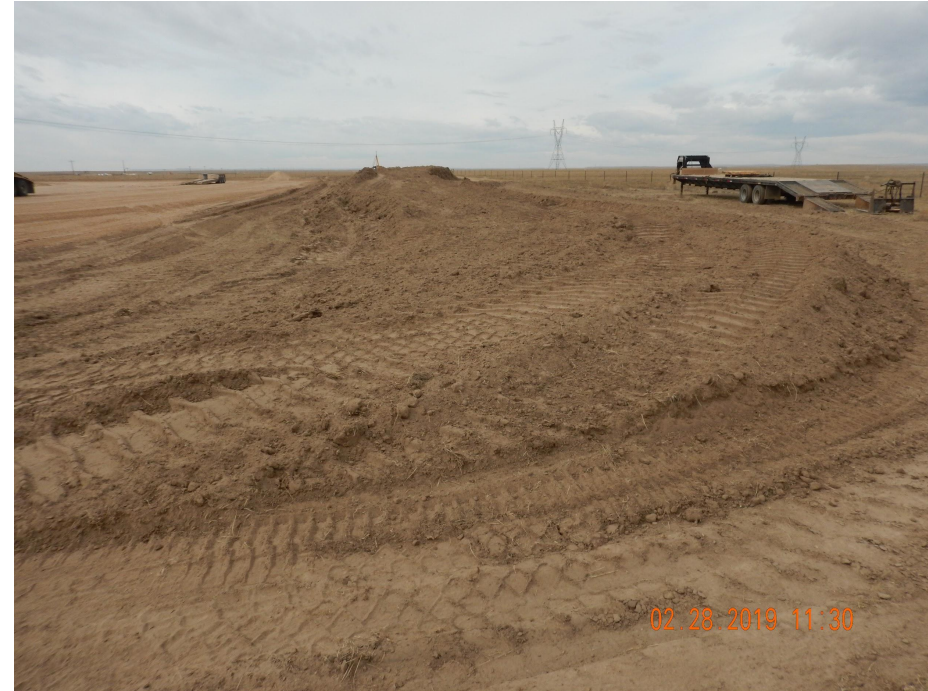
**Photo 2.** Photo taken from the northeastern perimeter of location, facing West. Photo illustrates the topsoil stockpile. Based on field observations and calculations, Operator has not salvaged the required amount of topsoil. Operator shall properly stabilize the topsoil stockpile per Rule 1002.c.

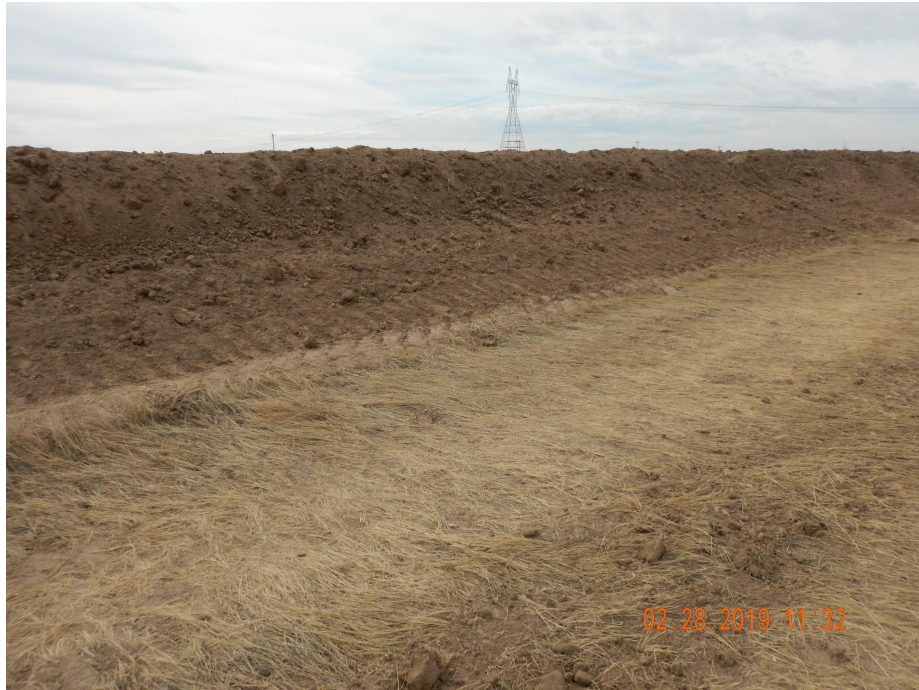
**Photo 3.** Photo taken from the northern perimeter of location, facing Southwest. See comments under Photo 2.

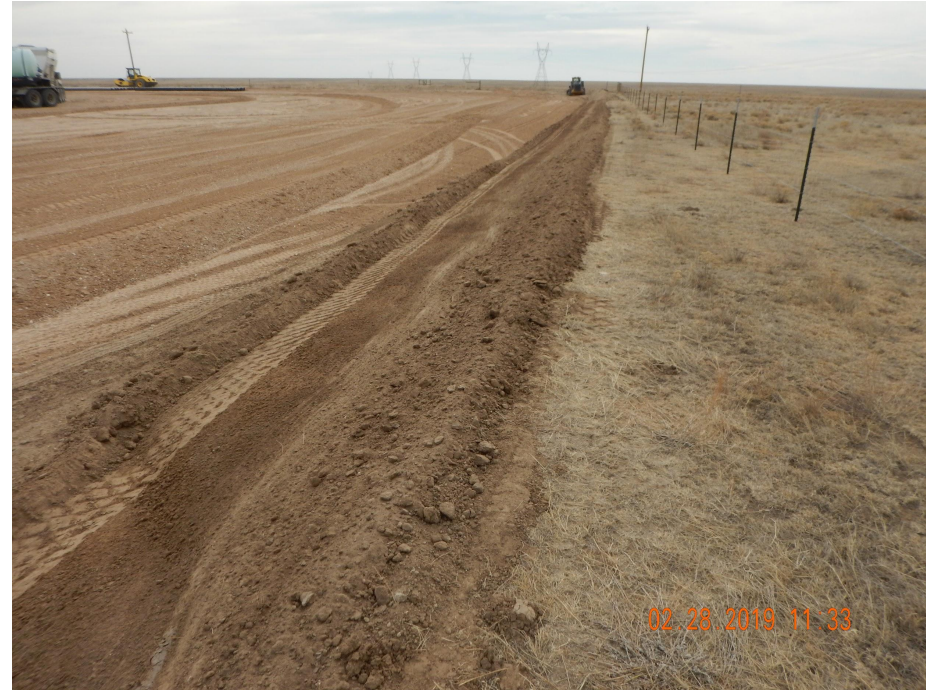
**Photo 4.** Photo taken from the western perimeter of location, facing South. Photo illustrates unconsolidated soil material that shall be stabilized, as this is susceptible to wind and water erosion.

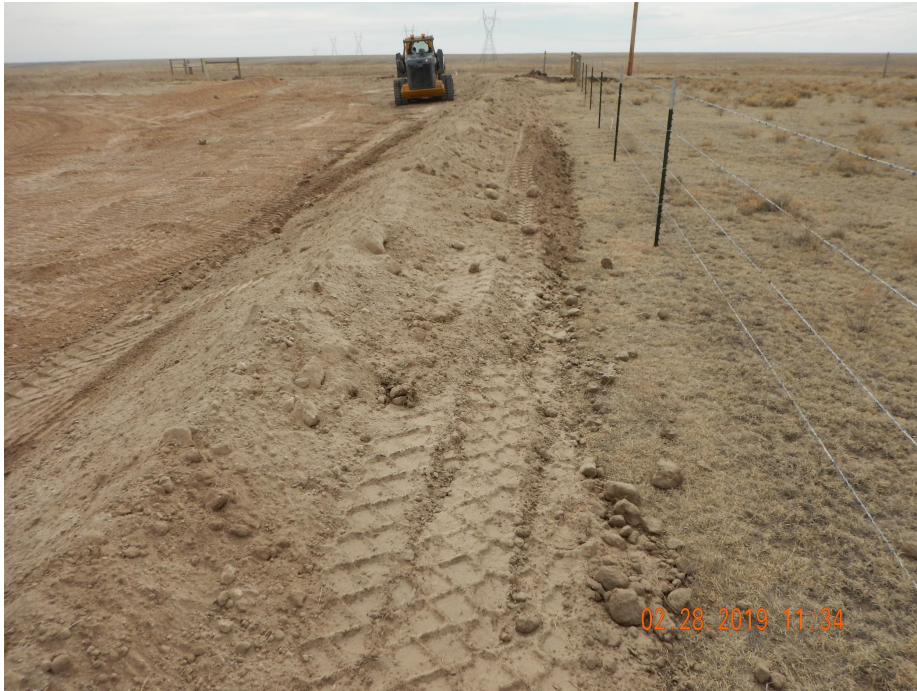
**Photo 5.** Photo taken from the southwestern perimeter of location, facing South. See comments under Photo 4.

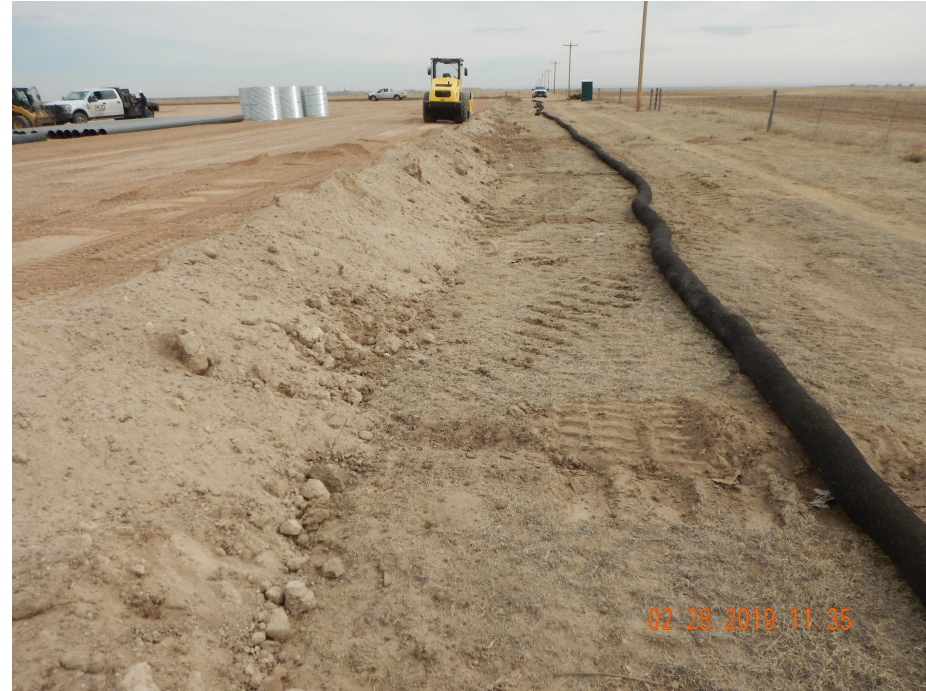
**Photo 6.** Photo taken from the southwestern perimeter of location, facing East. Photo illustrates unconsolidated soil material that shall be stabilized and wattle BMP that has not be staked.

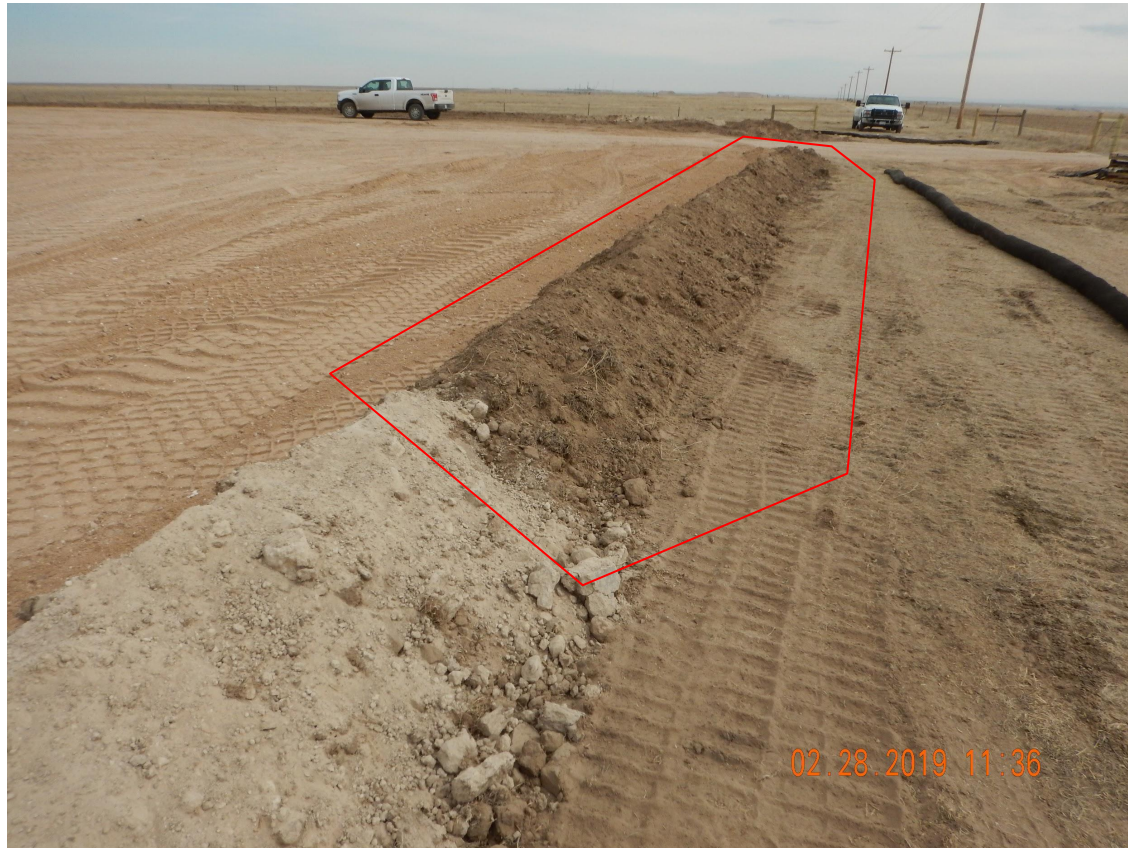
**Photo 7.** Photo taken from the southeastern perimeter of location, facing East. Photo illustrates Operator is using topsoil to create a berm BMP. See comments under Photo 6.
