Inspection Photos 02/13-14/2019 & 3/13/19
Location: KP Kauffman Grant Tank Battery
Facility ID # 446608

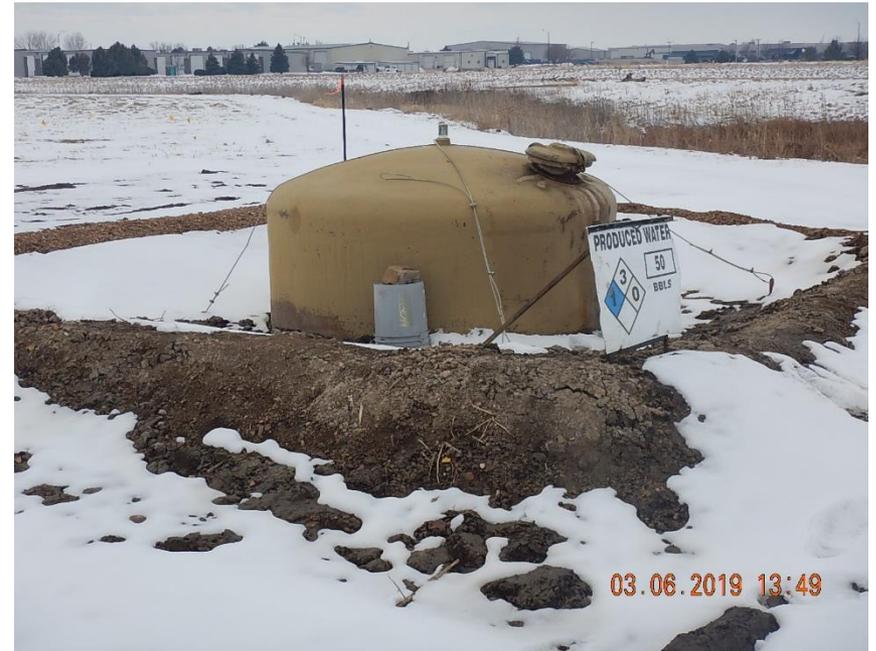
Fiberglass PBV - 50 BBL Produced Water Tank

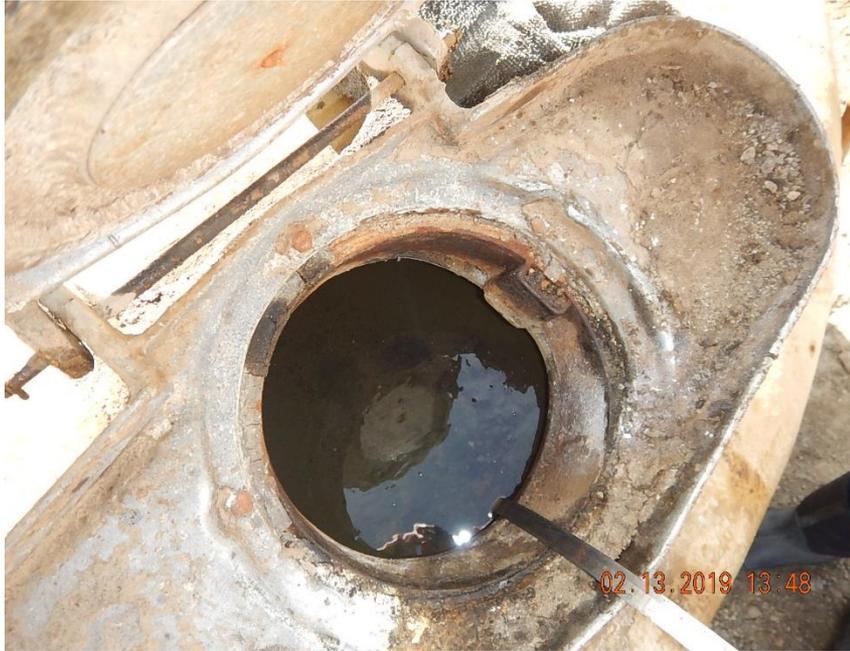
Produced water tank integrity testing – measuring fluid level during second day of test

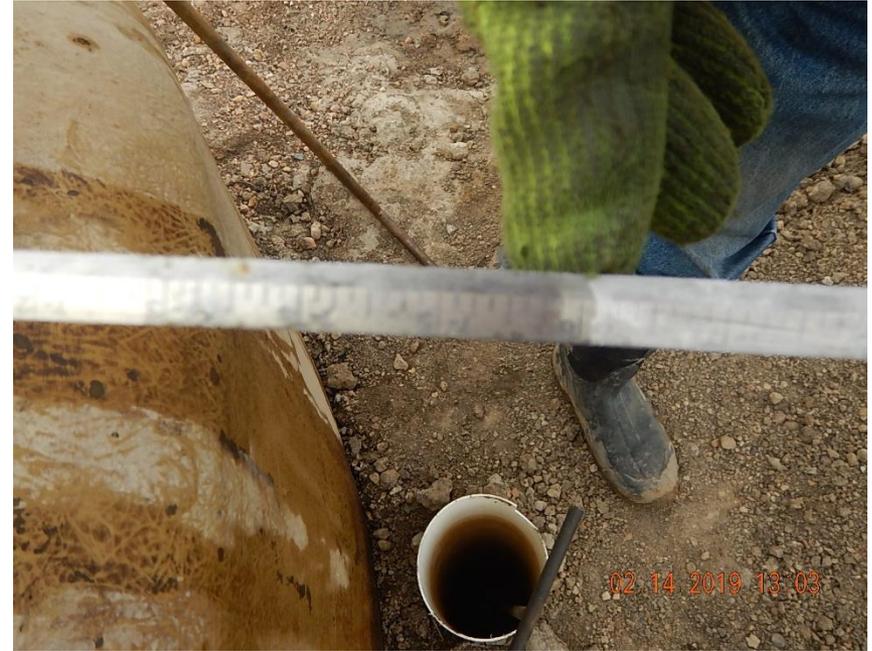
Produced water tank integrity testing; gauge reading at approx. 48 hrs. No drop in fluid level – Test Deemed Satisfactory

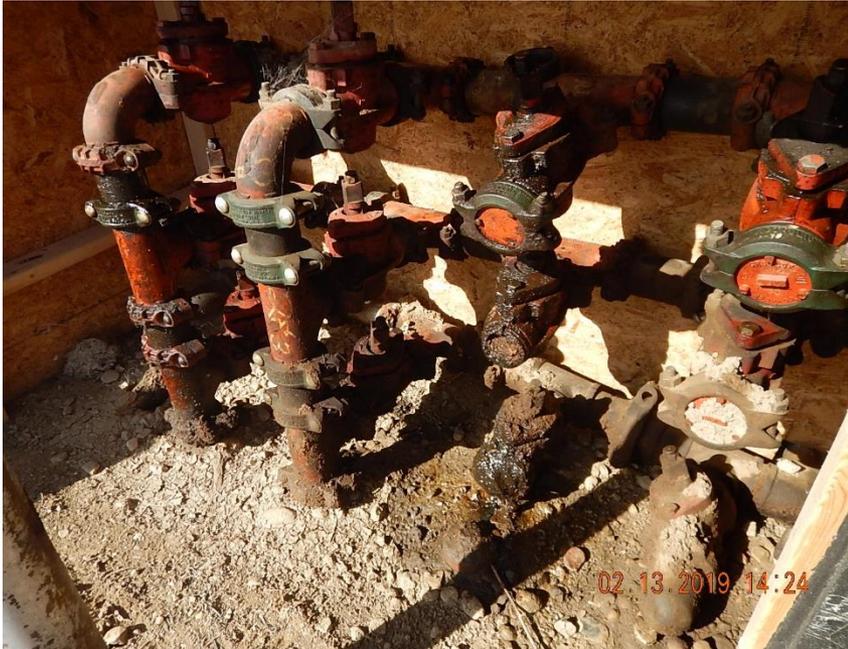
Active fluid leak observed at flowline manifold/ header

Repairs completed to flowline manifold following day;
Leaking valves removed; housekeeping completed

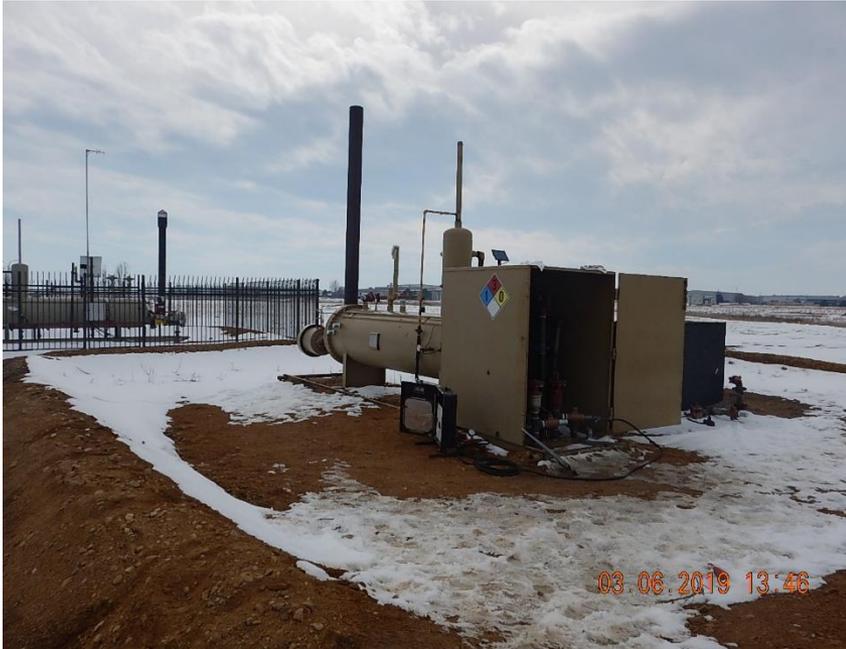
Pressure testing in progress at the heated horizontal separator on the produced water and crude oil dump flowlines; Chart recorder documenting results

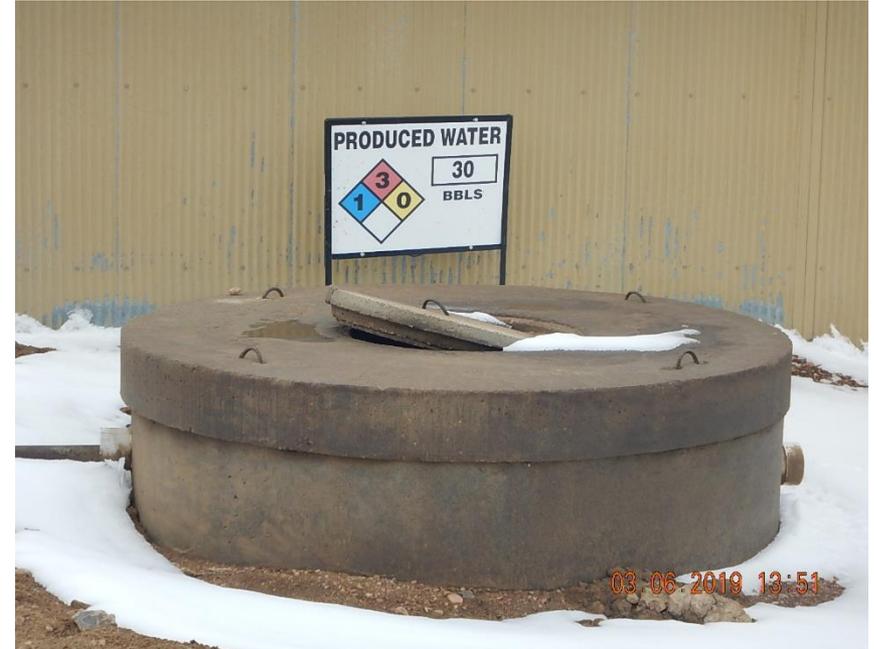
30 bbl concrete produced water vault on East side of location; Access cover needs to be re-installed

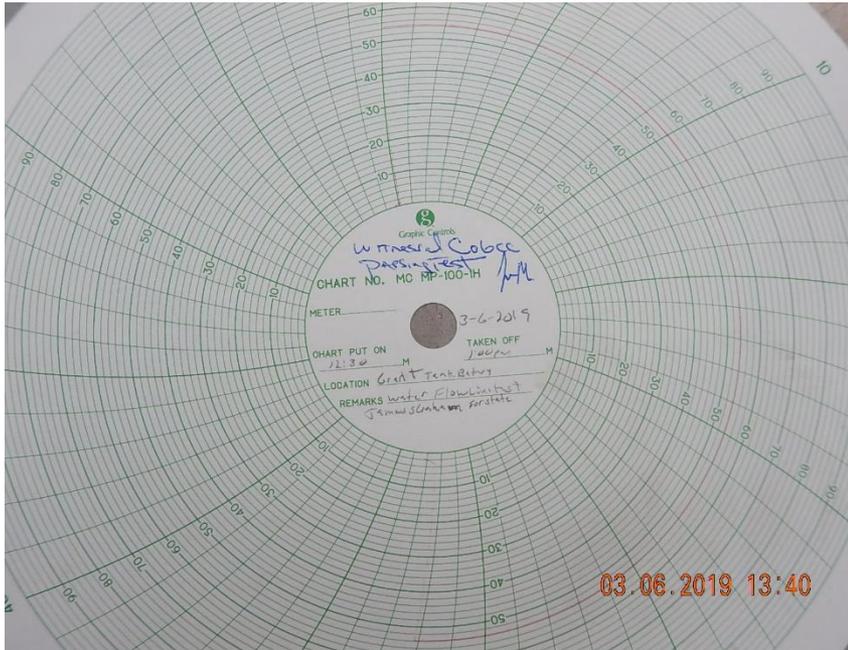
Flowline pressure test chart – Produced water dump flowline; Test meets rule and deemed satisfactory

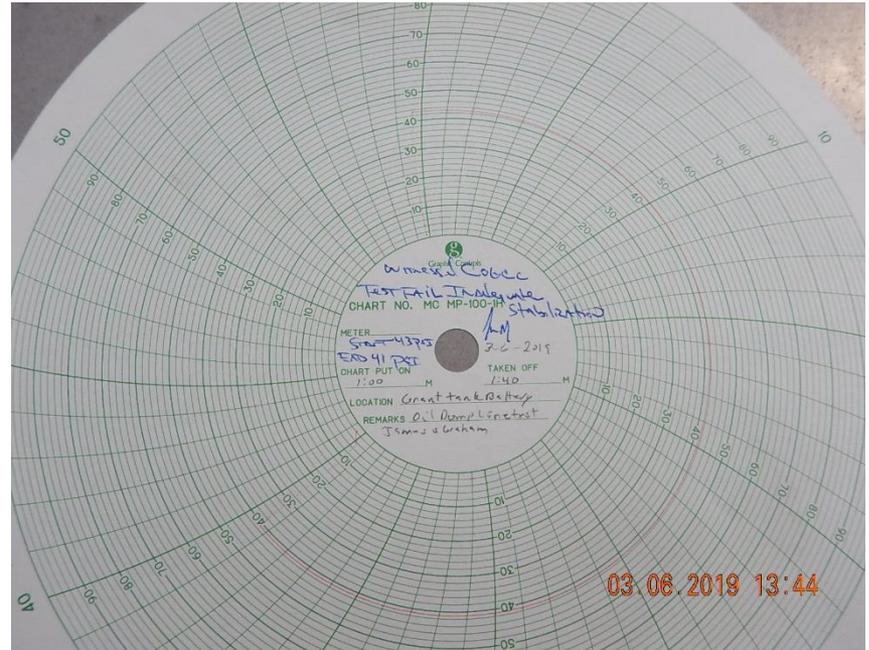
Flowline pressure test chart – Crude oil dump flowline; Test deemed failing due to inadequate pressure stabilization

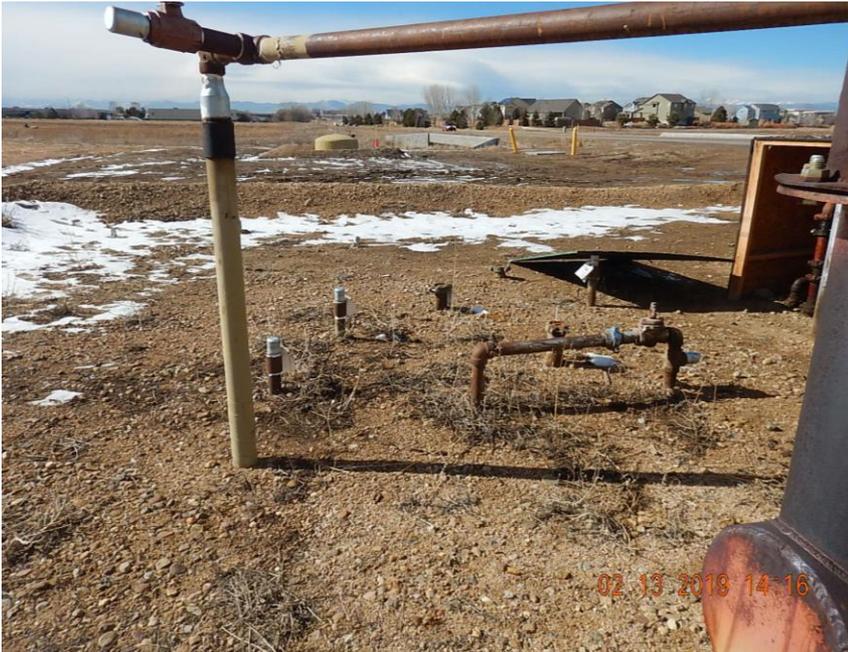
**Unused/ inactive flowline risers; Per COGCC rule 603.f.
inactive flowline risers to be removed by operator in 30 days;
View looking West**

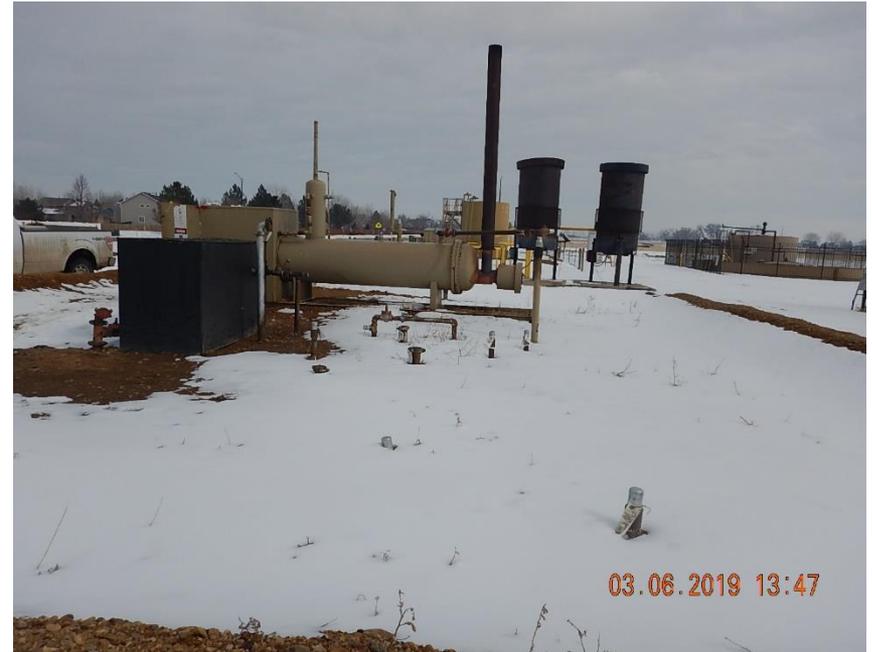
**Unused/ inactive flowline risers; Per COGCC rule 603.f.
inactive flowline risers to be removed by operator in 30 days;
View looking East**
