Inspection Photos
Location Name: STORM PEAK 44-6
API #: 05-071-08949
Insp. Doc. # 695100310

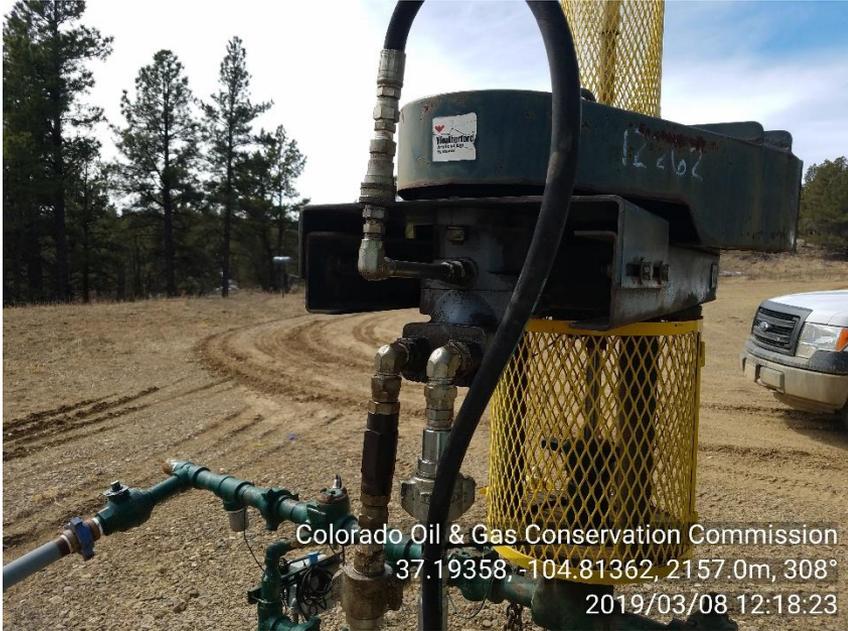
PHOTO 3: I WITNESSED 1" HYDRAULIC LINE DRIP HYDRAULIC FLUID.

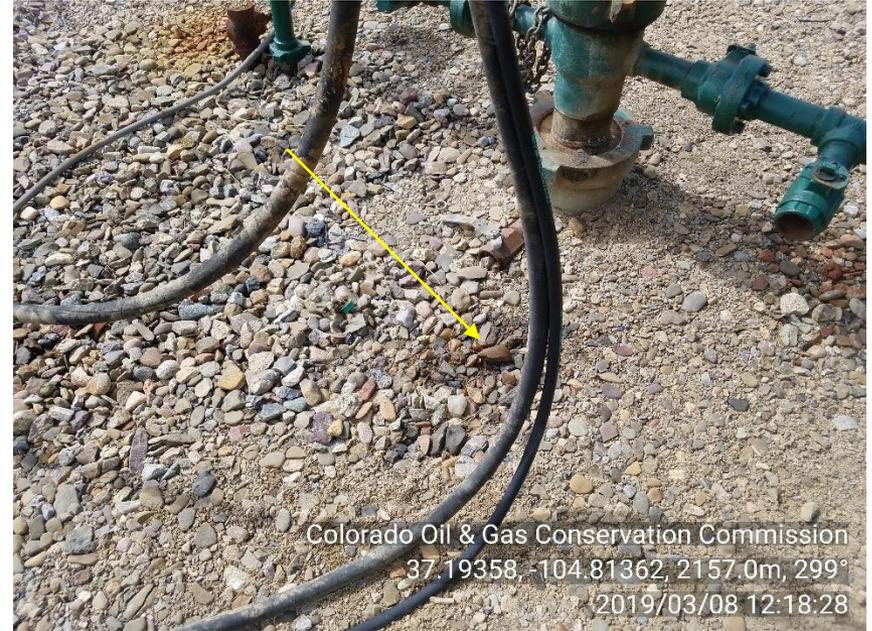
PHOTO 4: IMPACTED SOIL BENEATH 1" HYDRAULIC LINE.

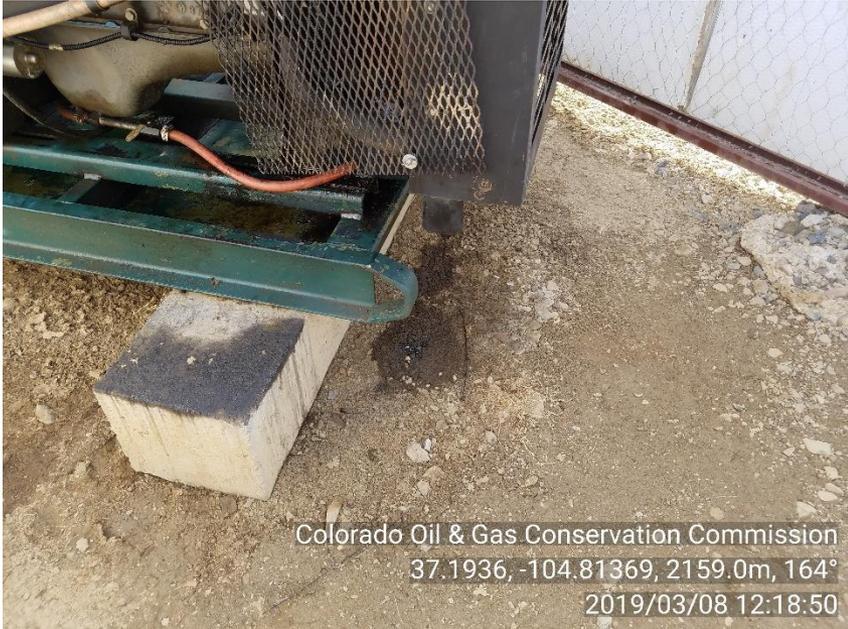
PHOTO 5: APPEARS ENGINE IS LEAKING OIL. IMPACTED SOIL BENEATH FRONT OF ENGINE SKID.

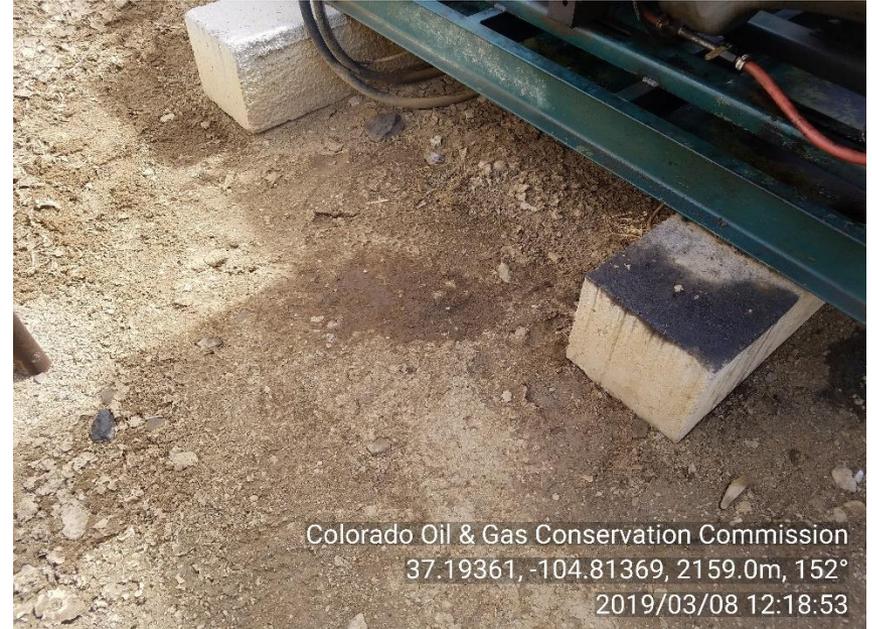
PHOTO 6: IMPACTED SOIL ON NORTH SIDE OF ENGINE SKID. I COULD NOT DETERMINE SOURCE OF LEAK.

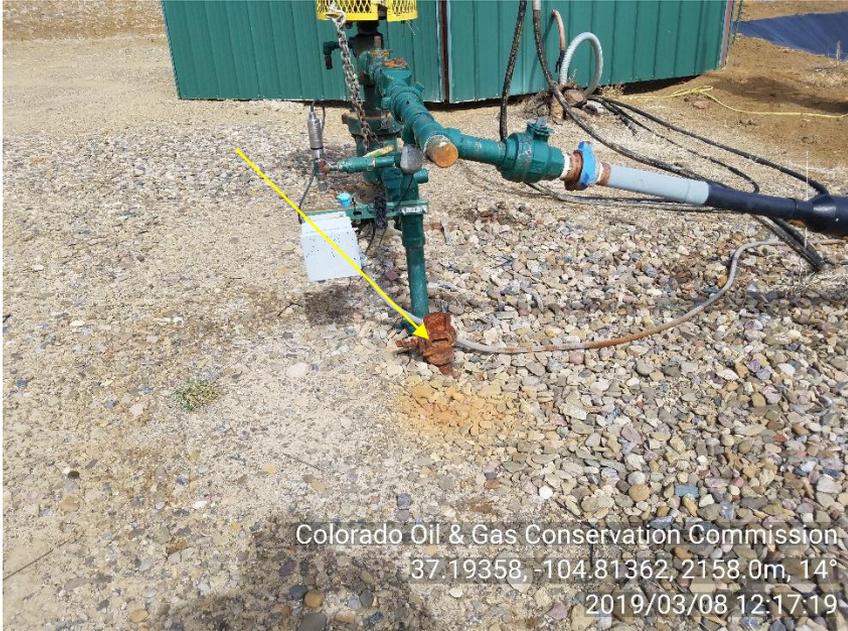
PHOTO 7: UNMARKED UNUSED RISER. VALVE IS BROKE

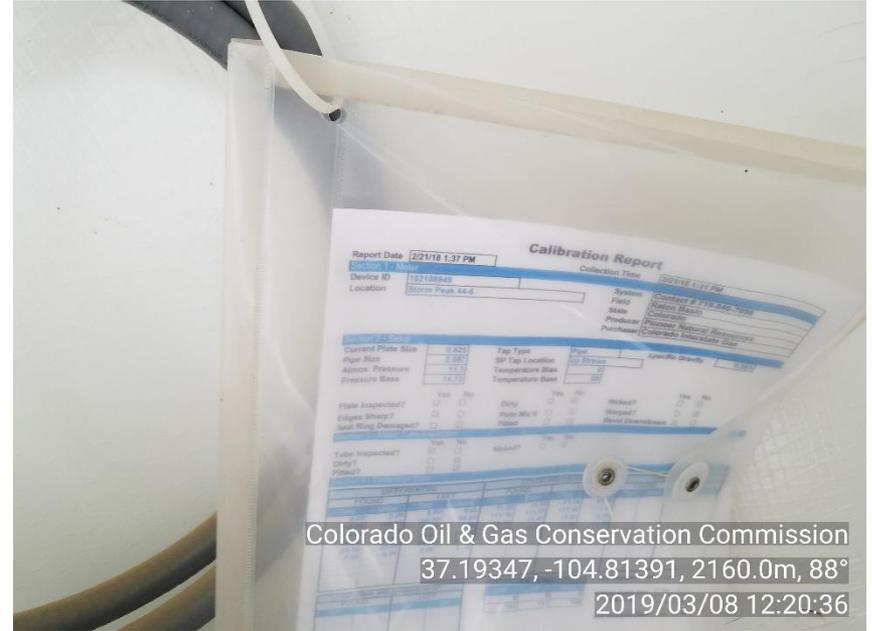
PHOTO 8: CALIBRATION REPORT IS PAST DUE. IT HAS BEEN OVER ONE YEAR SINCE LAST CALIBRATION.
