Inspection Photos
Operator: Javernick Oil
Location/API #: 043-06124
Date: 2/27/2019

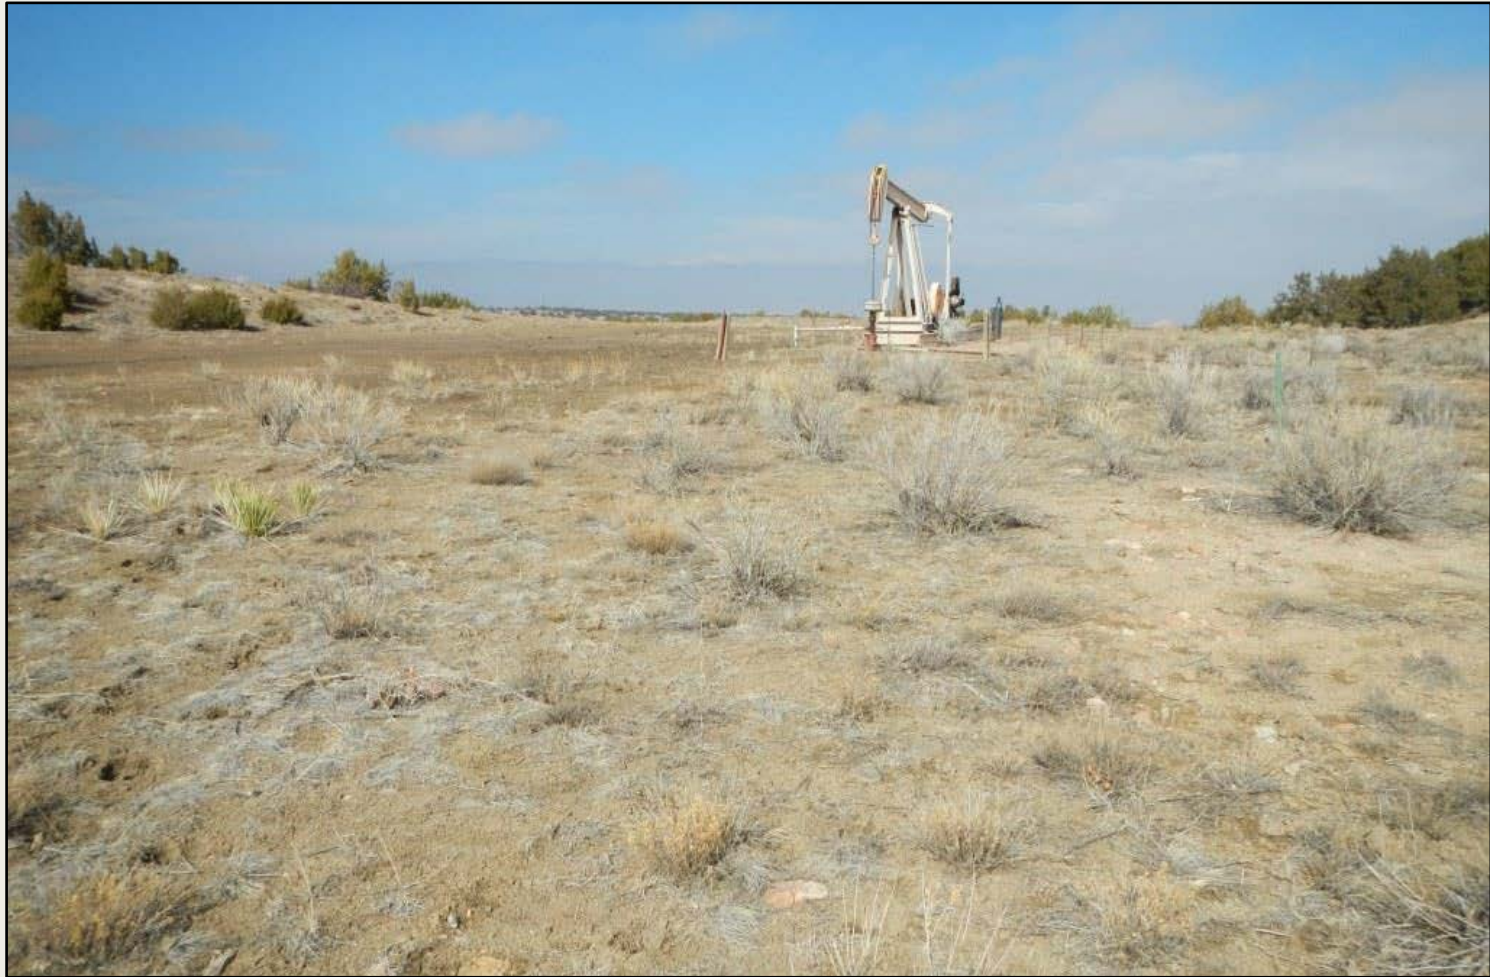
Photo 1. View of the project area from the southwestern edge facing center. Revegetation is progressing within the interim reclamation areas.

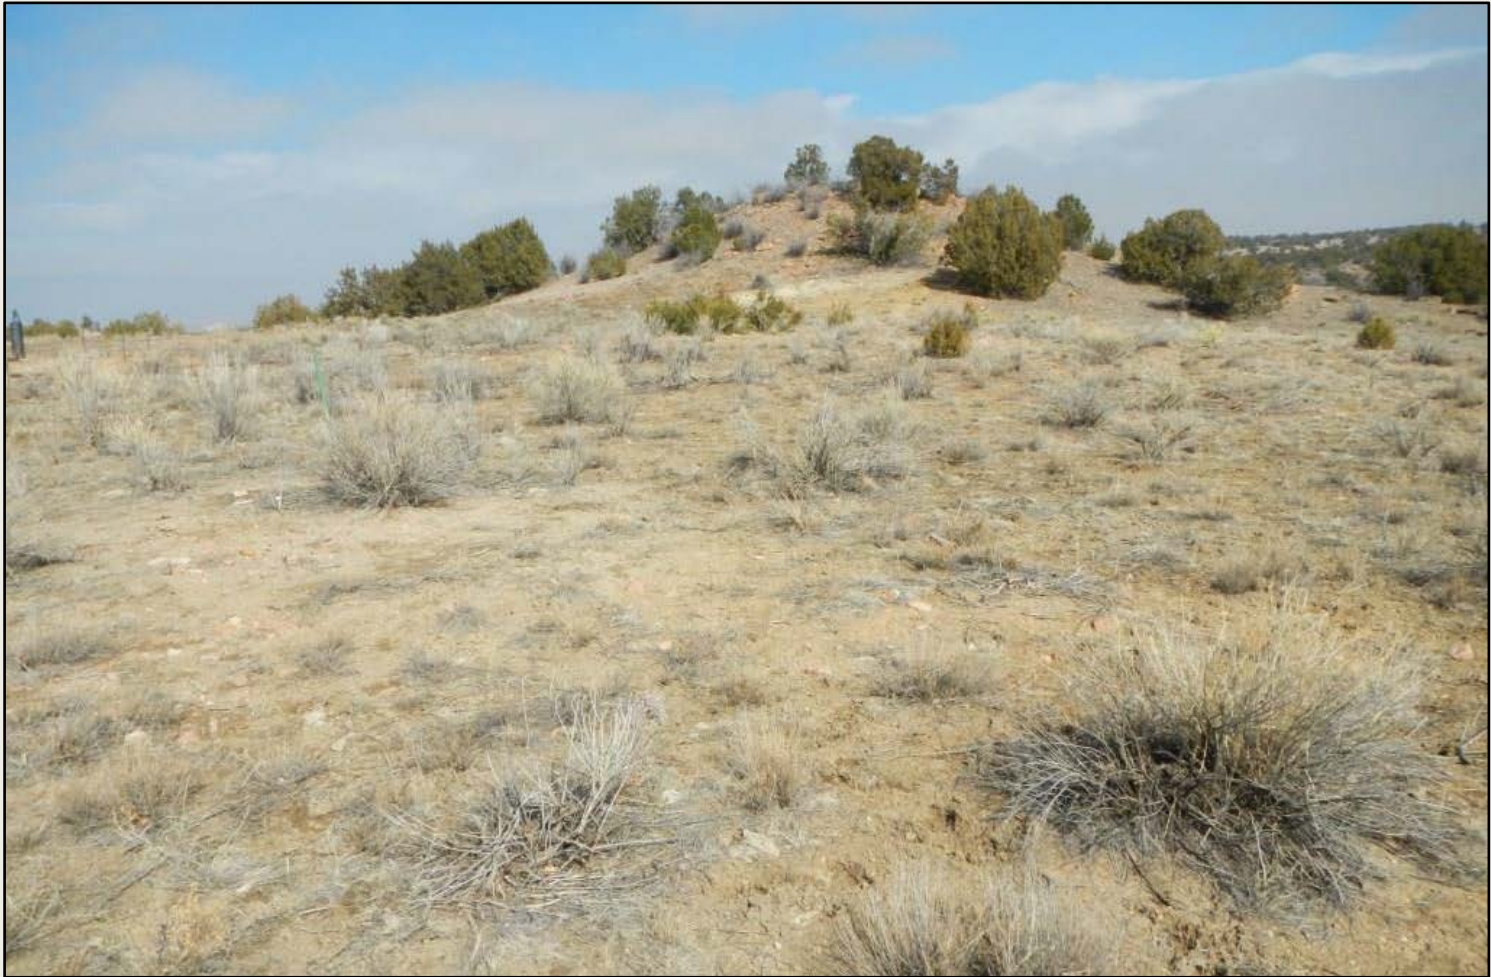
Photo 2. View of the southern project area from the southwestern edge facing eastward.

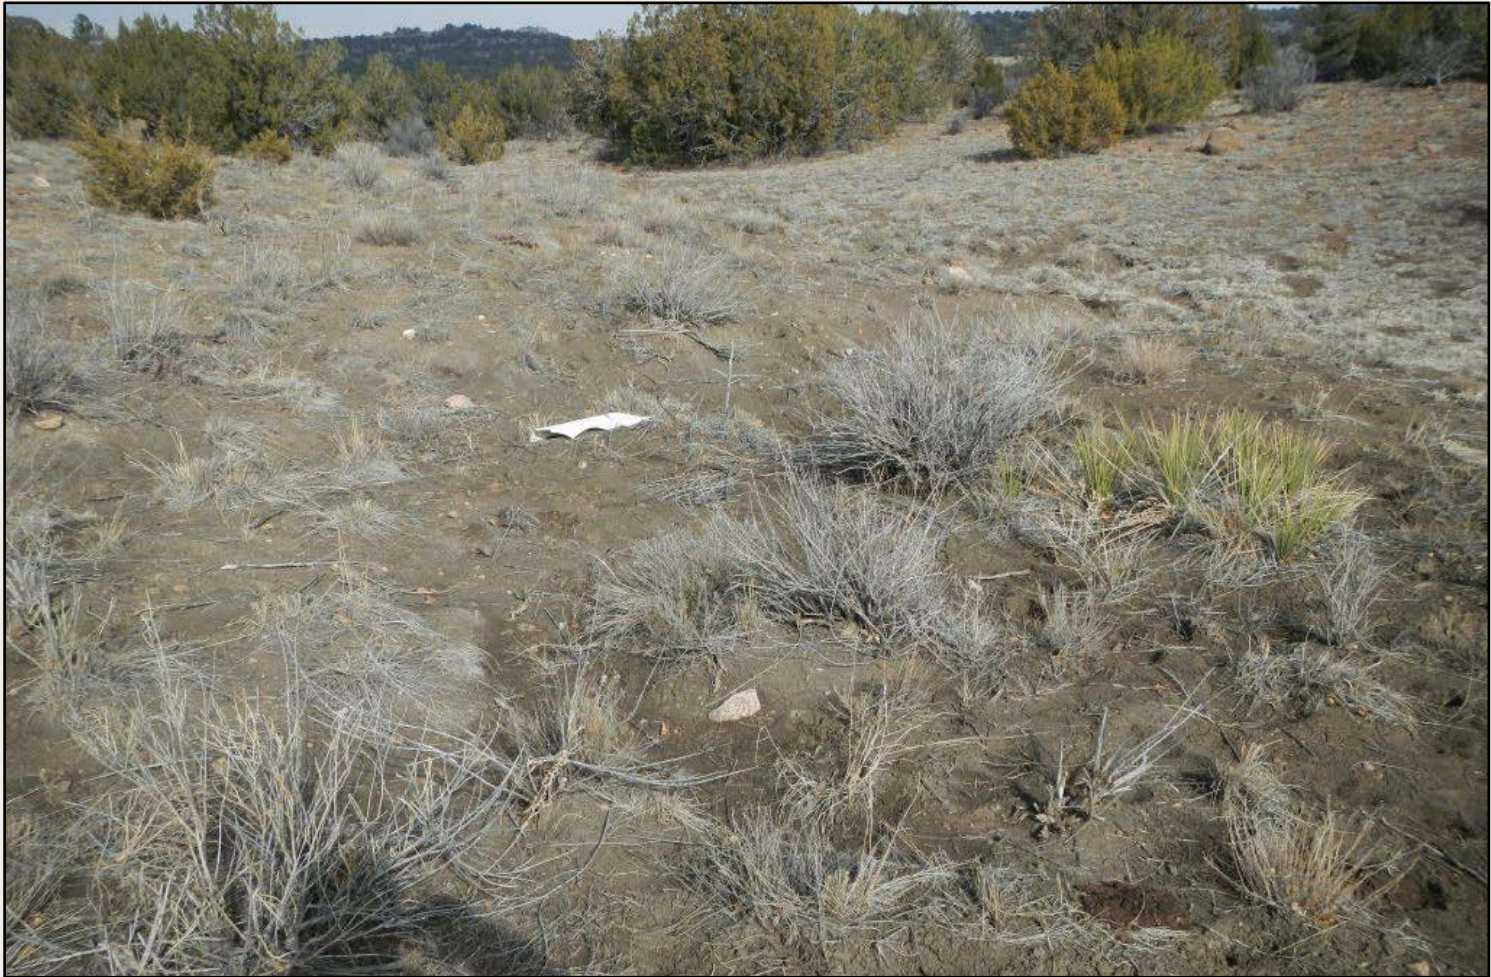
Photo 3. View of area within the southeastern project area where an erosional channel is forming and stormwater controls are needed.

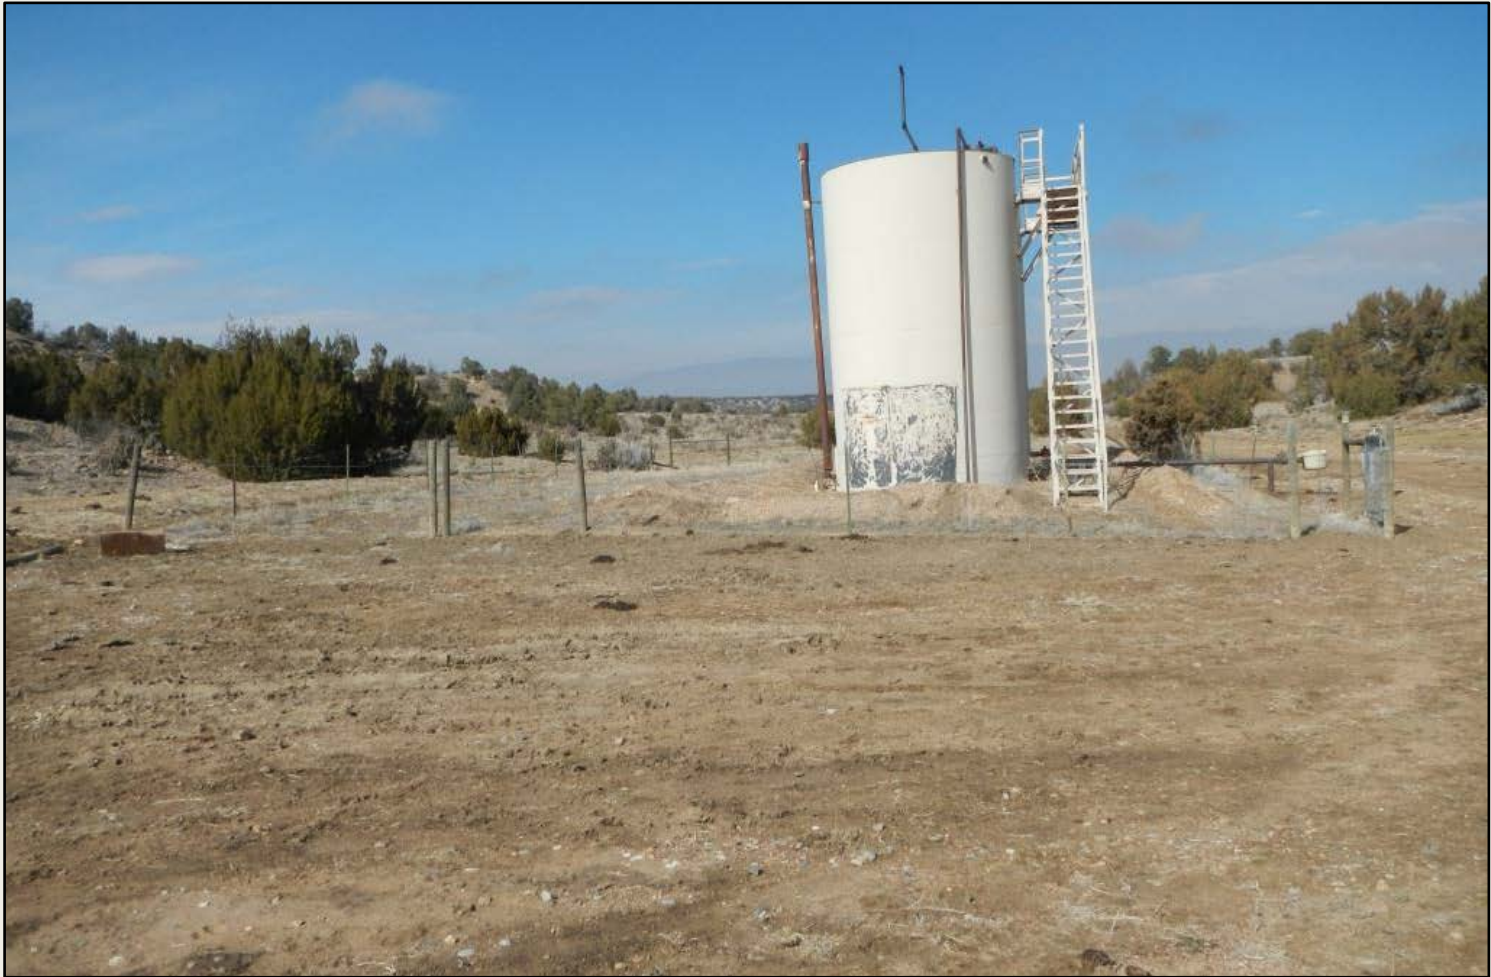
Photo 4. View of tank battery location south of the well pad.
