Inspection Photos
Operator: Ausco Petroleum Inc.
Location/API #: 043-06219
Date: 2/28/2019

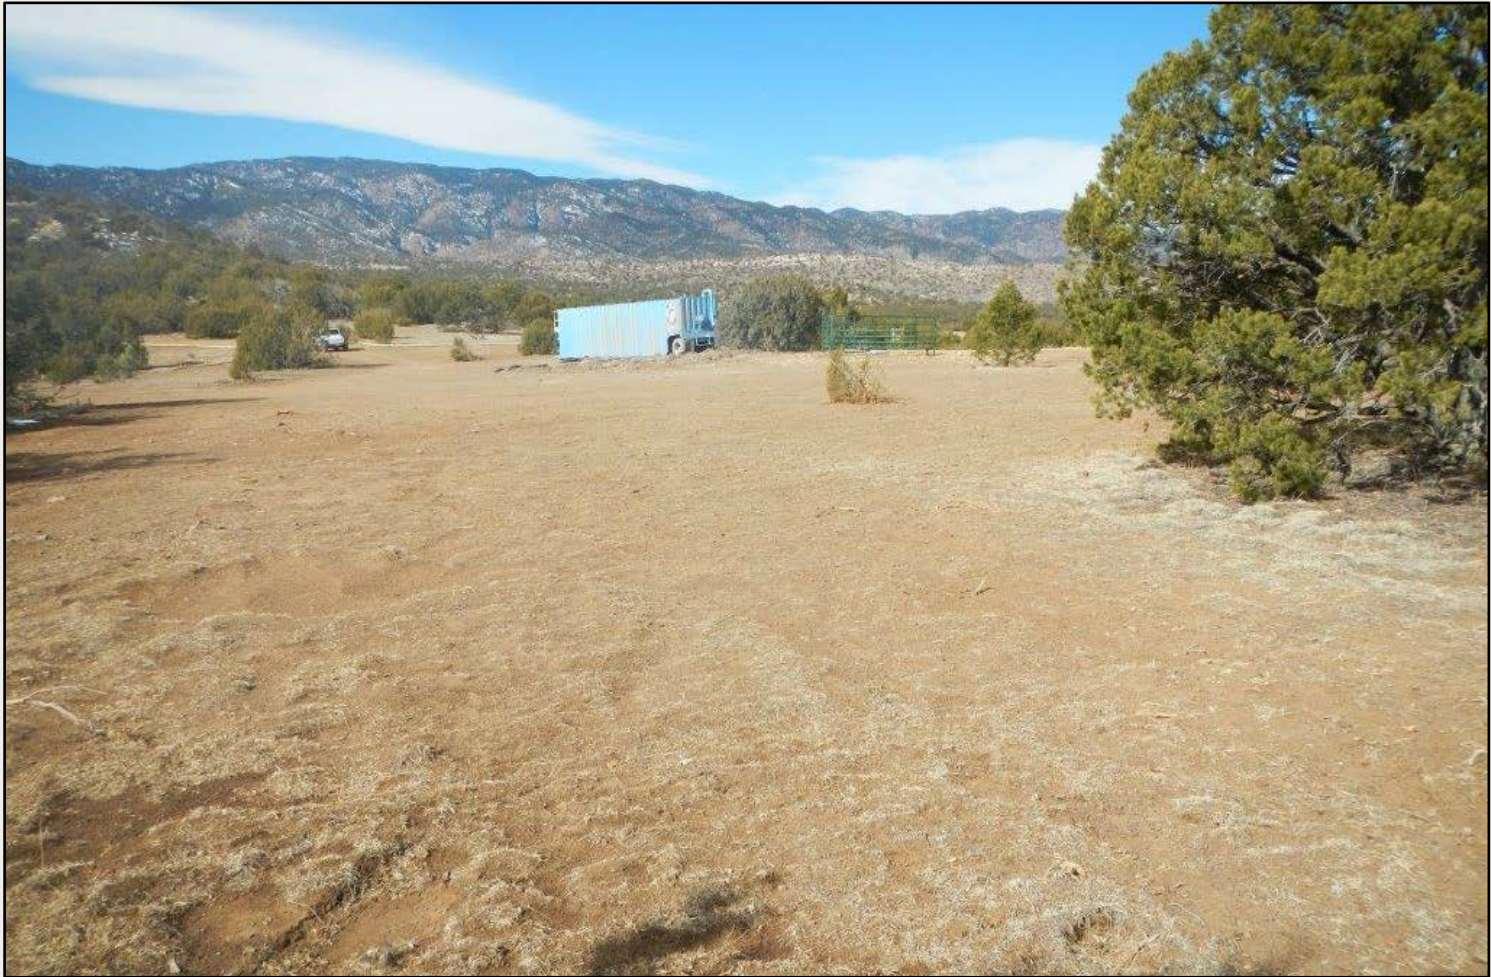
Photo 1. View of the project area from the eastern project area facing center toward the well.

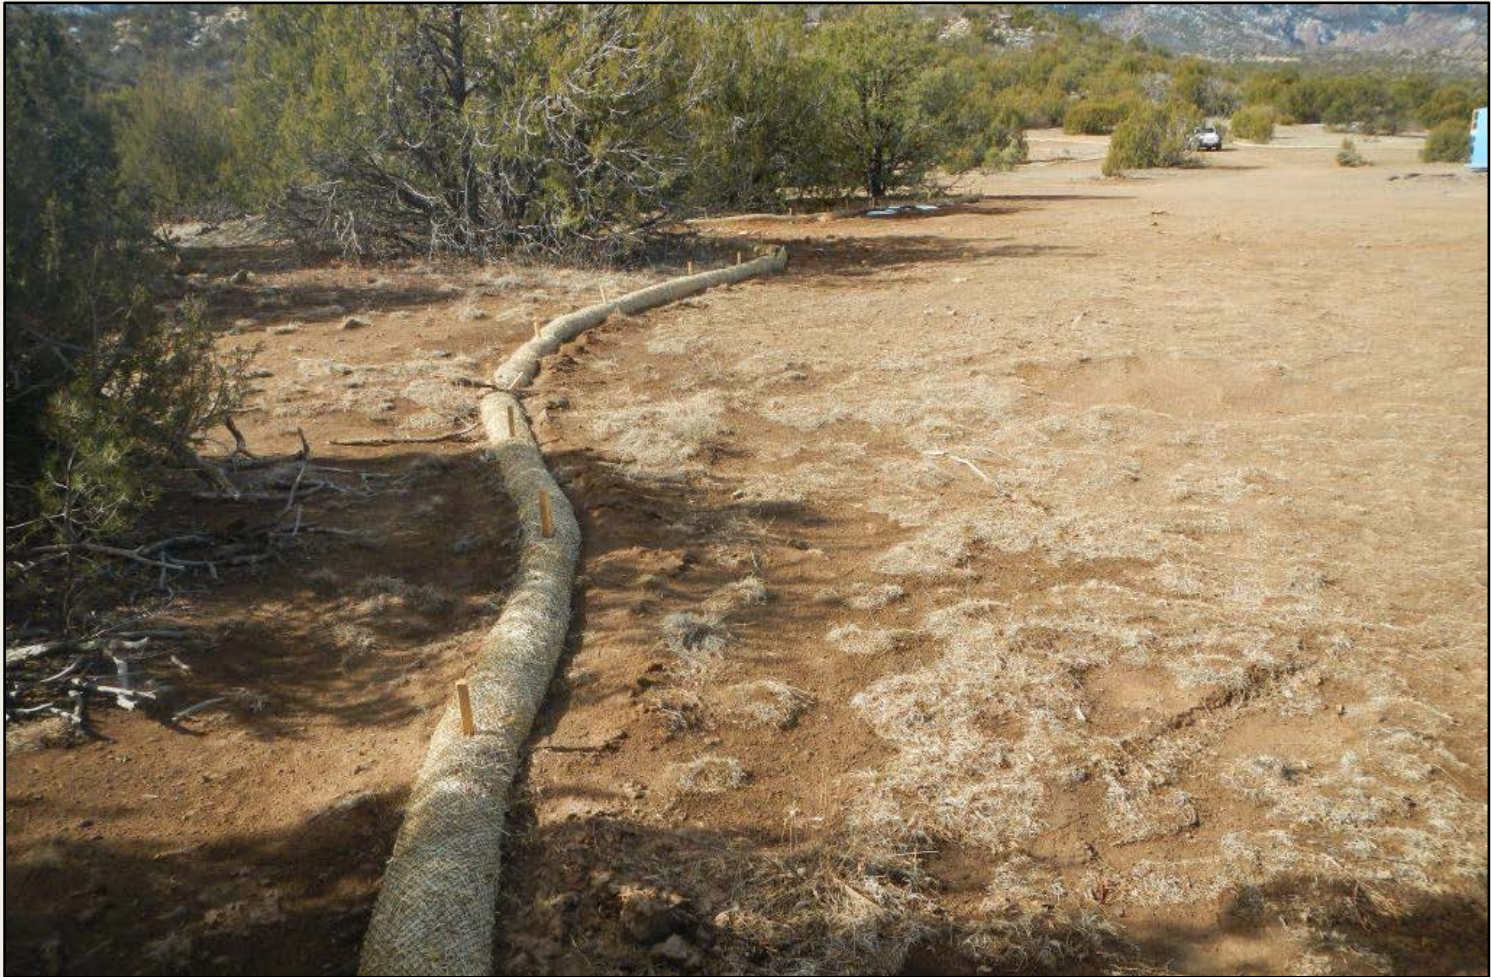
Photo 2. View of the eastern project area from the eastern corner facing southward. Wattles are placed around the perimeter of the project area.

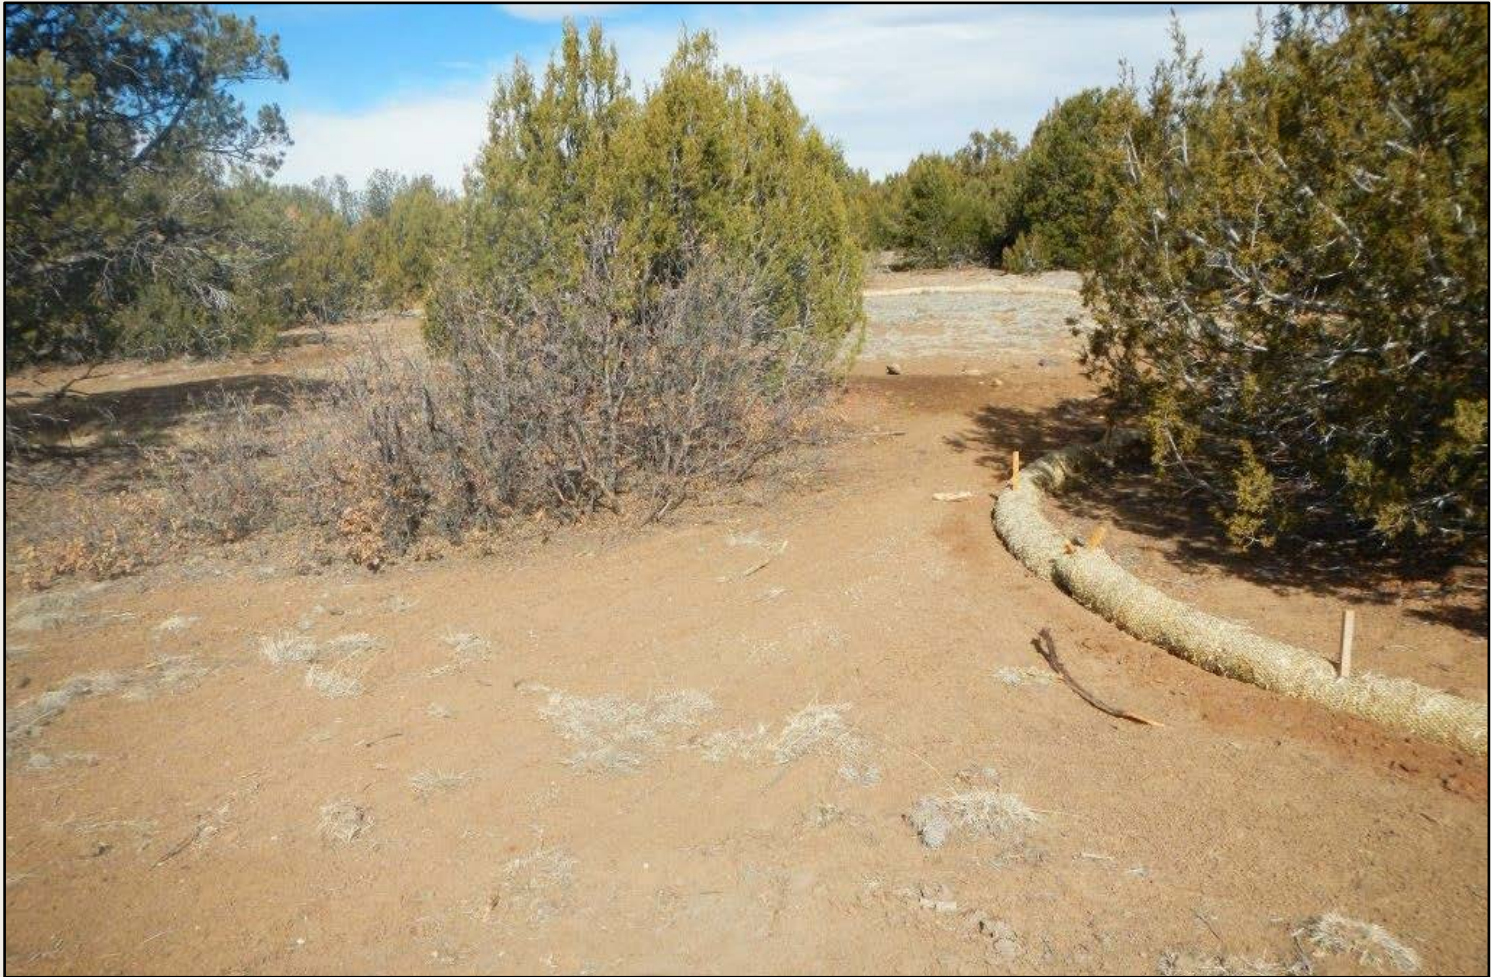
Photo 3. View of the northern project area from the eastern corner facing northwestward.

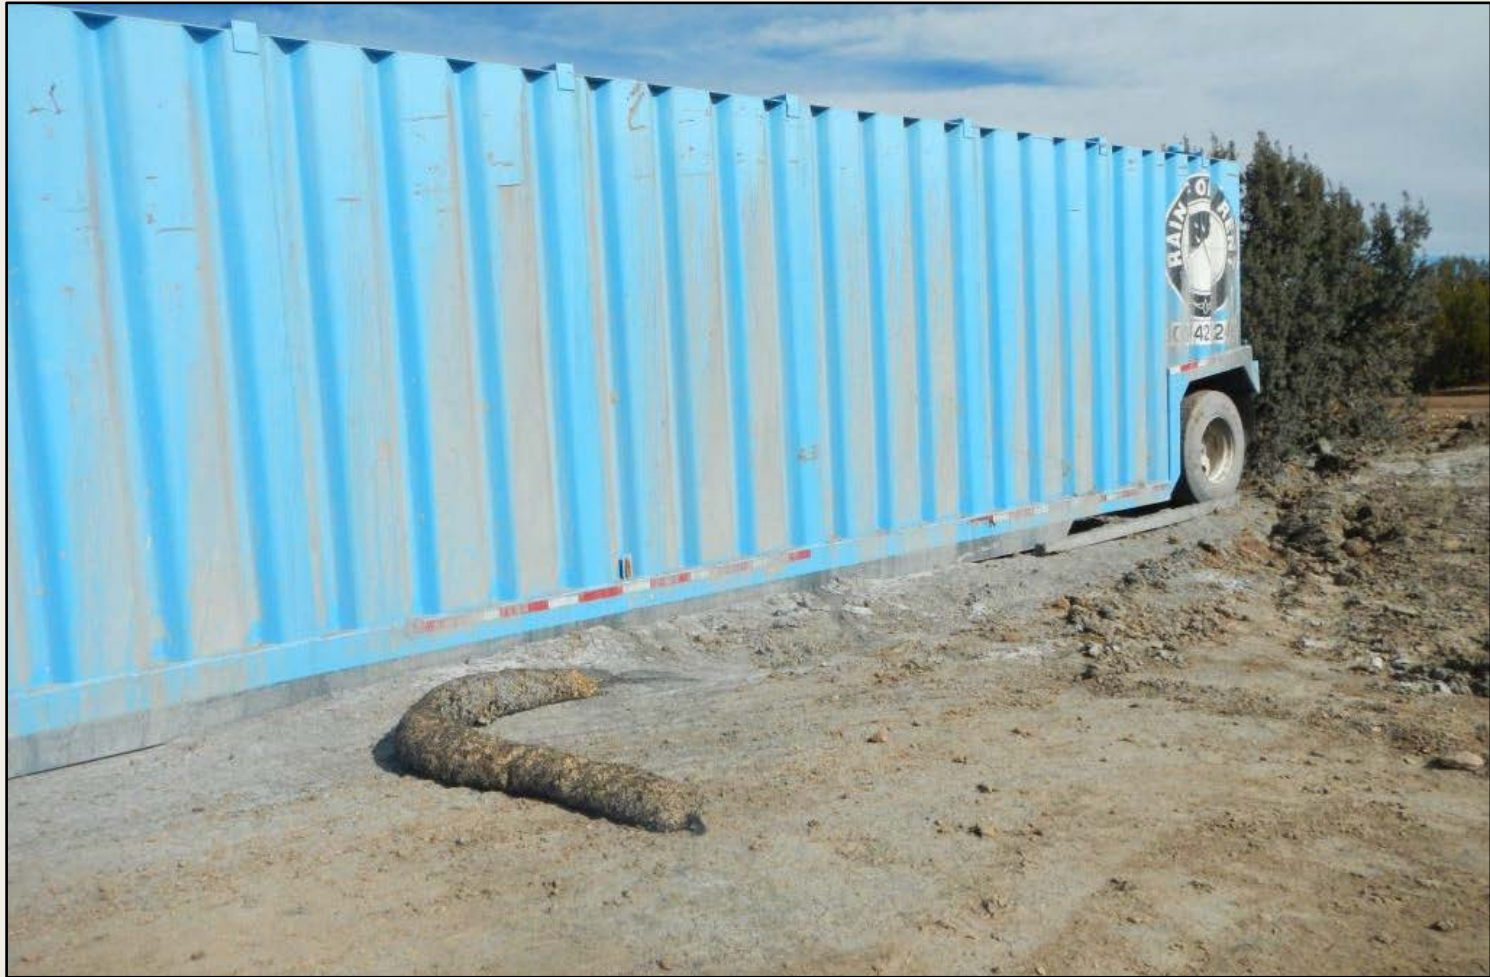
Photo 4. View of area around water truck where it appears that drilling fluids have been released.

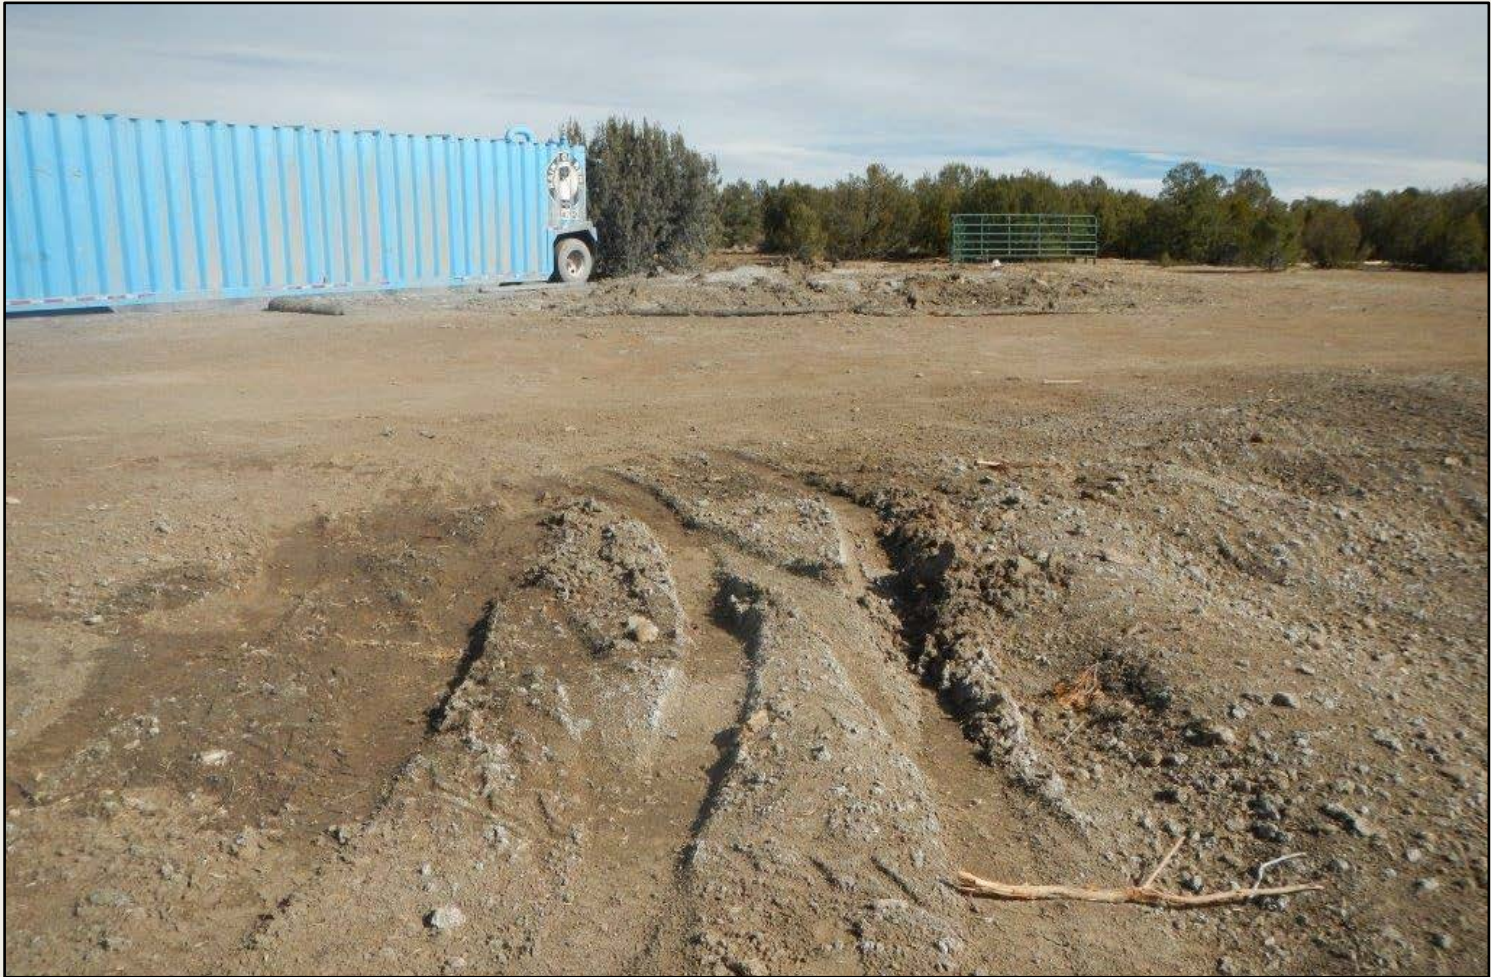
Photo 5. View of area downslope from well and water truck where salt crust and mud may indicate release of drilling fluids flowing downslope from the project area.

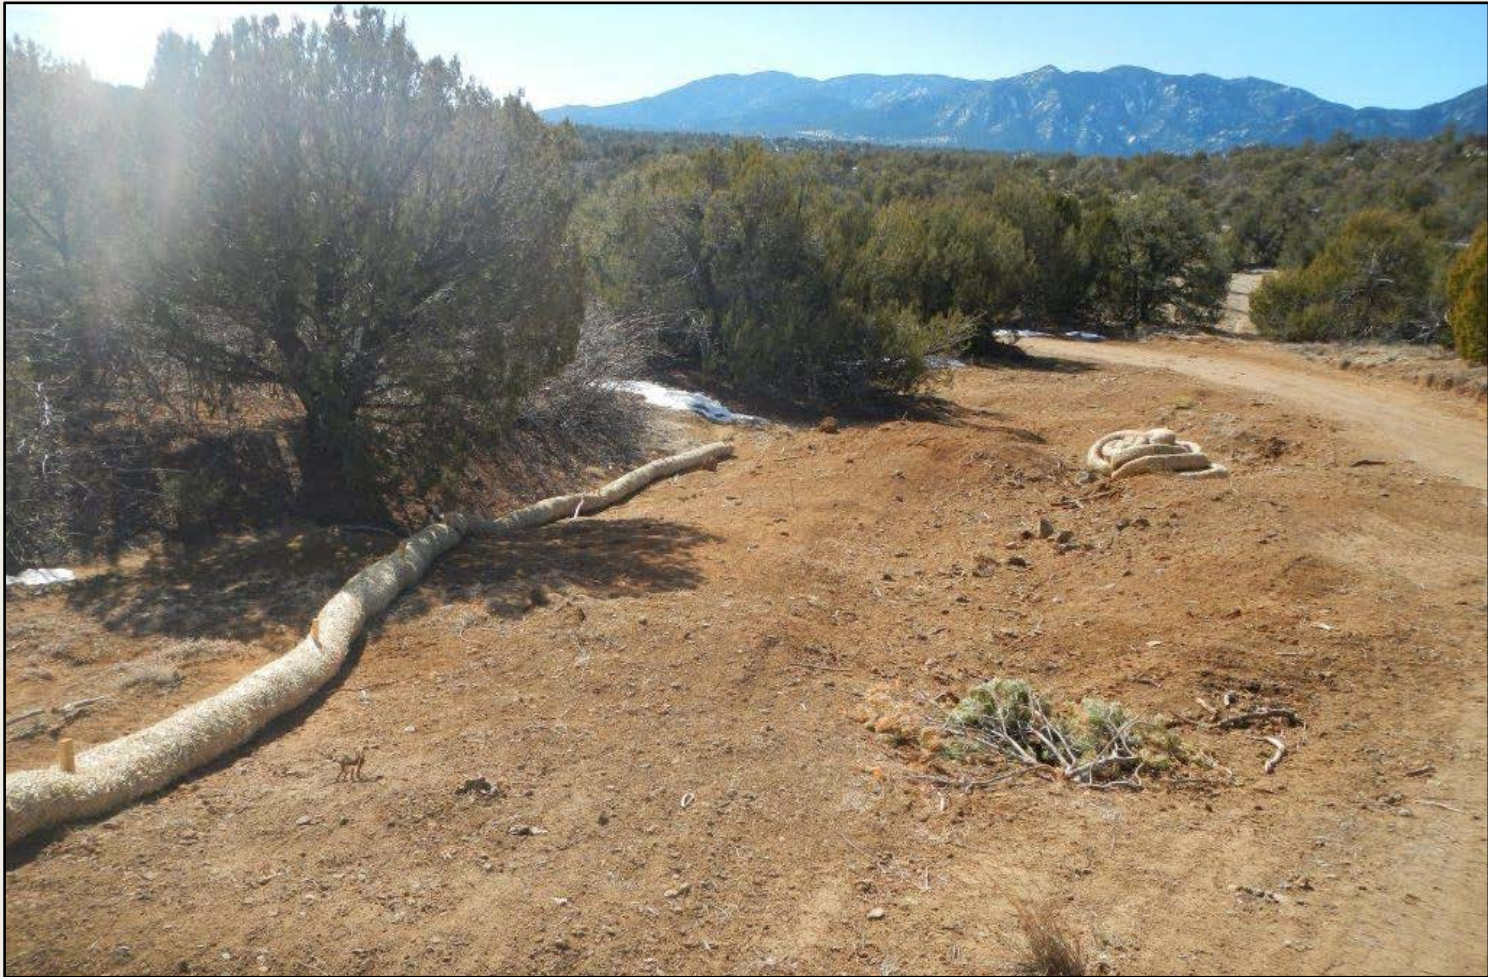
Photo 6. View of area near the access entrance where wattle installation is not completed.

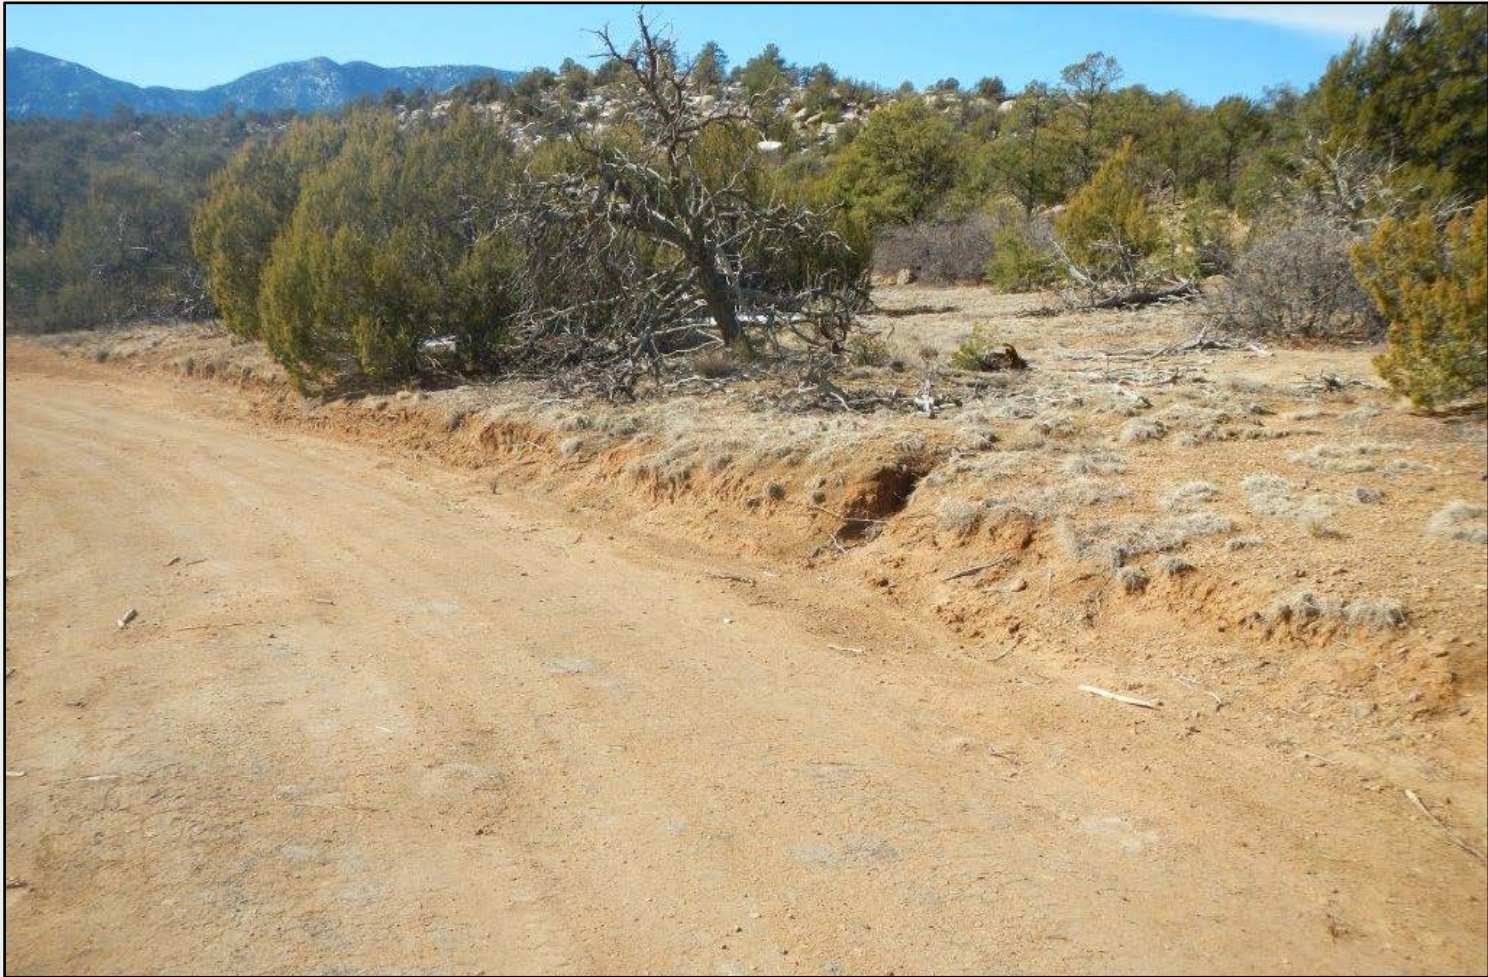
Photo 7. View of area along access where run-on controls and stabilization are needed. Additional areas along access where stormwater needs to be managed and controlled remain.
