Inspection Photos

Operator: MALLARD EXPLORATION LLC # 10670

Location ID: 447902

Inspection Doc. Number: 682504576

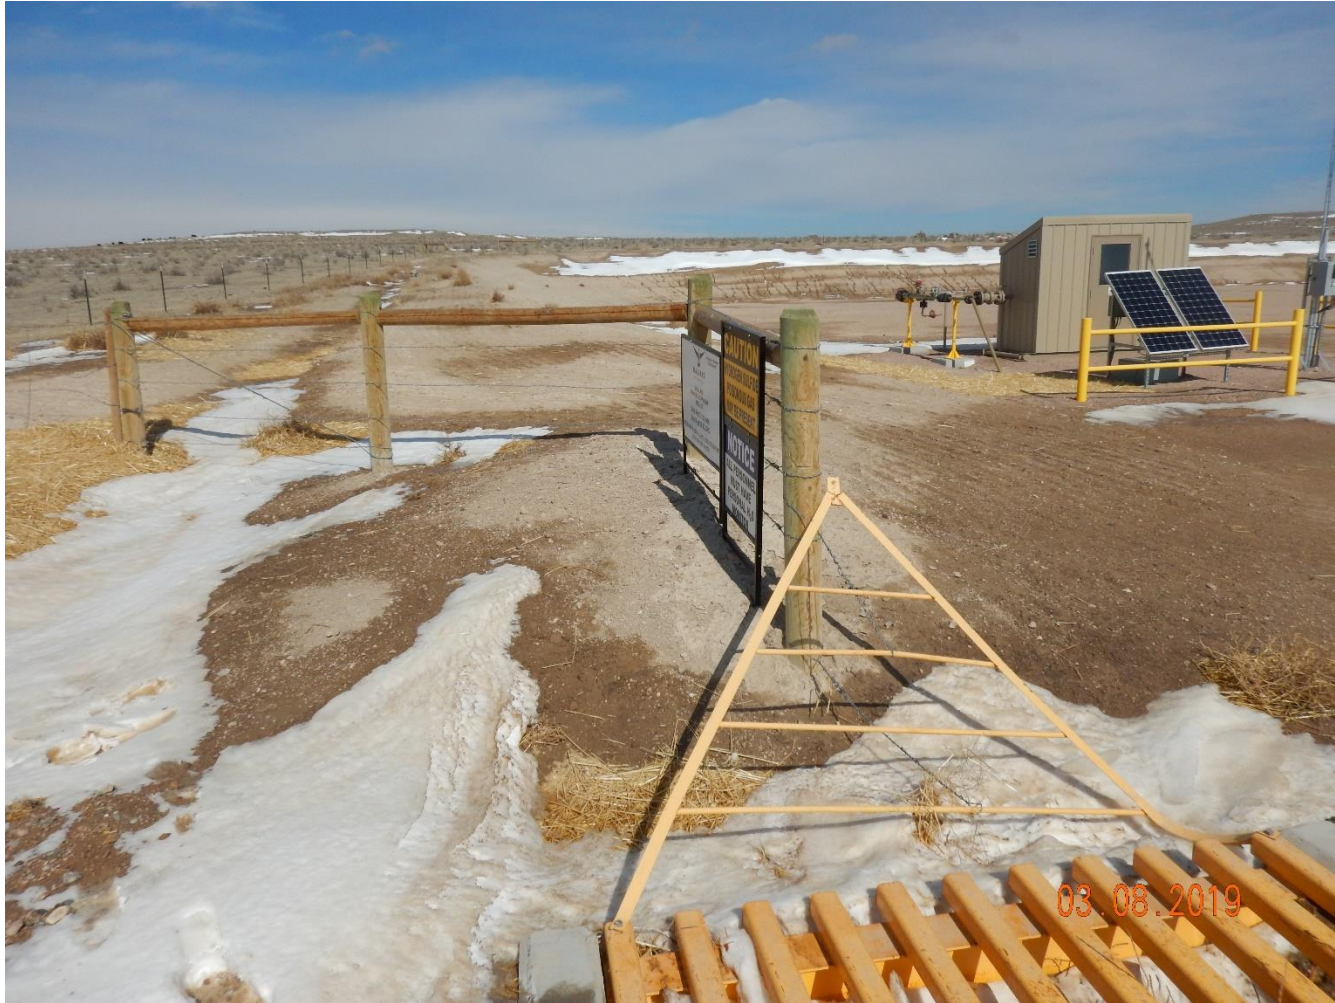
Photo 2: Photo taken from the west end of the location, facing north. Photos 2-4 provide an overview of the location from north, east to south

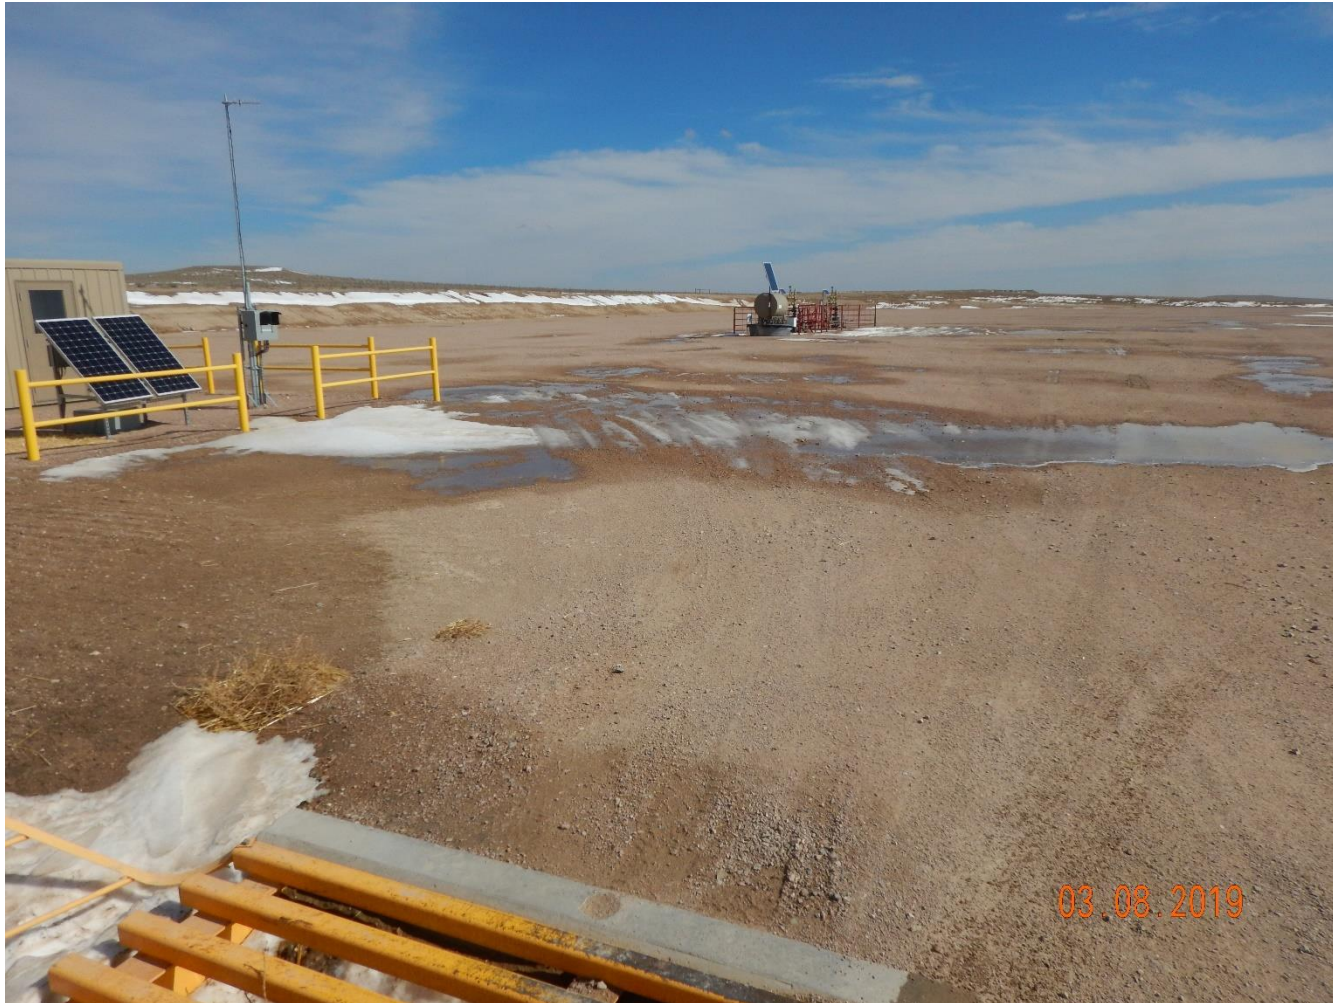
Photo 3: See comments under photo 2.

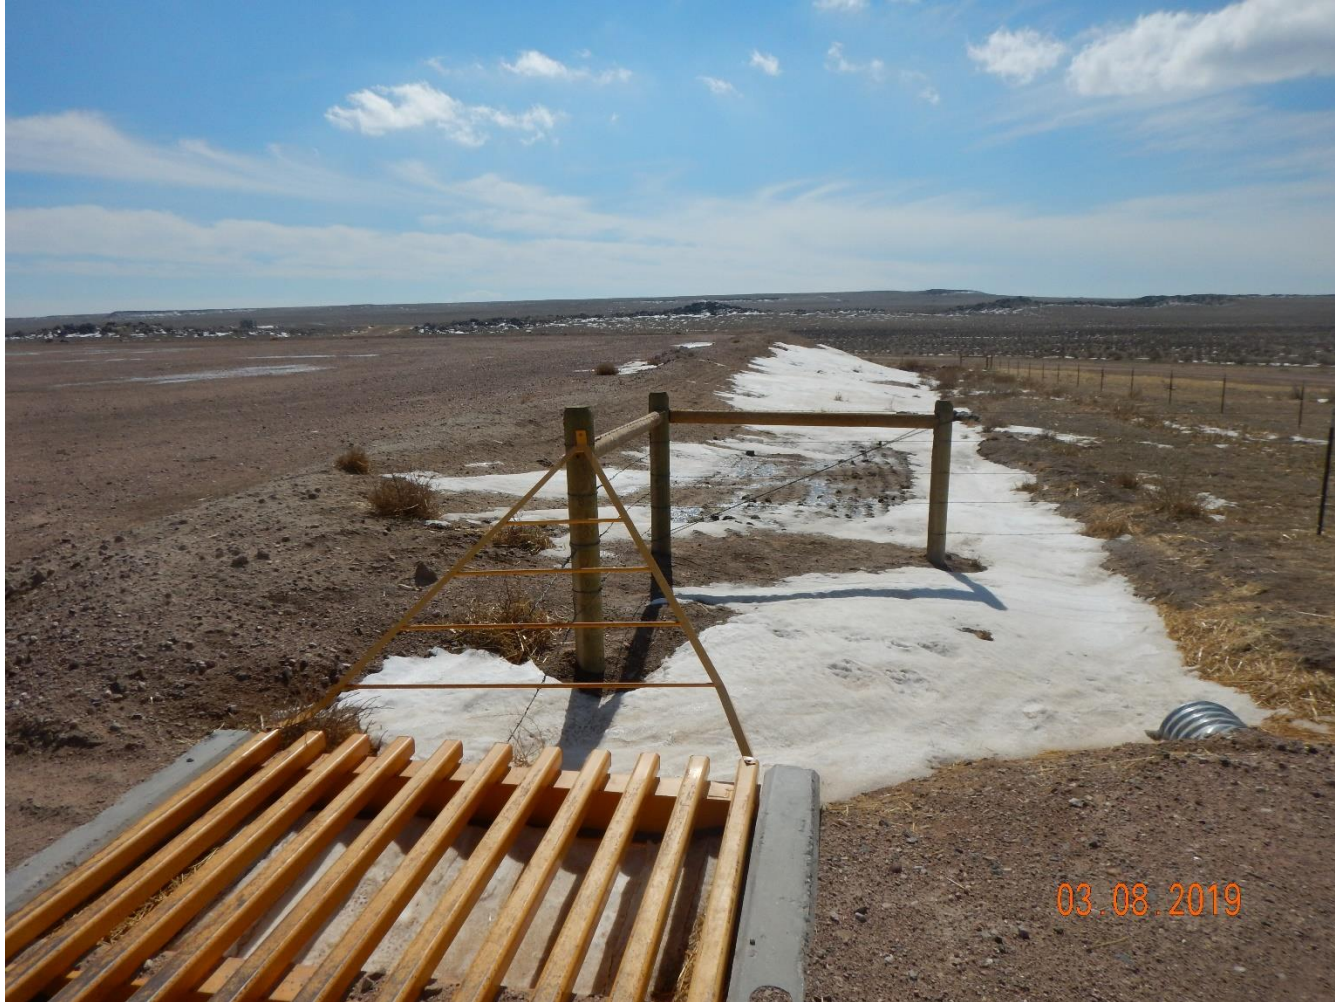
Photo 4: See comments under photo 2.

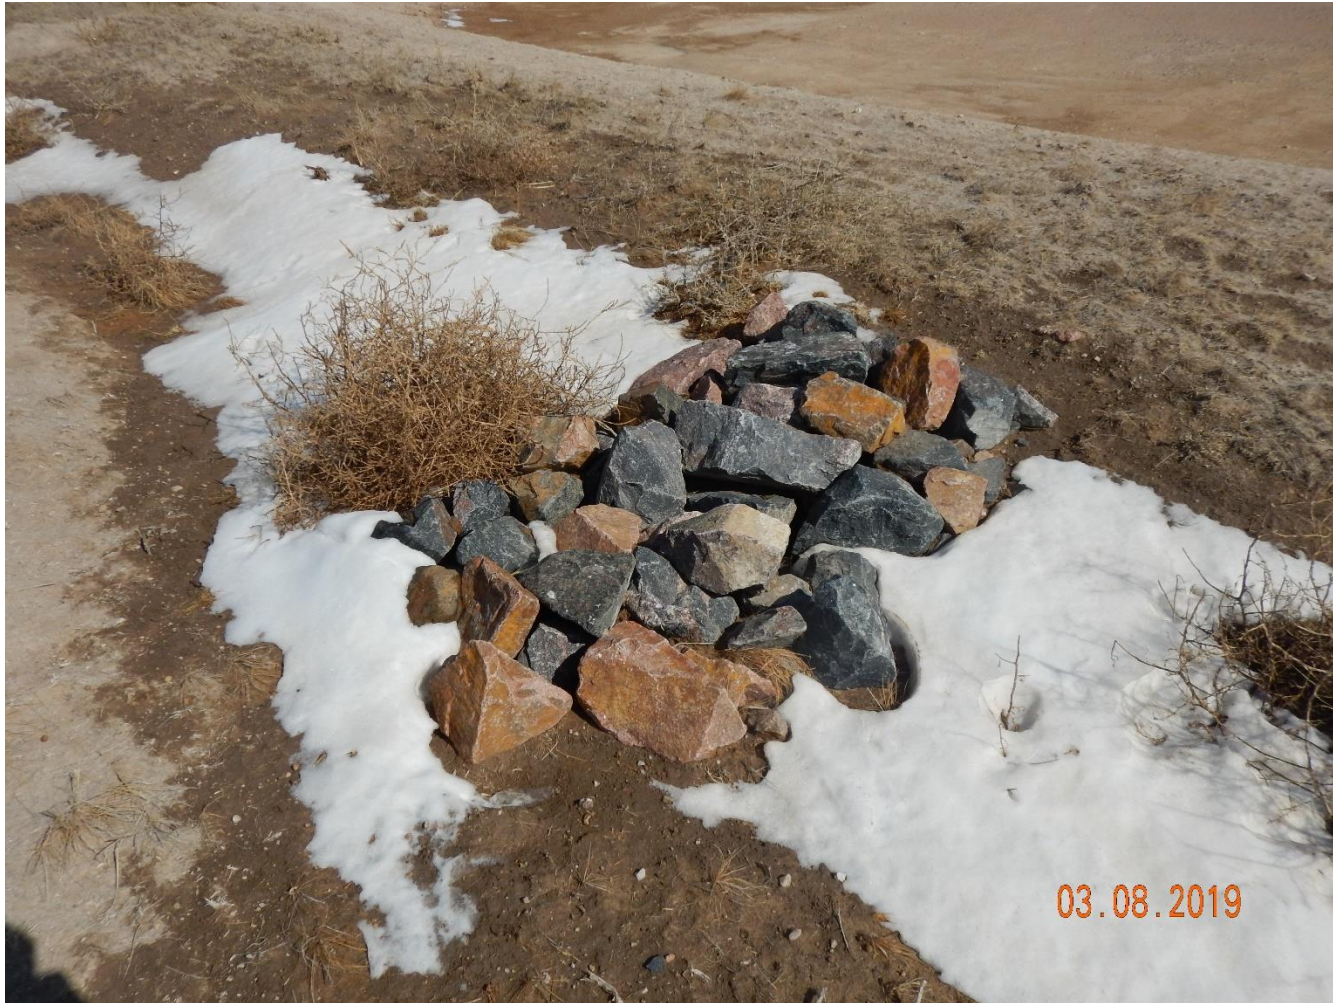
Photo 5: Photo taken from the stormwater ditch on the west end of the location. Photo shows velocity check. Operator appears to have only used large aggregate rock within check. This is not advised as stormwater will likely accelerate around the large rock and may contribute to erosion degradation within the ditch.

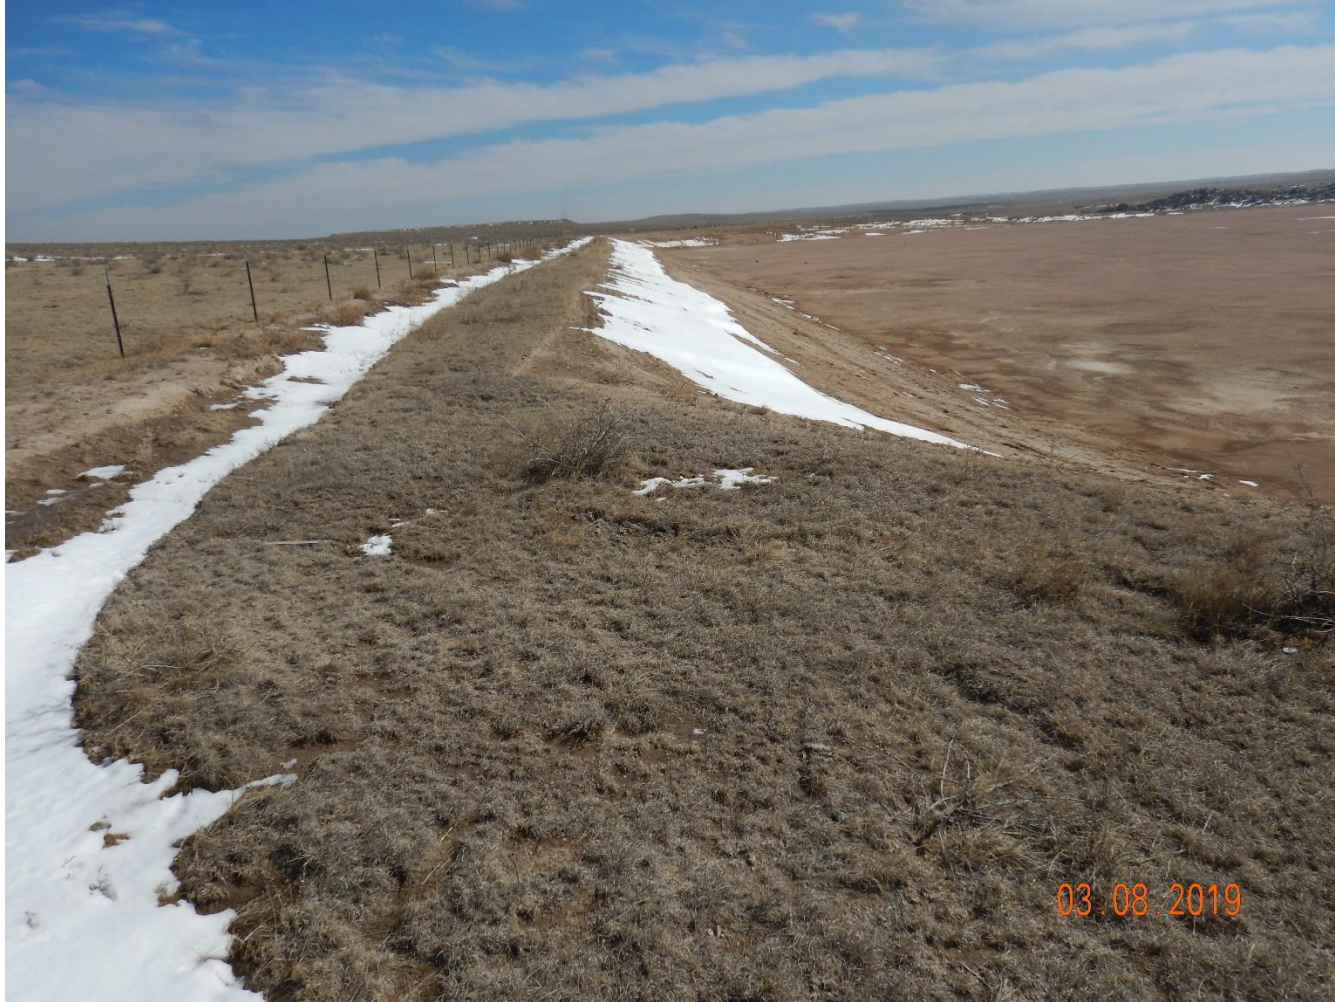
Photo 6: Photo taken from the northwest corner of the location, facing east. Photo shows stormwater ditch along perimeter of the north end of the location. Photo also provides overview of location.

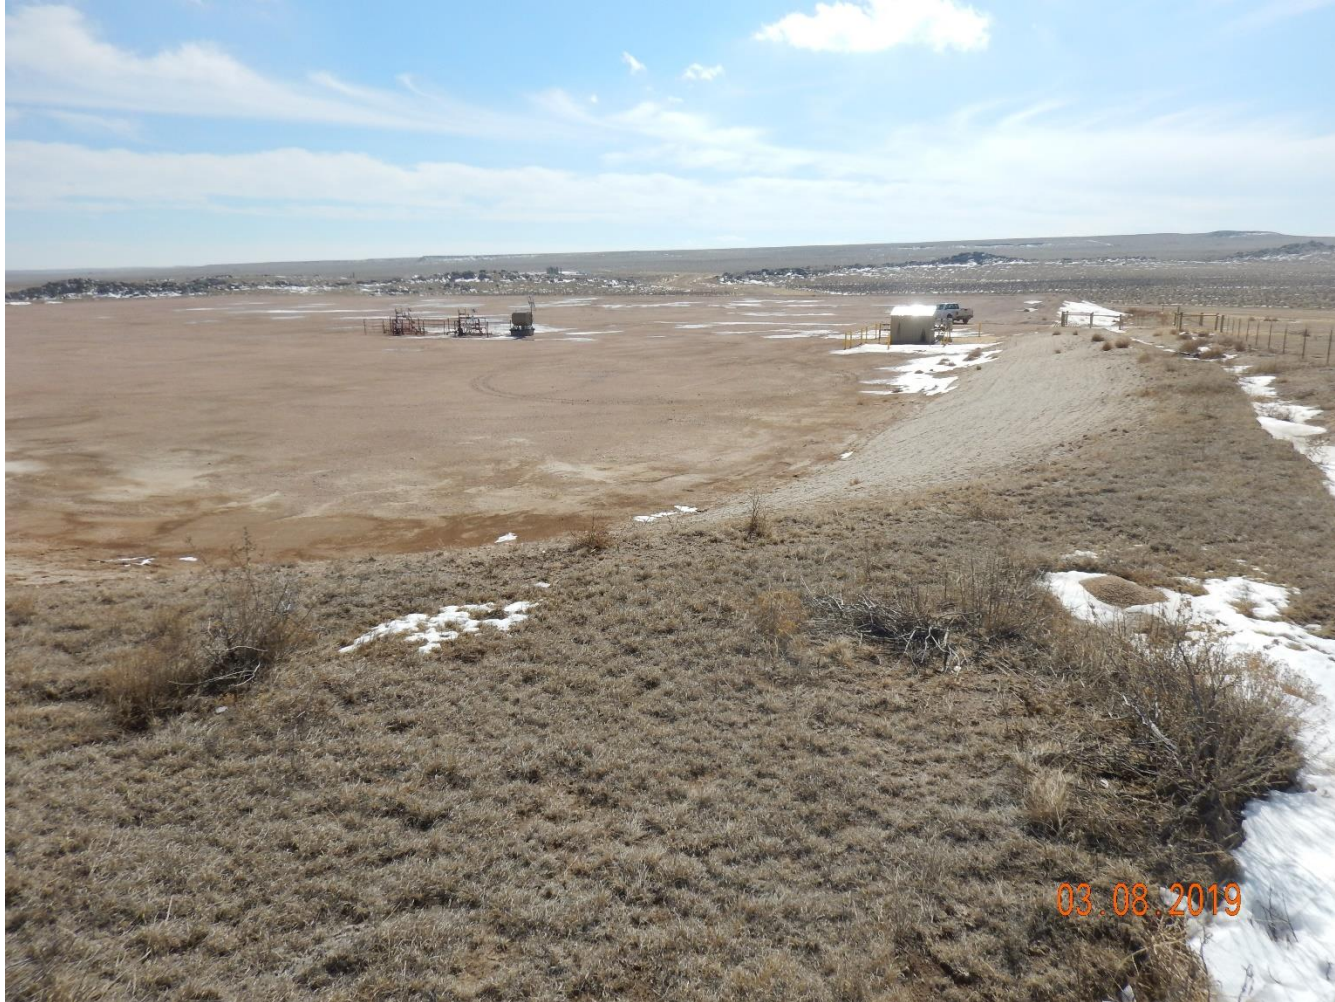
Photo 7: Photo taken from the northwest corner of the location, facing south. Photo shows stormwater ditch along perimeter of the west end of the location. Photo also provides overview of location.

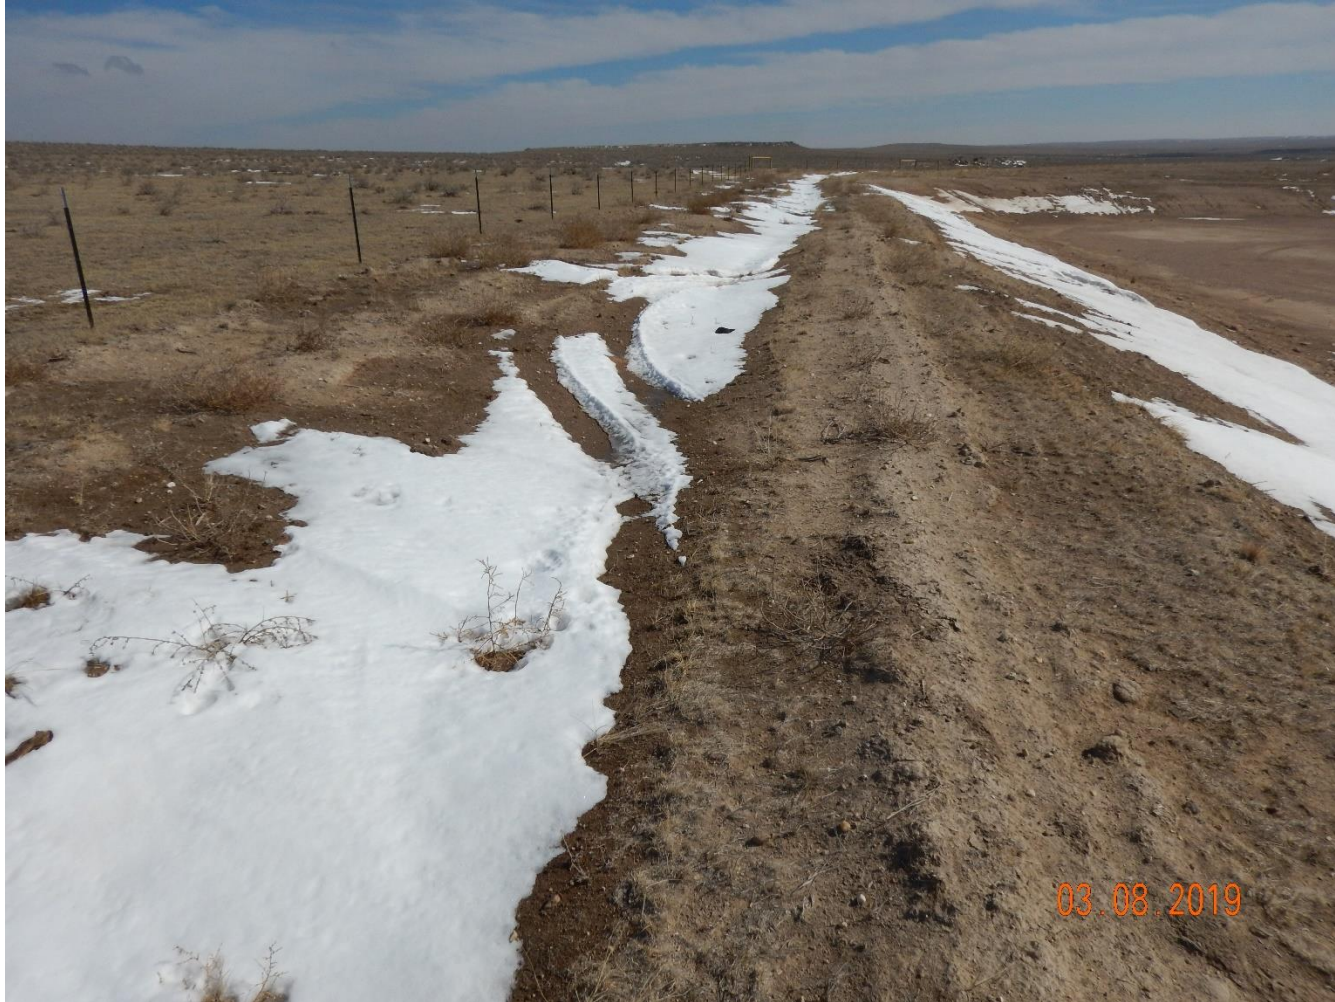
Photo 8: Photo taken from the ditch of the north end of the location, facing east. Photo shows tracks left by a vehicle that appears to have traveled upon the slopes and ditch of the location. This does not comply with surface disturbance minimization.

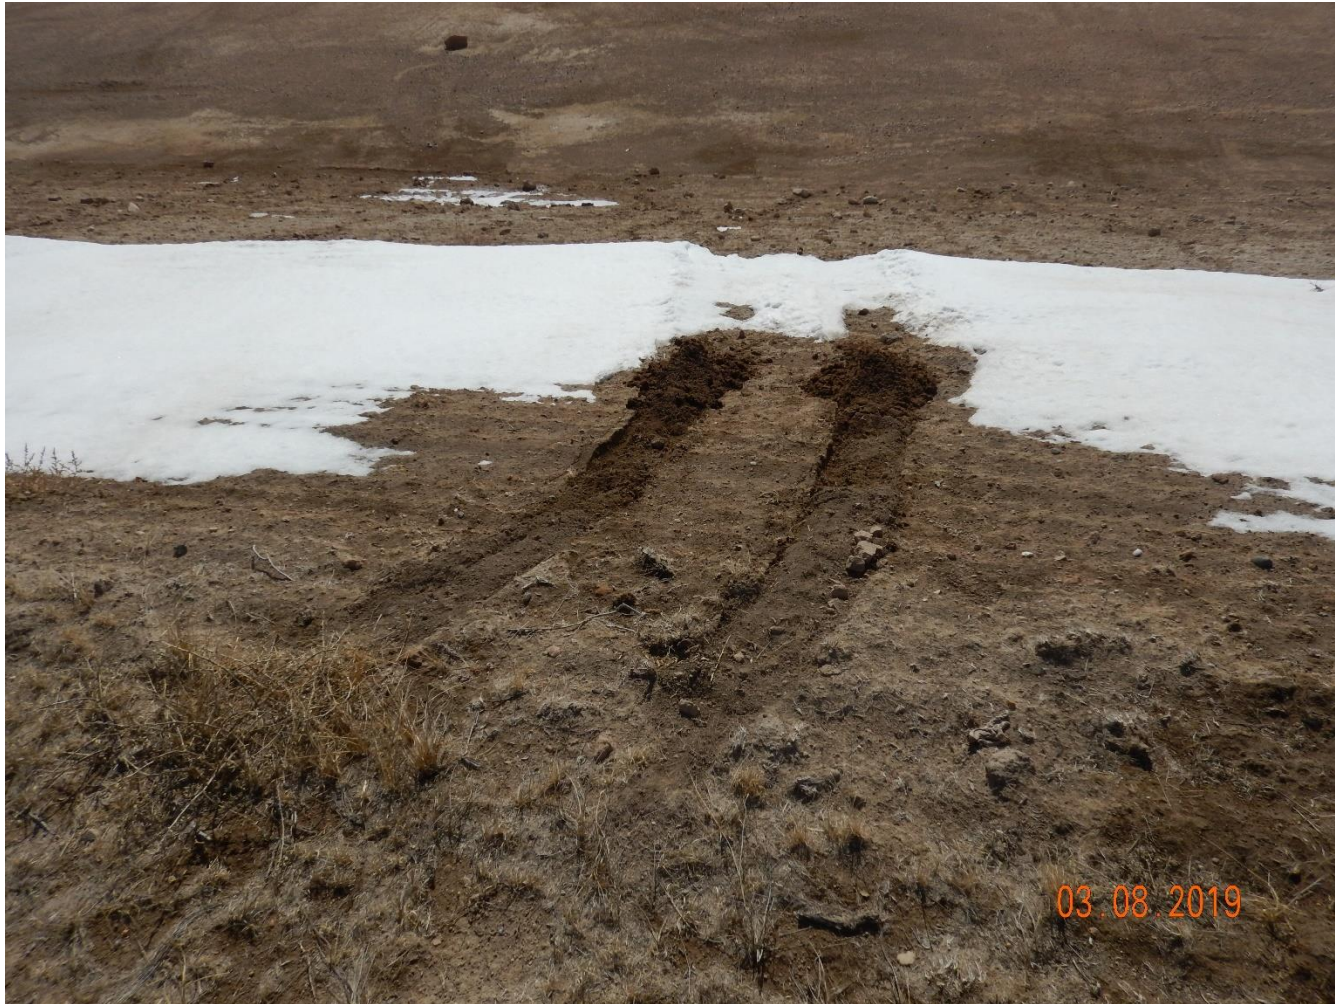
Photo 9: Photo taken from north end of the location, facing south. Photo shows tracks left by a vehicle that appears to have traveled upon the slopes and ditch of the location. This does not comply with surface disturbance minimization.

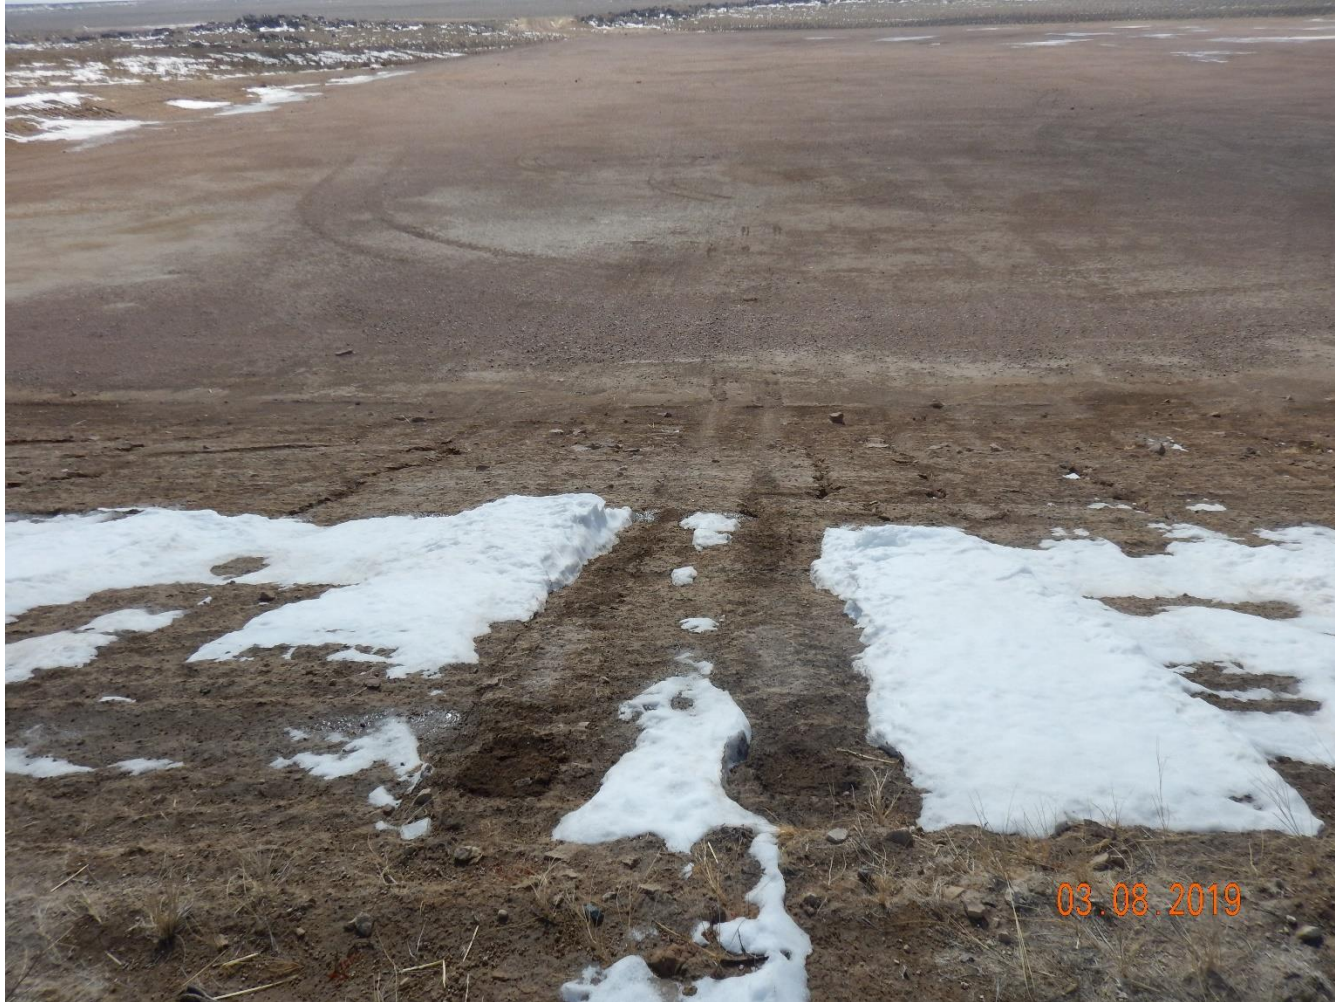
Photo 10: Photo taken from north end of the location, facing south. Photo shows tracks left by a vehicle that appears to have traveled upon the slopes and ditch of the location. This does not comply with surface disturbance minimization.

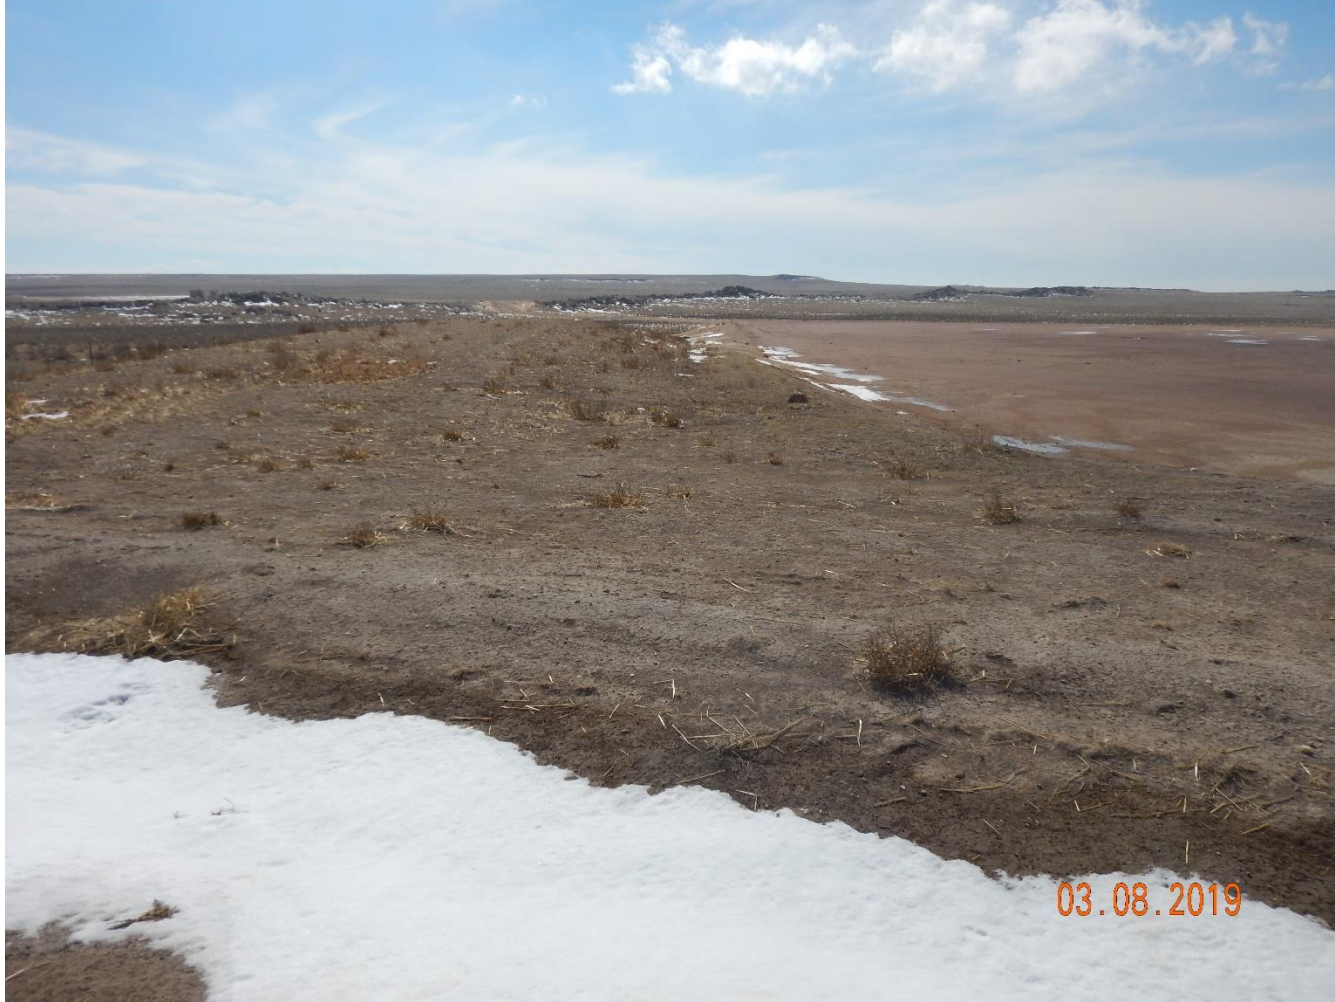
Photo 11: Photo taken from the ditch of the northeast end of the location, facing south. Photo shows topsoil stockpile on the east end of the location.

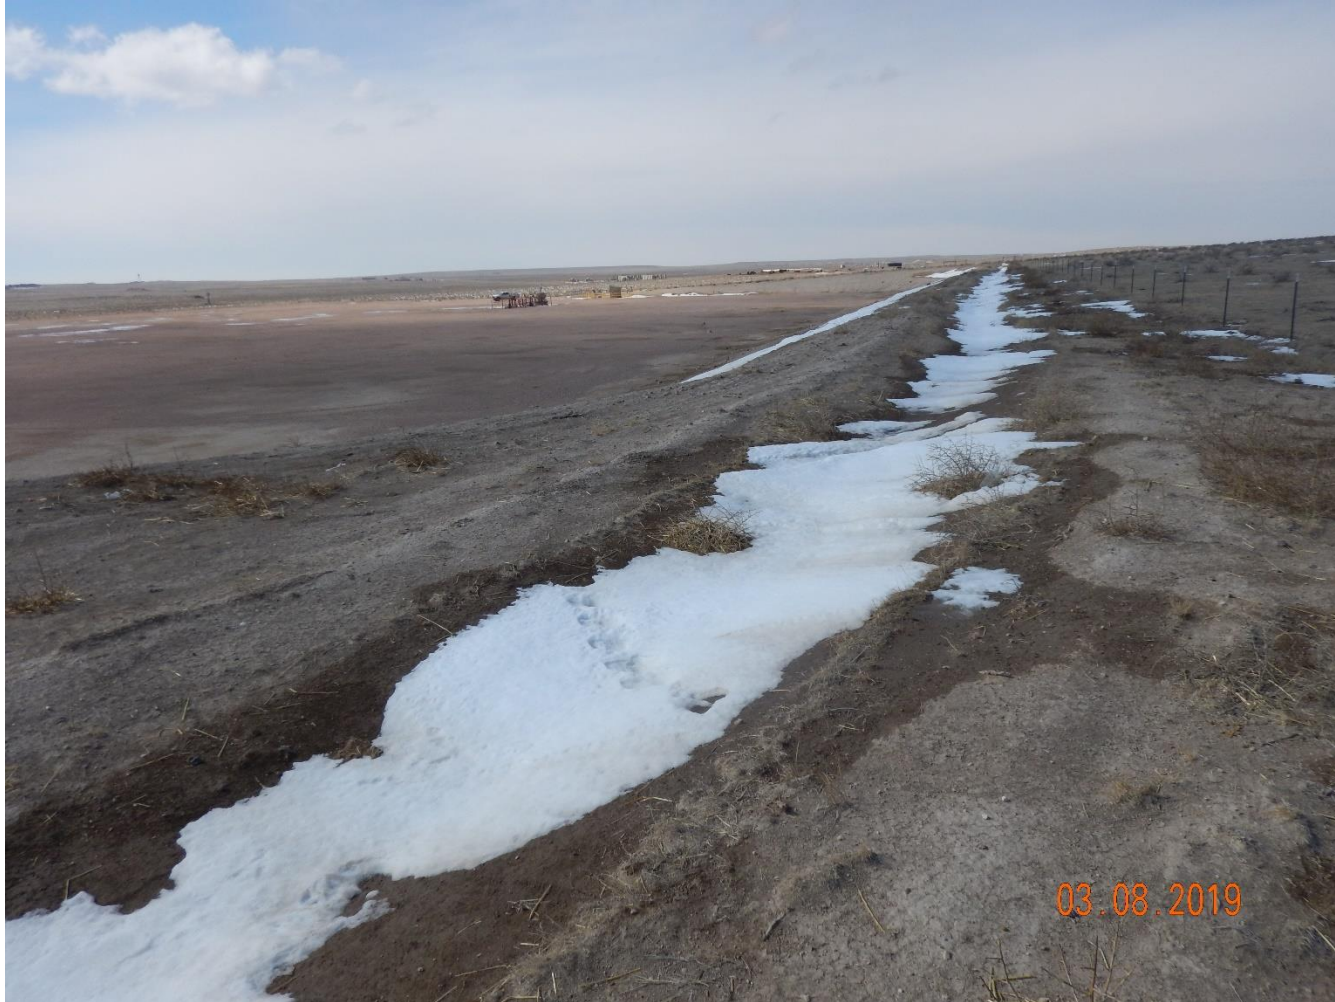
Photo 12: Photo taken from the ditch of the northeast end of the location, facing west. Photo shows stormwater ditch along perimeter of the west end of the location. Photo also provides overview of location.

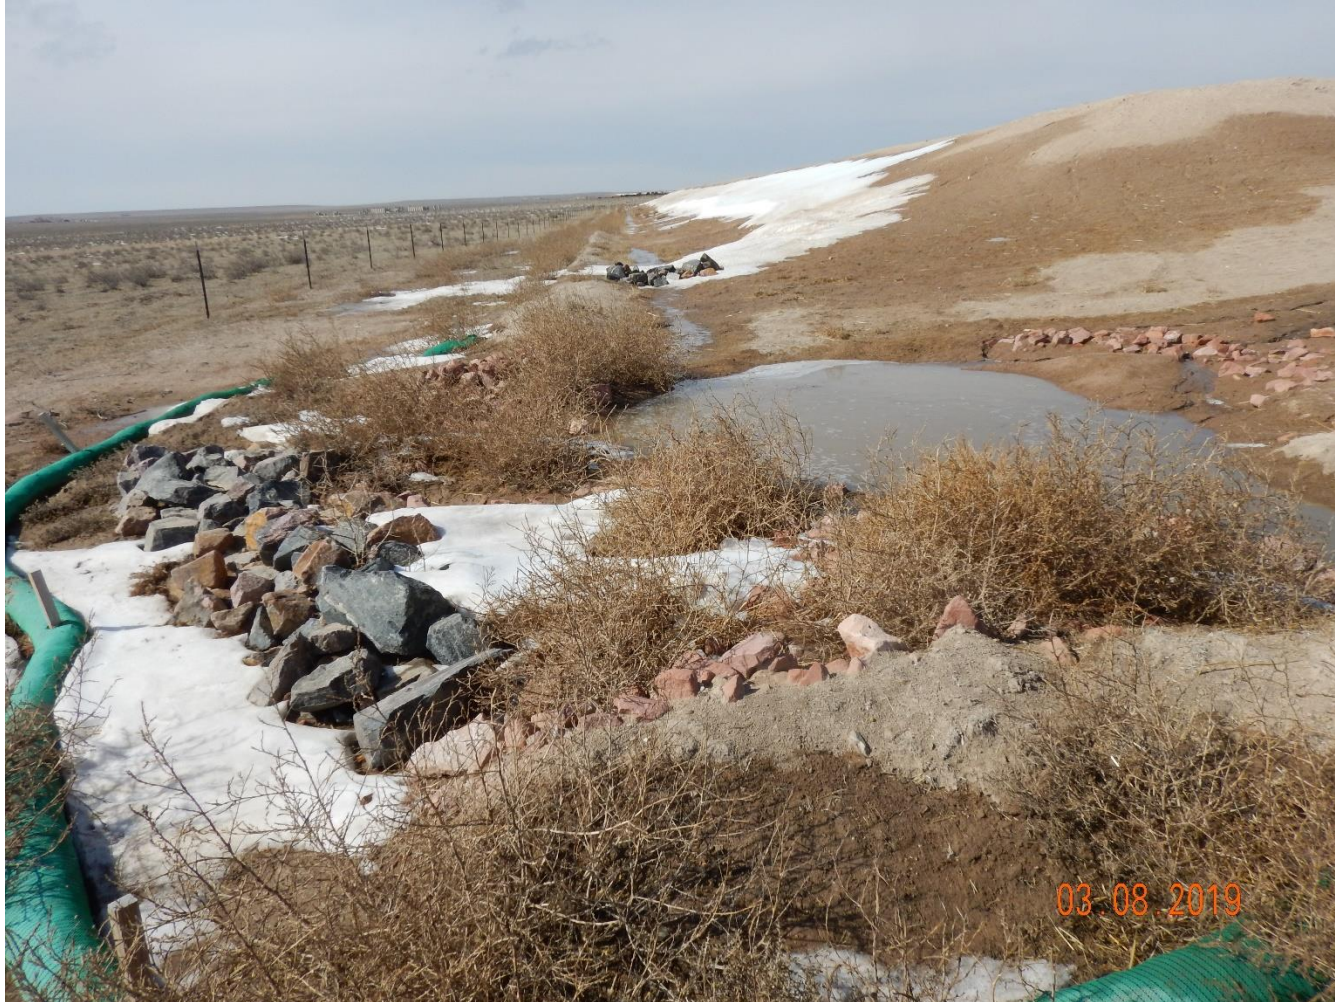
Photo 13: Photo of sediment trap on the southeast corner of the location.

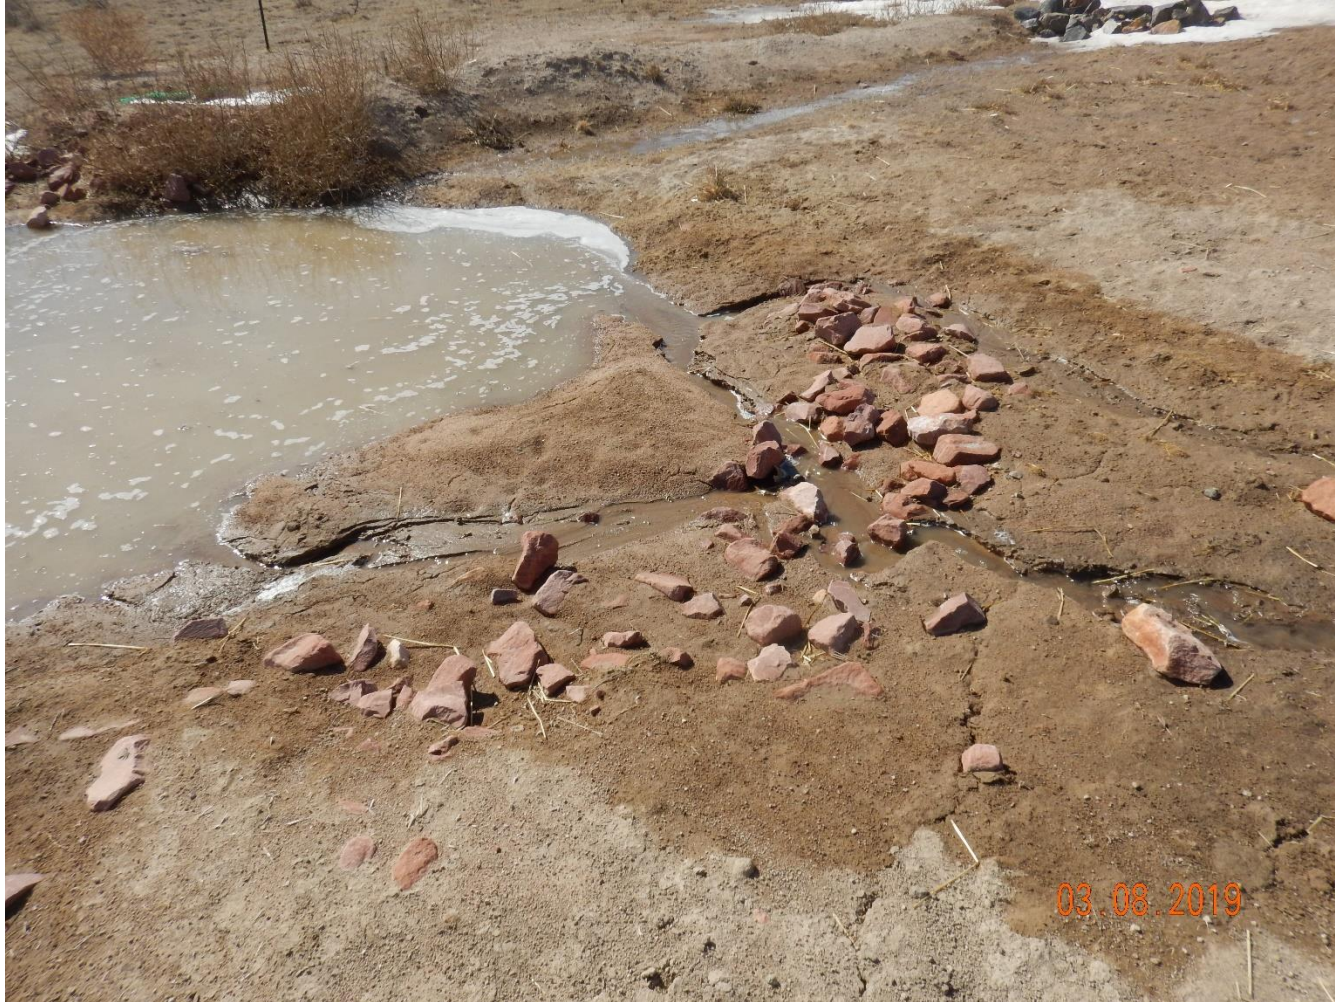
Photo 14: Photo taken from the sediment trap on the southeast corner of the location. Photo shows erosion degradation at the inlet of the BMP. Inlet protection appears to have either been “blown out” by stormwater discharge, or has become inundated with sediment and no longer in proper functioning condition.

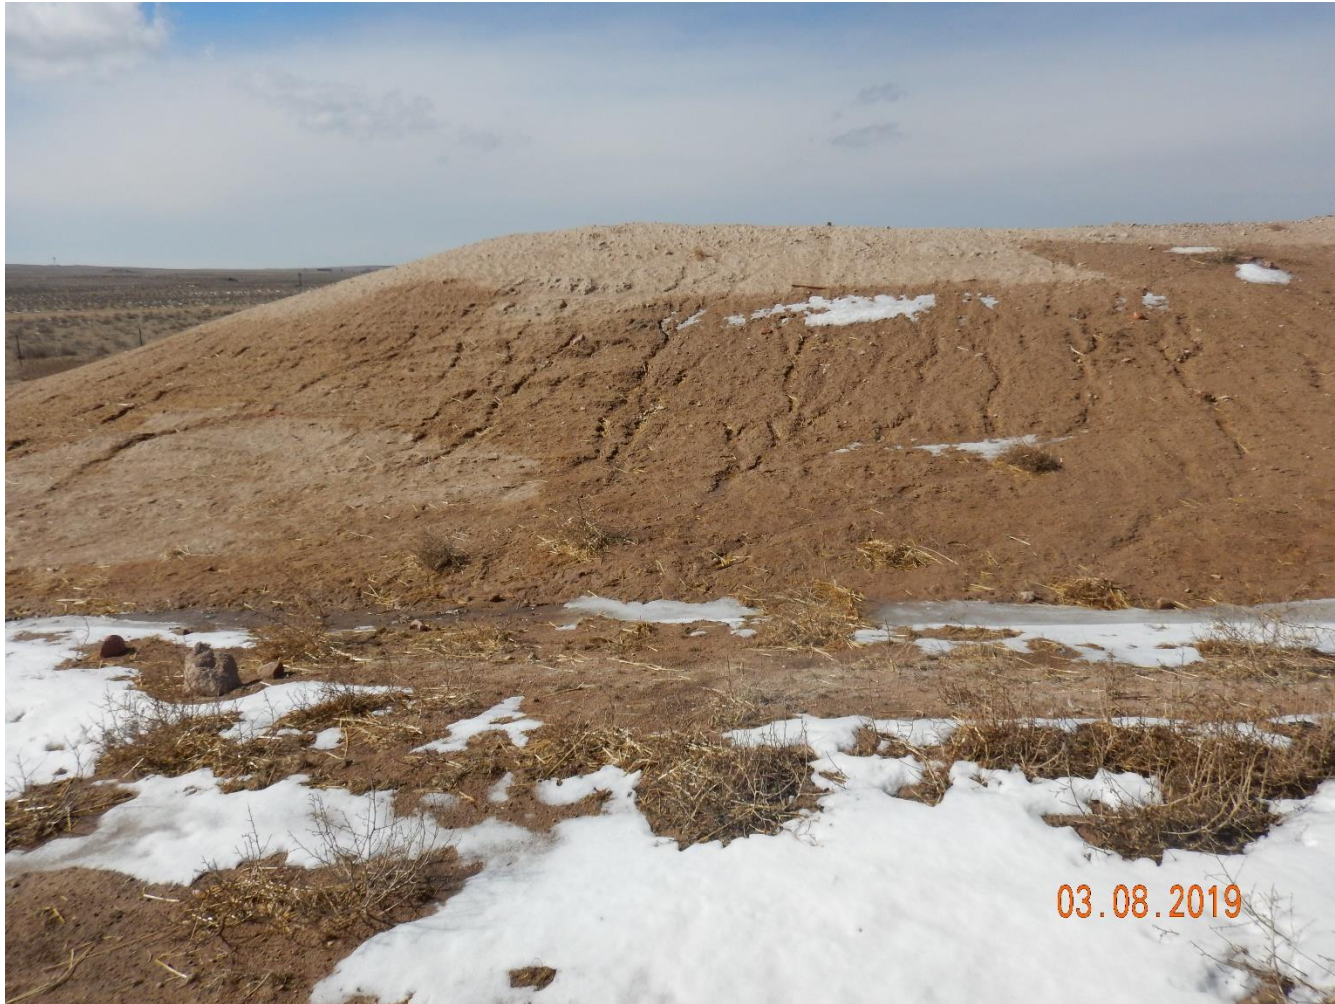
Photo 15: Photo taken from the southeast corner of the pad, facing west. Photo shows stormwater erosion degradation on the slopes of the pad.

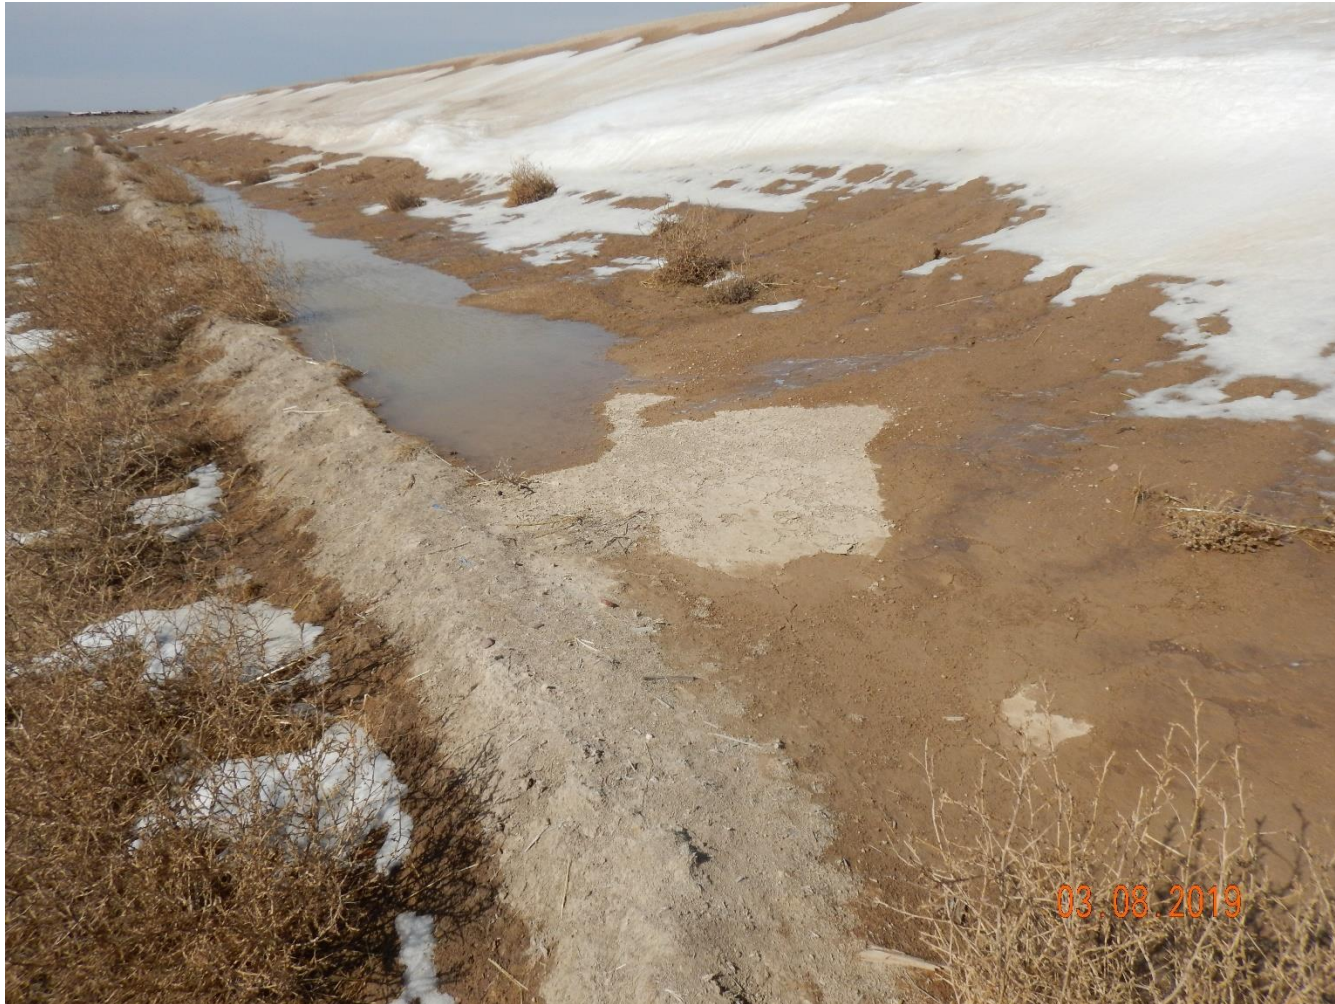
Photo 16: Photo taken from the stormwater ditch on the south end of the location, facing northwest. Photo shows ditch has filled with sediment. Maintenance required.

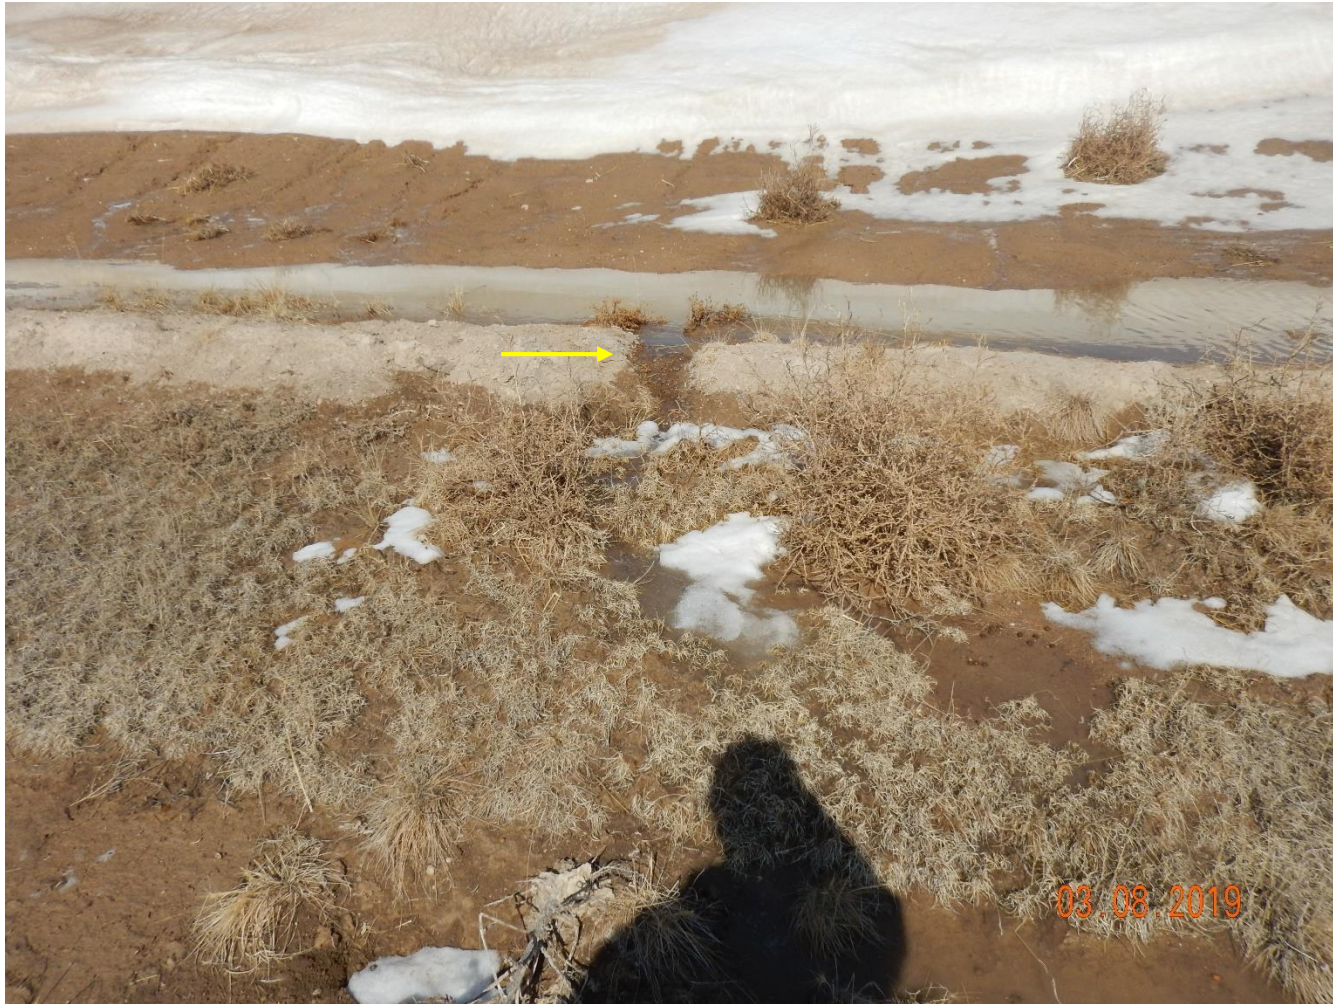
Photo 17: Photo taken from the stormwater ditch on the south end of the location. Photo shows section of the ditch that appears to have filled with sediment allowing stormwater to breach the BMP and discharge from location.
