Inspection Photos

Operator: MALLARD EXPLORATION LLC # 10670

Location ID: 447902

Inspection Doc. Number: 682504576

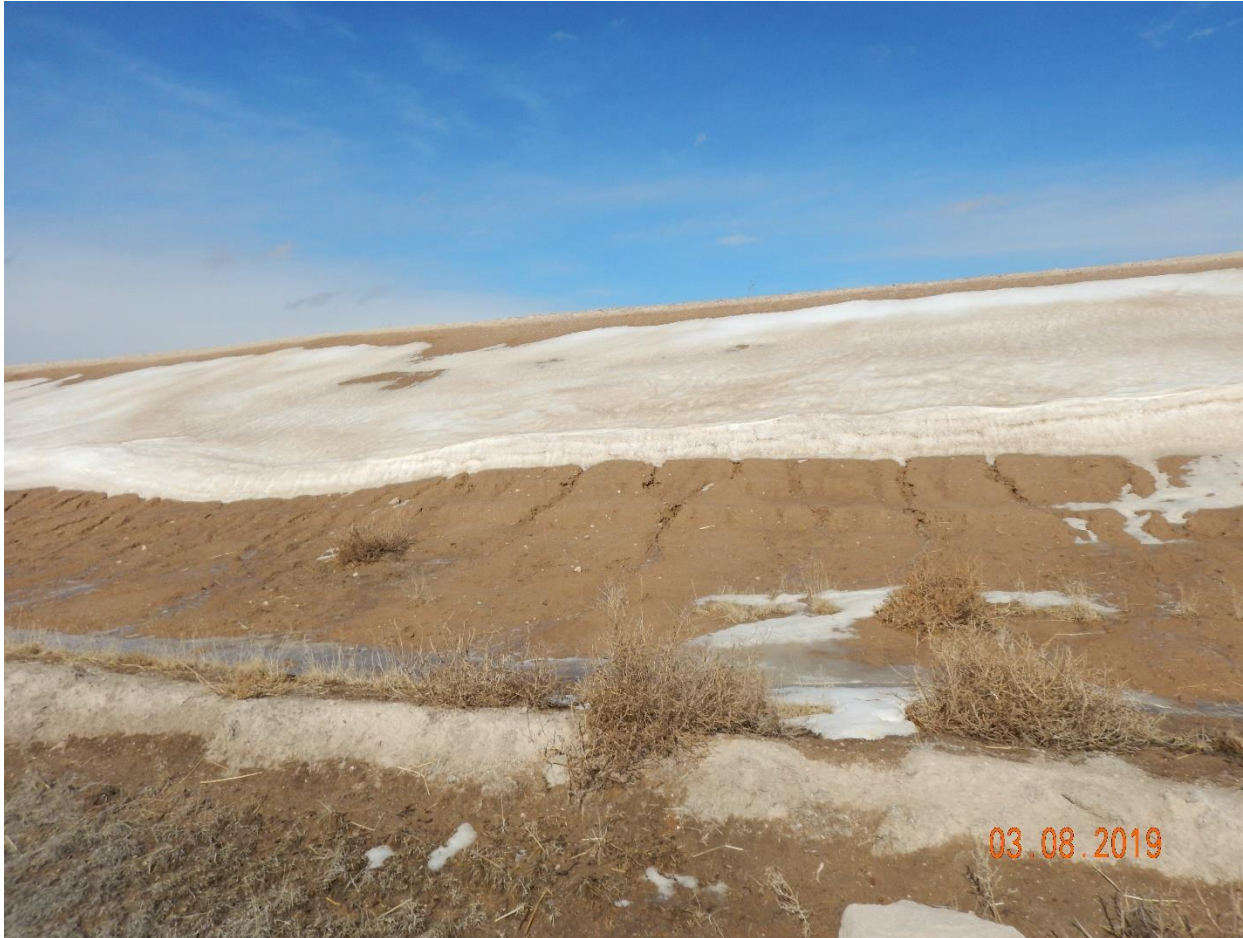
Photo 18: Photo taken from the south end of the location, facing north. Photo shows stormwater erosion degradation on the slopes of the pad.

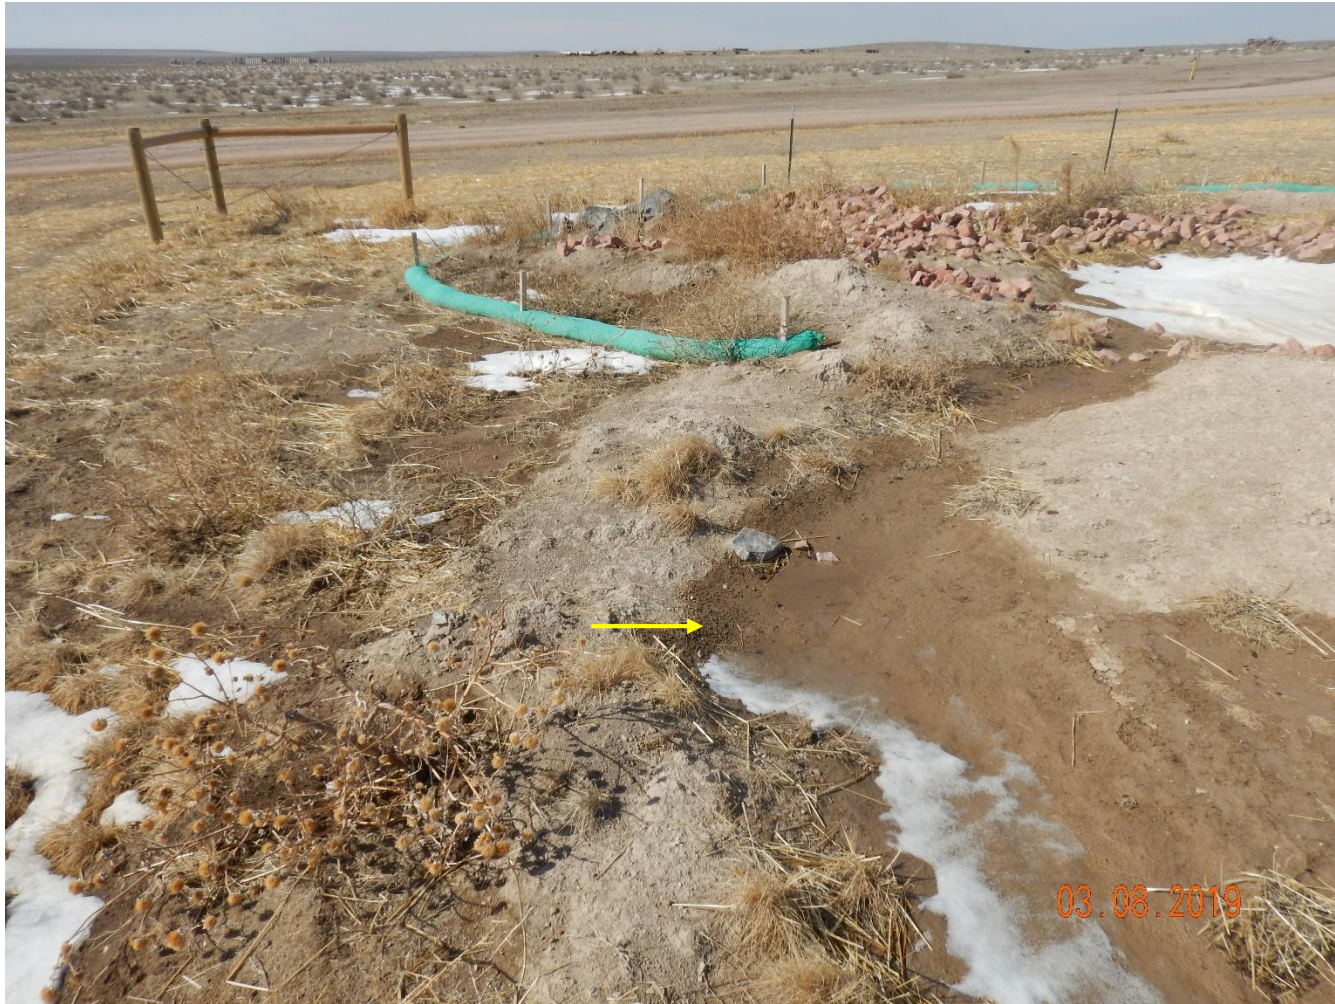
Photo 19: Photo taken from the sediment trap on the southwest corner of the pad. Photo shows areas of the ditch leading into the trap that has filled with sediment and is at equal elevation to the berm.

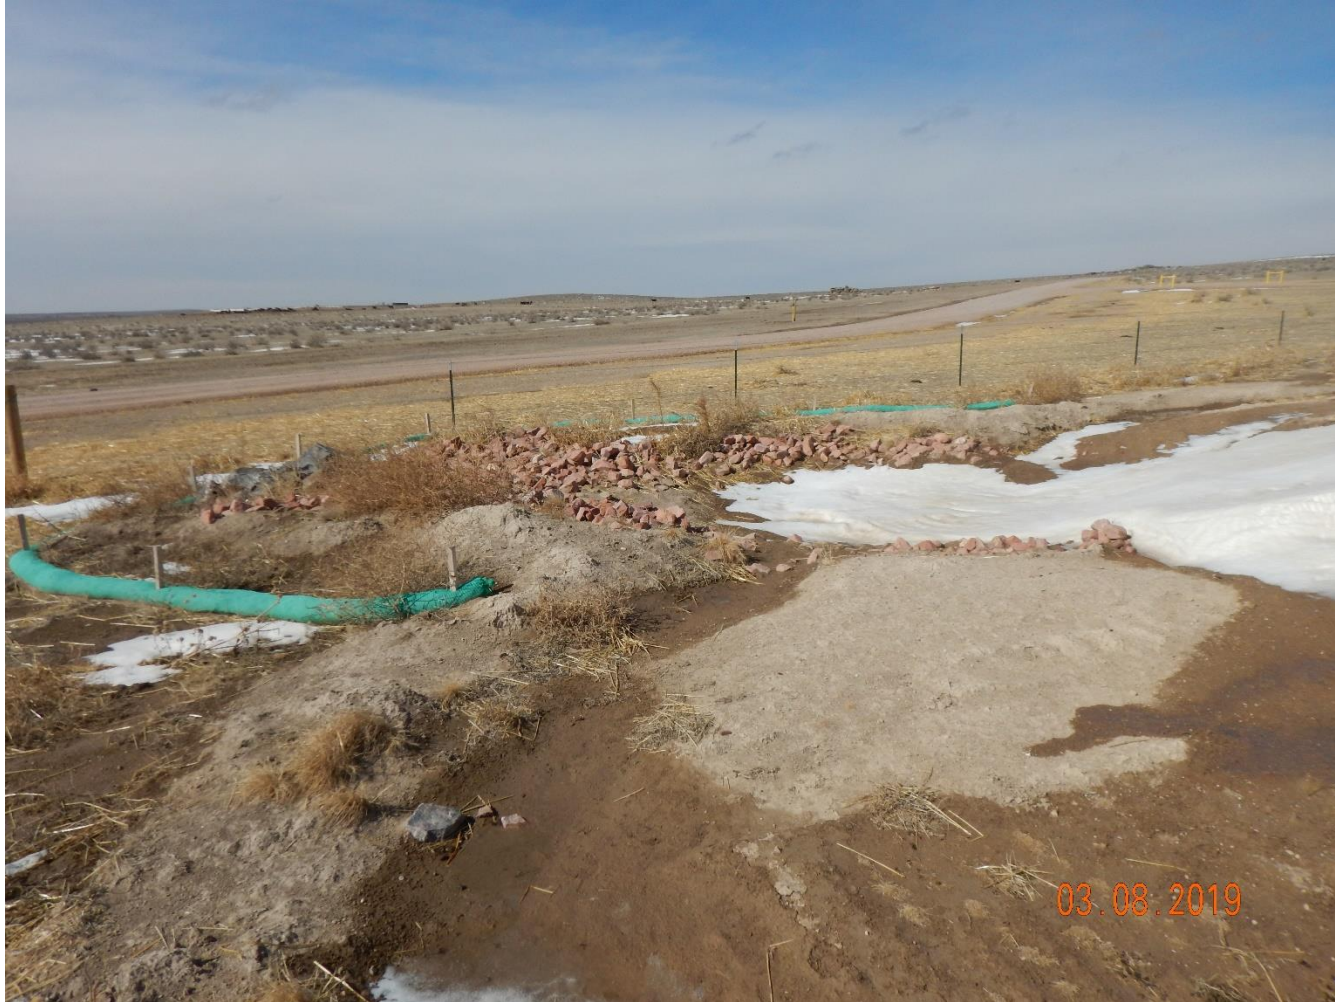
Photo 20: Photo taken from the sediment trap on the southwest corner of the pad, facing northwest. Sediment trap does not appear to be sufficient in size (length/width/depth) to mitigate stormwater run off from the pad.

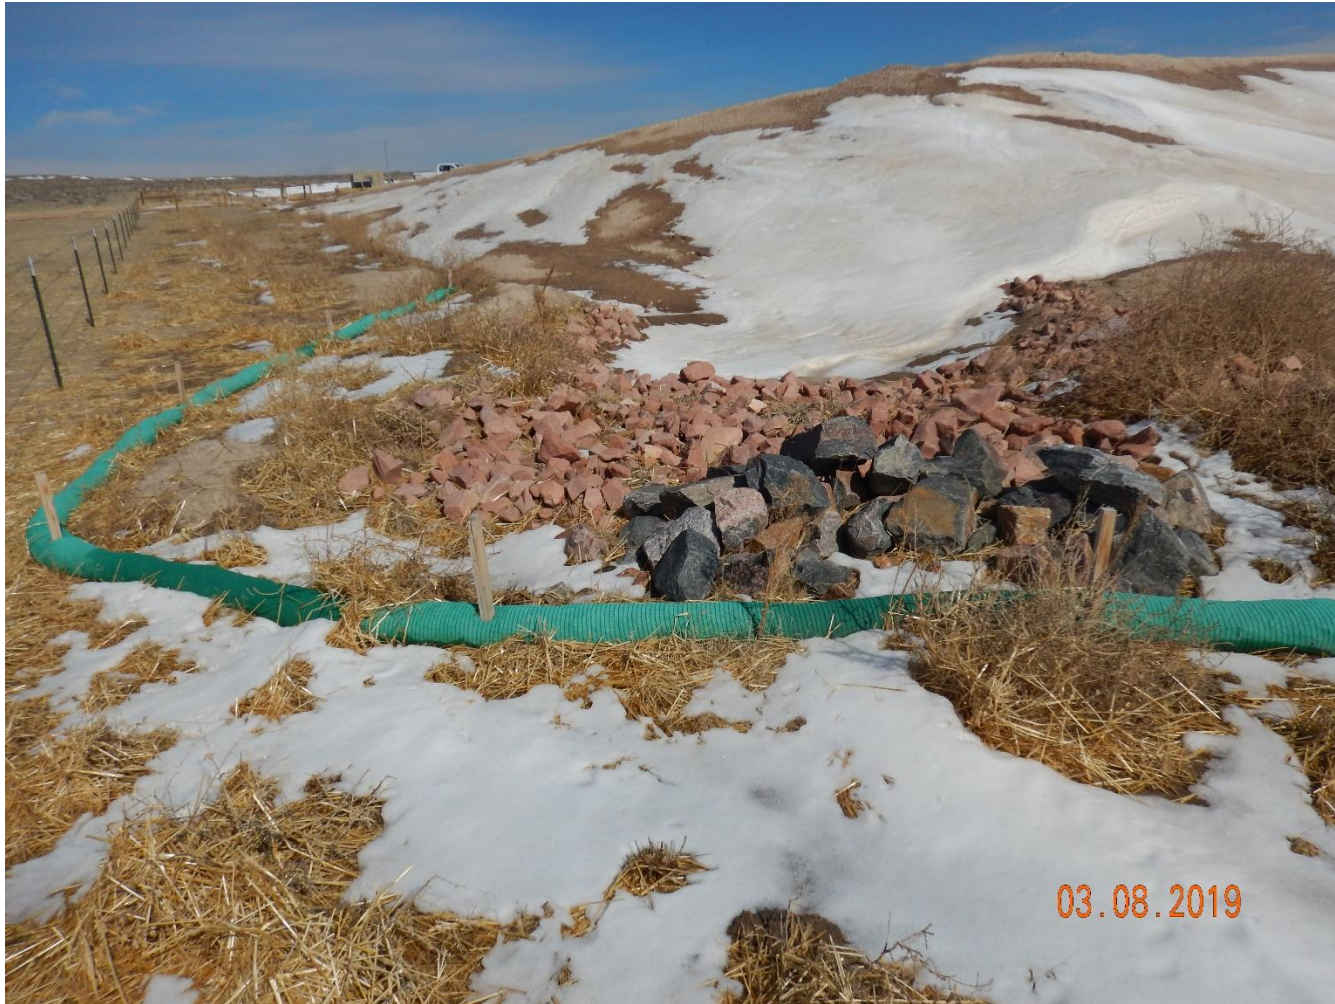
Photo 21: See comments under photo 20

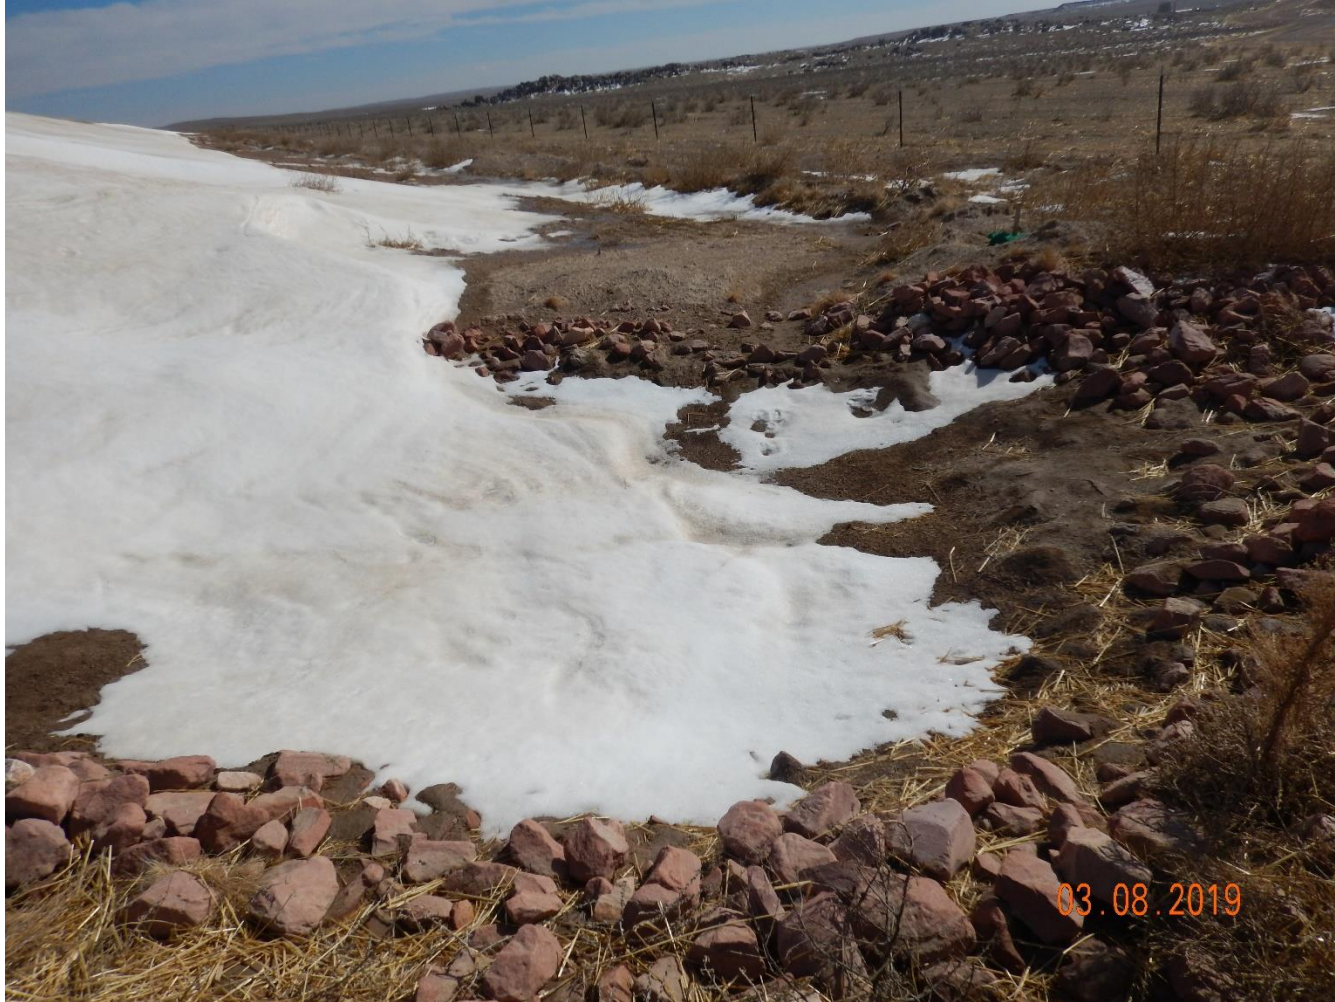
Photo 22: See comments under photo 20

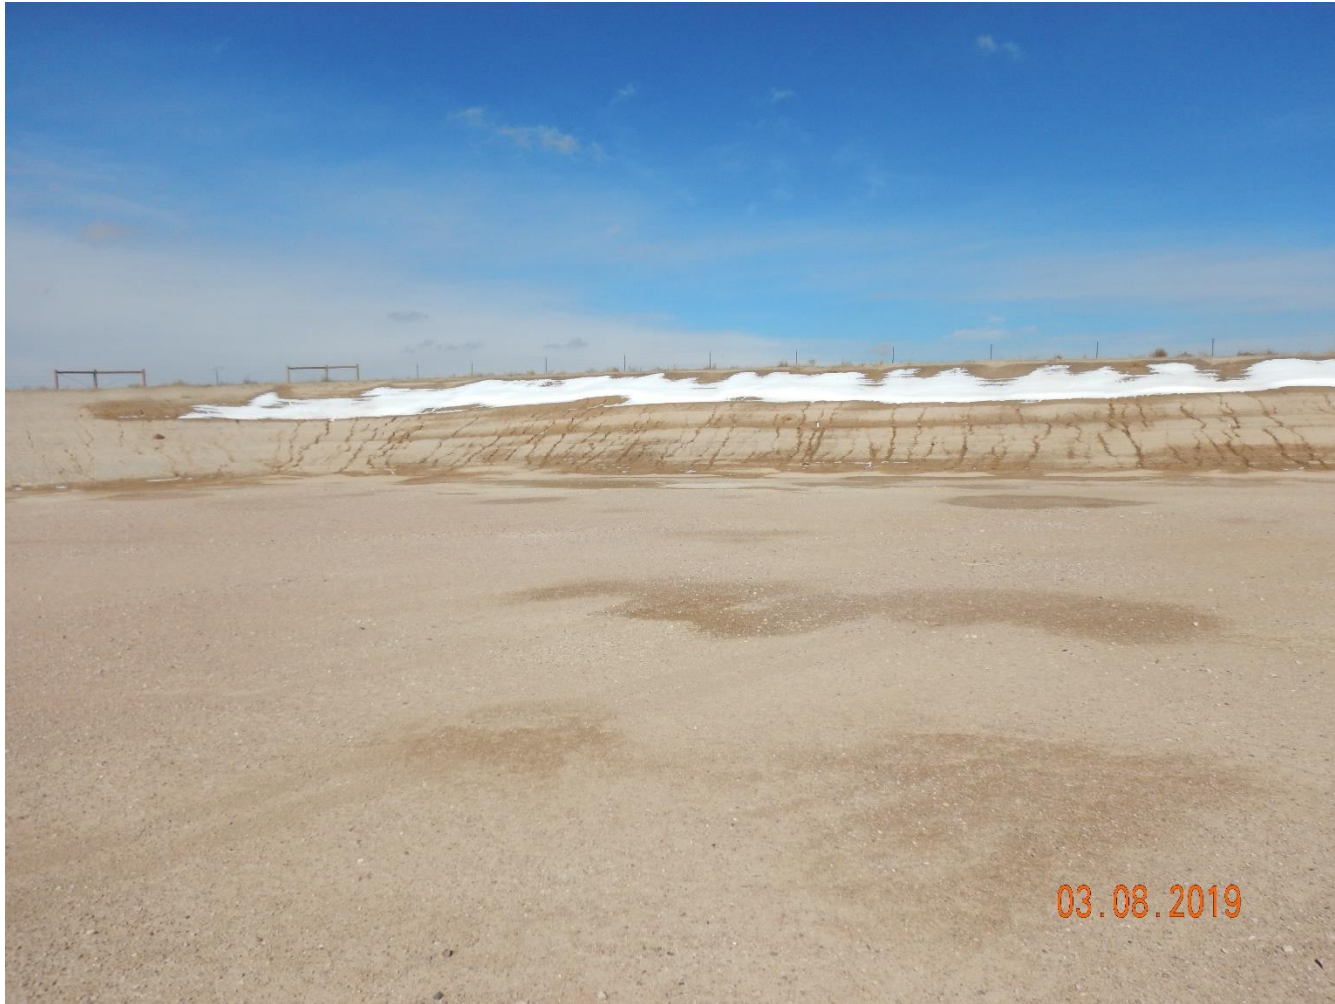
Photo 23: Photo taken from the northwest end of the pad, facing north. Photo shows stormwater erosion degradation on the slopes of the pad.

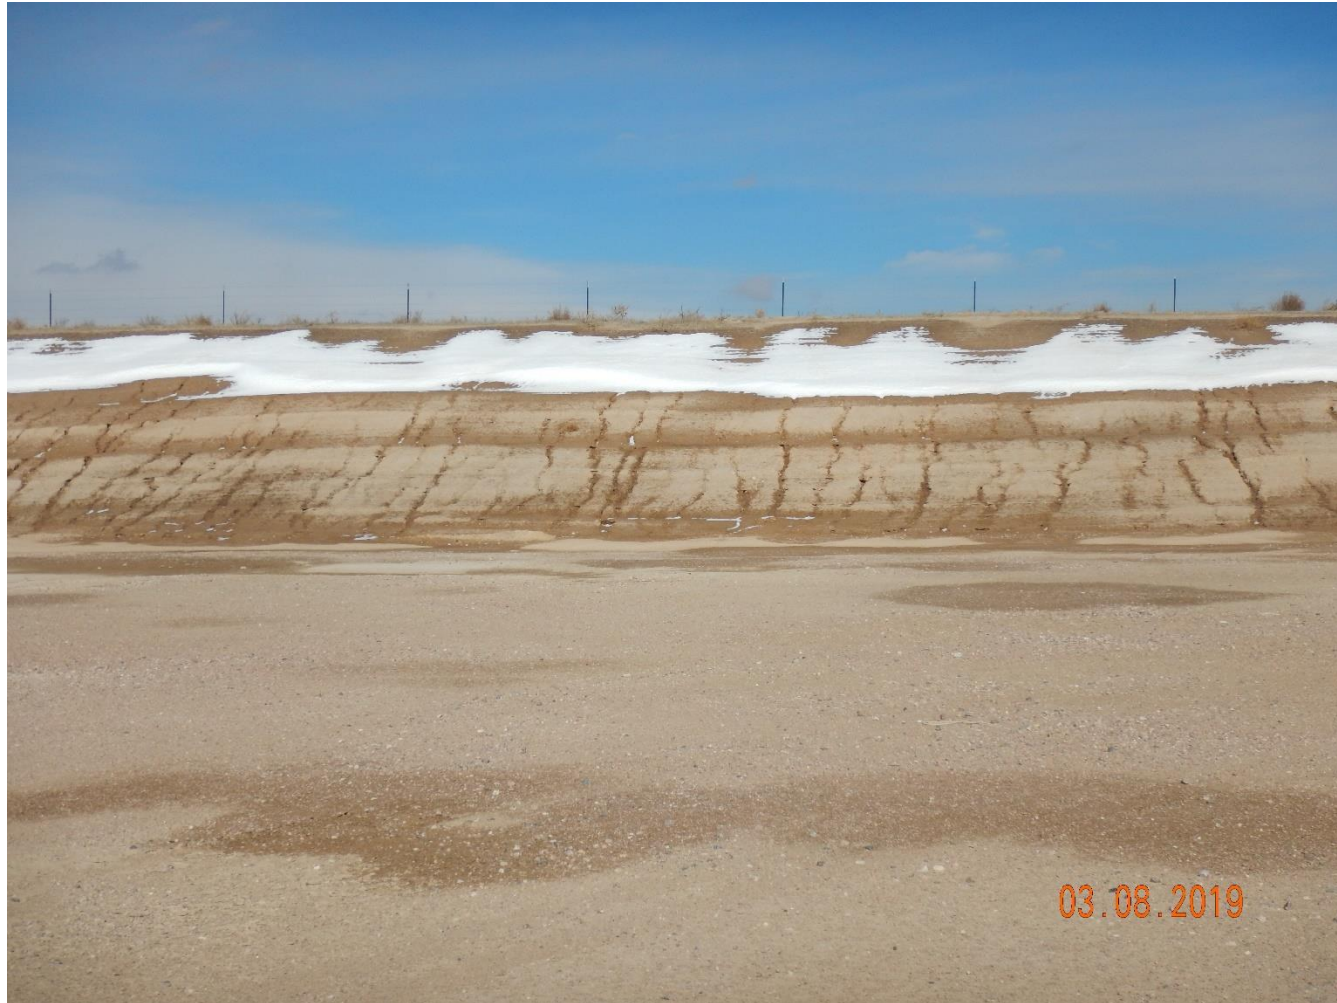
Photo 24: See comments under photo 23.

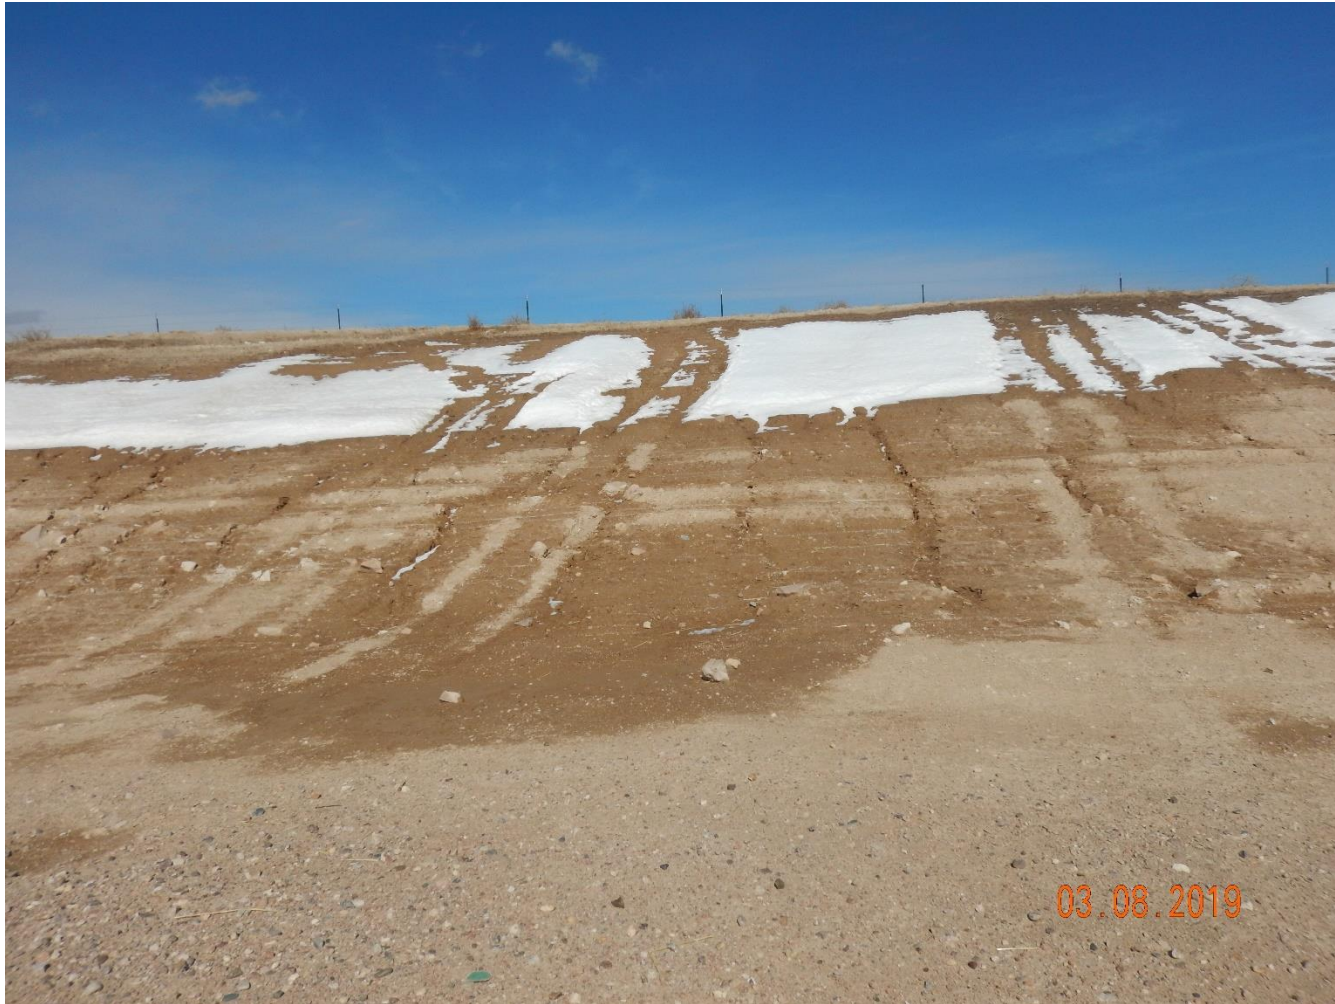
Photo 25: See comments under photo 23. Photo also shows tracks left by a vehicle that appears to have been traveling upon the slopes and ditch of the location. This does not comply with surface disturbance minimization. Vehicle travel may also be contributing to erosion degradation of the pad.

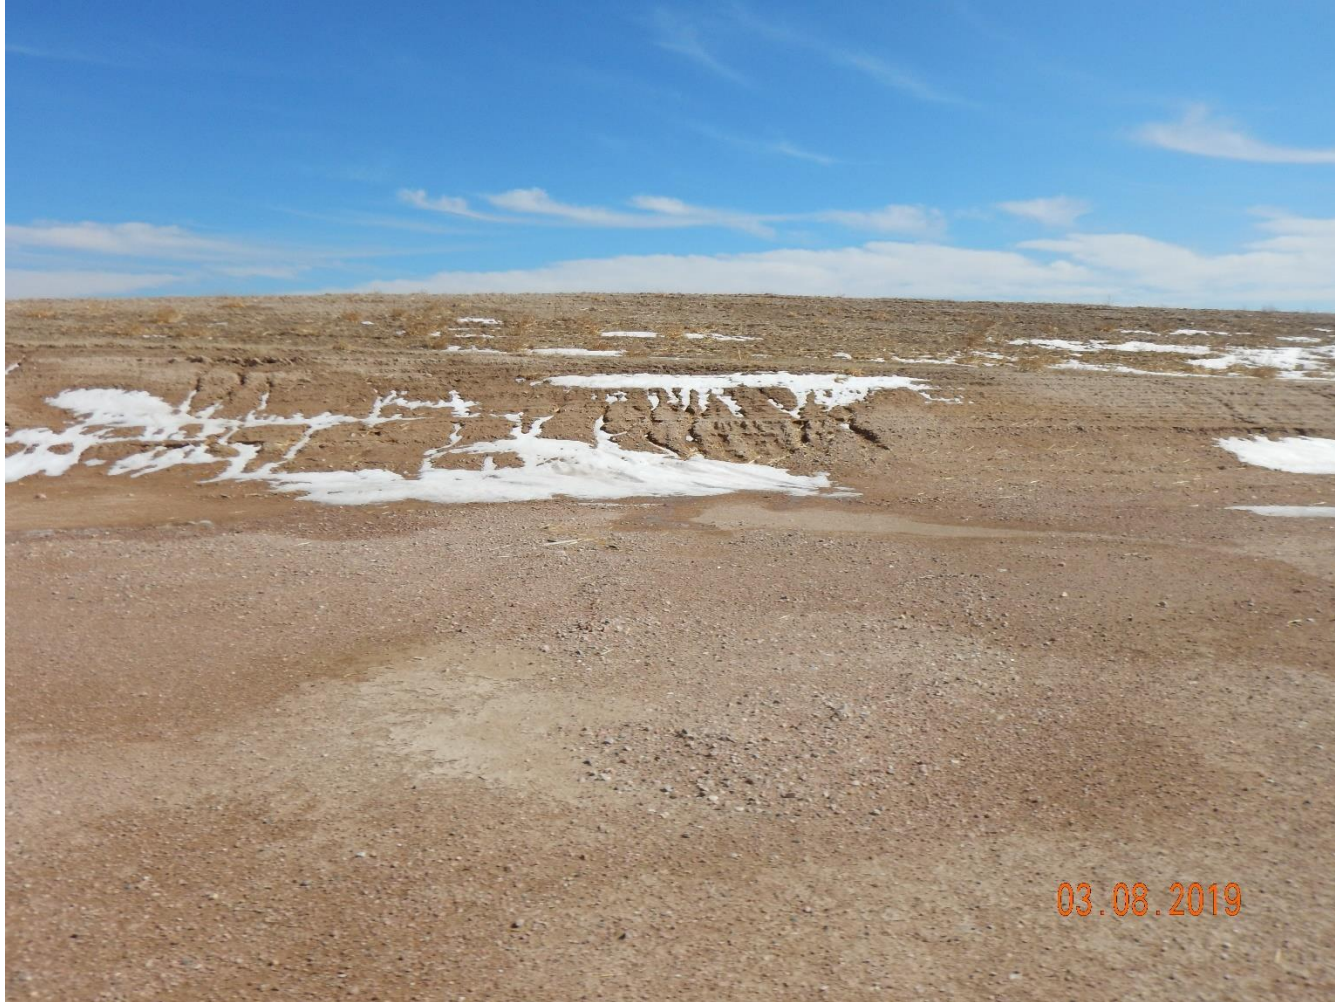
Photo 26: Photo taken from the east end of the pad, facing east. Photo shows erosion degradation at the topsoil stockpile.

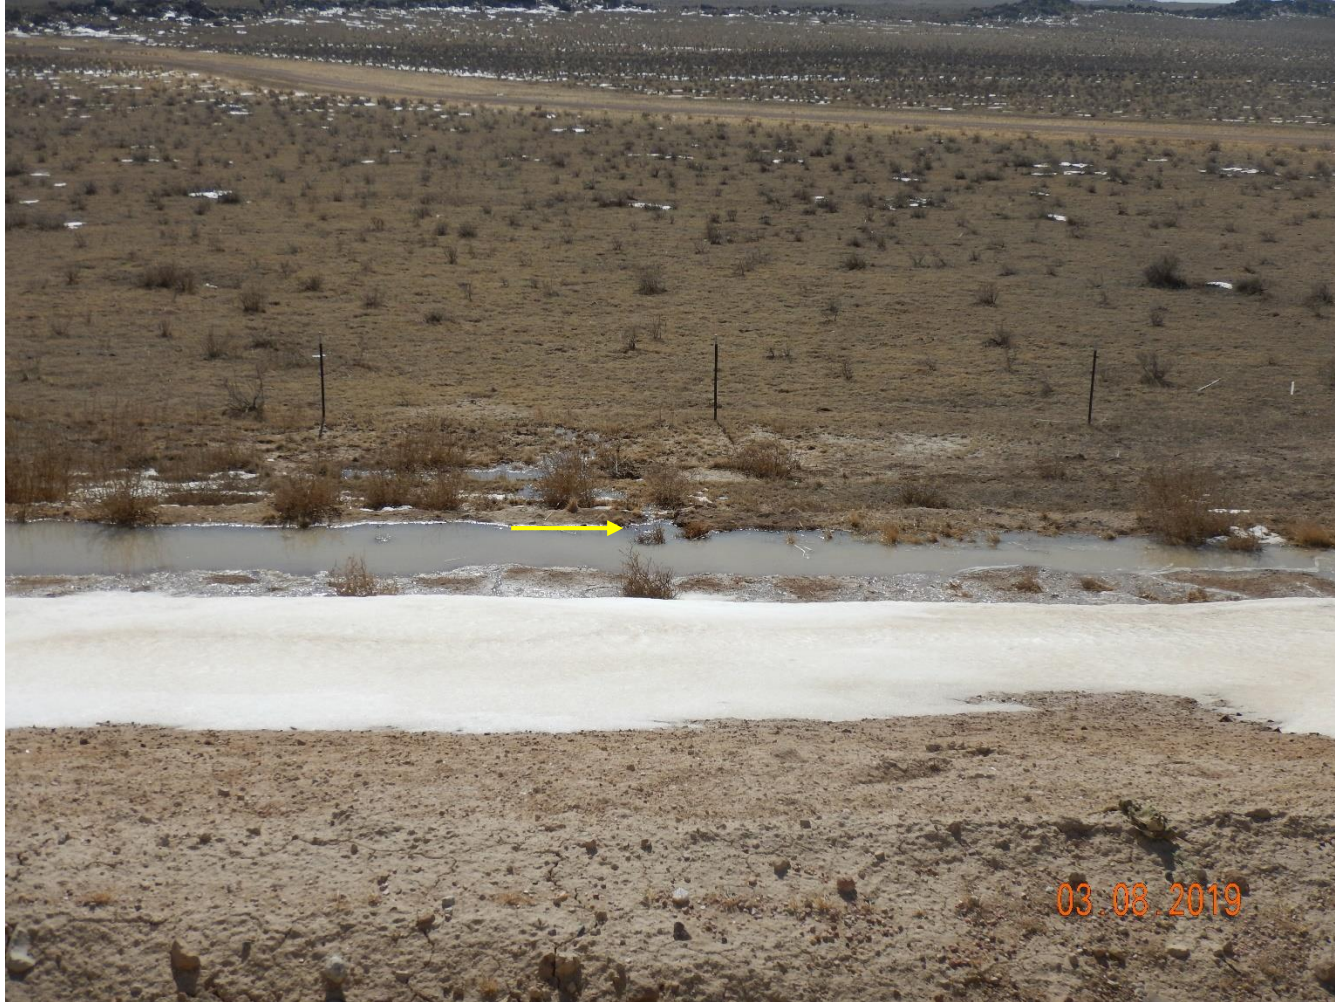
Photo 27: Photo taken from the south end of the pad, facing south. Photo shows section of the ditch that appears to have filled with sediment allowing stormwater to breach the BMP and discharge from location.
