Inspection Photos
Operator: Javernick Oil
Location/API #: 043-05088
Date: 2/28/2019

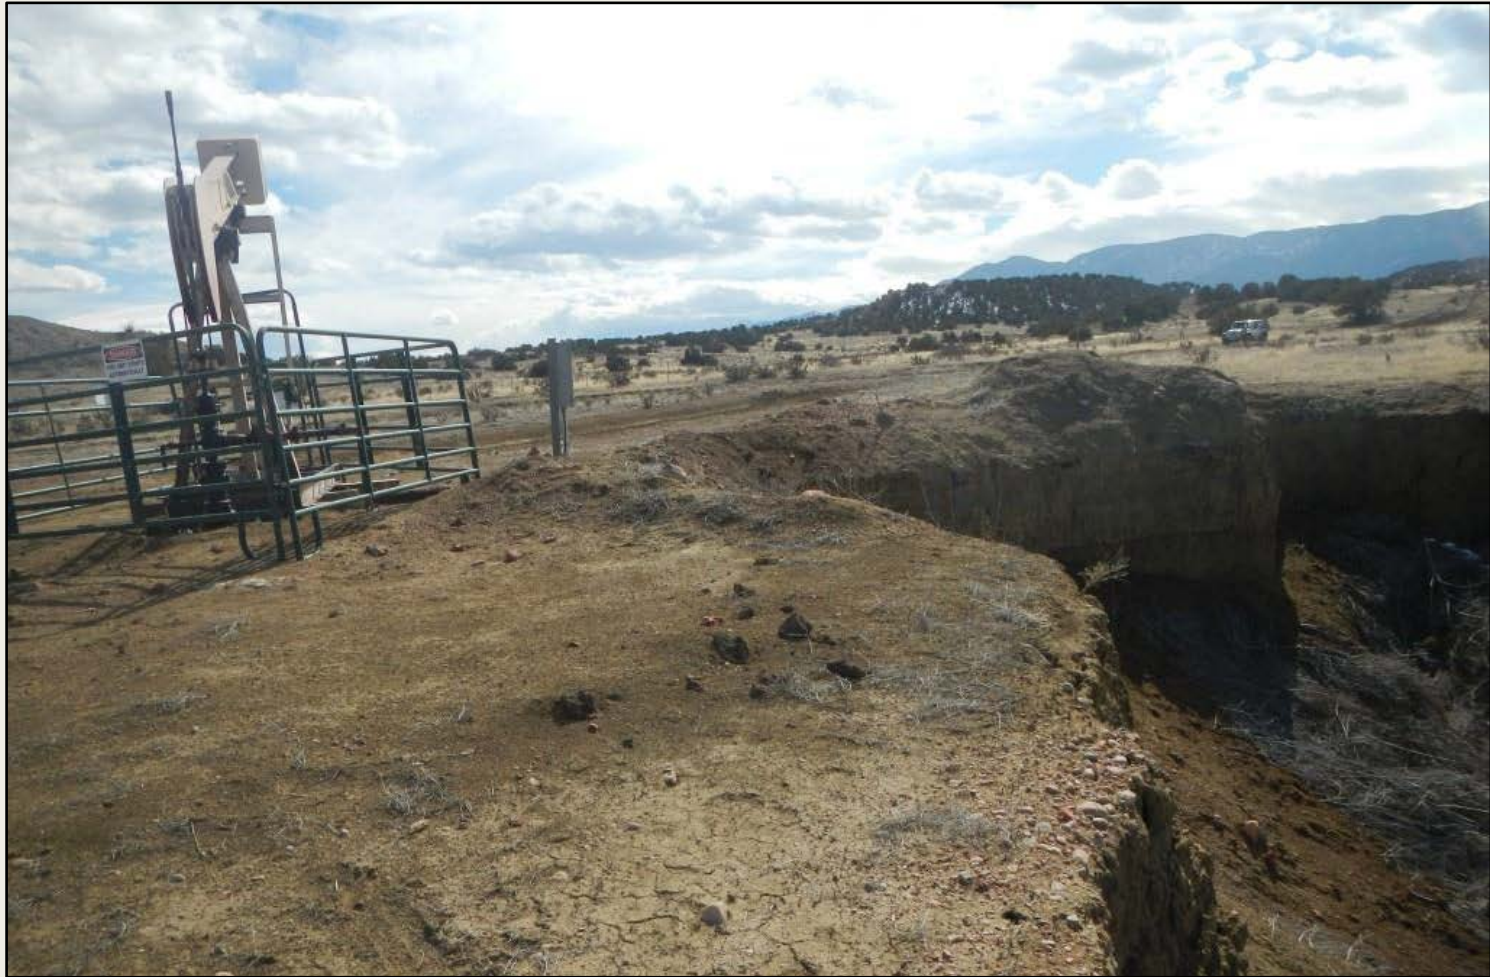
Photo 1. View of the western project area from the western edge facing southward. Wellhead is adjacent to an erosion channel. This area needs immediate stabilization to prevent any further erosion.

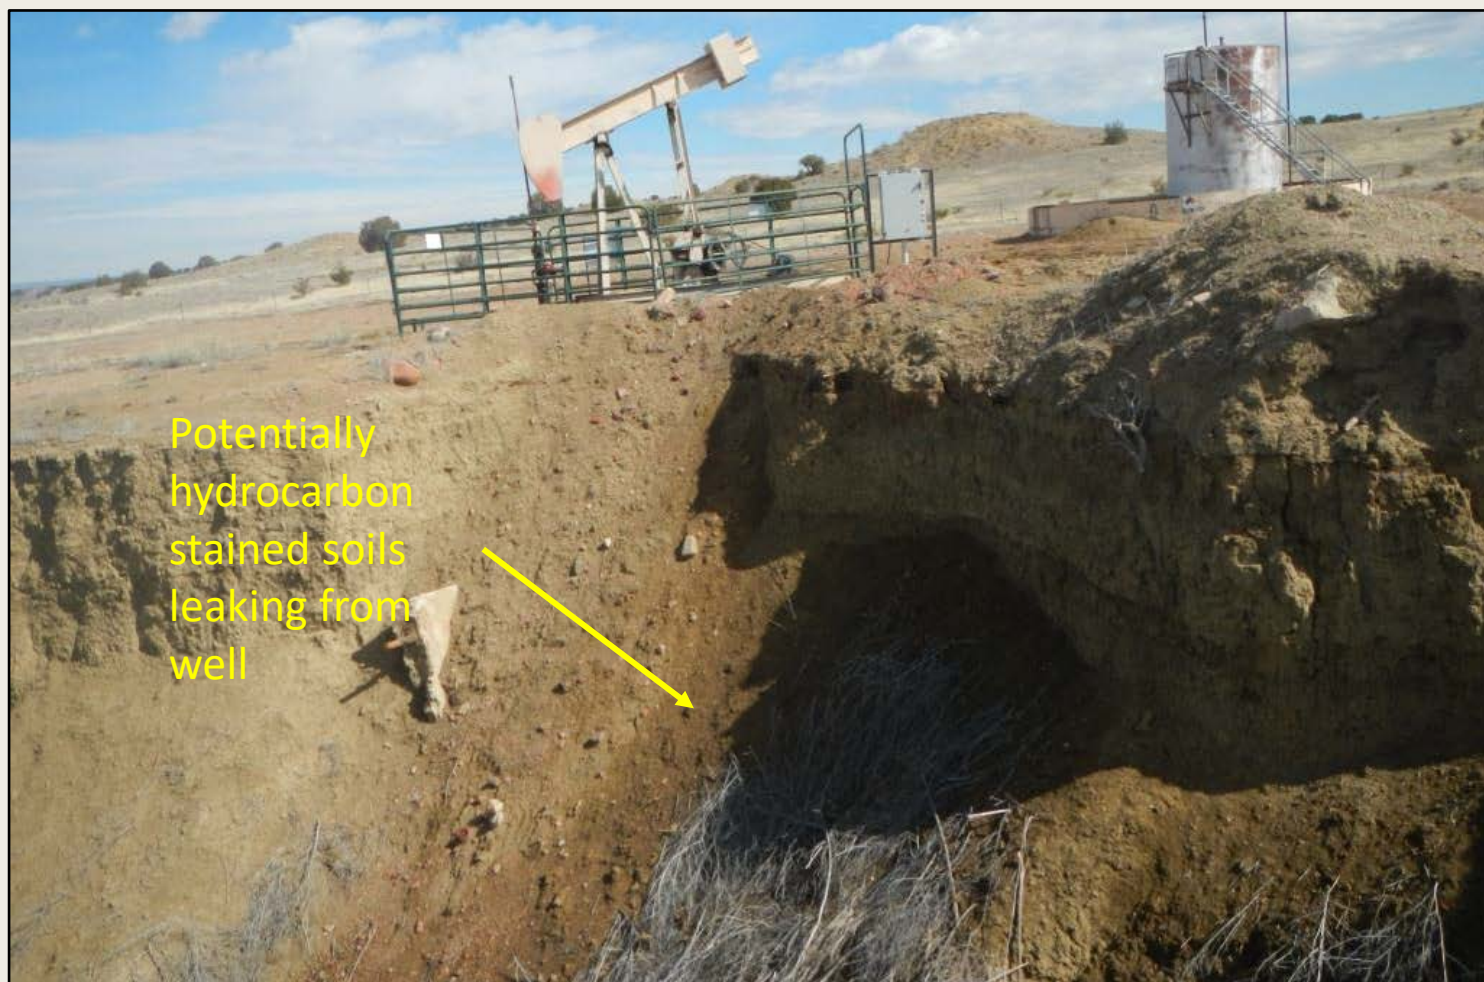
Photo 2. View of the well had from the southwestern edge facing northeastward. Active erosion is visible. Dark soils may indicate oil-stained soils. Location is not stable.

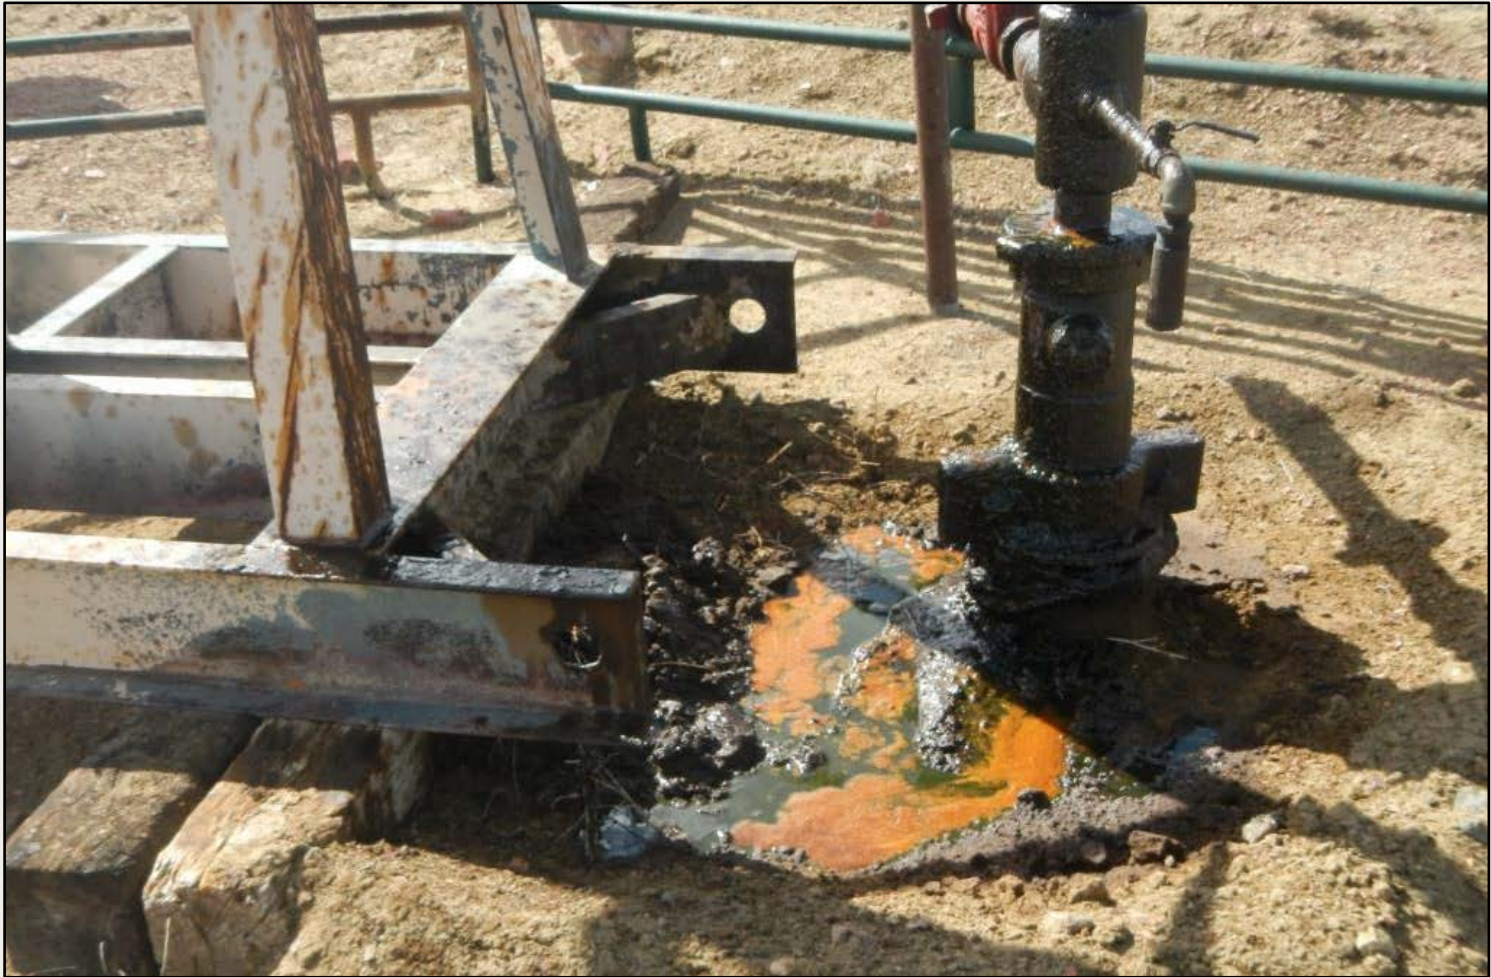
Photo 3. View of hydrocarbon material pooling around wellhead.

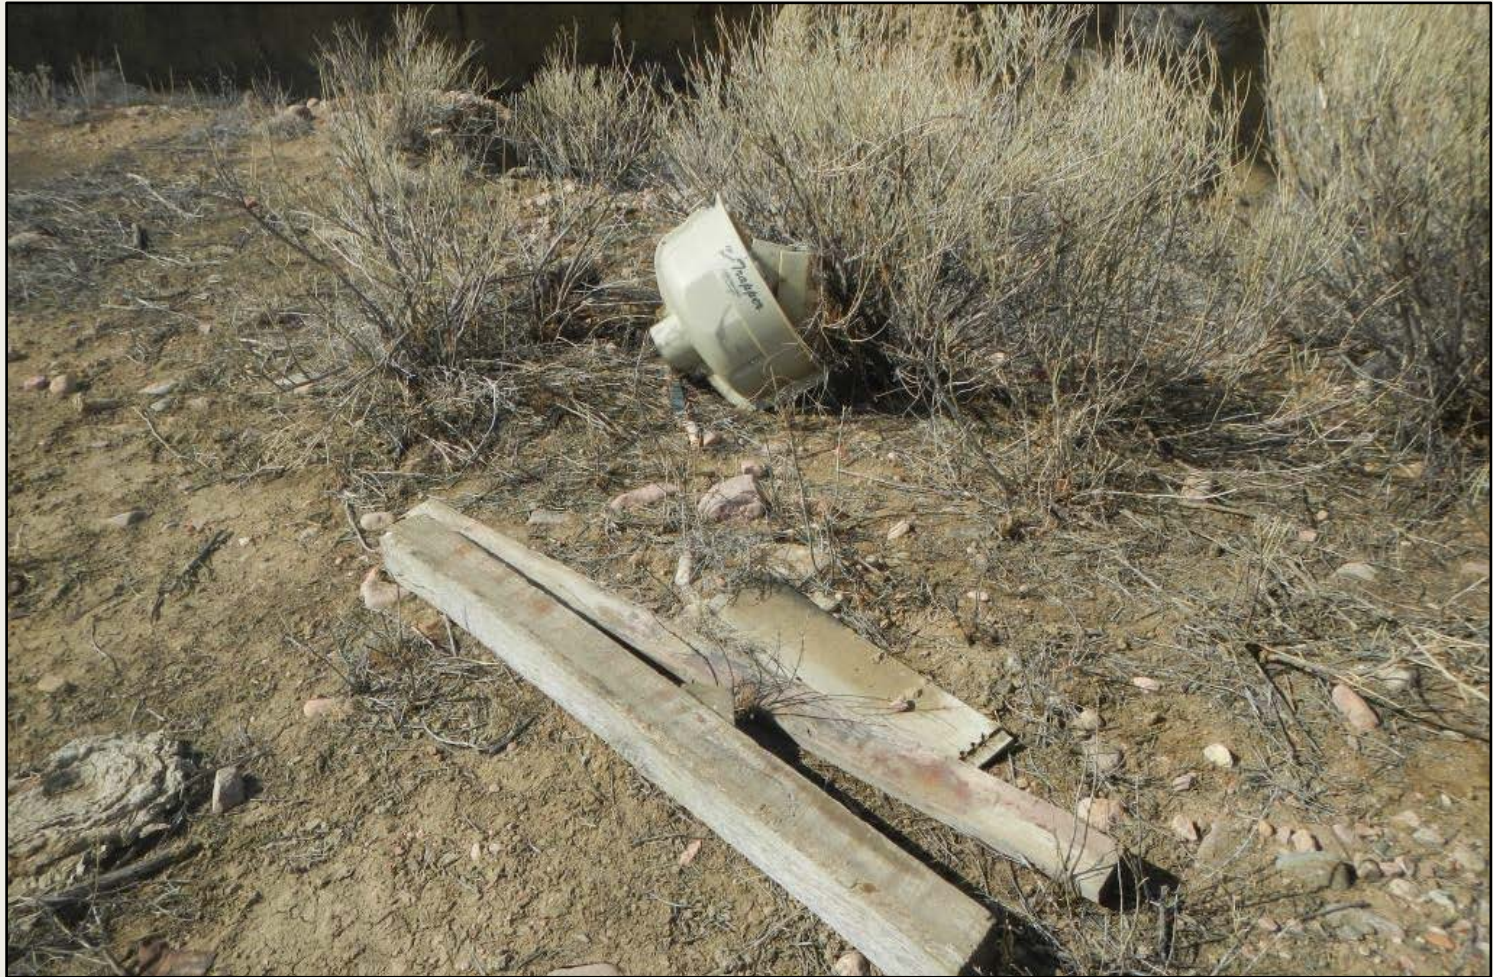
Photo 4. View of debris on the well pad.

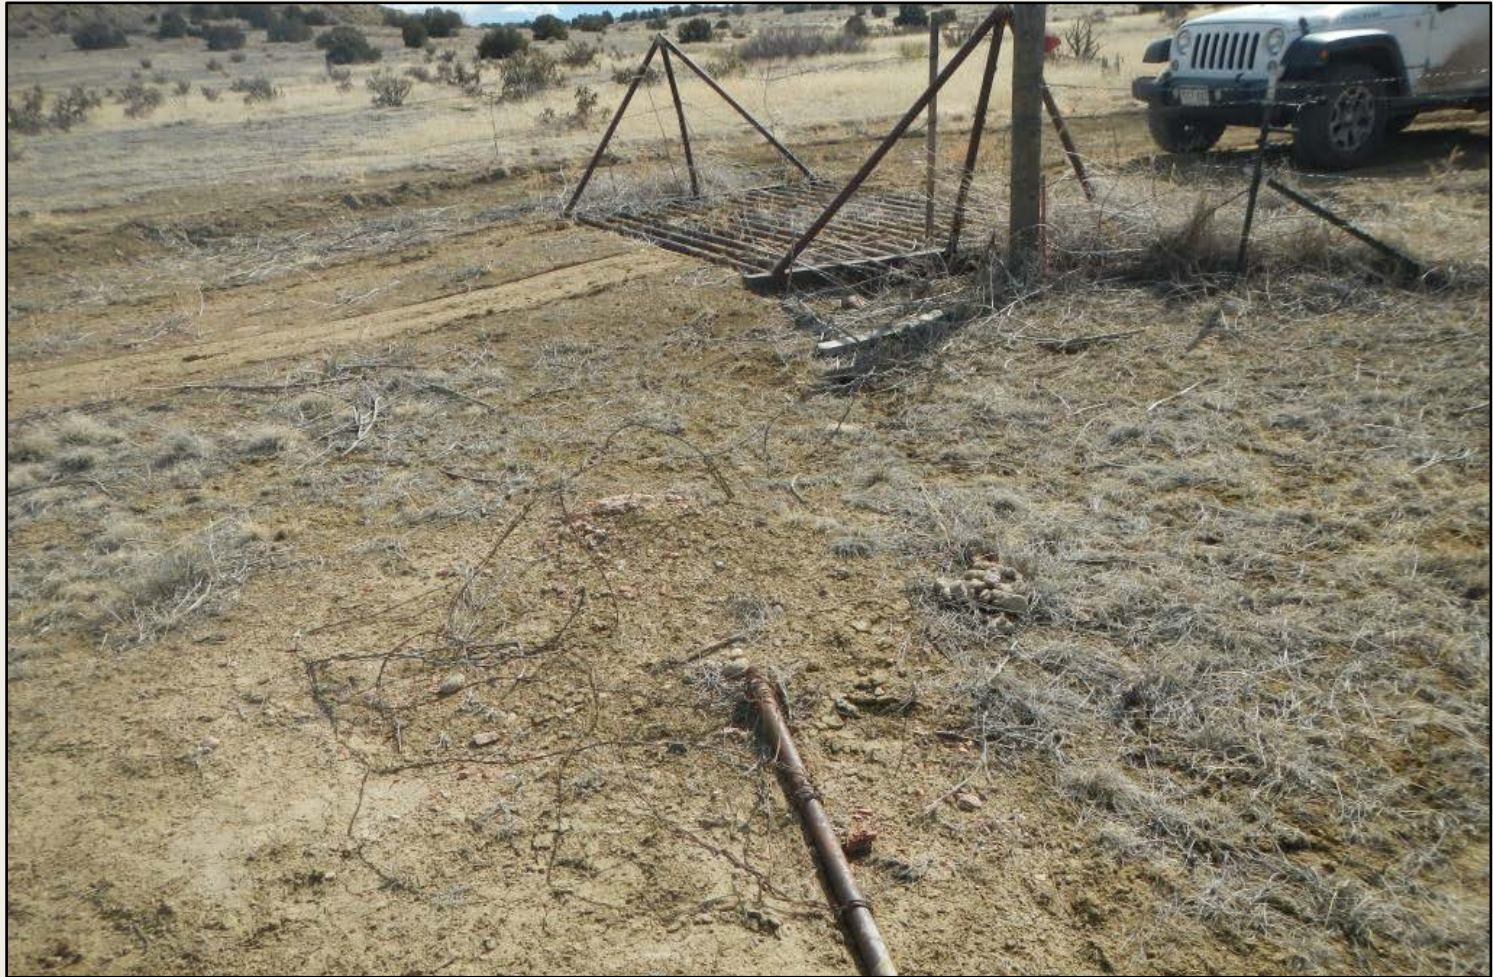
Photo 5. View of barbed wire debris at the gated entrance to the well pad.

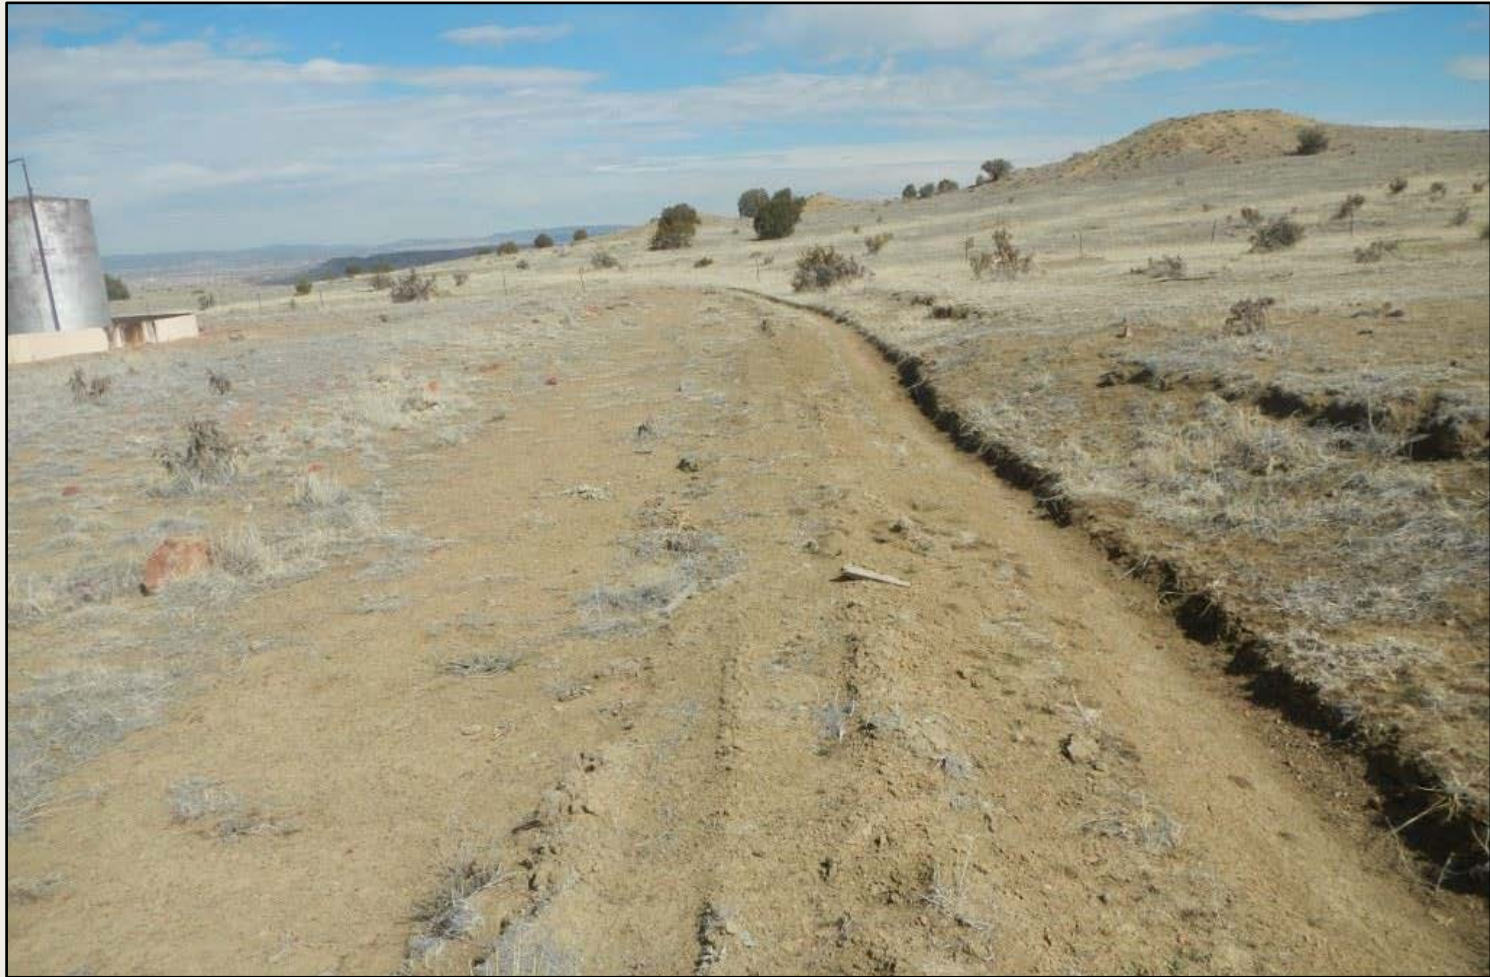
Photo 8. View of stormwater diversion for run-on control along the eastern edge of the project area. Does not appear sufficient to divert stormwater flows from significant runoff events.

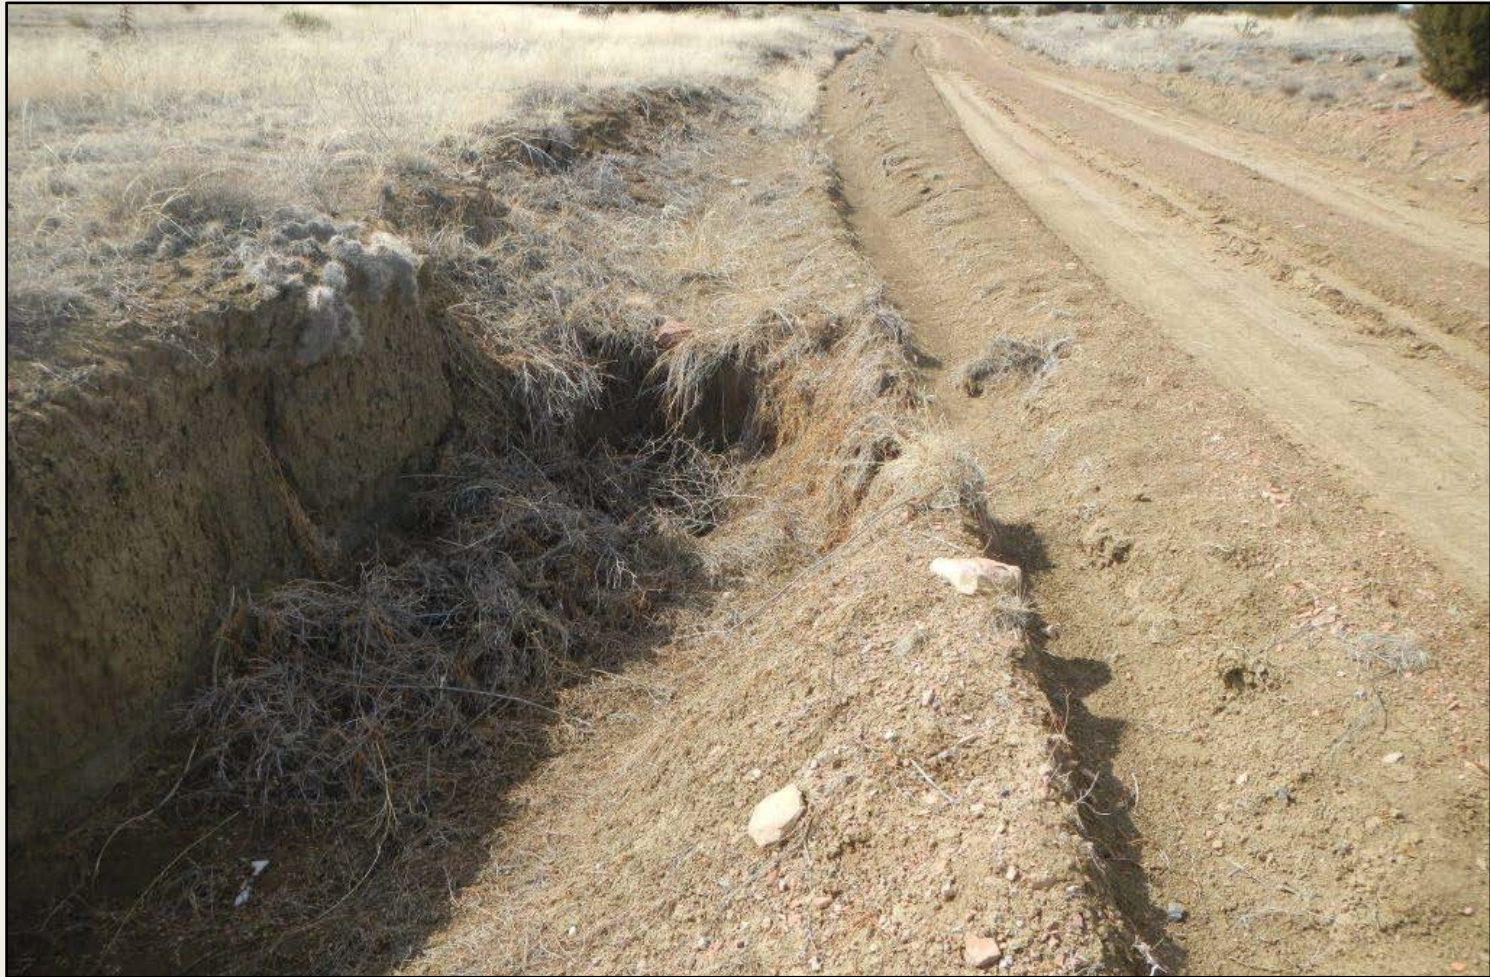
Photo 9. View of erosional headcut, approximately 3 feet wide and deep, along the eastern edge of the access road. Stormwater controls are needed to stabilize erosion within the roadside ditches.
