Inspection Photos

Location Name: Anschutz Equus Farms #4-26-33-0108C2

Location ID: 437854

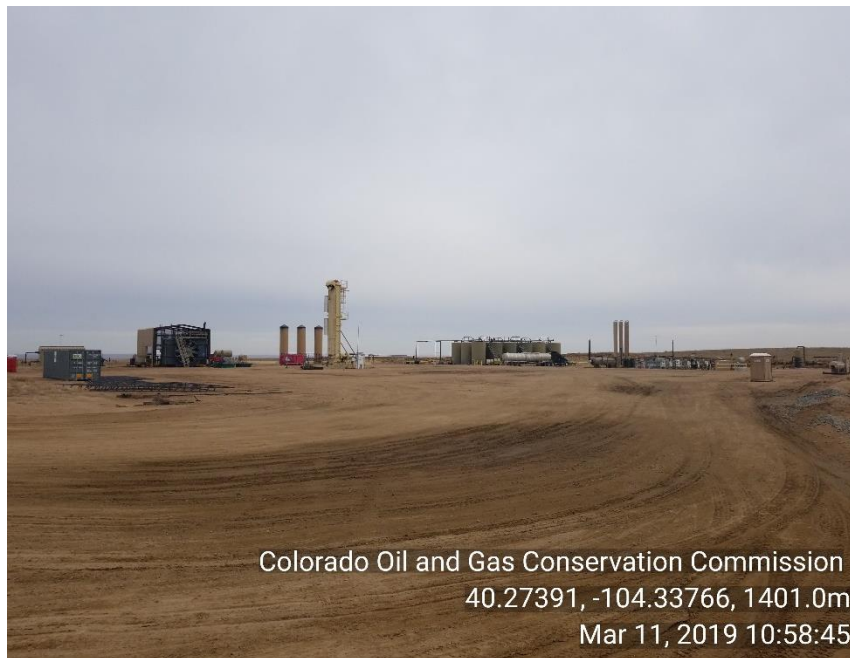
Photo 1 Loc Pic

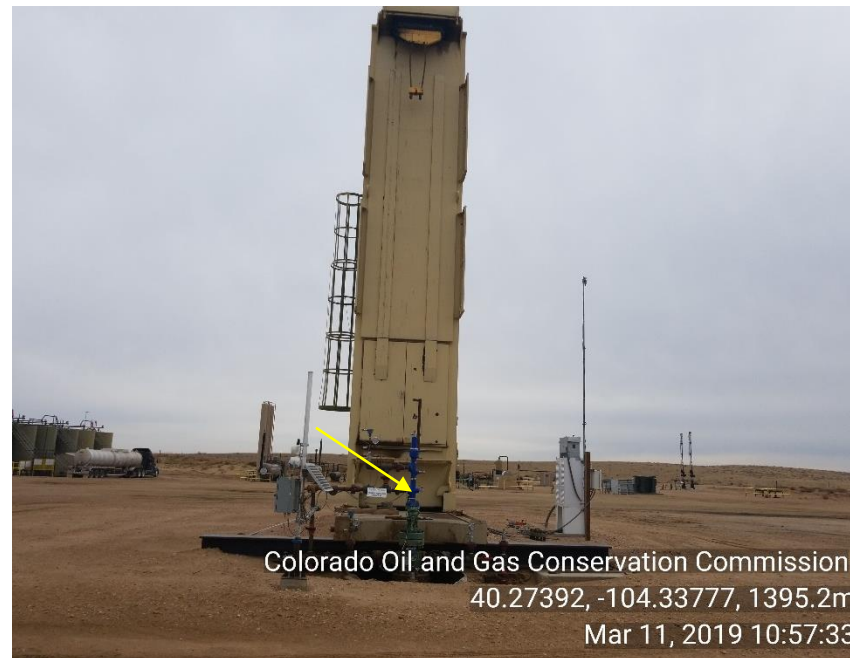
Photo 2 WH/ unused equipment hyd PU not being used WH has Plunger lift.

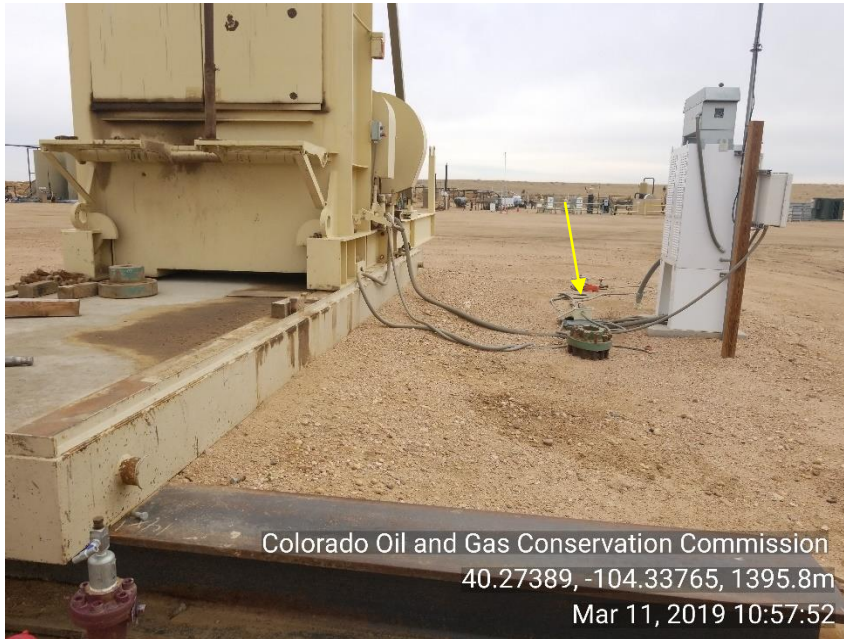
Photo 3 Unused equipment (parts)

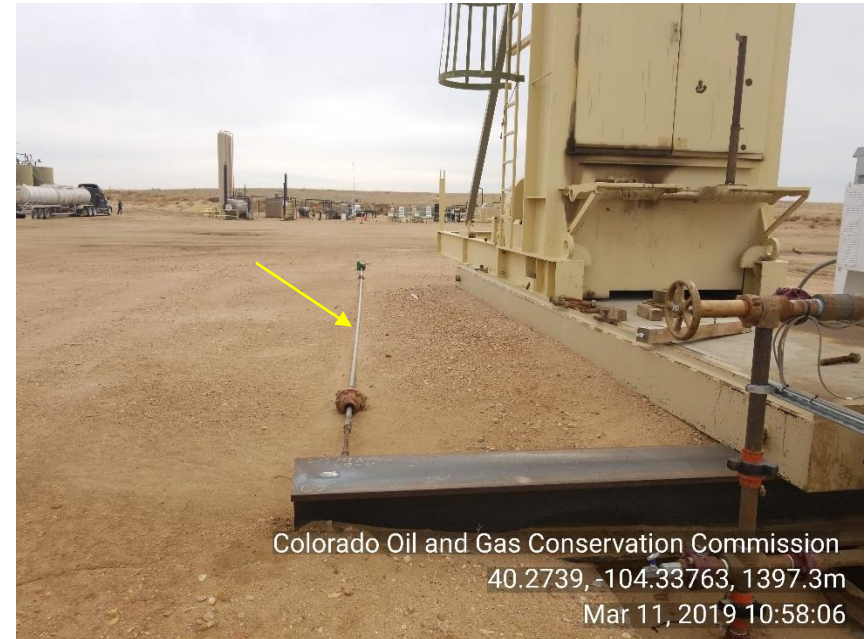
Photo 4 unused equipment polish rod

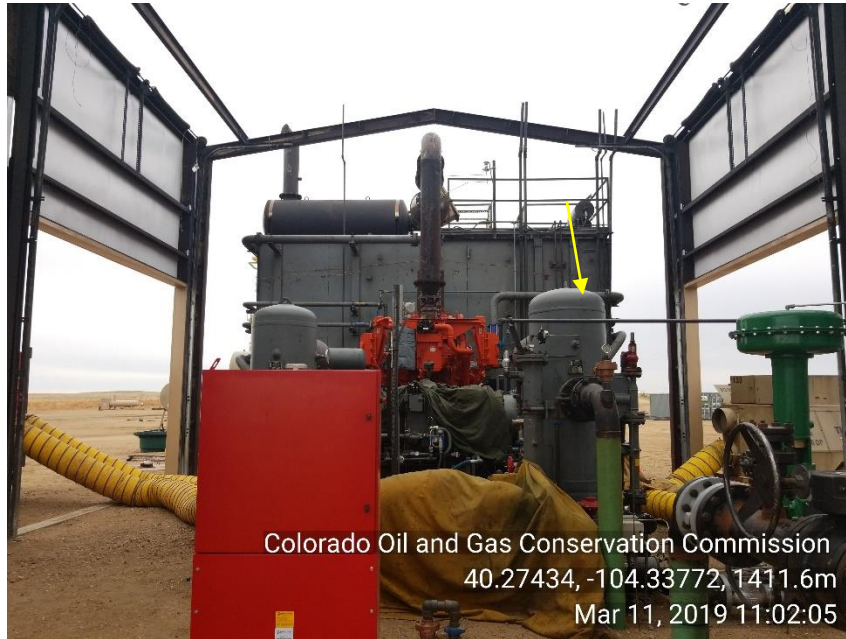
Photo 5 Gas compressor Pic. Tarps and hoses from heaters

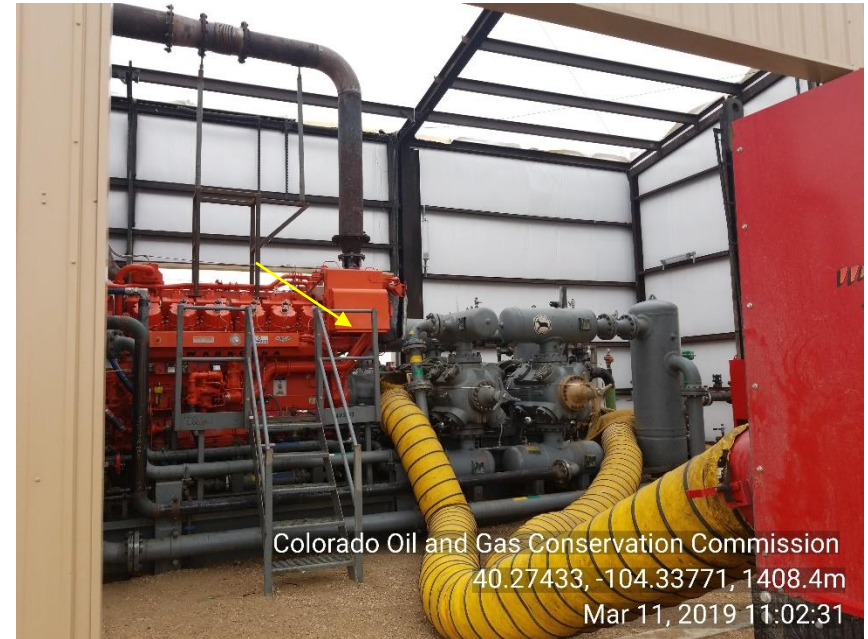
Photo 6 Gas compressor pic. Heater and hoses.

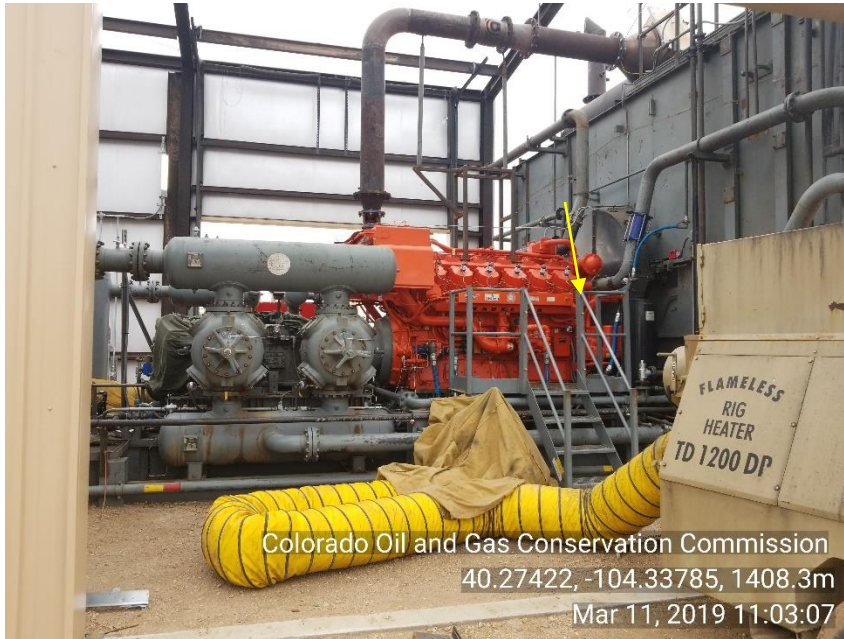
Photo 7 Gas compressor Pic. Tarps and hoses from heaters

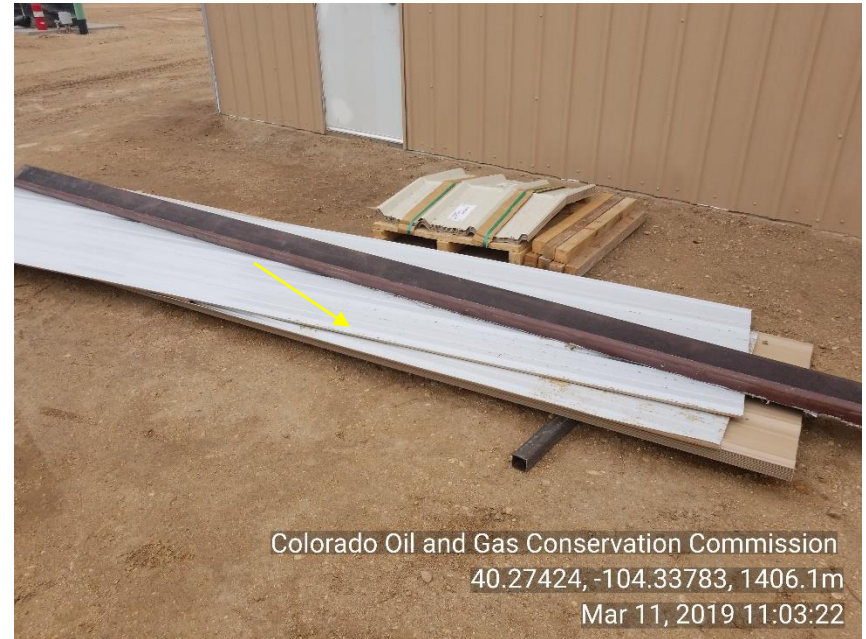
Photo 8 roofing material new and strapped to pellets.

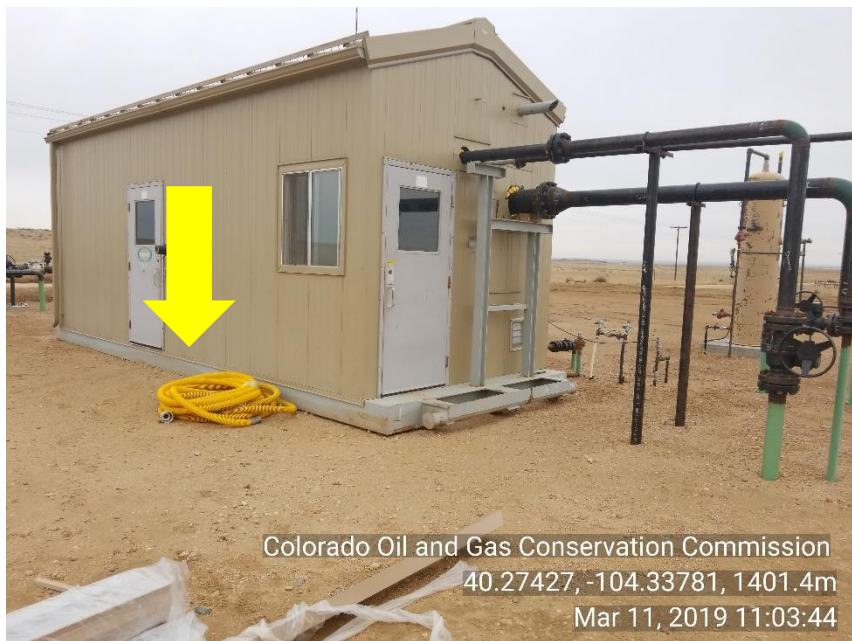
Photo 9 Separator building unused equipment 2" hose.

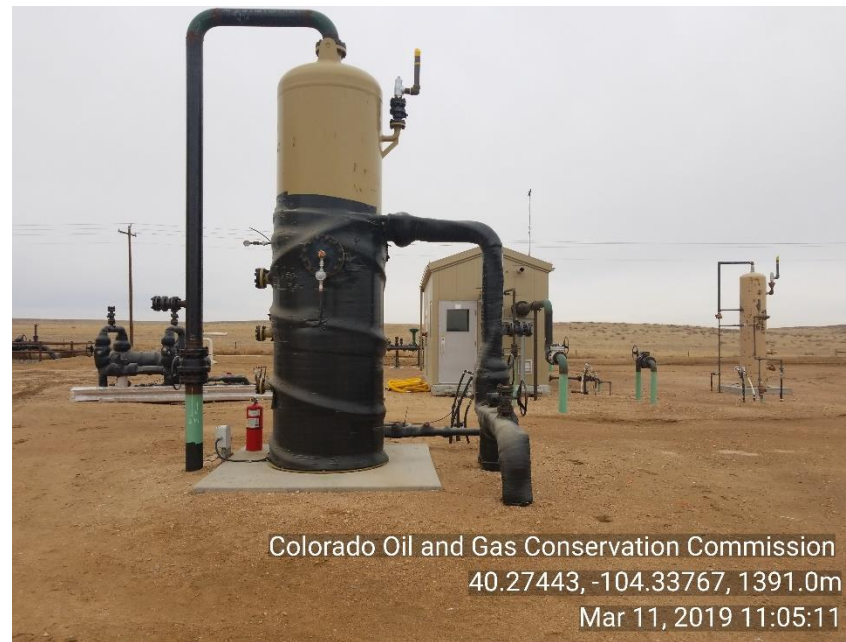
Photo 10 Vert separators and separator building.

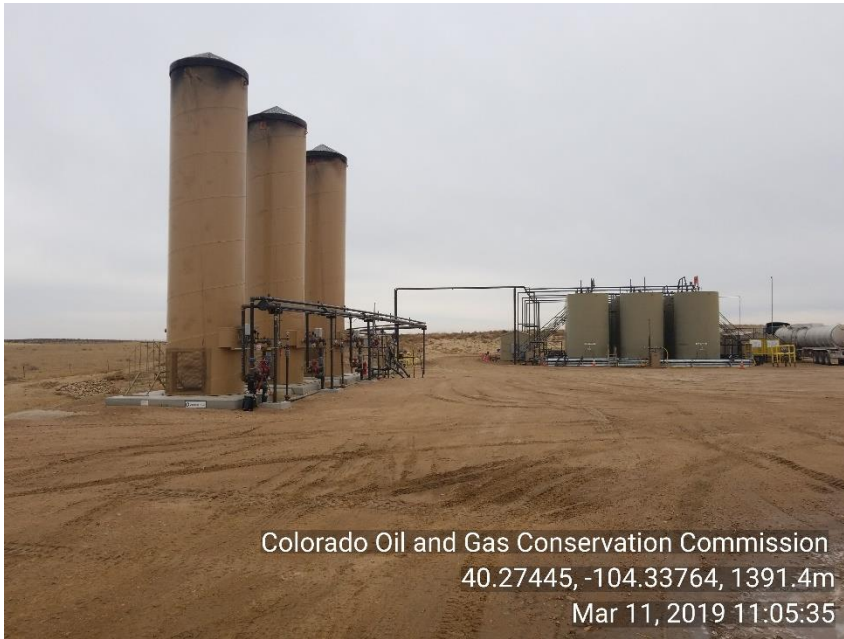
Photo 11 ECD's and battery pic

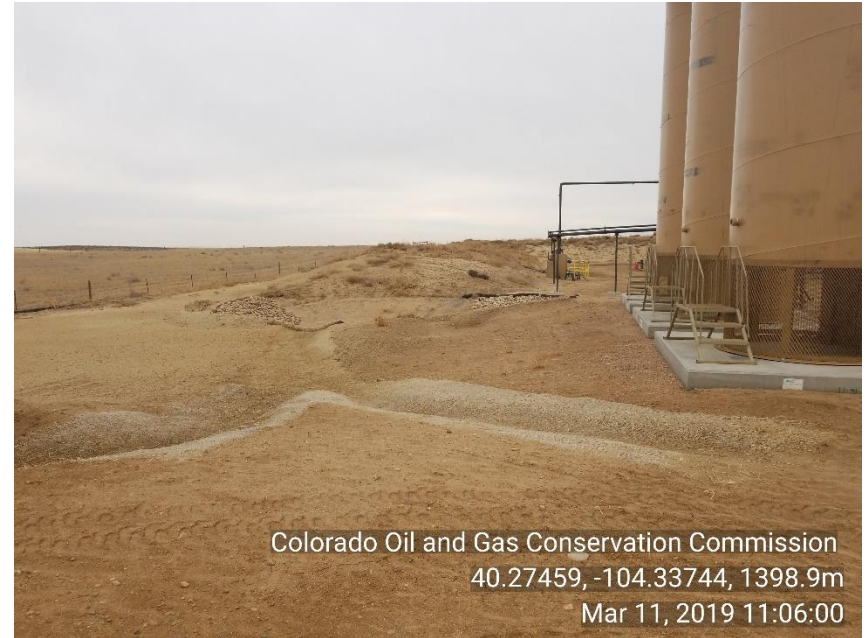
Photo 12 location drainage and sediment trap

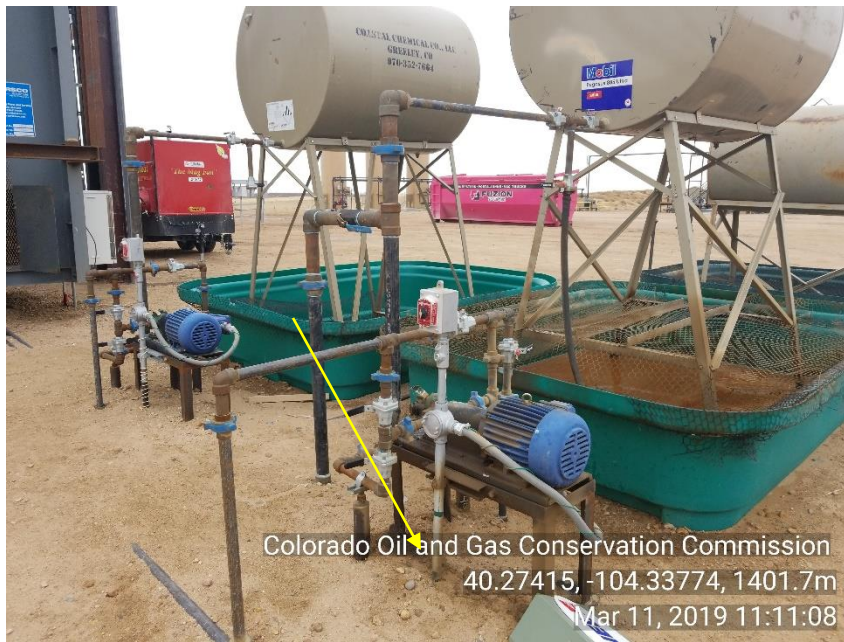
Photo 13 Stained soil under transfer pump for motor oil

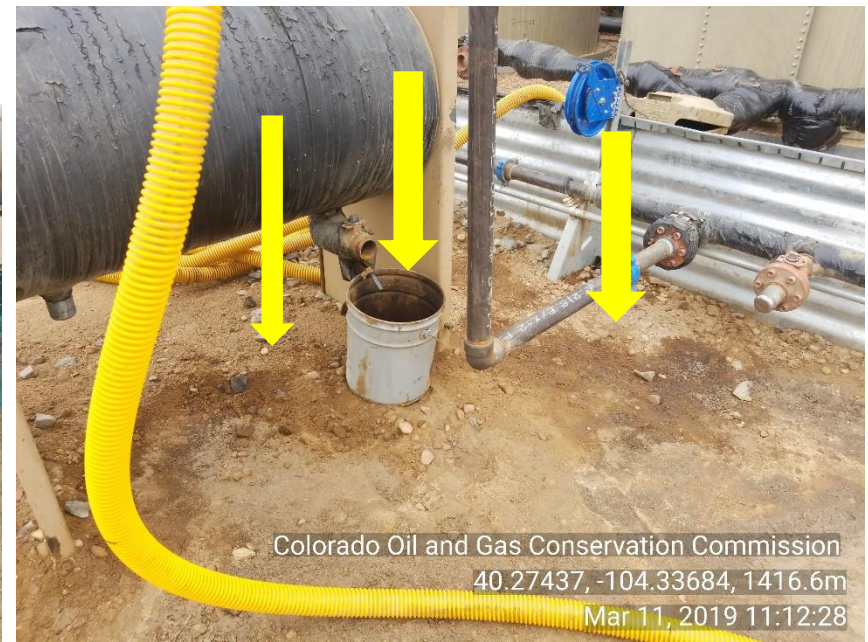
Photo 14 Stained soil under and around Knock out tank in front of TNK BTRY. 5 gal bucket is trash

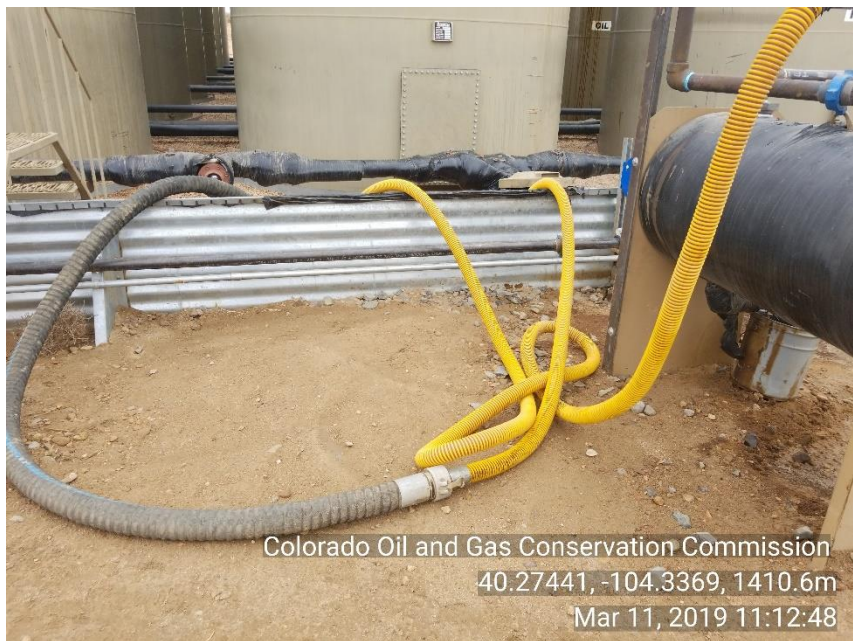
Photo 15 unused equipment hoses for loading out not stored properly and outside containment

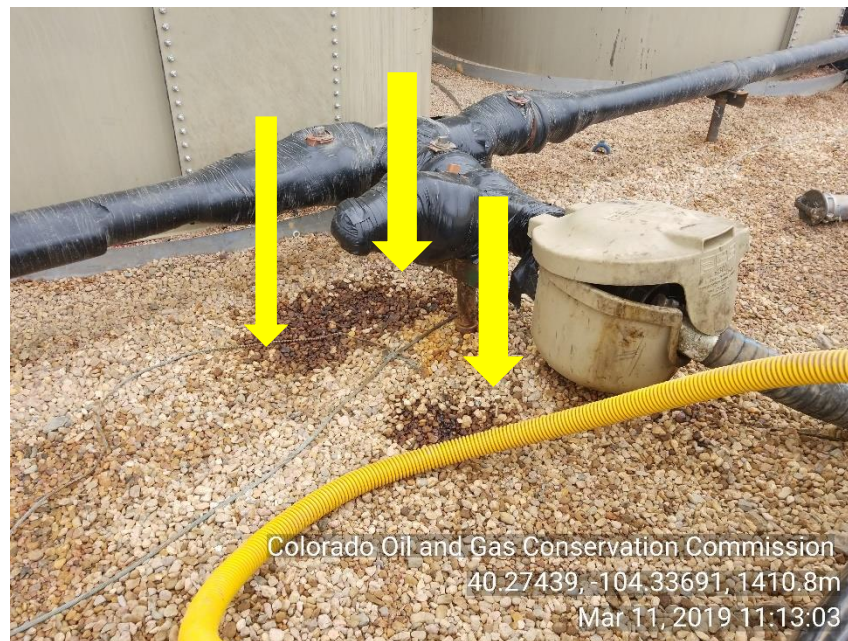
Photo 16 Stained soil under and around load out line to TNK BTRY inside containment

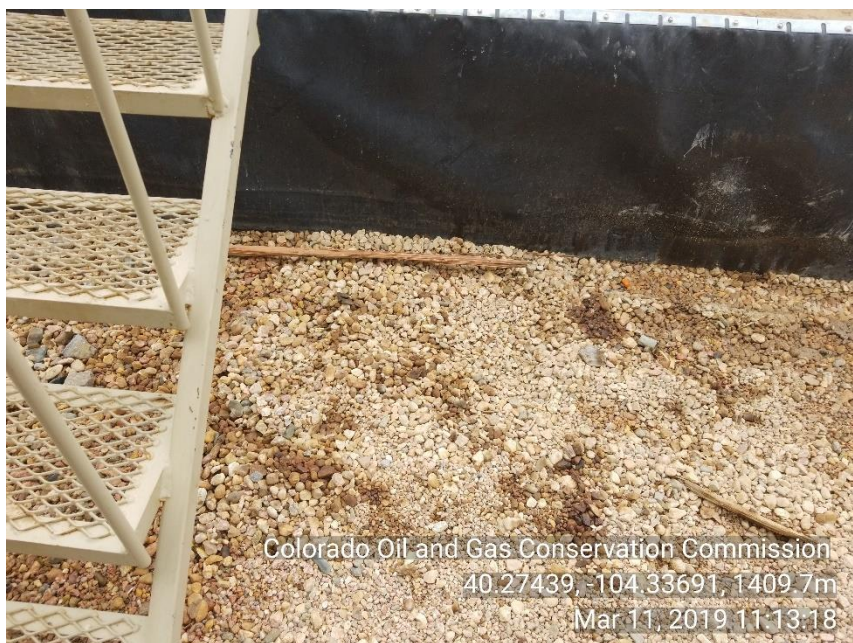
Photo 17 stained soil inside crude oil containment

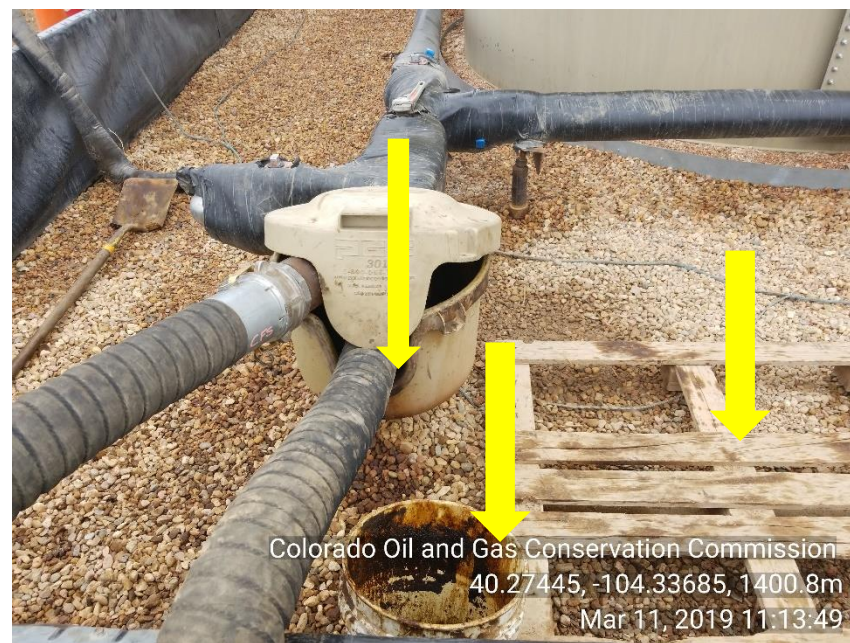
Photo 18 Stained soil under and around load out line to TNK BTRY inside containment. 5 gal bucket and pellet are trash inside containment.

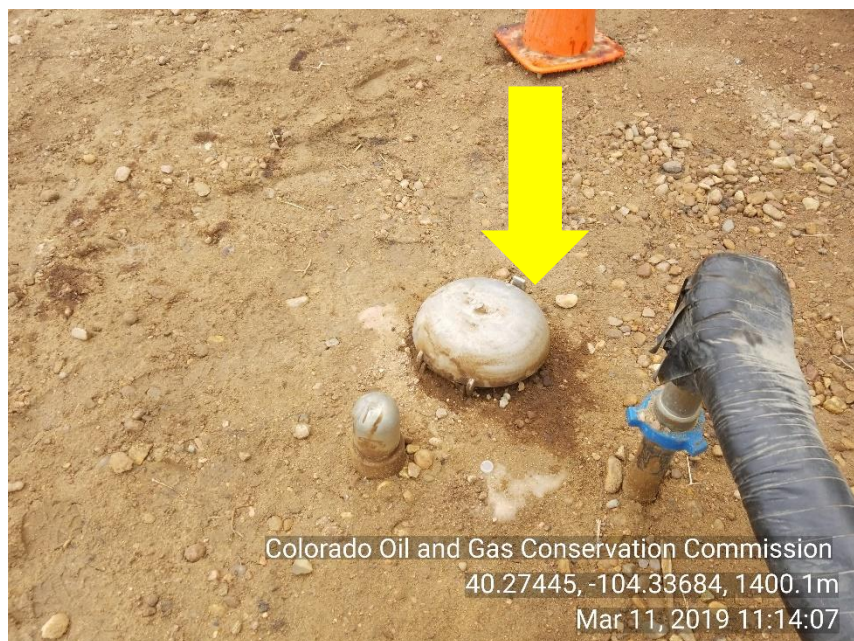
Photo 19 stained soil around lid of what appears to be buried vault out side containmet wall.

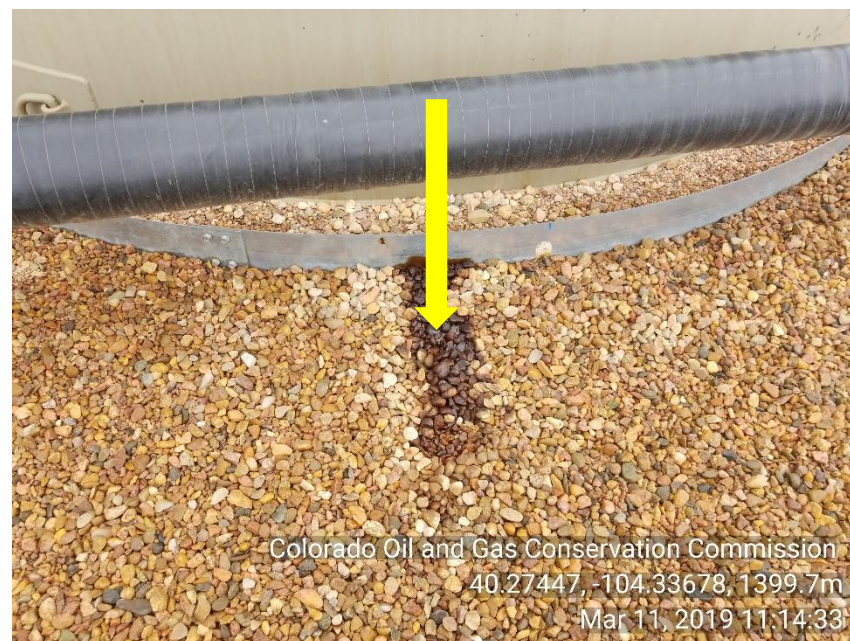
Photo 20 Stained soil around grade ring of crude oil tank inside containment

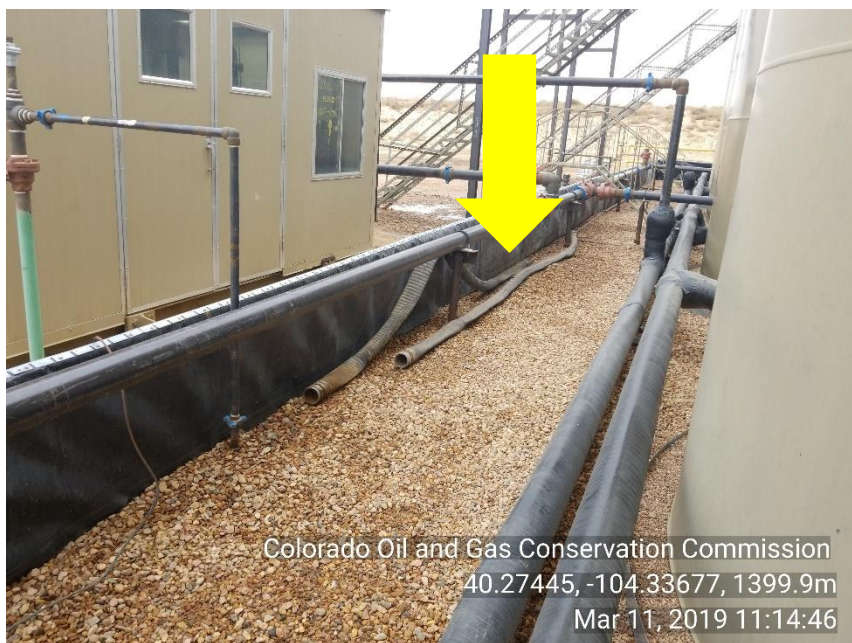
Photo 21 Unused equipment 3" hoses

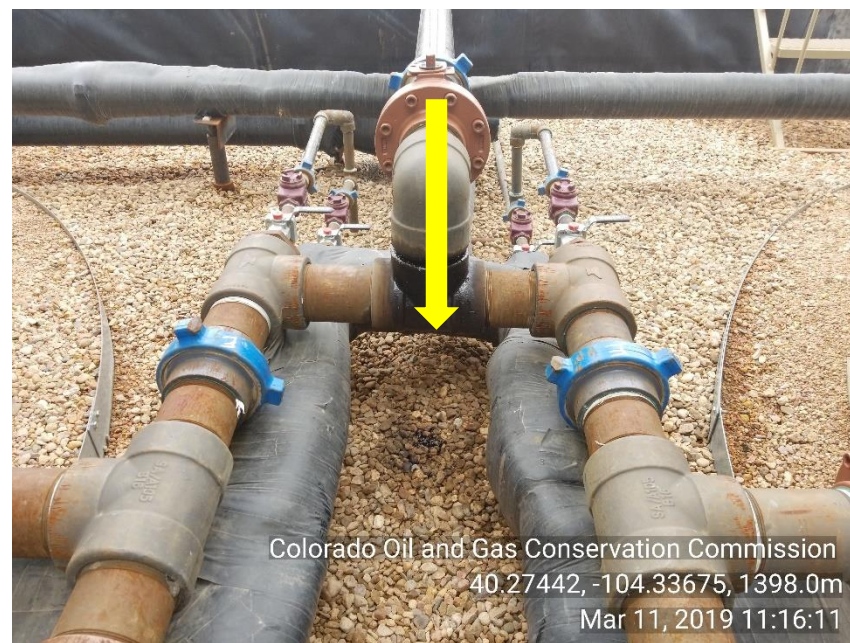
Photo 22 Stained soil under connecting lines to crude oil tanks. Mechanical issue piping

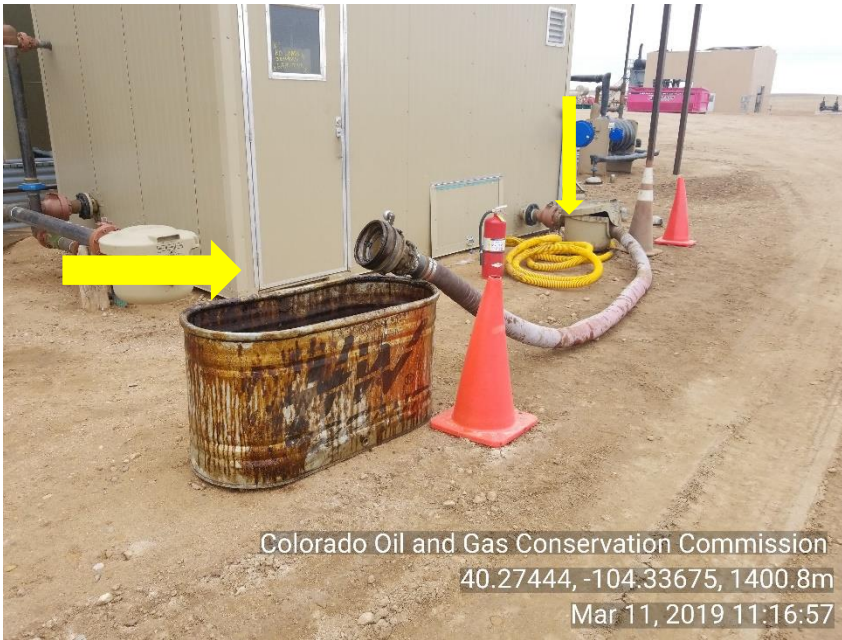
Photo 23 Improper storage of hose's and no secondary containment under oil container

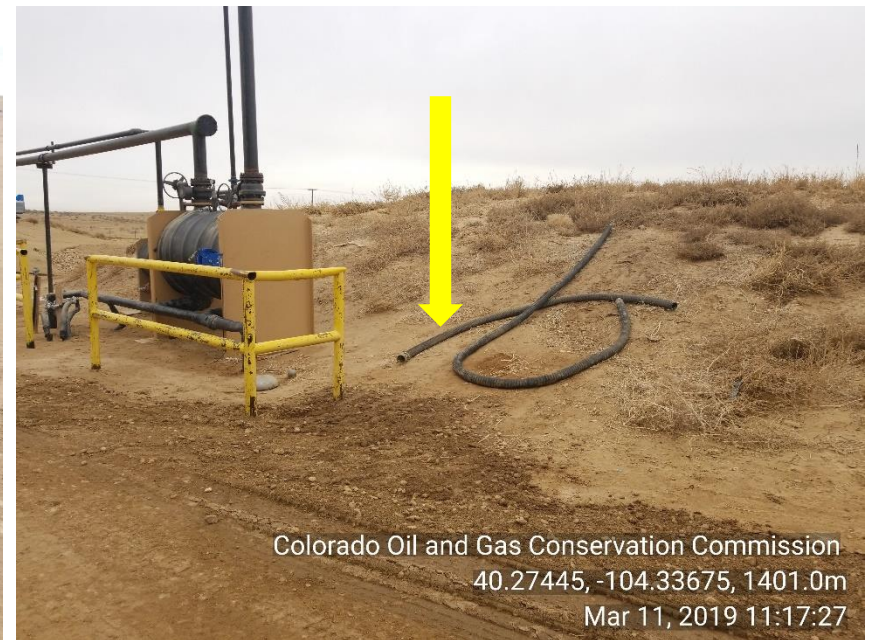
Photo 24 unused equipment 3' hose

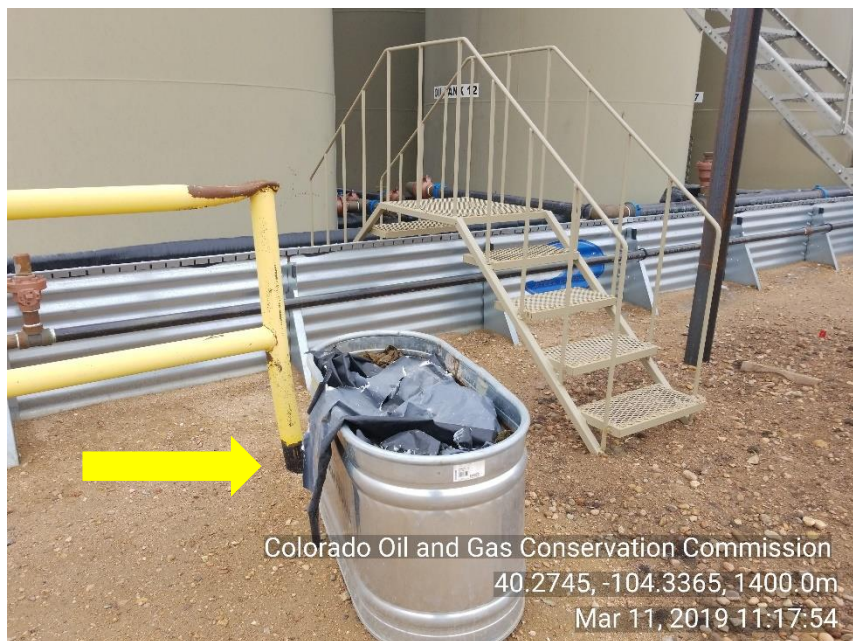
Photo 25 Trash: container with trash outside crude oil containment walls

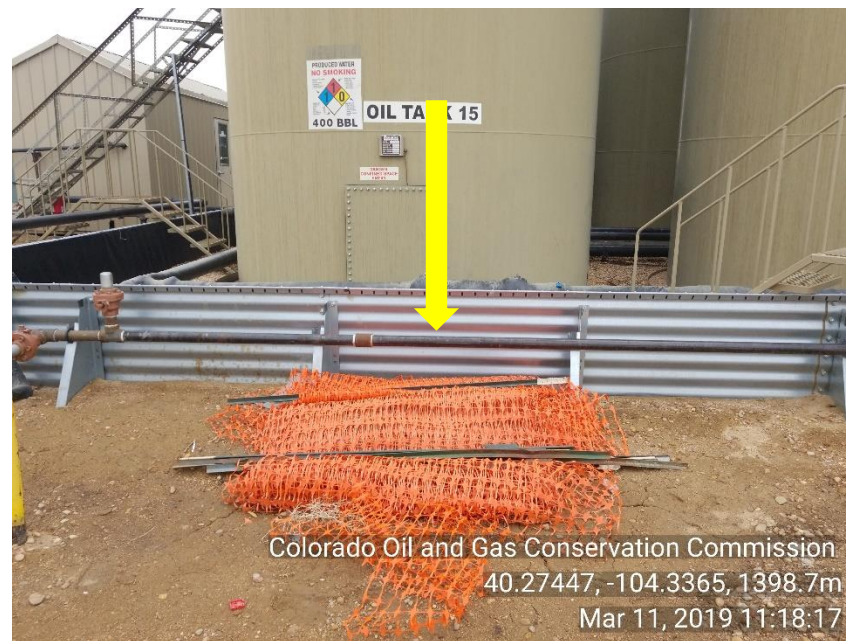
Photo 26 Trash: snow fence and T post outside crude oil containment walls.

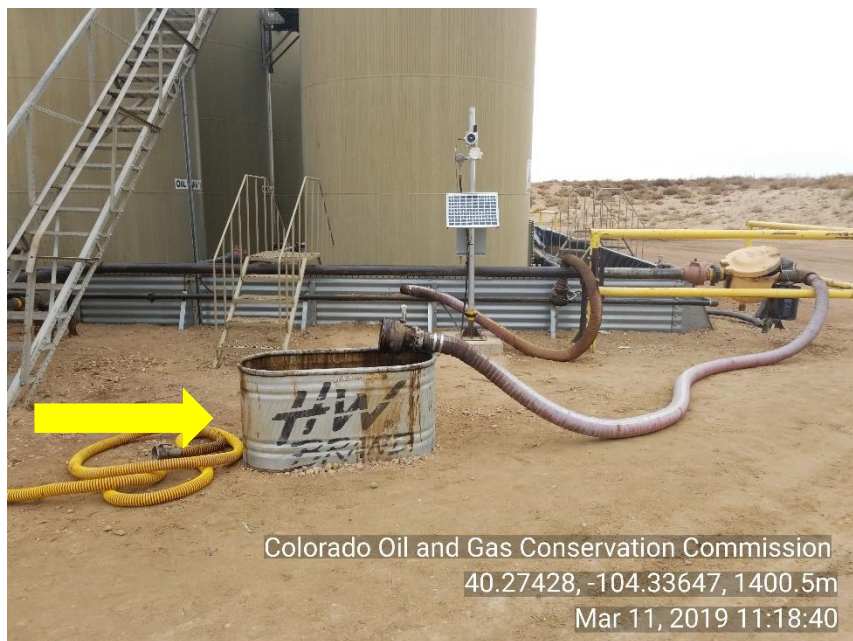
Photo 27 Improper storage of load line hoses. No secondary containment under oil container.

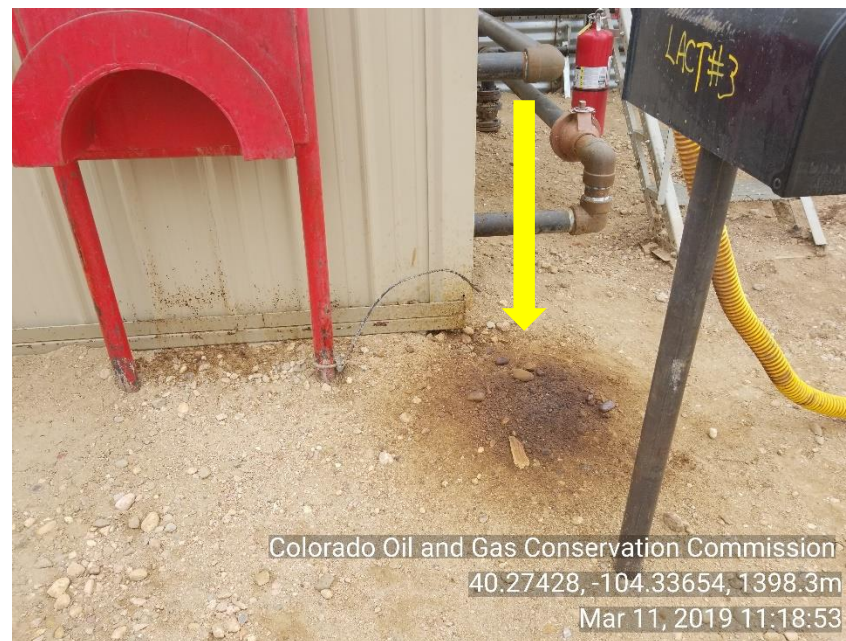
Photo 28 stained soil outside lact bulking out side of crude oil containment

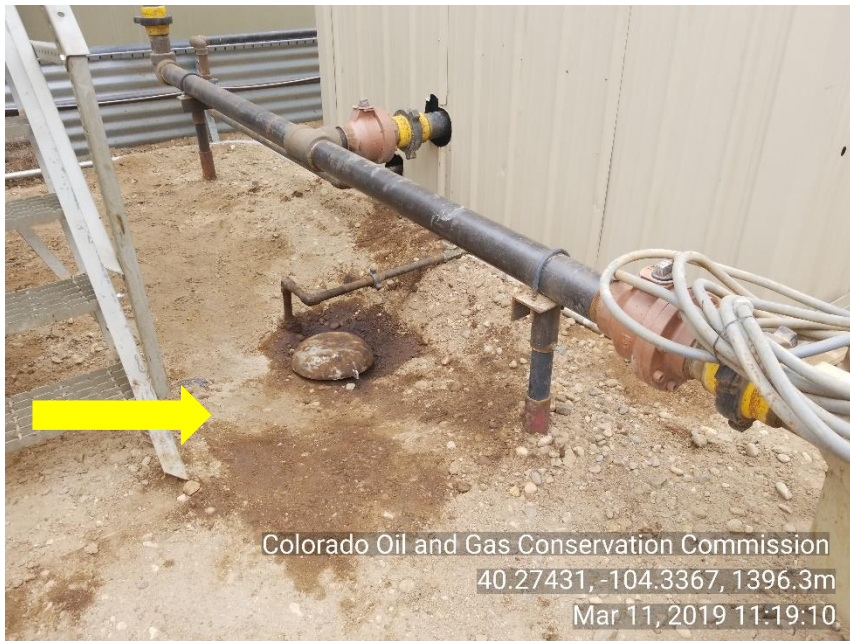
Photo 29 Stained soil out side of lact building around what appears to be buried vault.

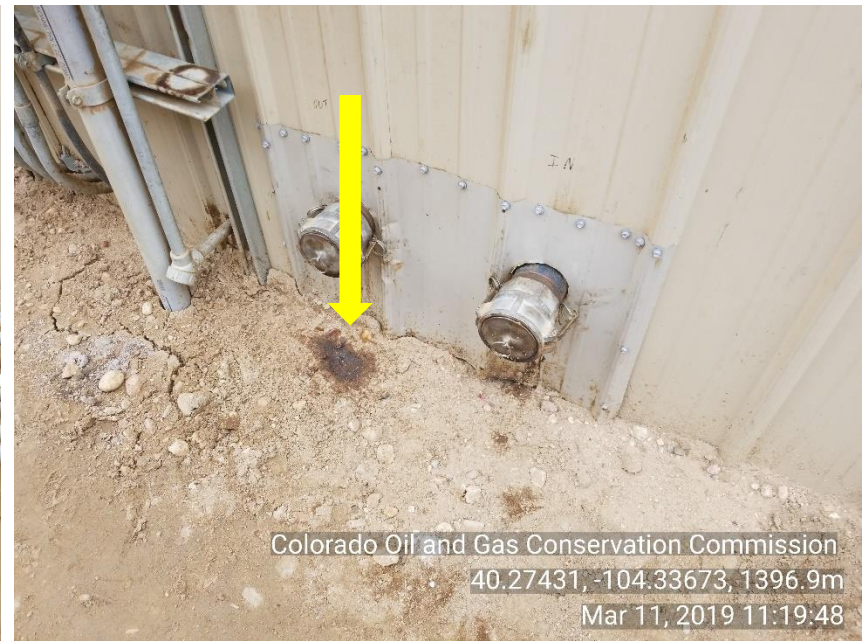
Photo 30 stained soil outside lact building out side of crude oil containment

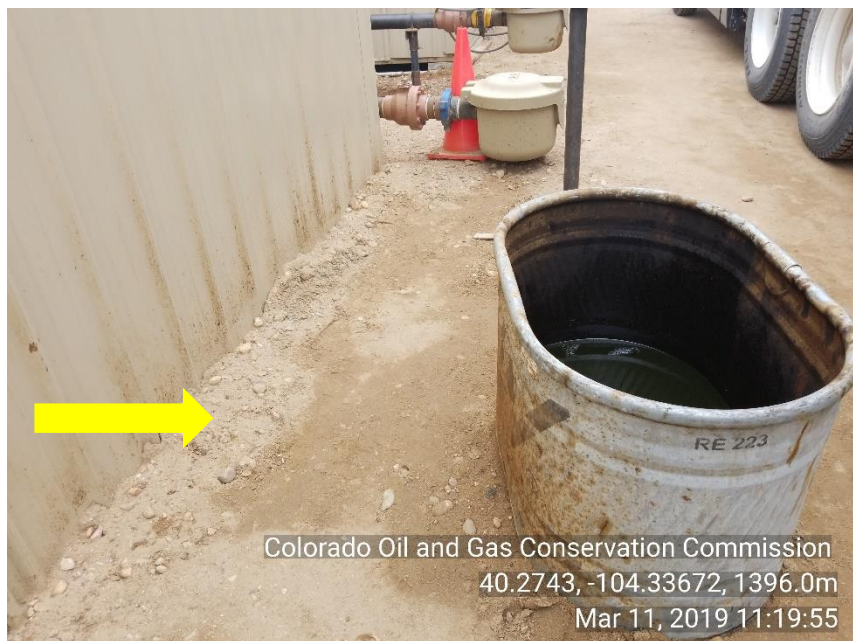
Photo 31 Unused equipment and not on secondary containment

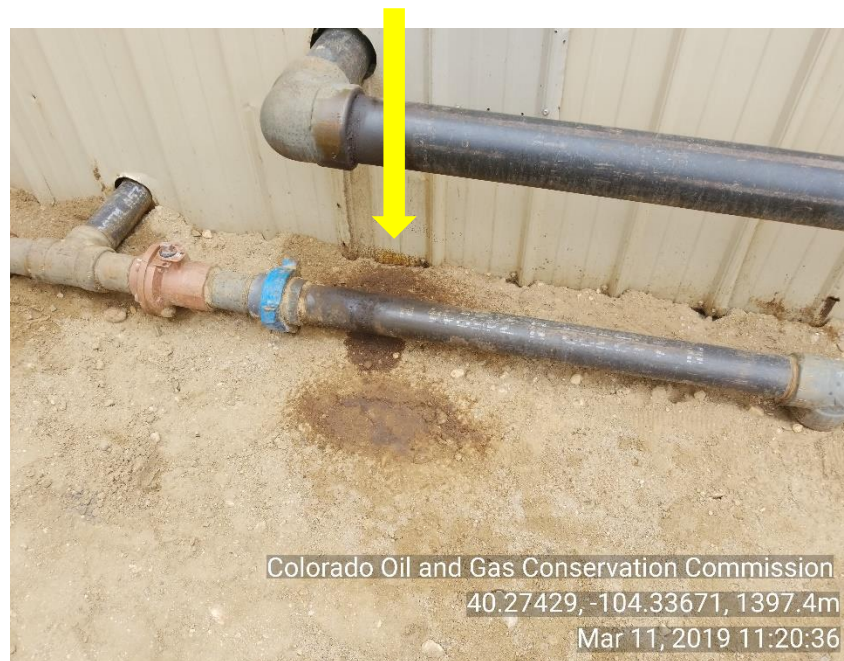
Photo 32 stained soil outside lact building out side of crude oil containment

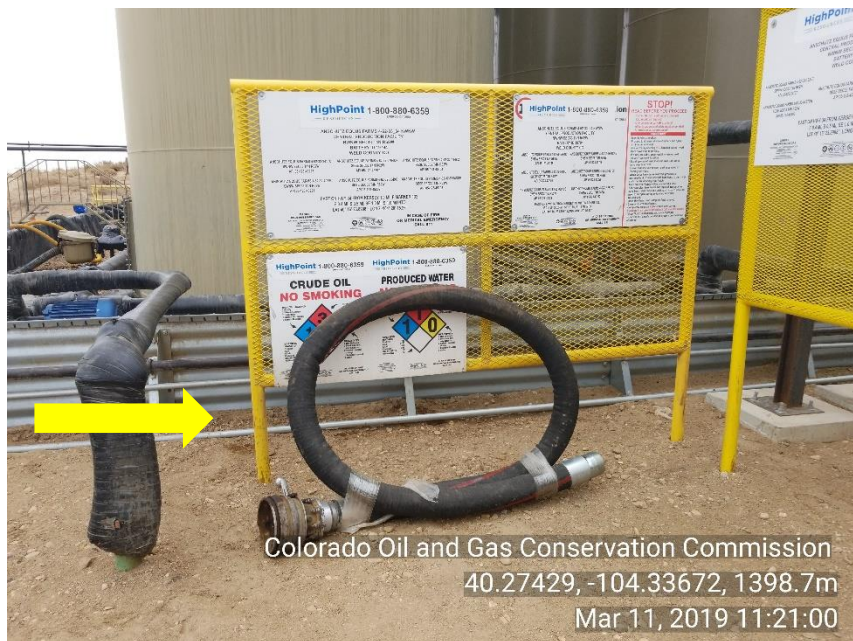
Photo 33 Unused equipment 4" hose

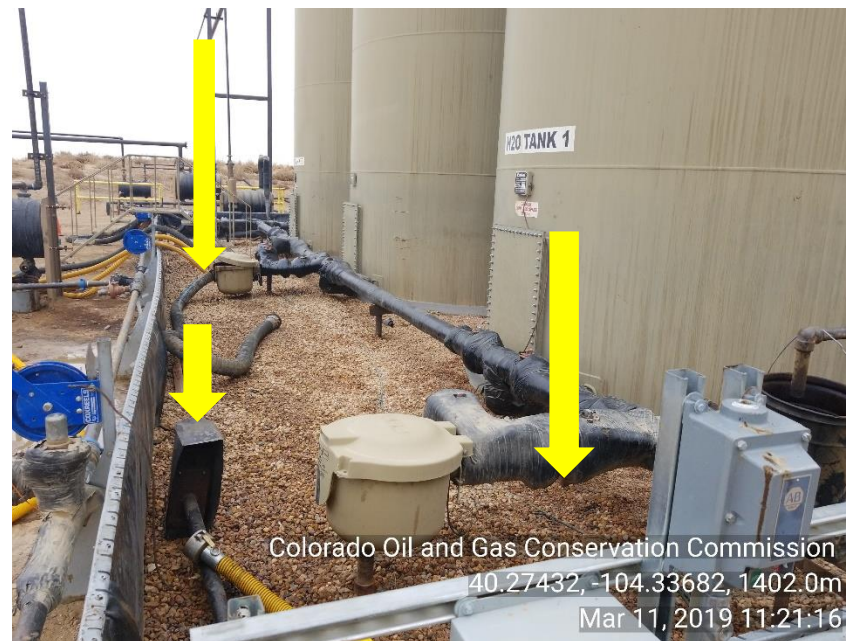
Photo 34 stained soil under load out lines, trash(mailbox) and improper storage of houses.

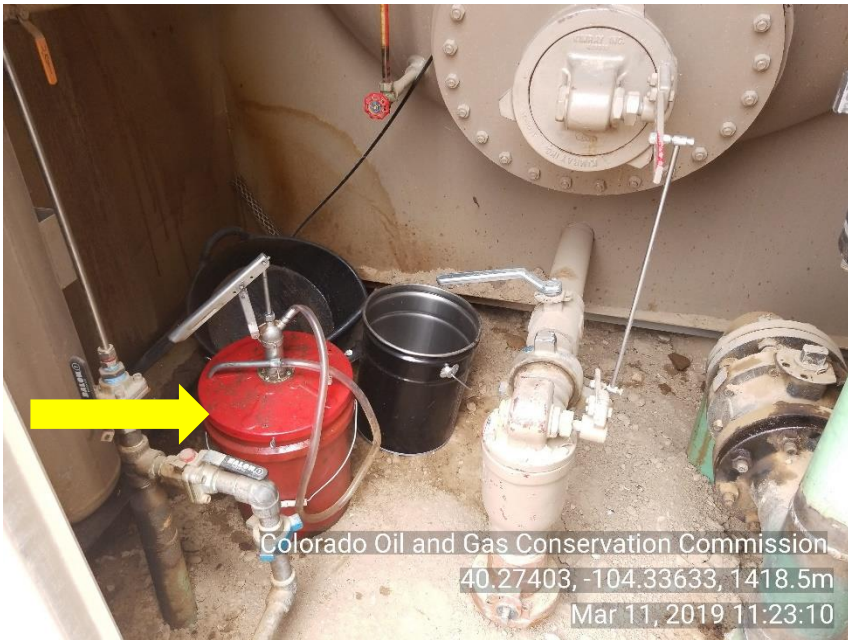
Photo 35 Trash: inside separator

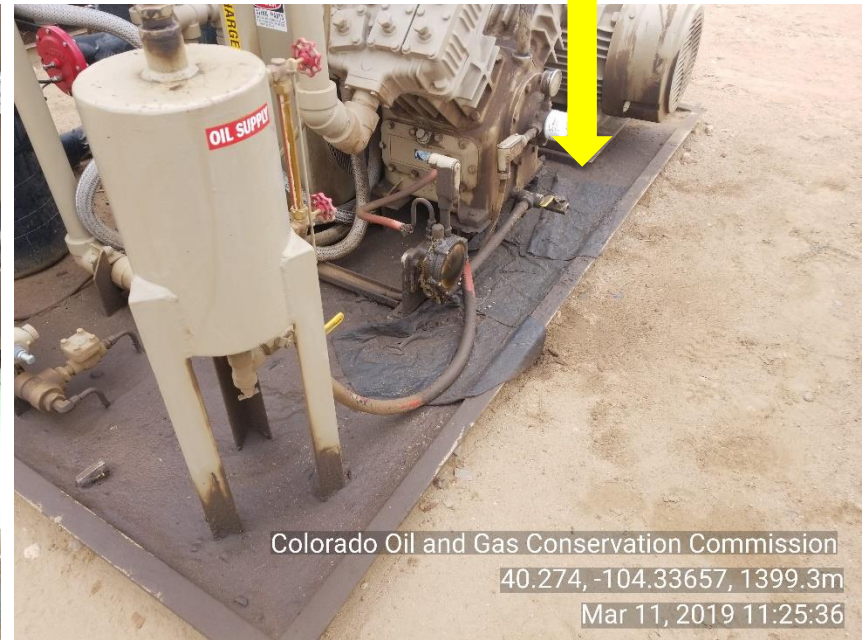
Photo 36 environmental diapers soaked with what appears to be oil hanging off skid

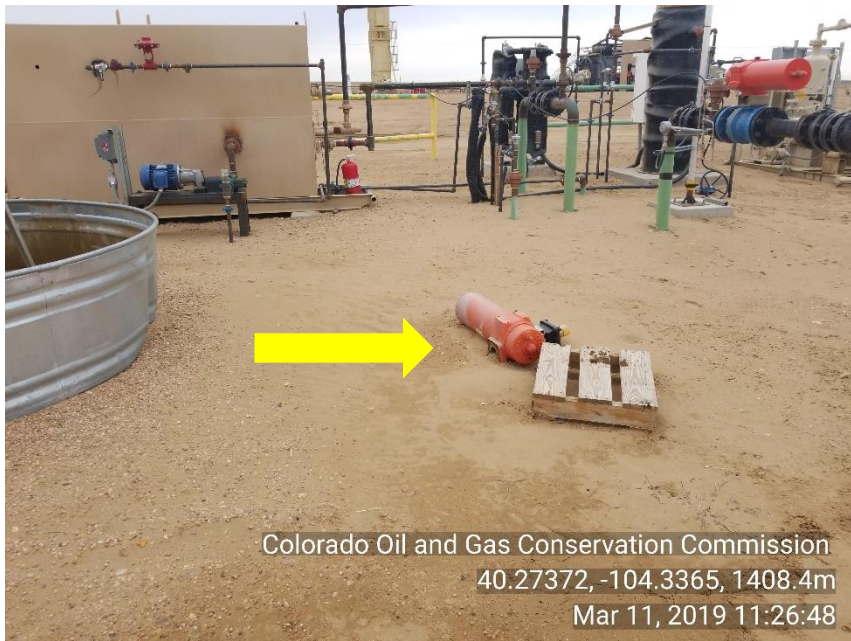
Photo 37 Unused equipment

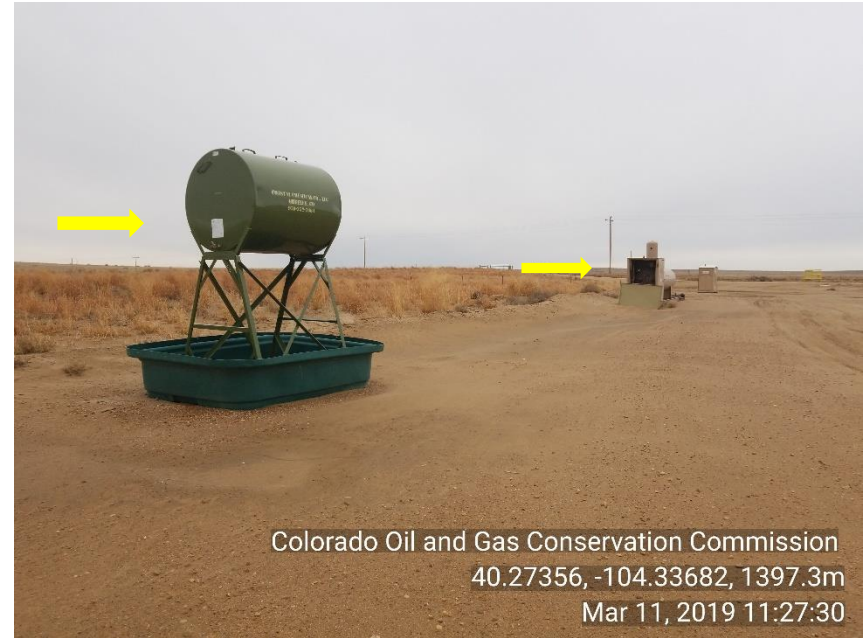
Photo 38 unused equipment oil tank and Hoz separator on edge of entrance to location

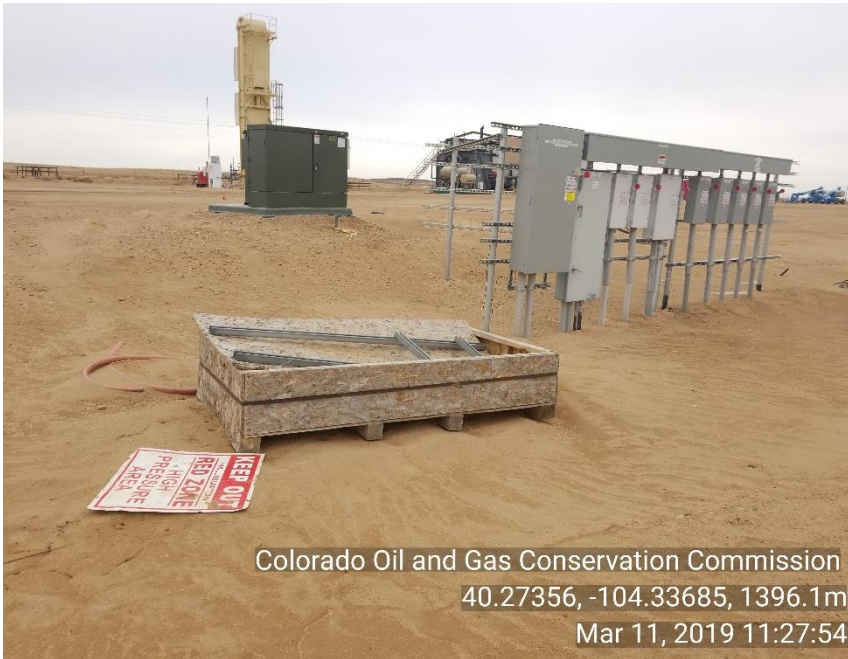
Photo 39 Unused equipment
