Inspection Photo (s)
Cook RMV 77-33
API # 05-045-07087
FIR Inspection # 689303492

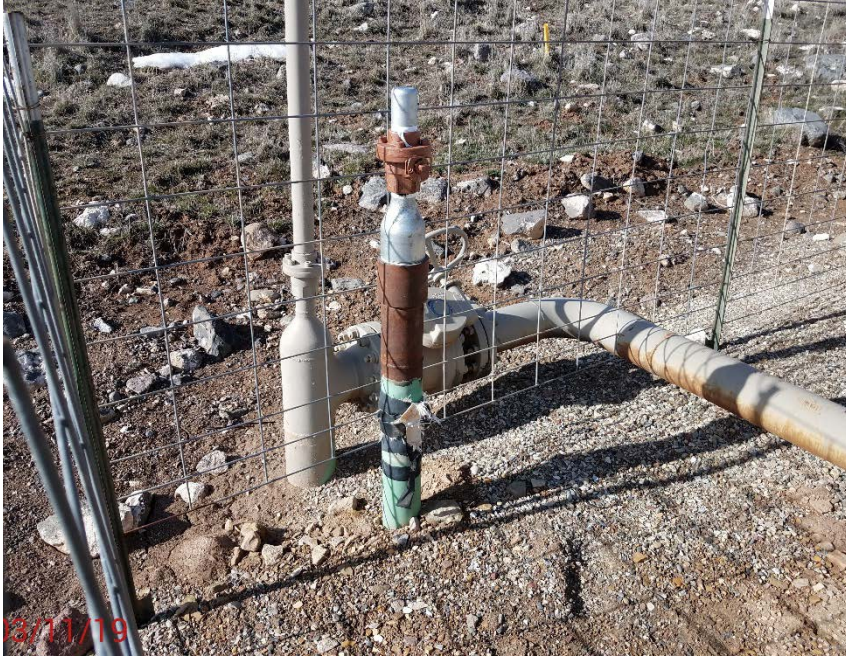
Location Photo #3, unmarked flowline riser near separators.

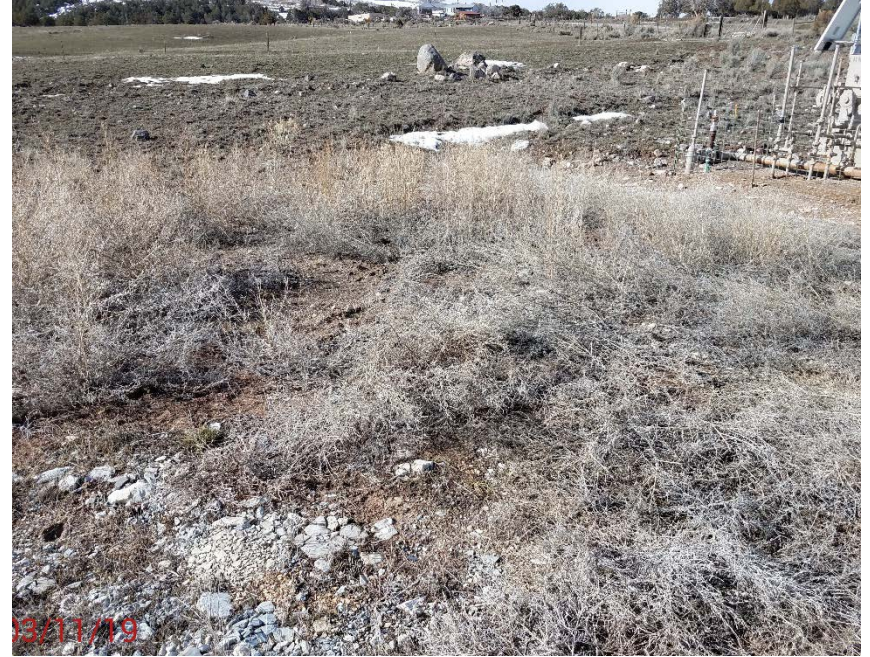
Location Photo #4, Debris on location.
