Inspection Photo (s)
Clough 128
API # 05-045-06384
FIR Inspection # 689303498

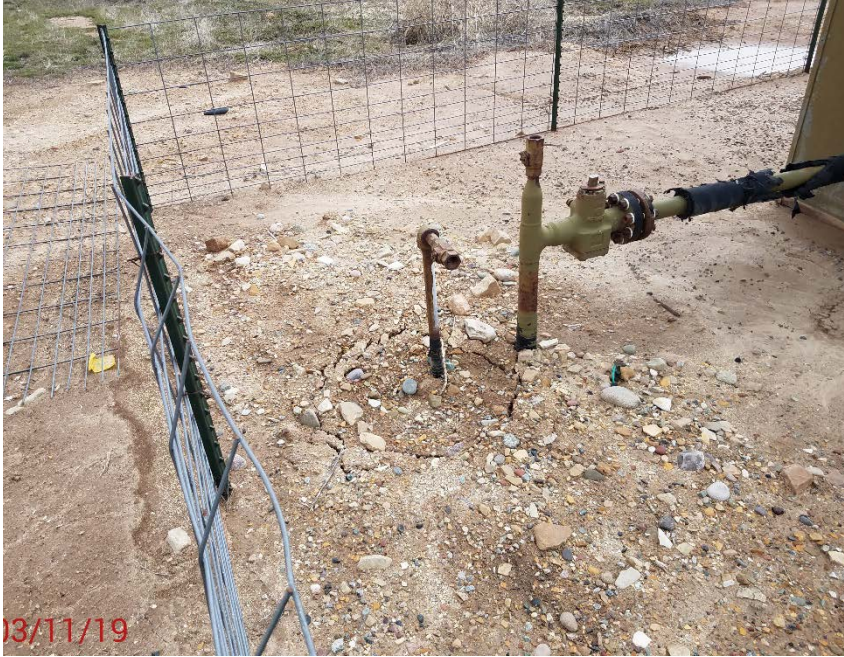
**Location Photo #3, unmarked flow line riser
near meter run.**
