Inspection Photo (s)
Clough RWF 421-23
API # 05-045-12566
FIR Inspection # 689303500

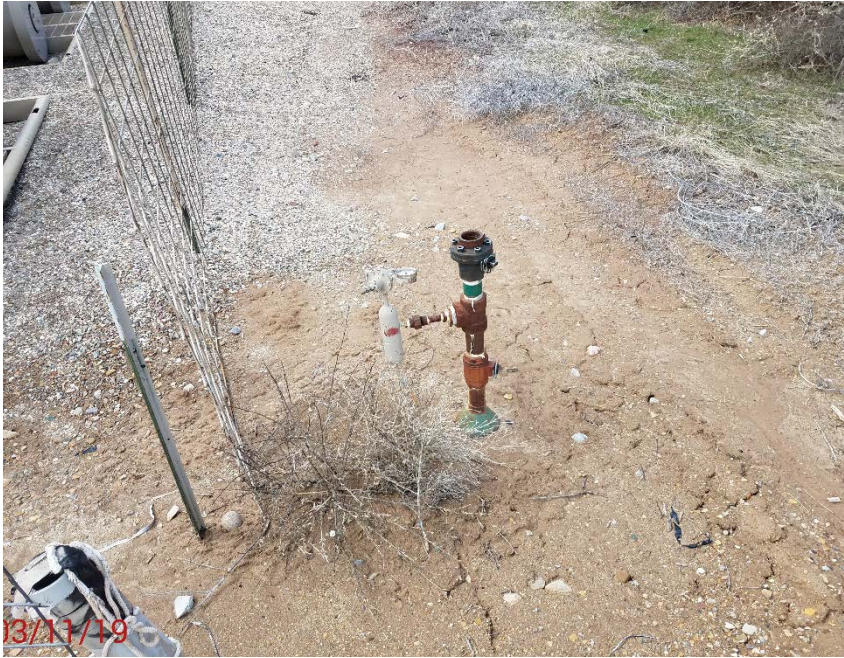
Location Photo #3, unmarked flowline.

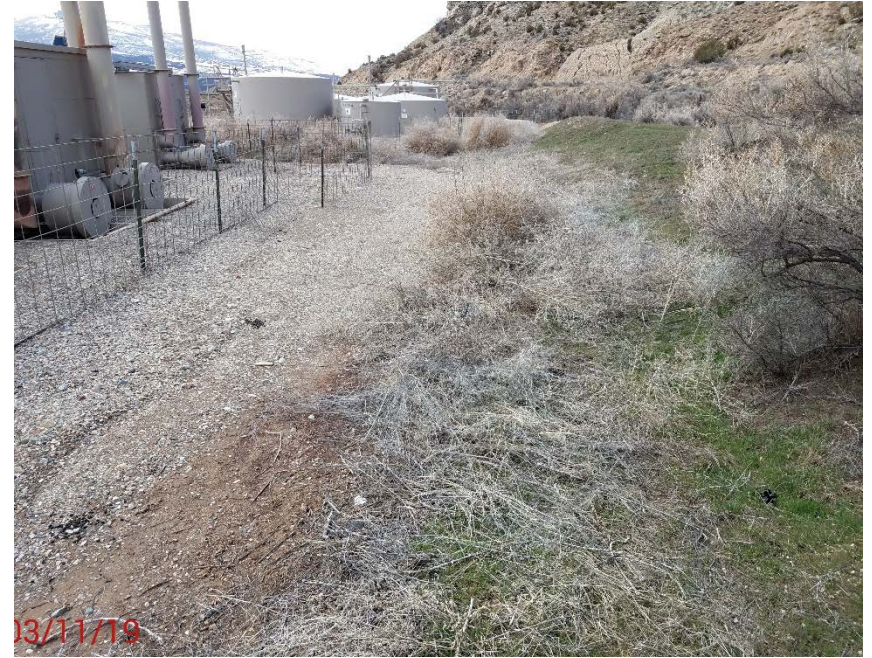
Location Photo #4, Debris behind the separators.

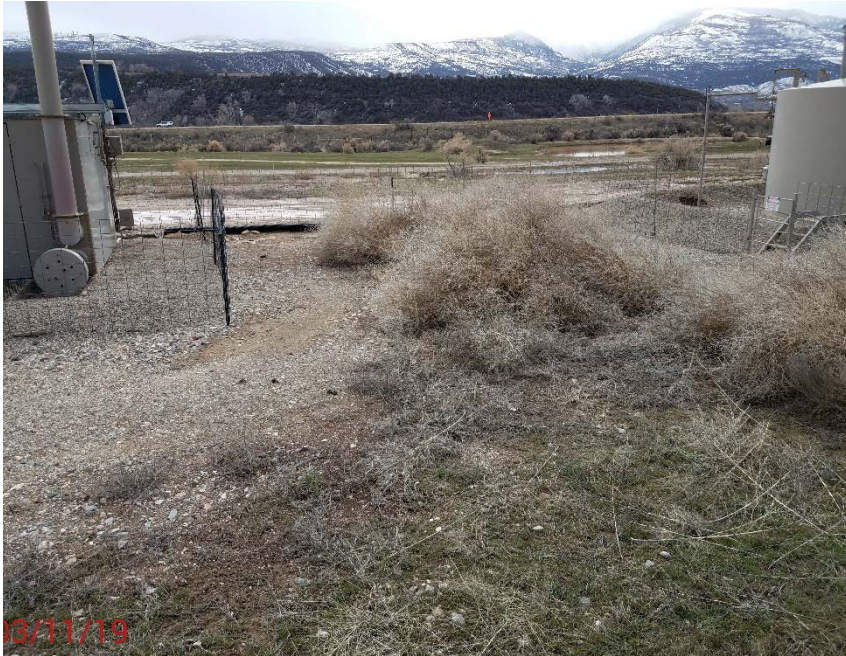
Location Photo #5, Debris west of separators.

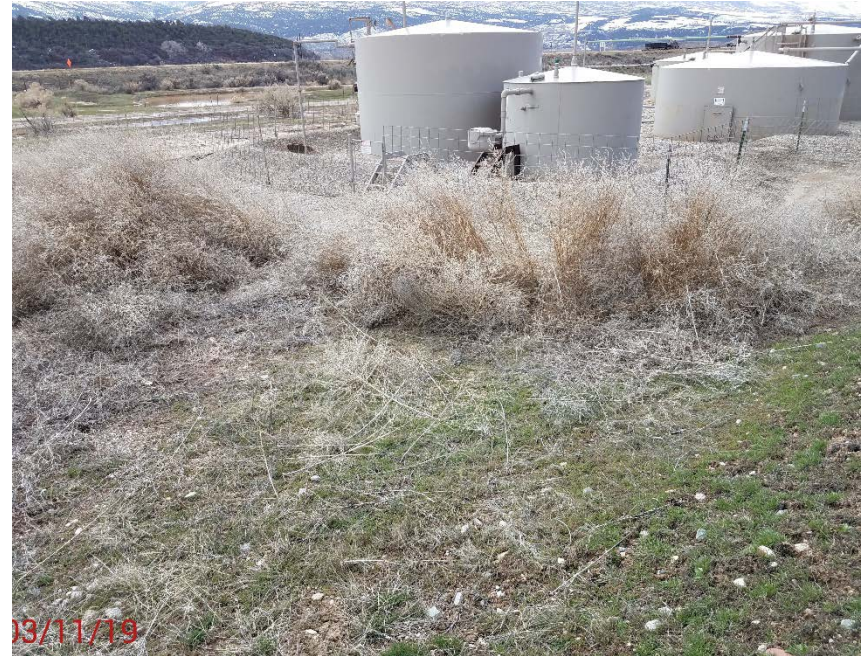
Location Photo #6, Debris west of separators.
