Inspection Photos
Operator: Javernick Oil
Location/API #: 043-40024
Date: 2/28/2019

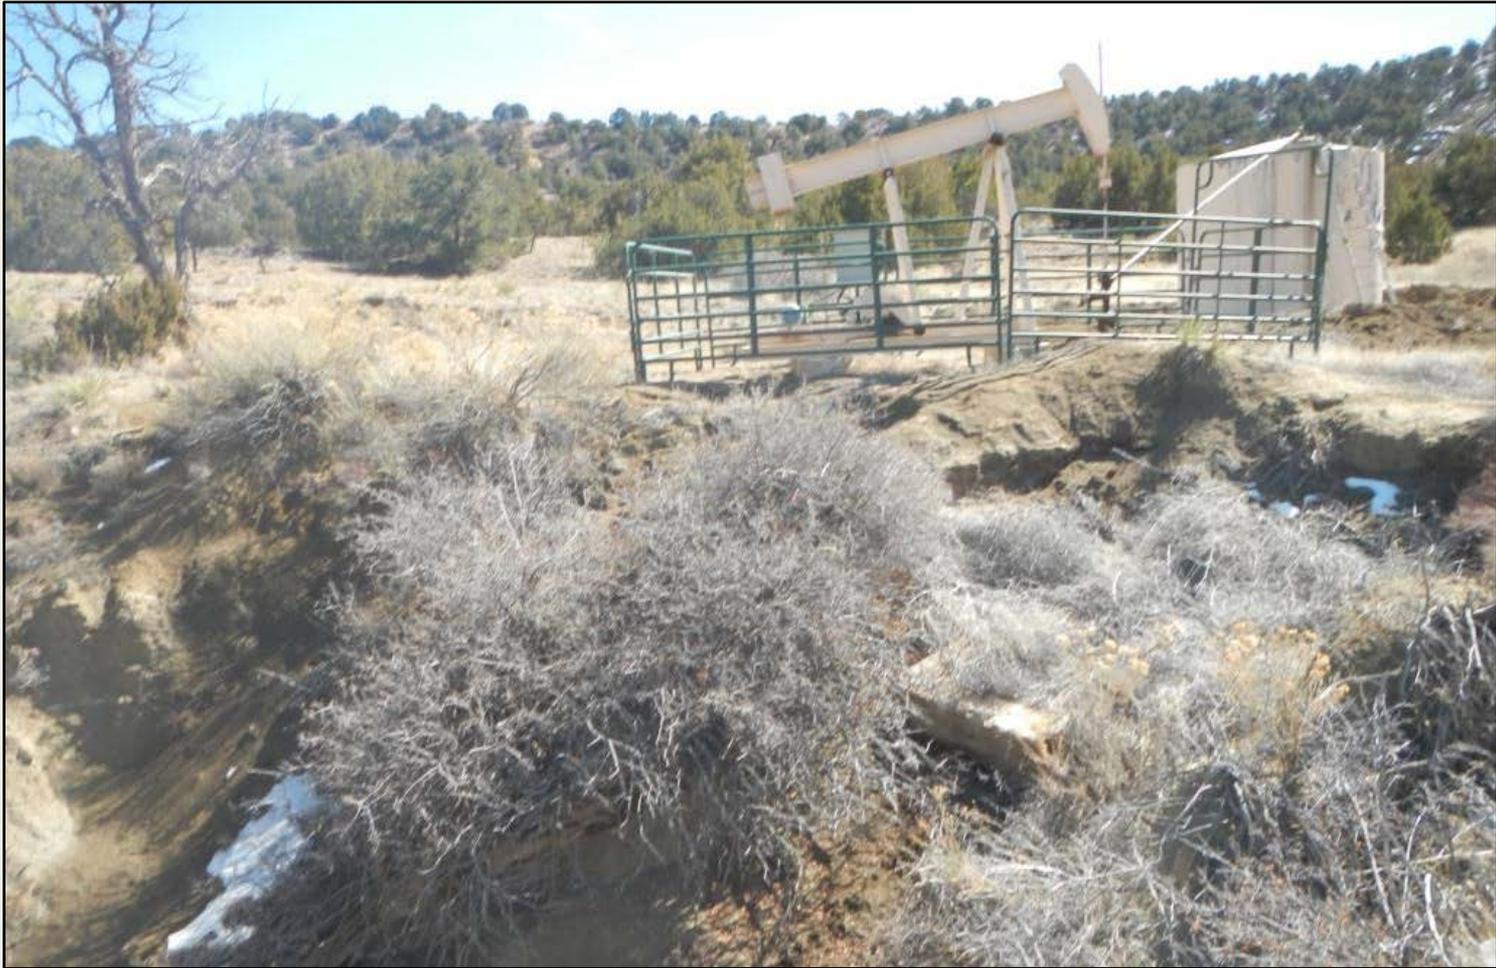
Photo 1. View of the northern project area from the northwestern edge facing toward the wellhead. Wellhead is adjacent to an erosion channel. This area needs immediate stabilization to prevent any further erosion.

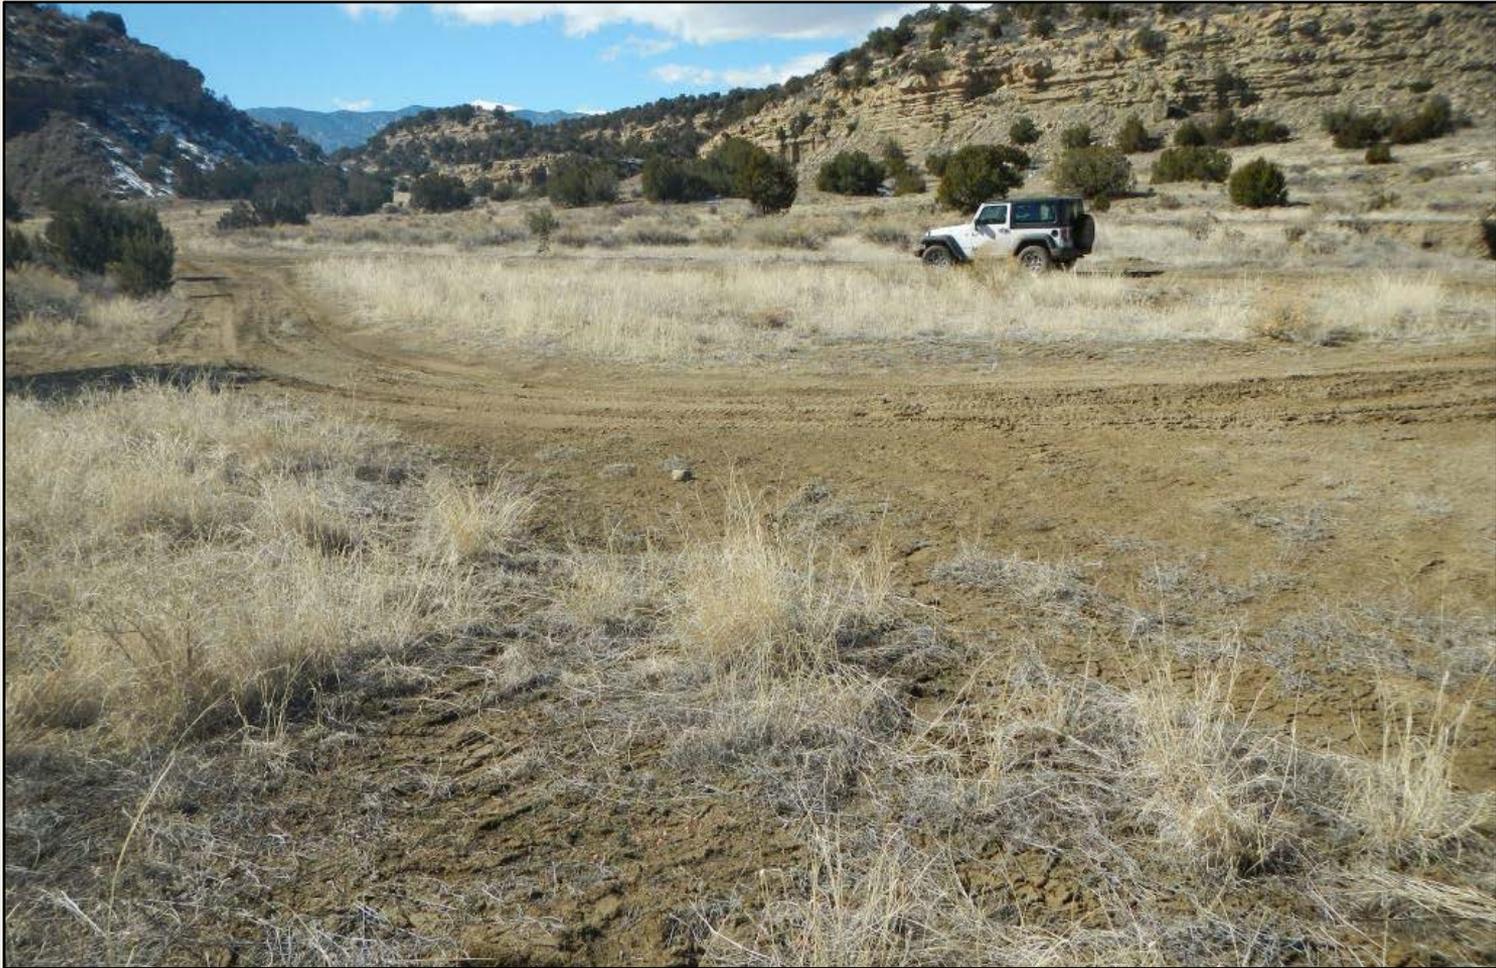
Photo 2. View of the project area from the southeastern corner facing northwestward. Revegetation within the teardrop and outer revegetation areas is progressing.

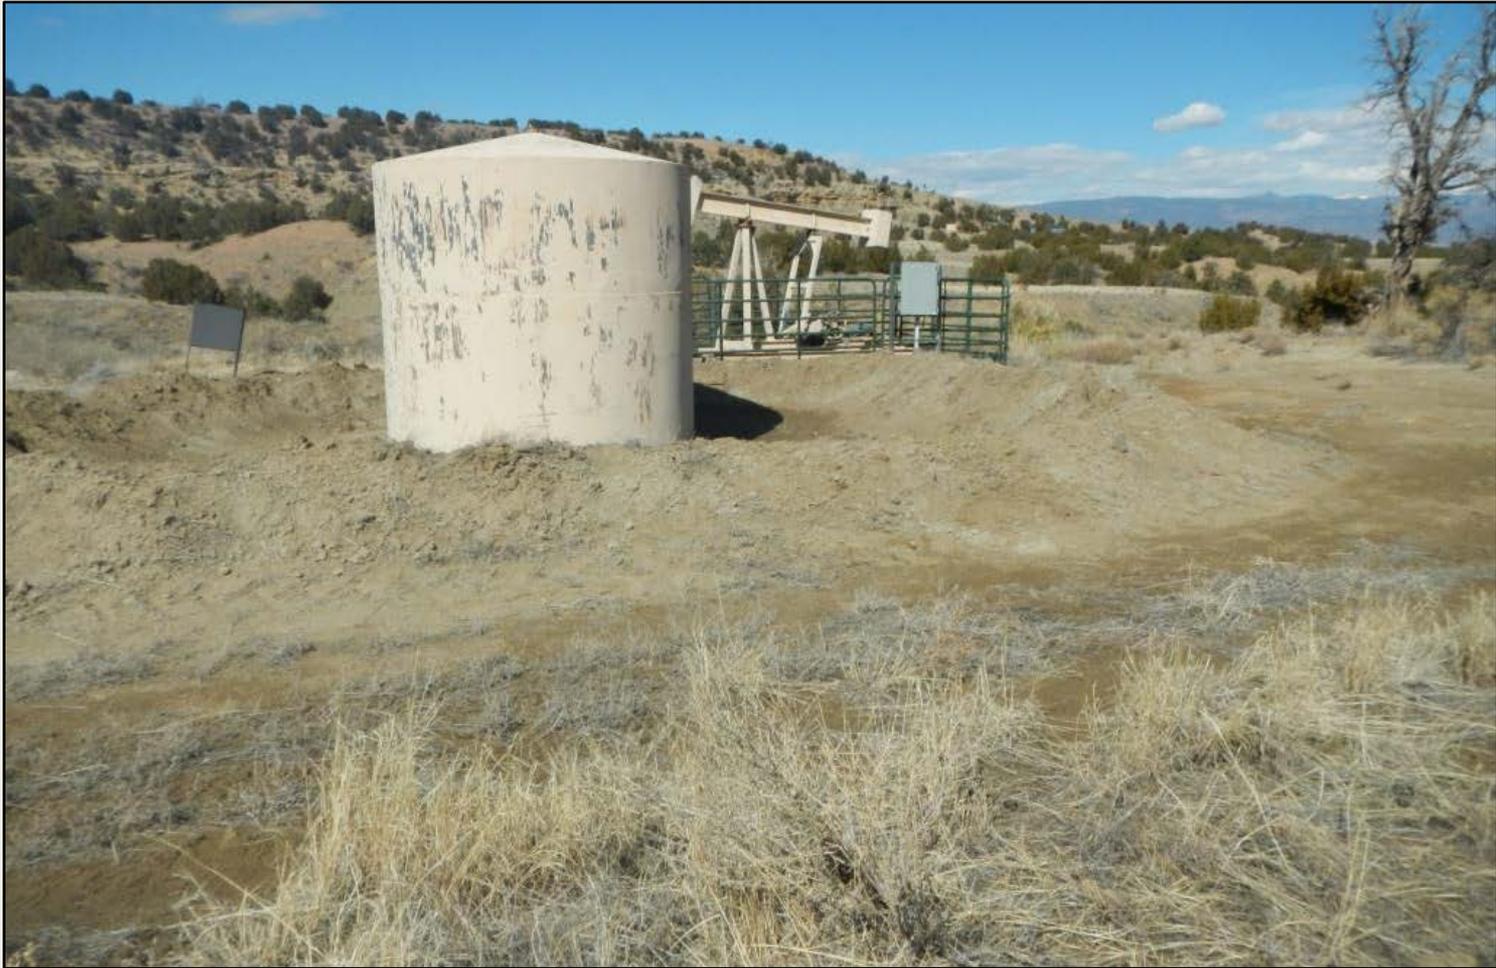
Photo 3. View of the project area from the southeastern project area facing northeastward from the southeastern edge.
