Inspection Photos

Operator: Javernick Oil
Location/API #: 043-40012
Date: 2/28/2019

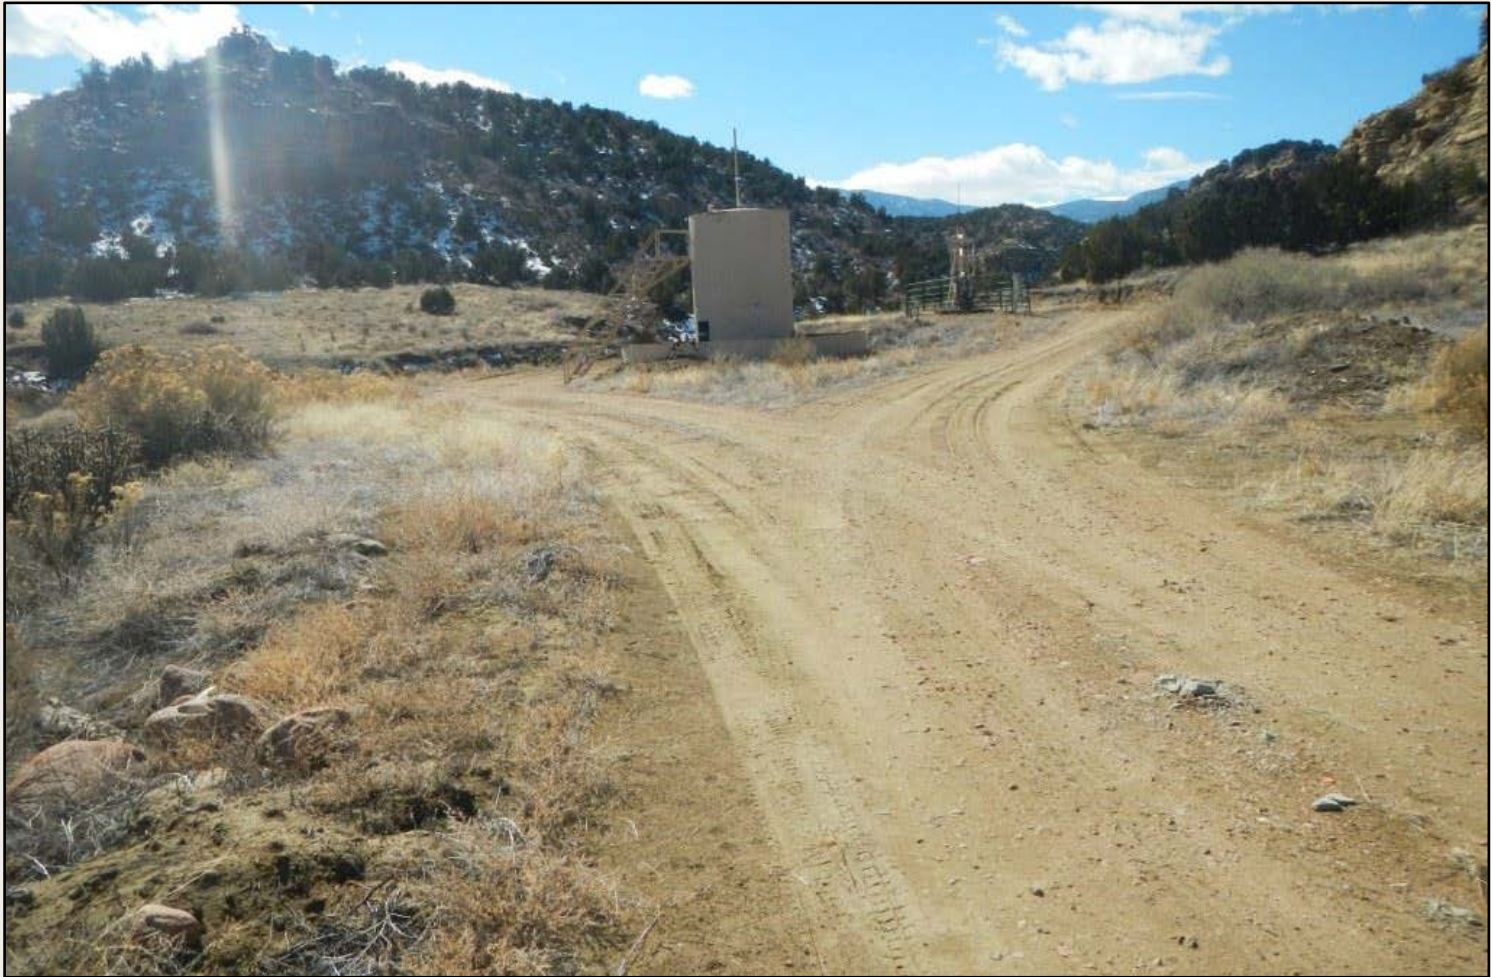
Photo 1. View of the project area from the well pad entrance facing center.

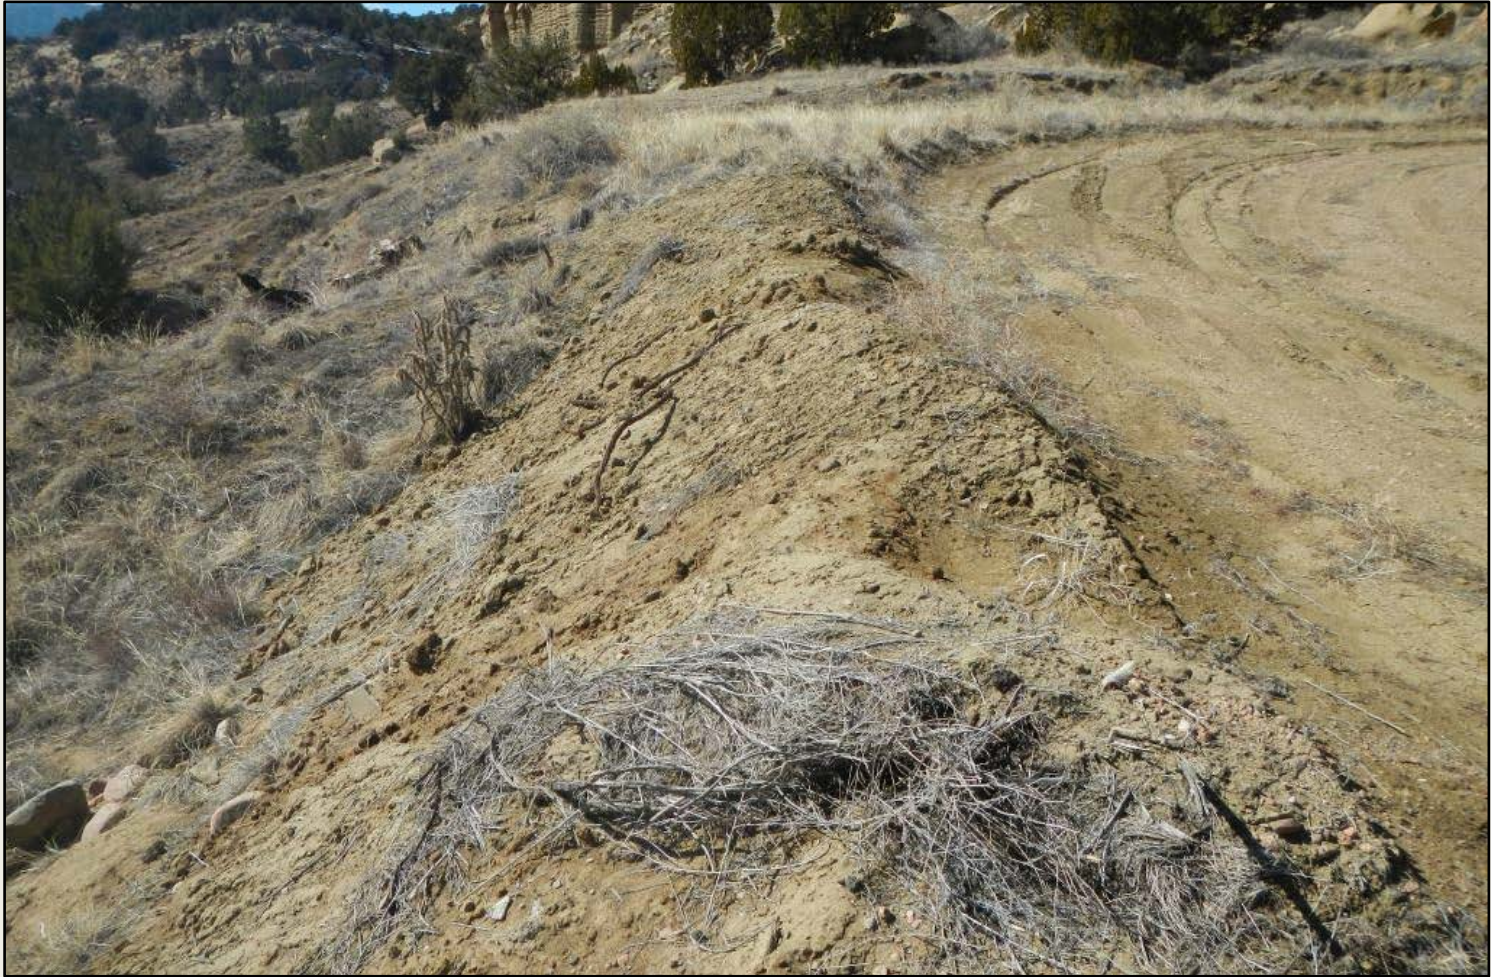
Photo 2. View of the eastern project area from the northeastern edge facing southward. Vegetation on the slope is sparse and needs stabilization. Metal cable debris is present. Loose soil on edge is insufficient to function as berm.

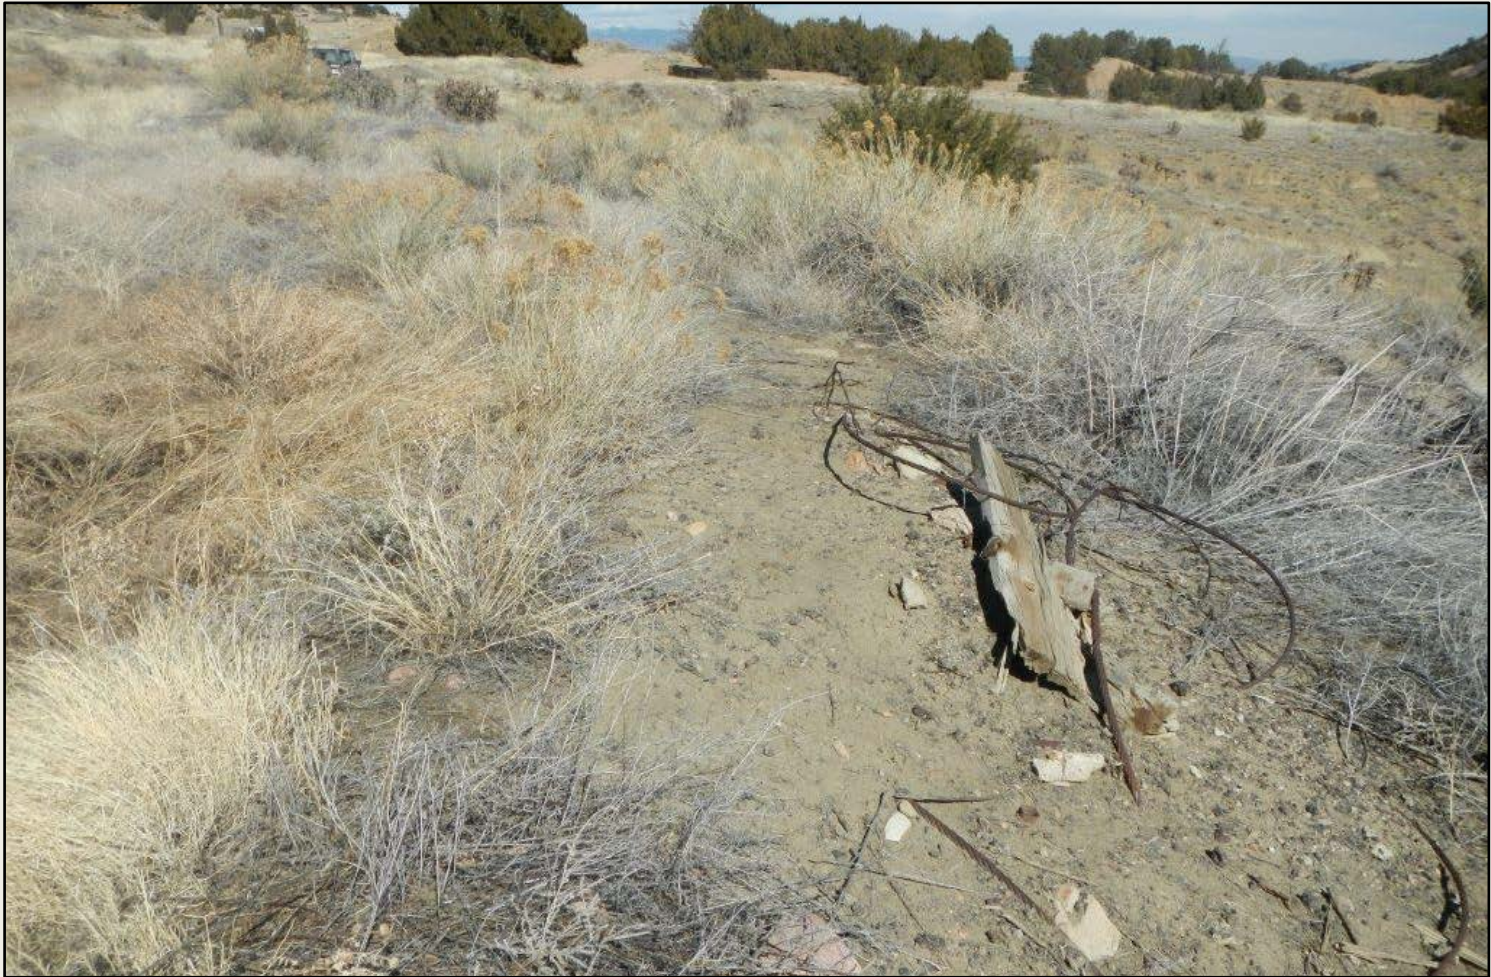
Photo 3. View of more cable and wood debris within the northeastern project area.

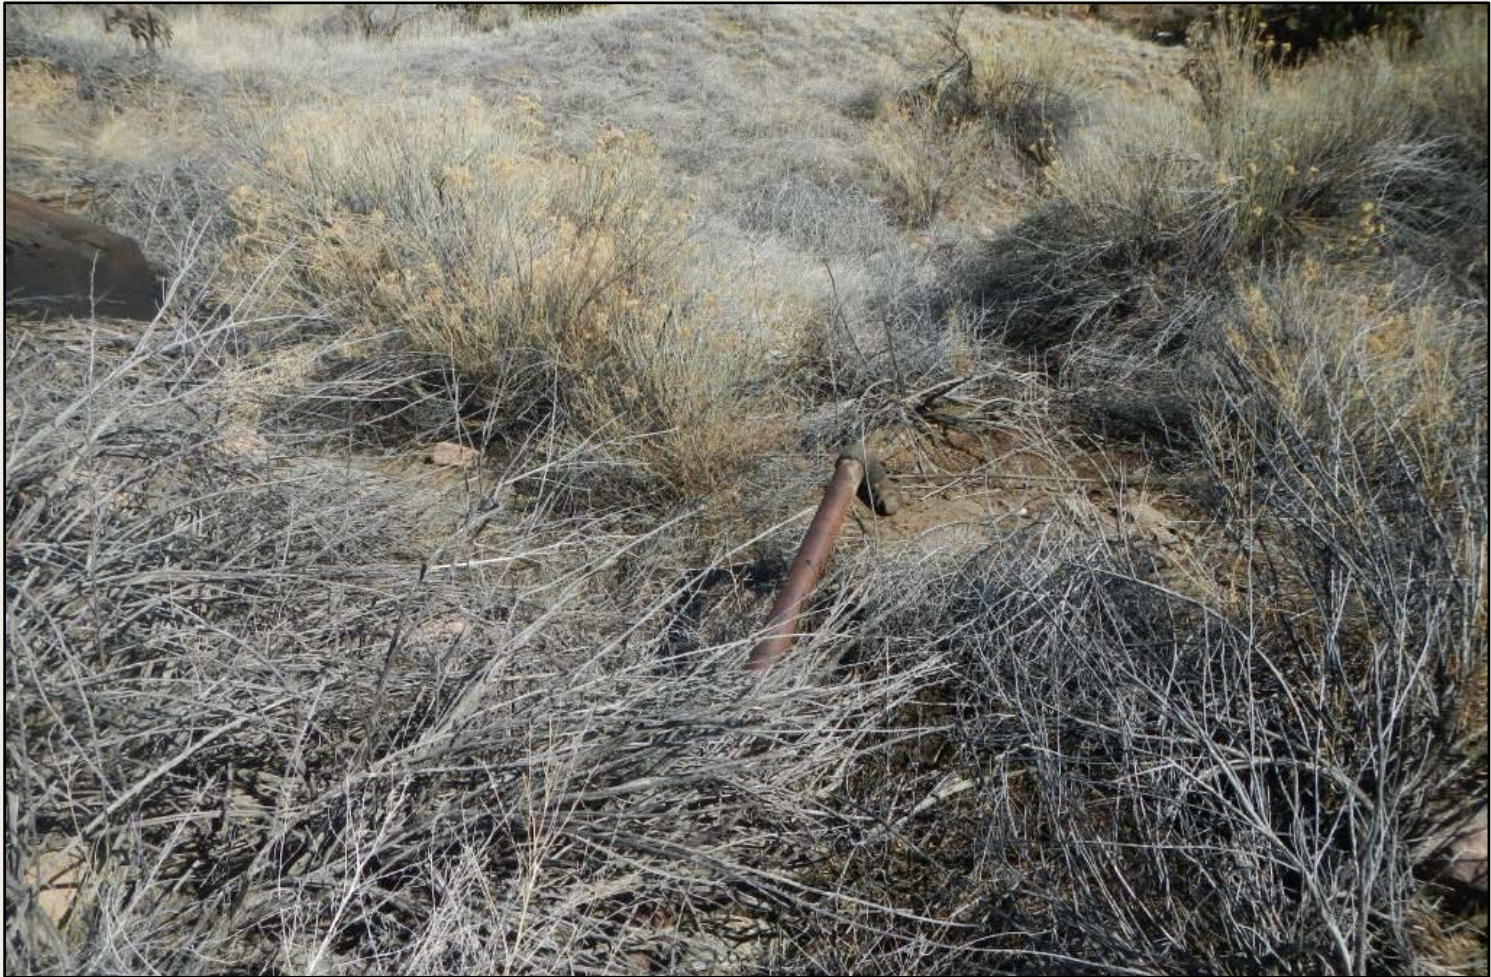
Photo 4. View of area where pipe daylights on eastern slope.

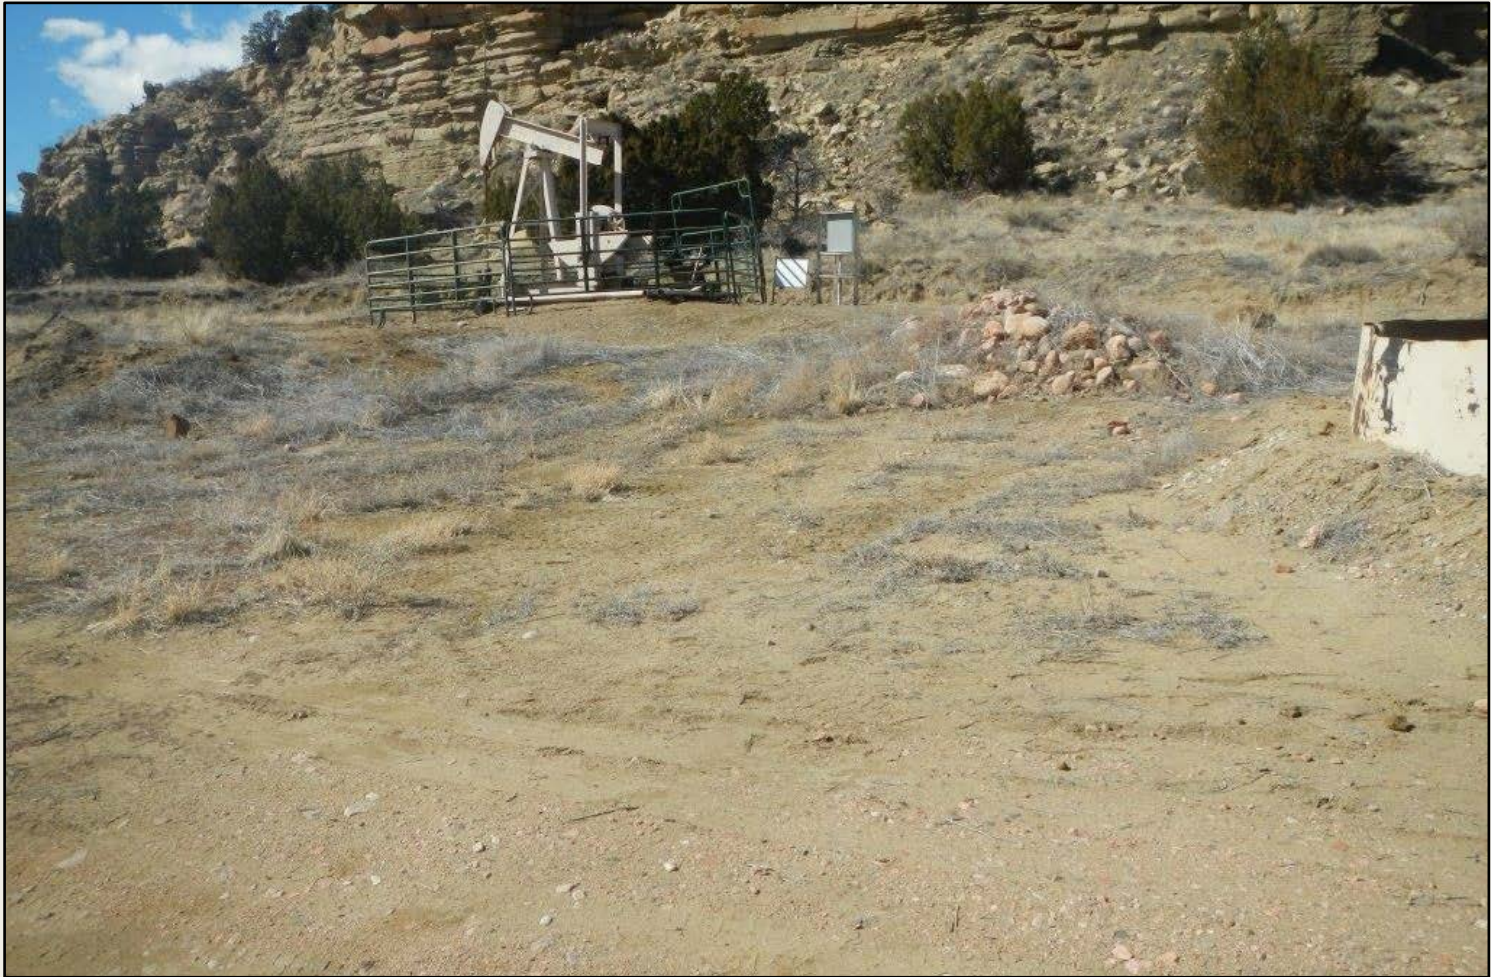
Photo 5. View of teardrop area that is weedy with poor revegetation.
