Inspection Photos

Operator: BISON OIL & GAS II LLC # 10661

Location ID: 452871

Inspection Doc. Number: 682504582

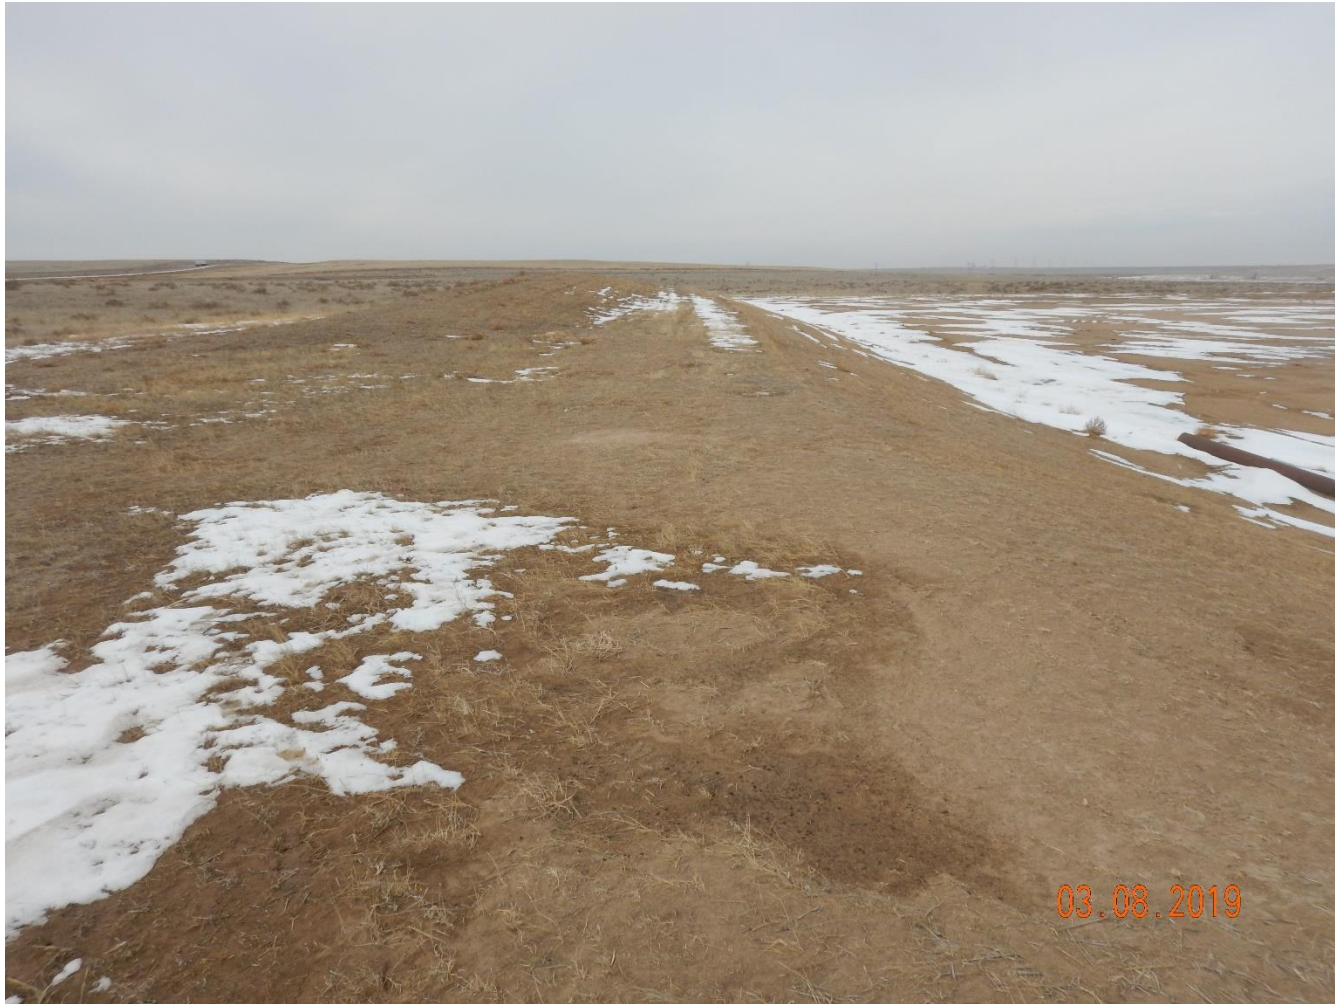
Photo 1: Photo taken from the southeast corner of the location, facing west. Photos 1-3 provide and overview of the location from west, northwest to north.

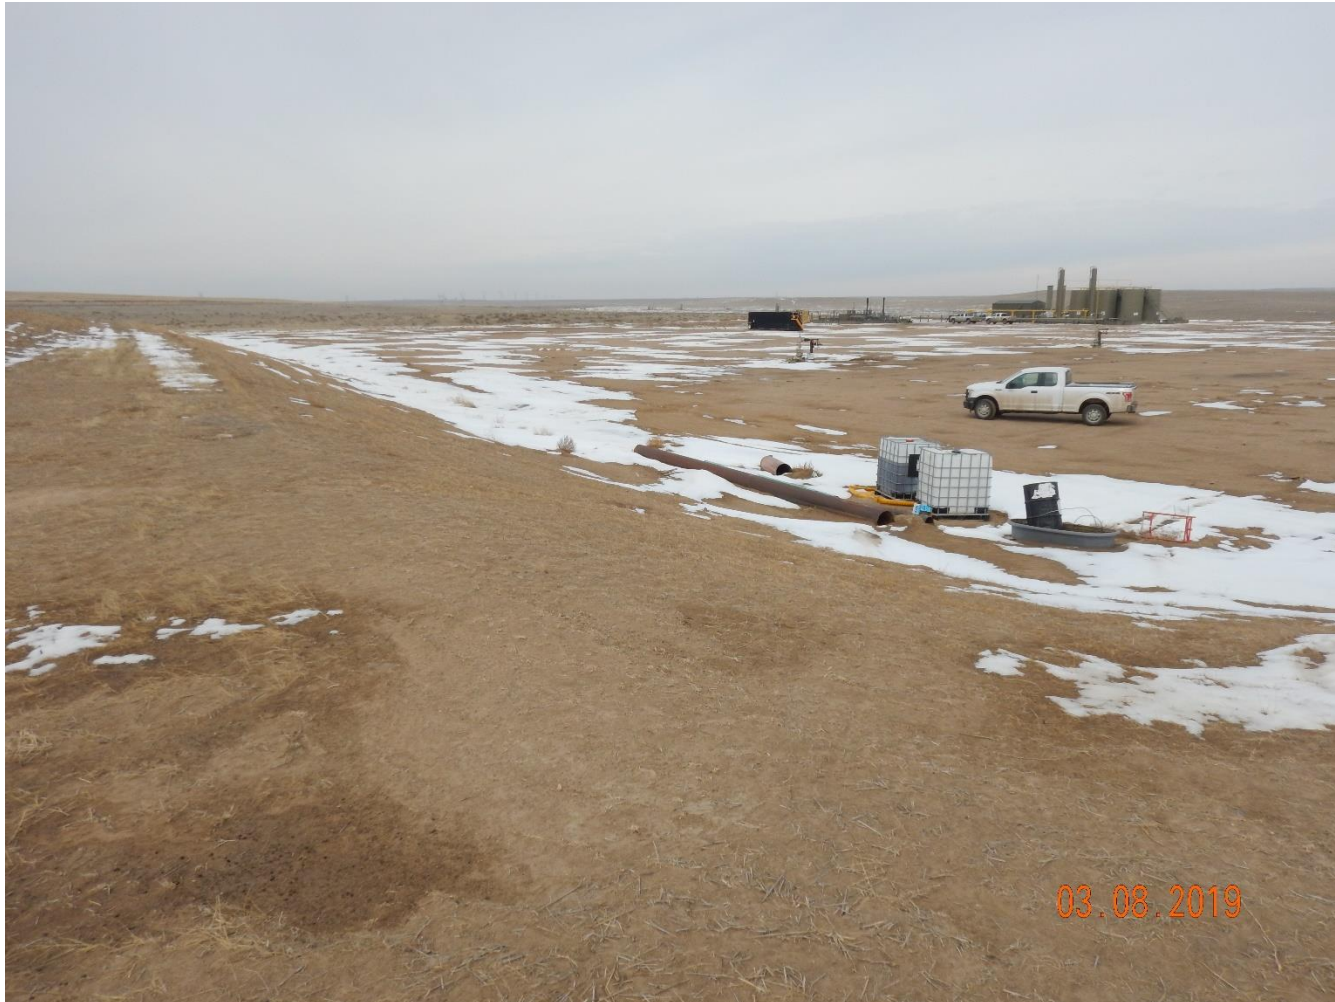
Photo 2: See comments under photo 1.

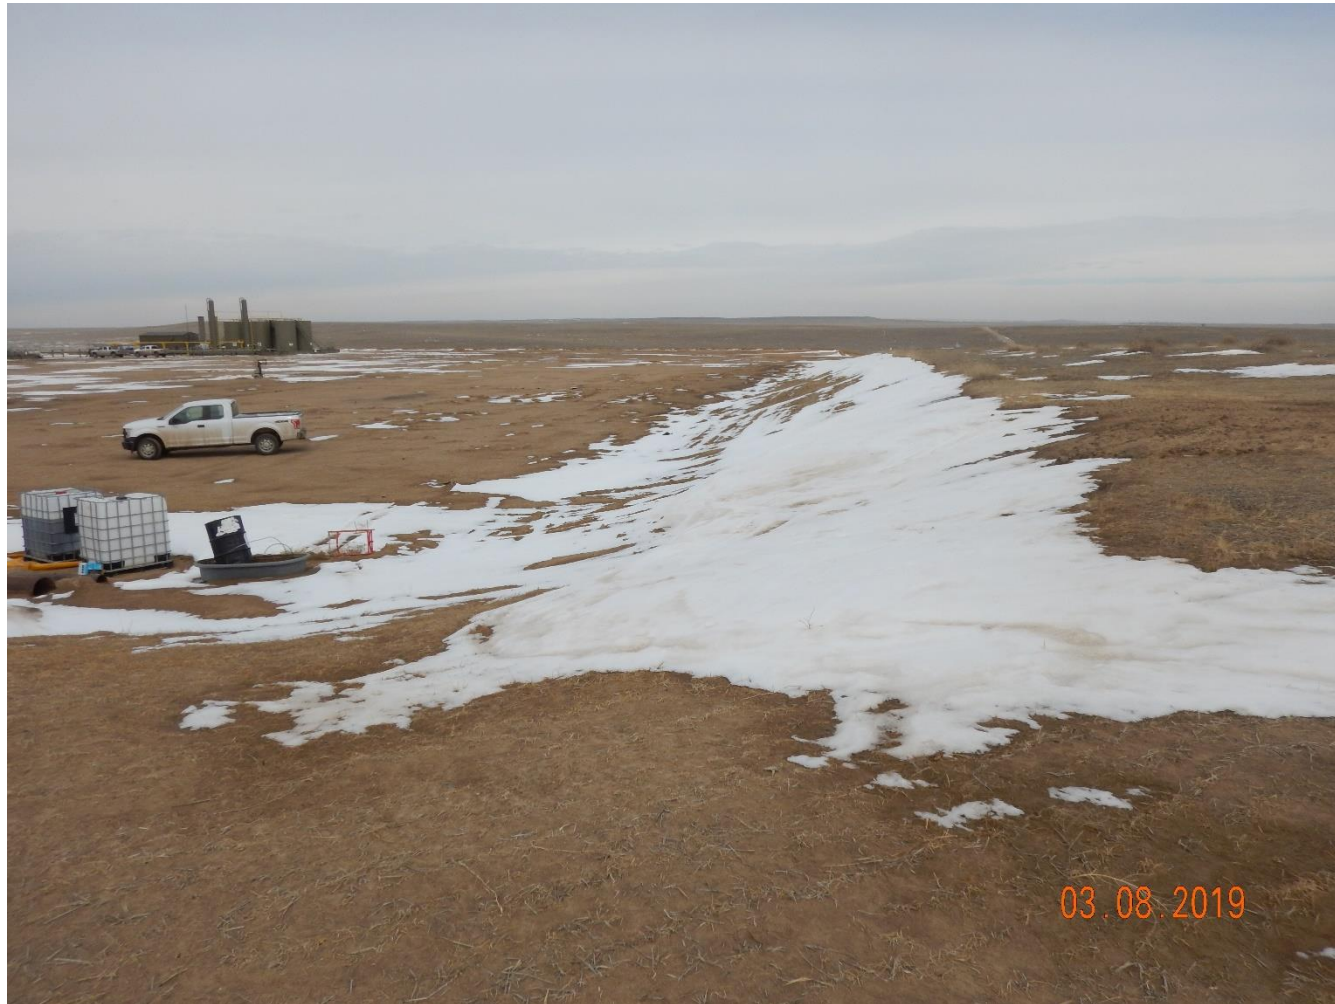
Photo 3: See comments under photo 1.

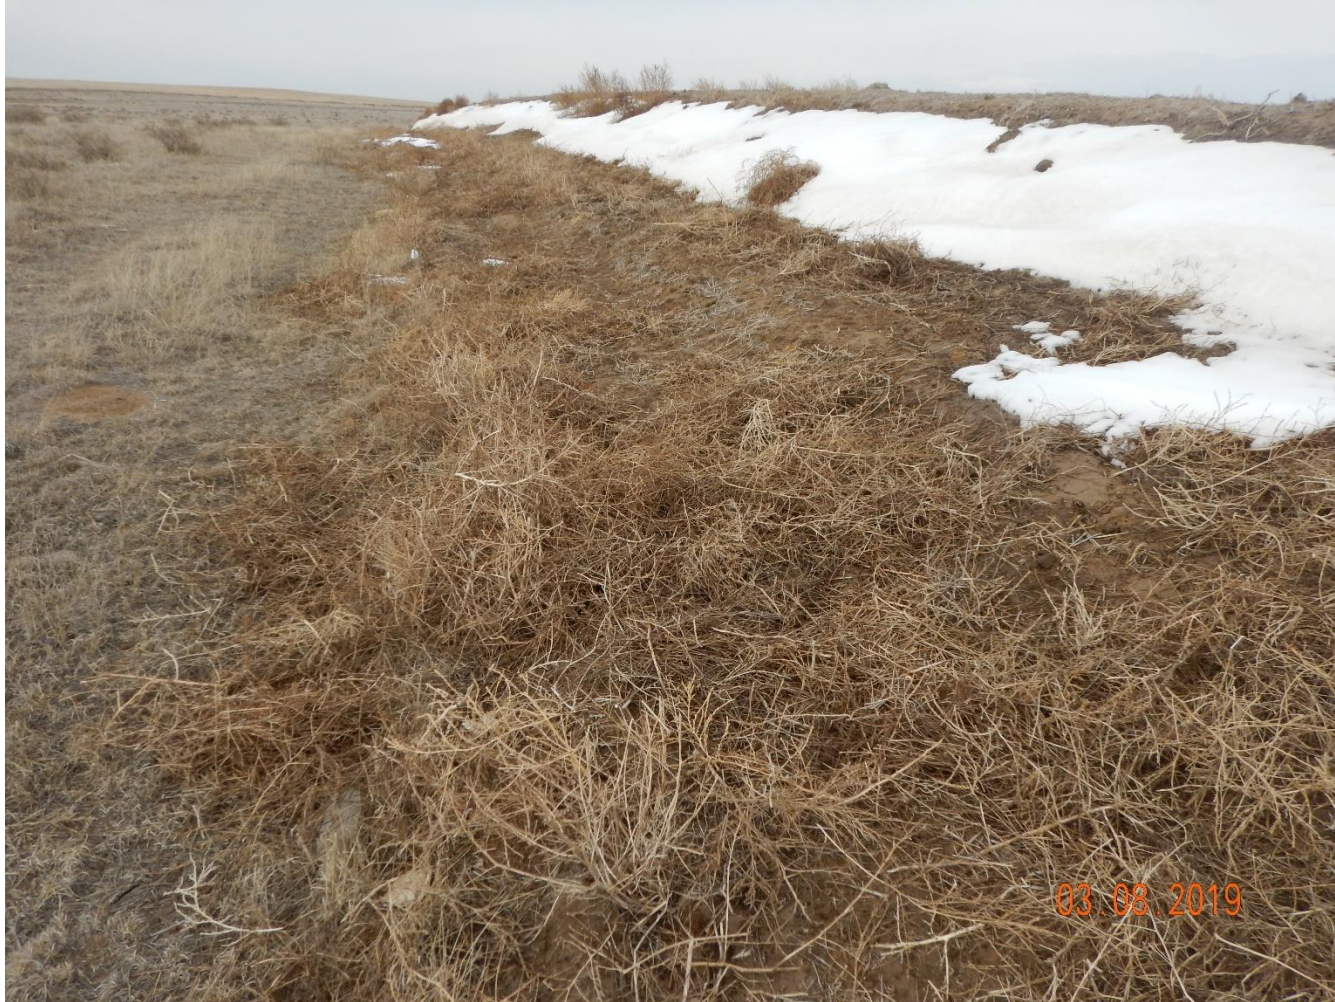
Photo 4: Photo taken from the south end of the topsoil stockpile. Photo shows operator has failed to prevent weed establishment in accordance with 1002.c.

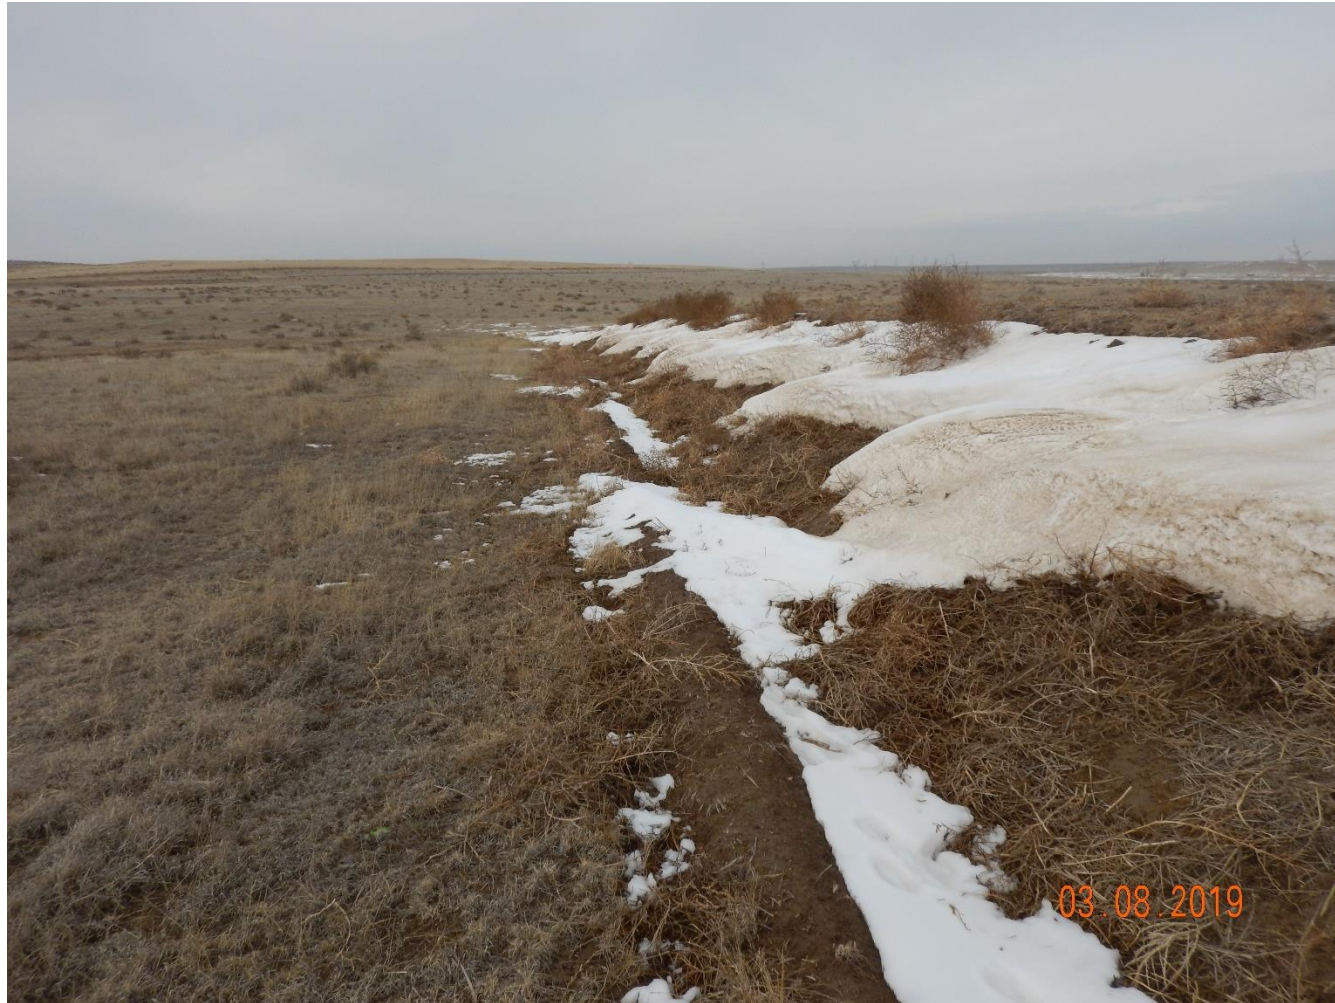
Photo 5: Photo taken from the south end of the topsoil stockpile. Photo shows operator has failed to prevent weed establishment in accordance with 1002.c. Photo also shows what appear to be a shallow ditch on the south end of the stockpile. Ditch does appear to have been constructed in accordance with good engineering practices, and does not appear to be sufficient. There does not appear to be any stormwater and erosion control BMPs on the east and west end of the topsoil stockpile. Stockpile is predominantly undesirable weedy plant species such as Russian Thistle and Kochia.

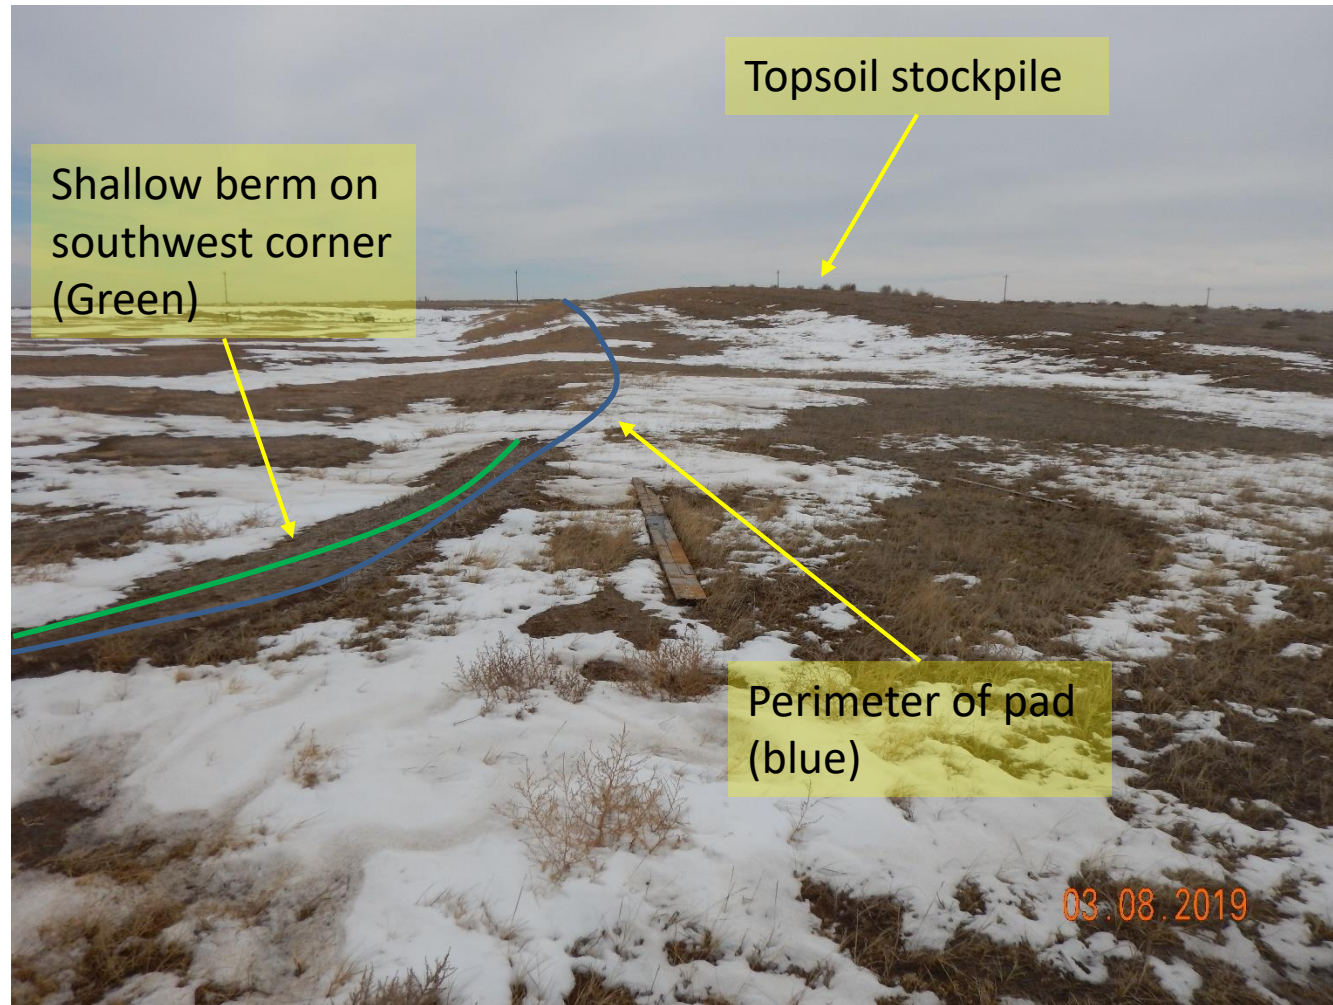
Photo 6: Photo taken from the southwest corner of the locaiton, facing east. Photo shows topsoil stockpile. Photo also shows that there does not appear to be any stormwater and erosion control BMPs on the west end of the topsoil stockpile. Stockpile is predominantly undesirable weedy plant species such as Russian Thistle and Kochia, or bare and exposed soil.

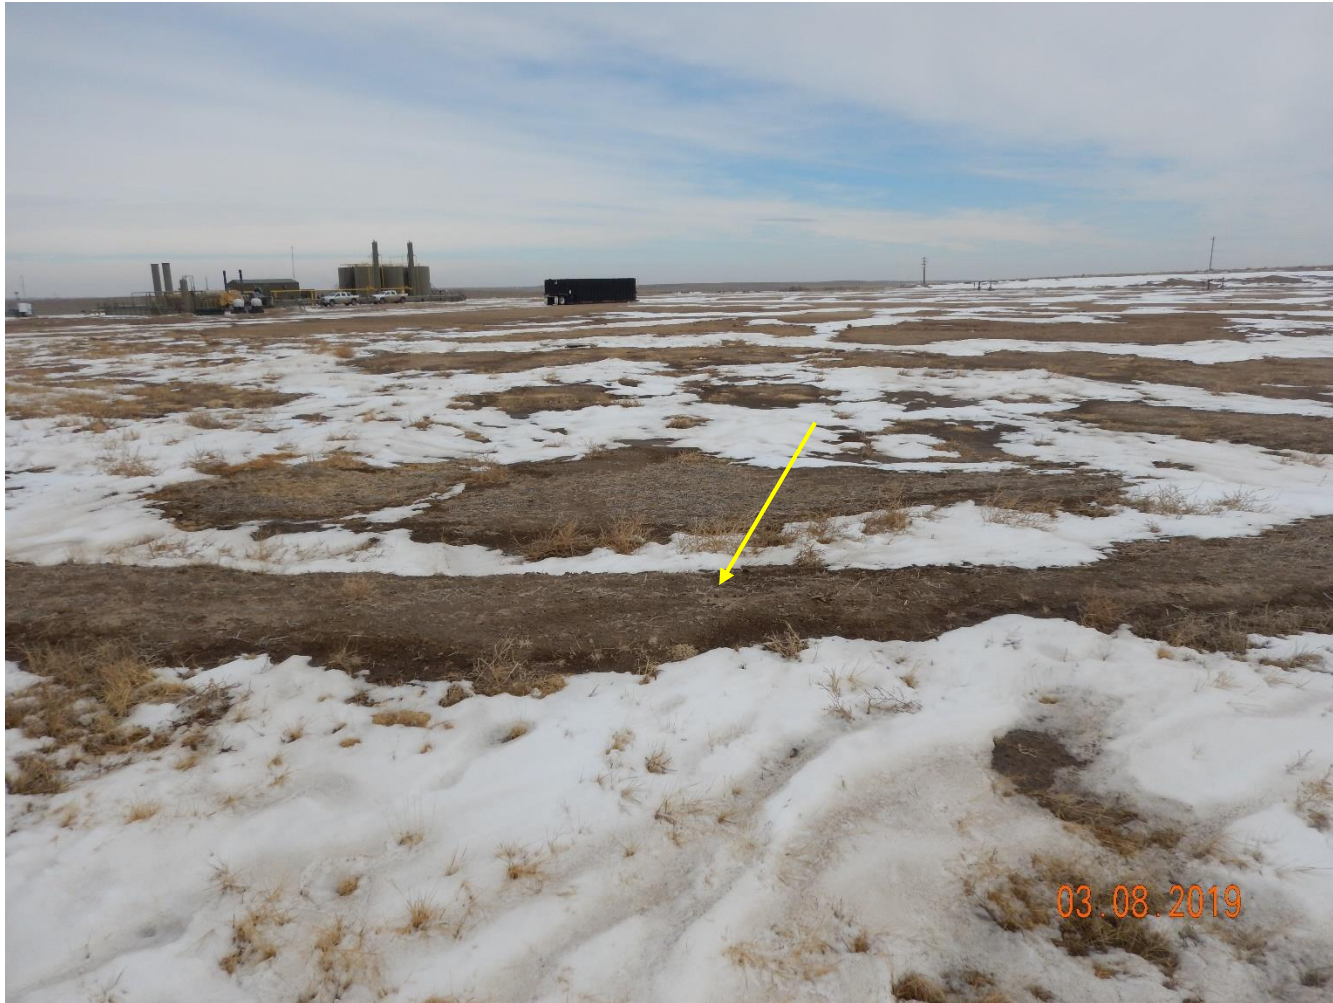
Photo 7: Photo taken from the southwest corner of the location, facing northeast. Photo provides overview of the location. Photo also shows shallow berm on the southwest end of the location.

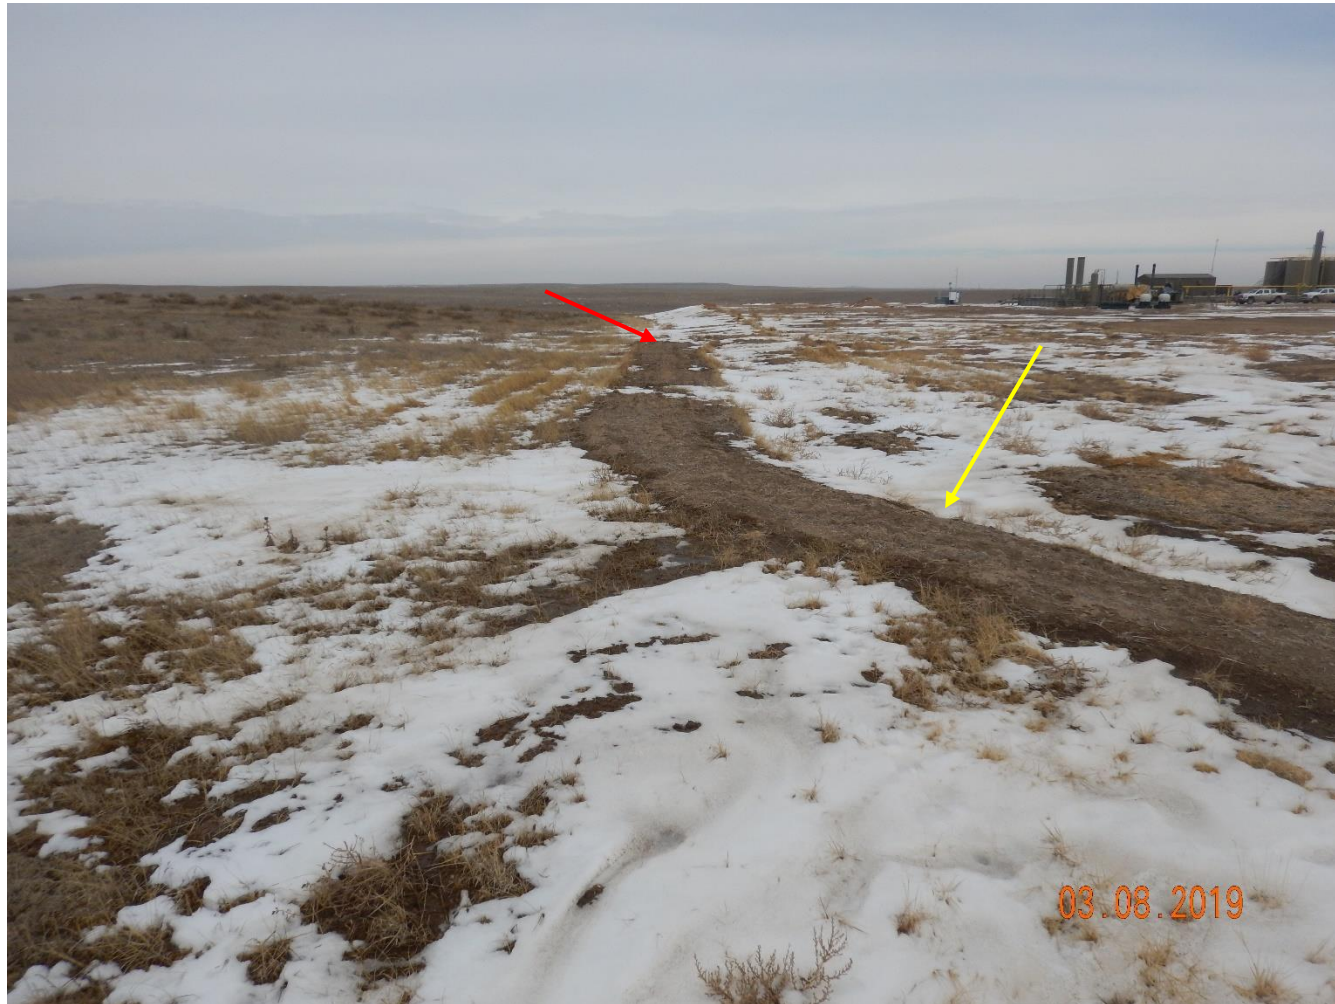
Photo 8: Photo taken from the southwest corner of the location, facing north. Photo provides overview of the location. Photo also shows shallow berm on the southwest end of the location. Berm travels north approximately a couple hundred of feet and ends (red arrow). There does not appear to be sufficient stormwater and erosion control BMPs at the end of berm to mitigate erosion degradation and sediment laden free stormwater discharge from location.

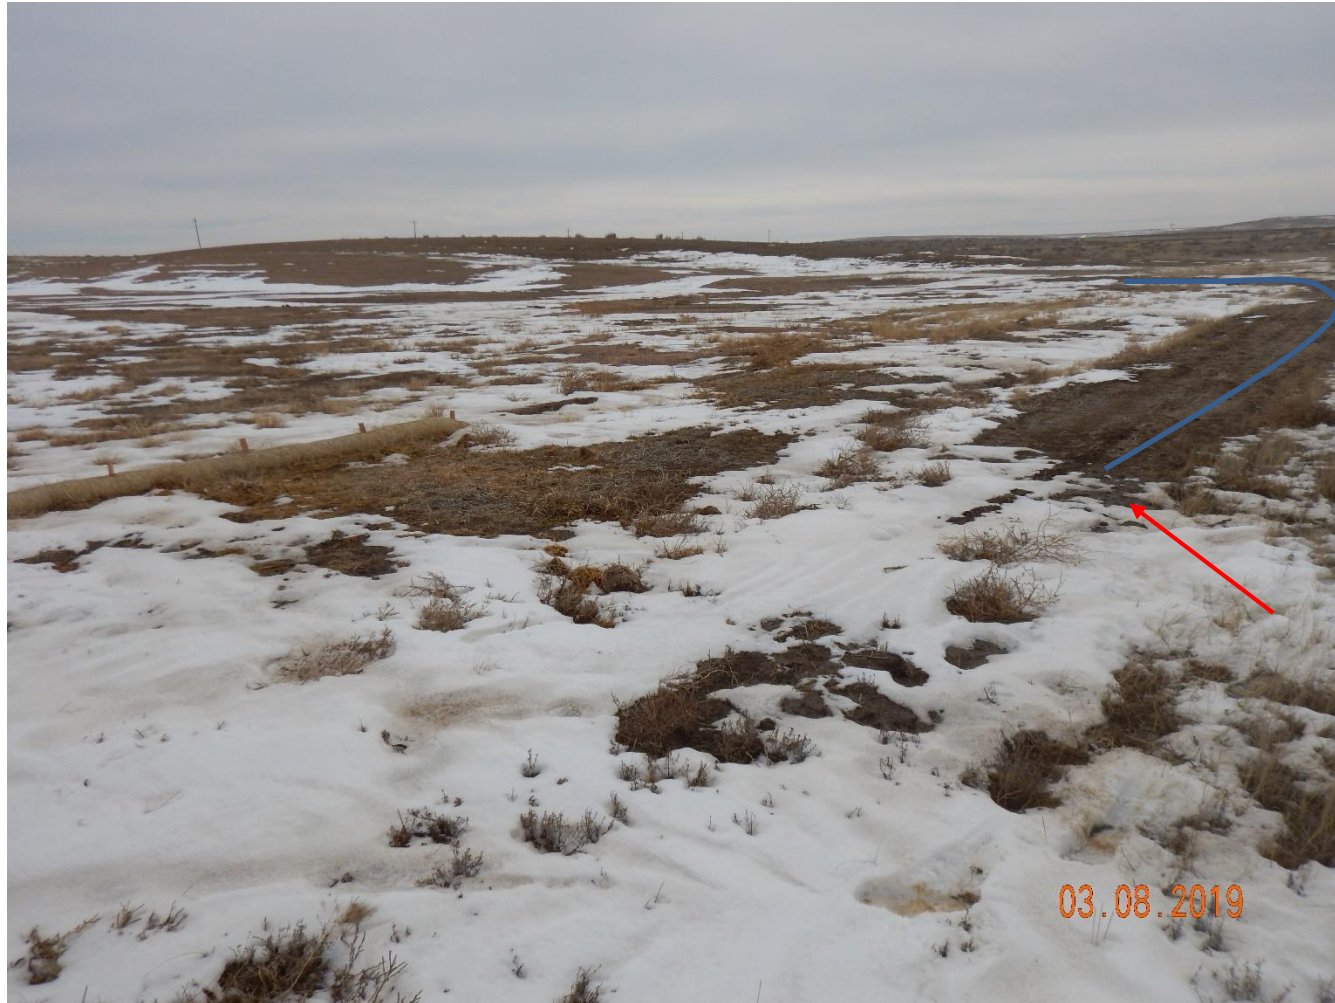
Photo 8.b: Continued from photo 8. Photo shows shallow berm (blue) on the southwest end of the location. Berm travels north a couple hundred of feet and promptly ends (red arrow). There does not appear to be sufficient stormwater and erosion control BMPs at the end of berm to mitigate erosion degradation and sediment laden free stormwater discharge from location.

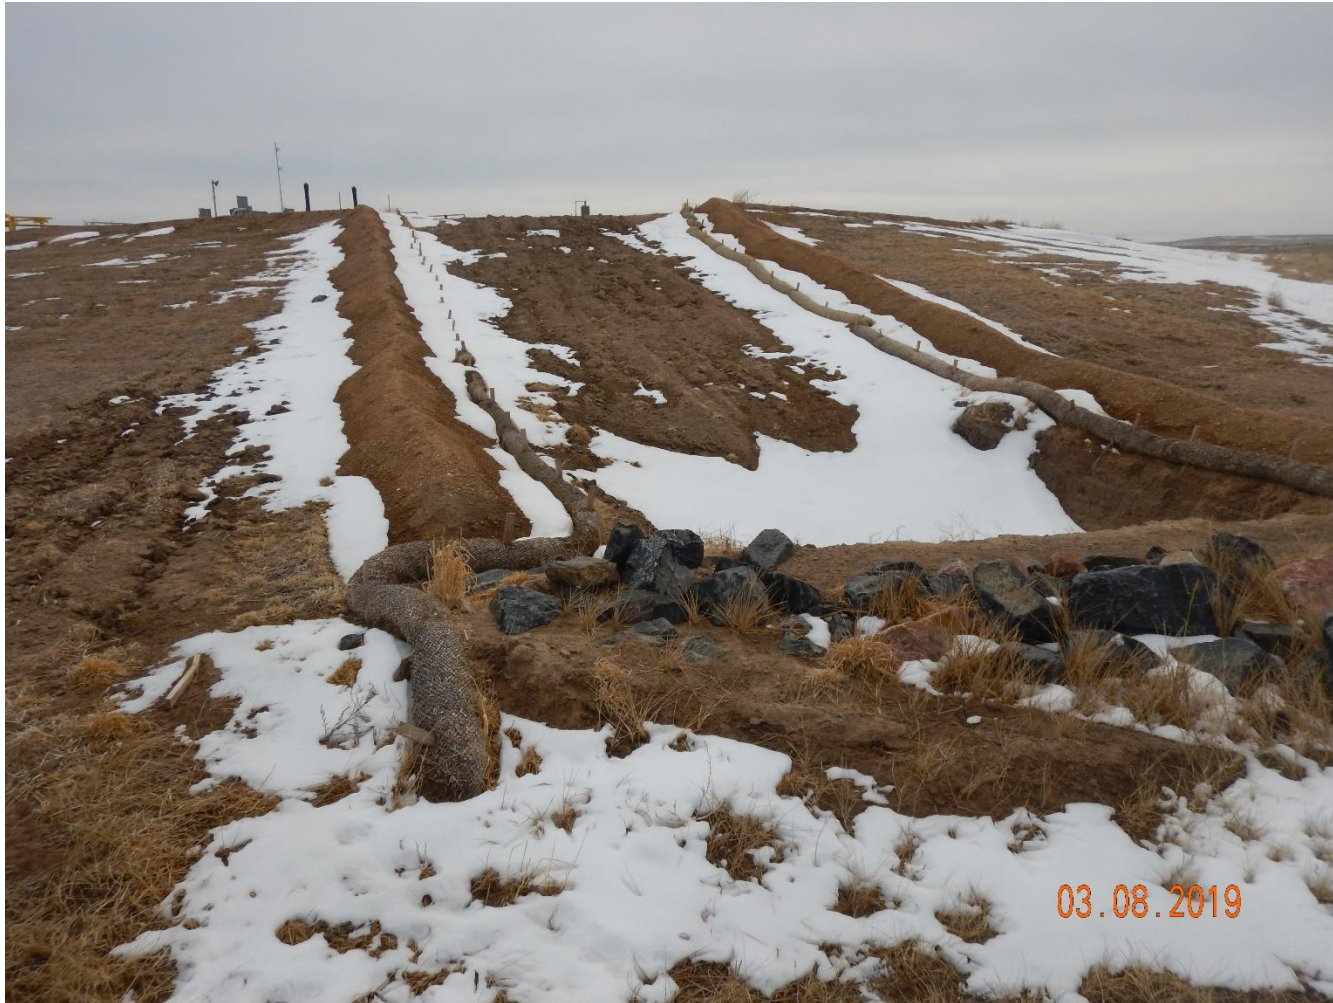
Photo 9: Photo taken from northwest corner of the location. Photo shows sediment trap. Operator has installed two (2) traps on the location. Sediment traps do not appear sufficient in size to mitigate stormwater runoff from the 14.5 acre disturbance area.

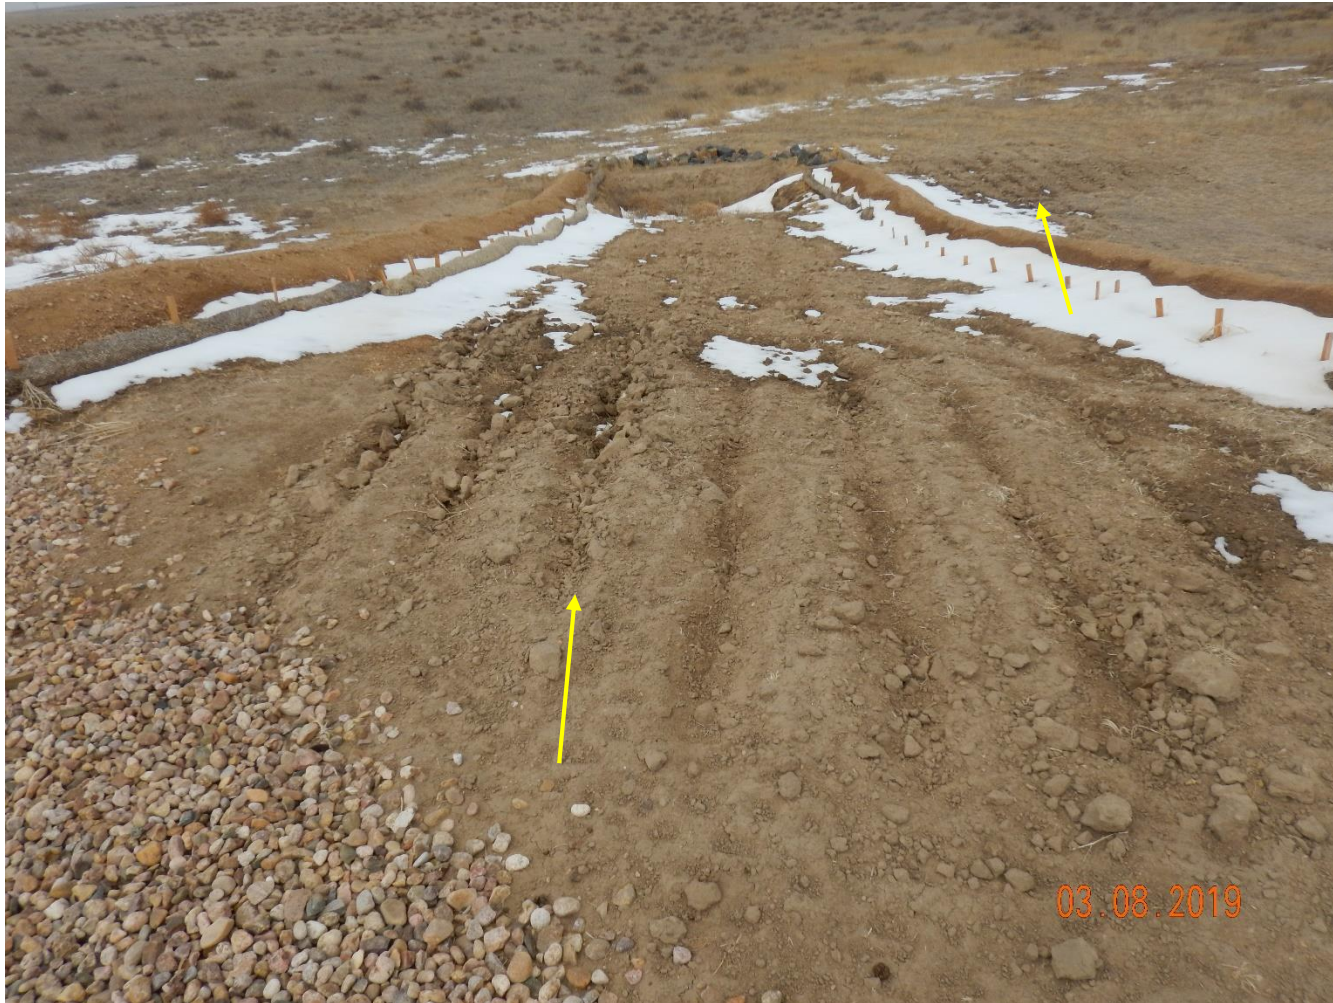
Photo 10: Photo taken from top of the sediment trap on the northwest corner of the location. Operator appears to have ripped the slope of, and areas around, the sediment trap. Ripping has been conducted in such a manner to promote stormwater erosion degradation rather than mitigate it.

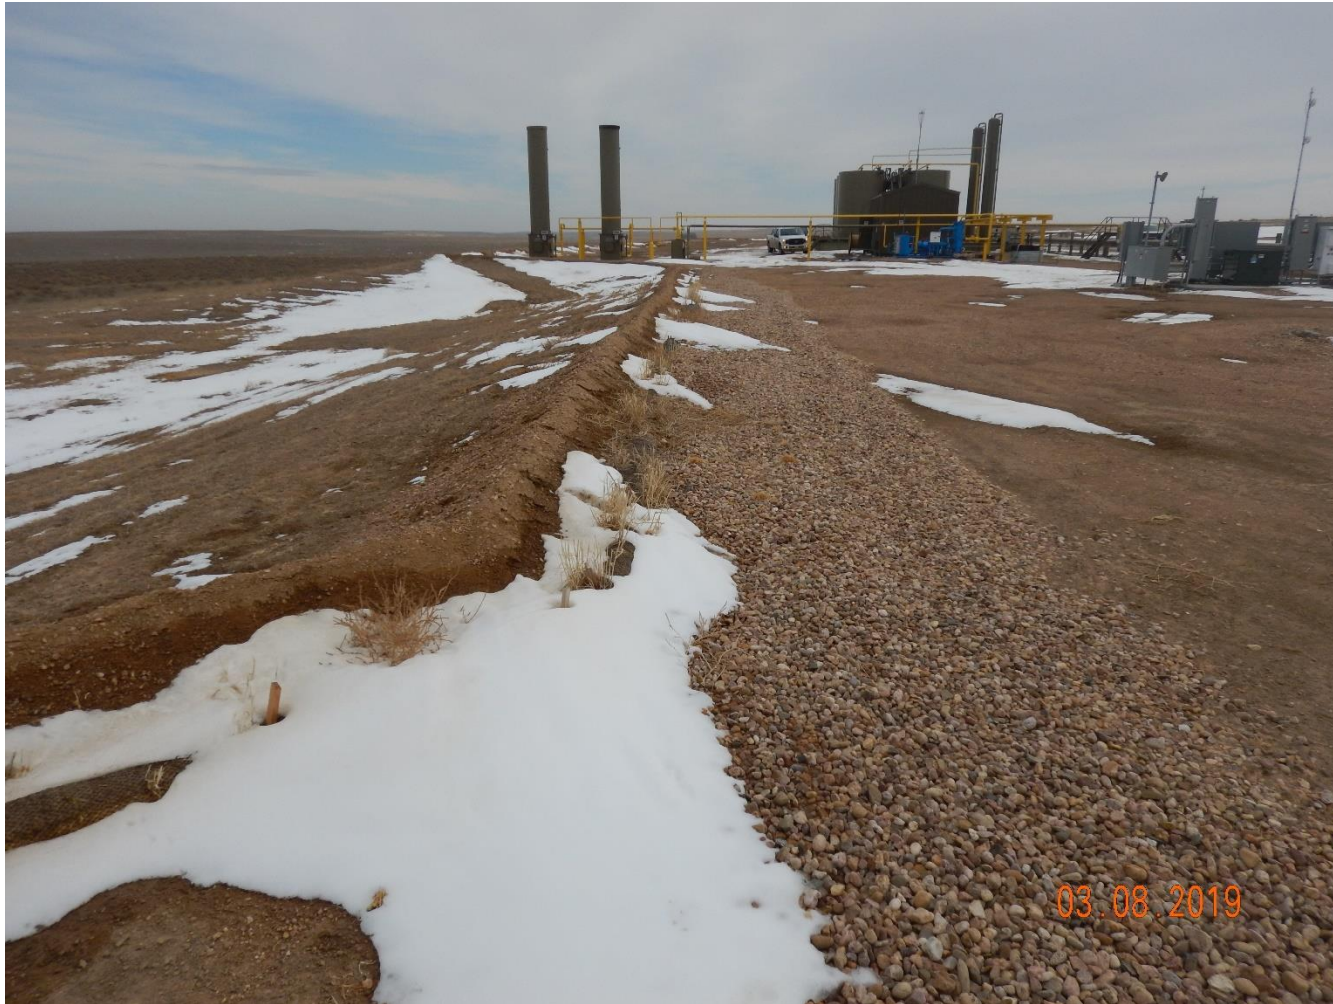
Photo 11: Photo taken from the northwest corner of the location, facing east. Photos 11-13 provide an overview of the location from east, southeast to south.

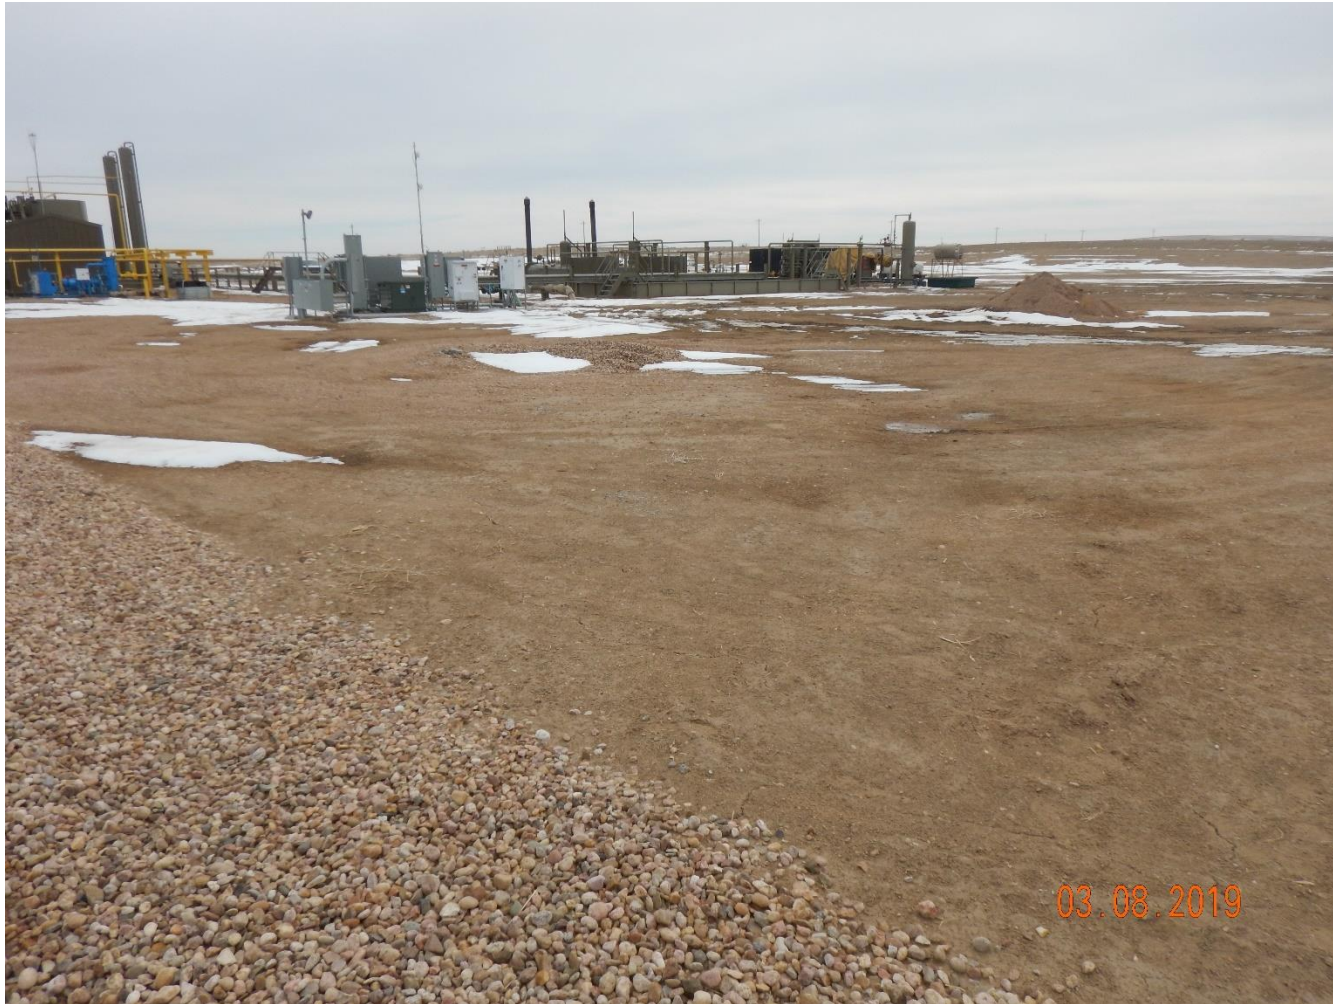
Photo 12: See comments under photo 11.

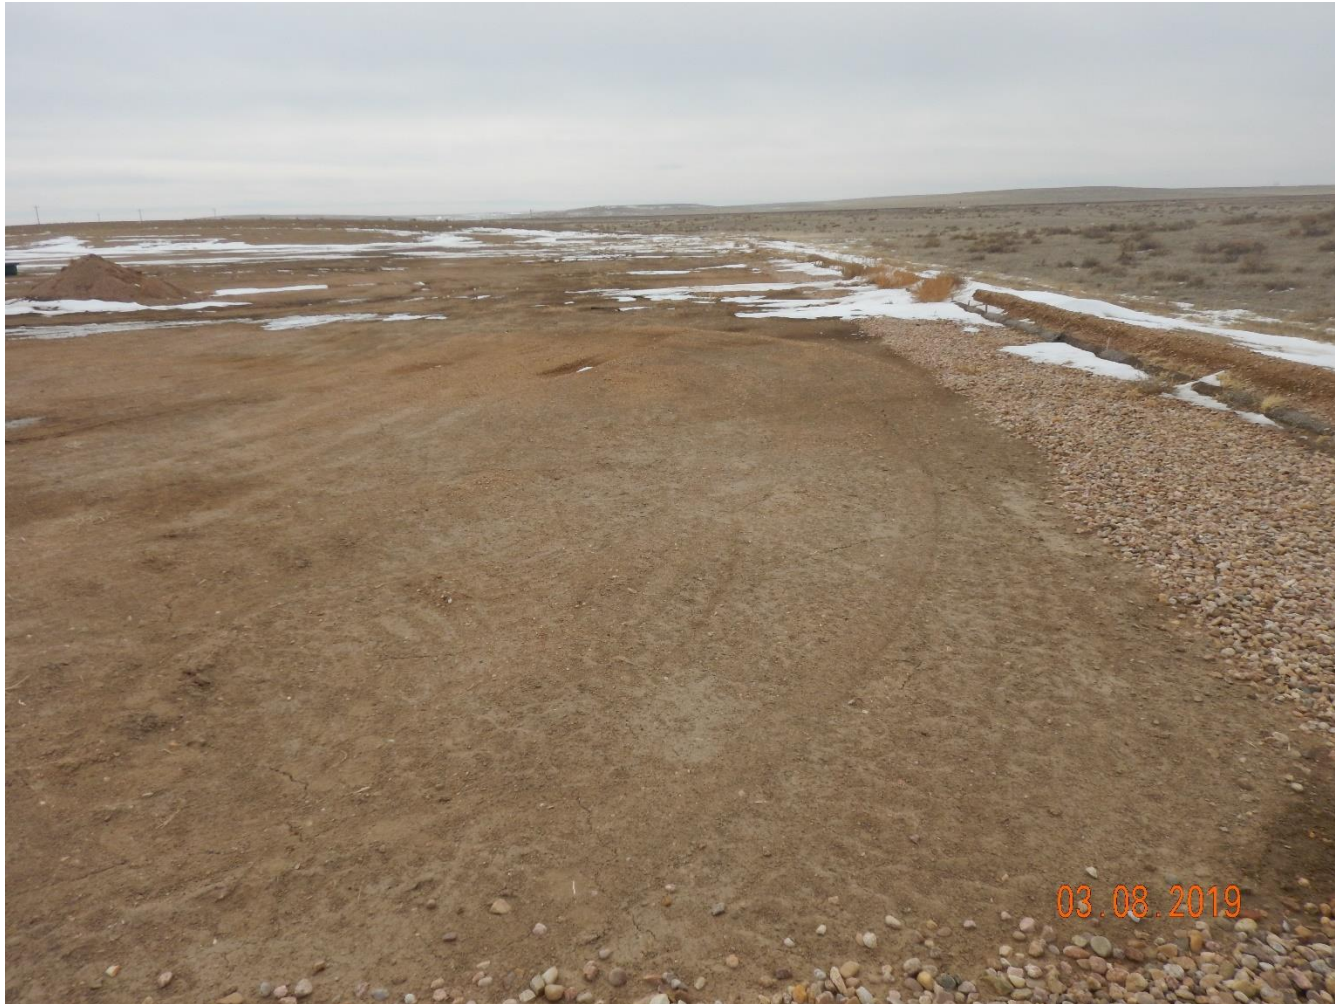
Photo 13: See comments under photo 11.

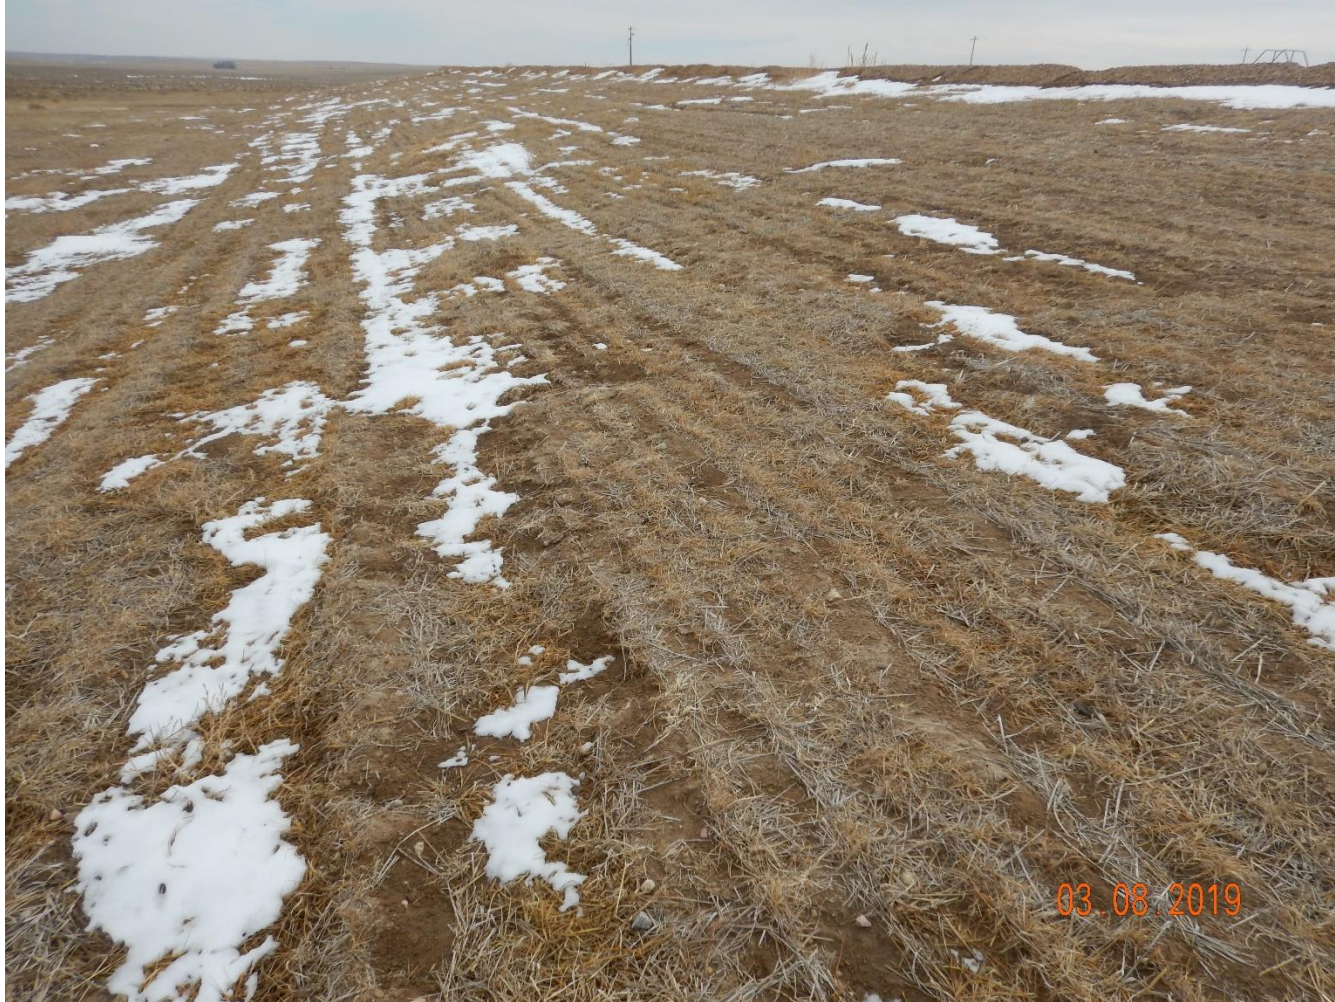
Photo 14: Photo taken from the north end of the location, facing east. Photo shows vegetative establishment on the slopes evident.

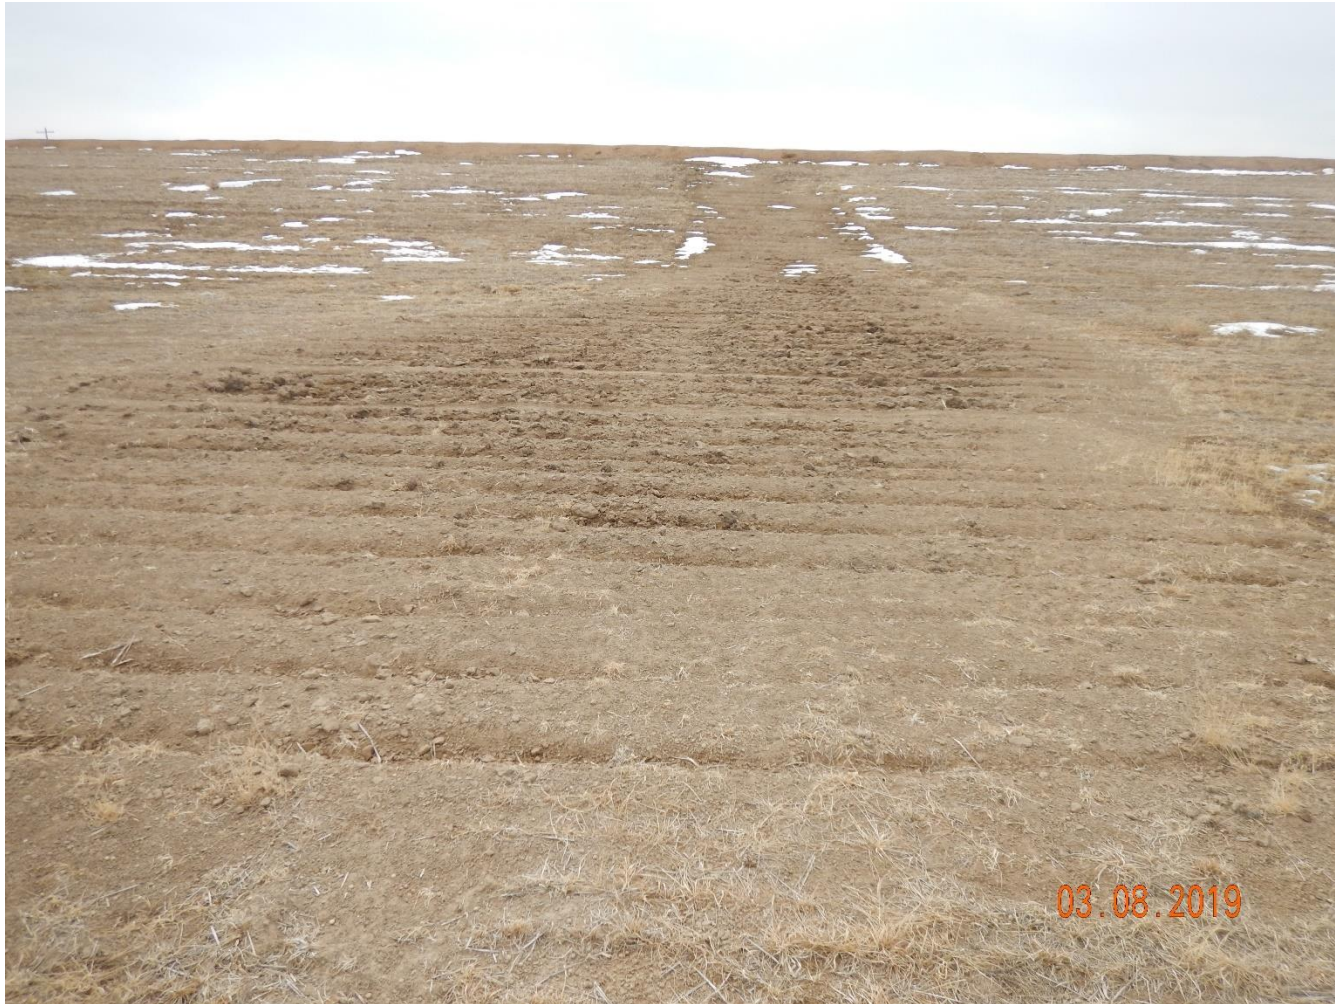
Photo 15: Photo taken from the north end of the location. Photo shows area where prior erosion degradation appears to have been repaired.
