Inspection Photos

Operator: BISON OIL & GAS II LLC # 10661

Location ID: 452871

Inspection Doc. Number: 682504582

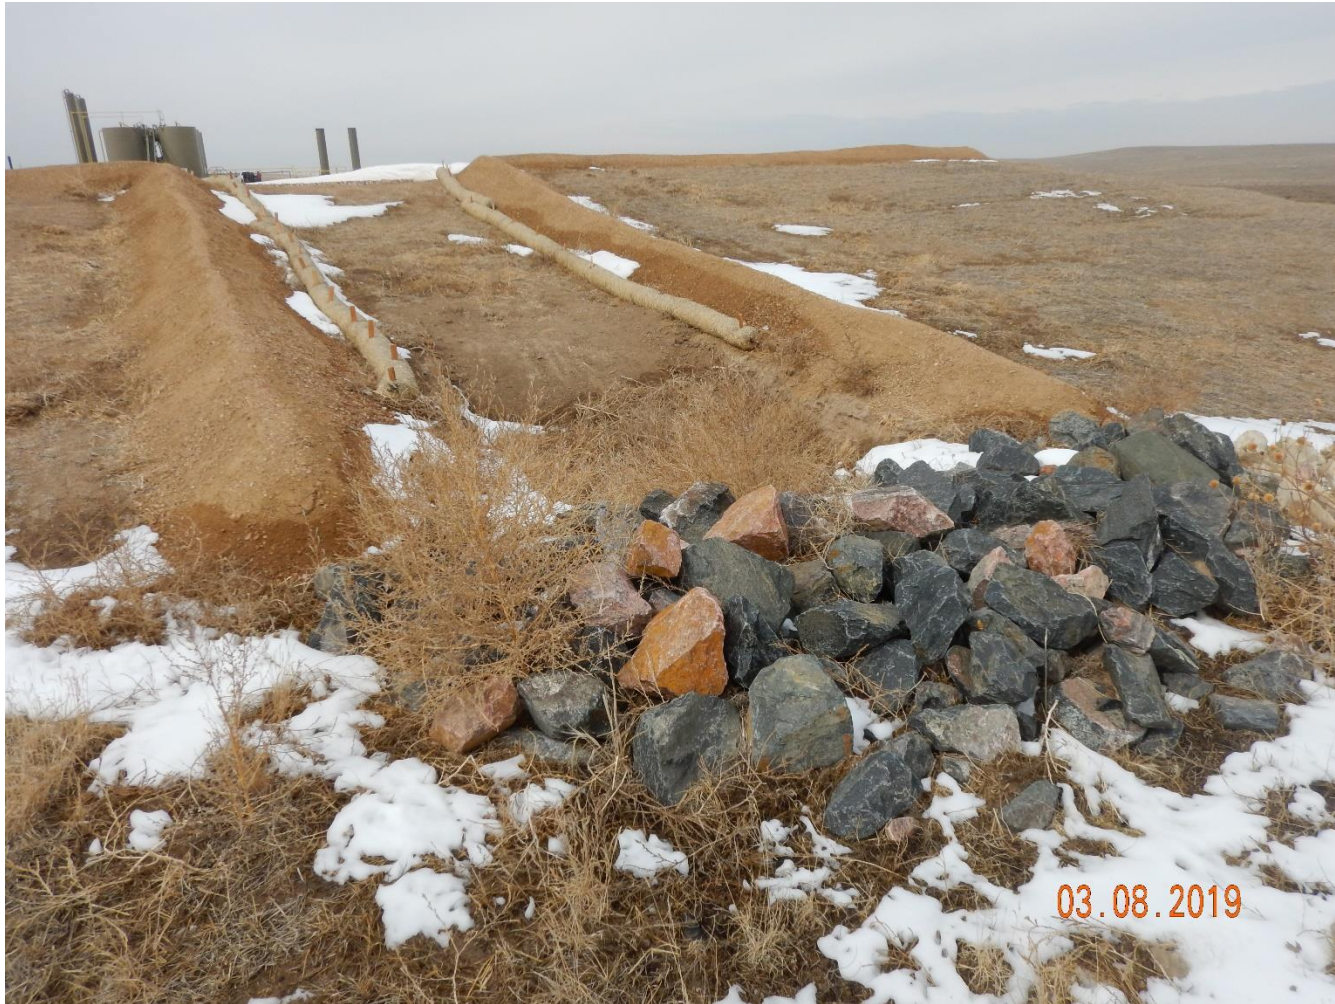
Photo 9: Photo taken from northwest corner of the location. Photo shows sediment trap. Operator has installed two (2) traps on the location. Sediment traps do not appear sufficient in size to mitigate stormwater runoff from the 14.5 acre disturbance area.

Photo 16: Photo taken from the sediment trap on the northeast corner of the location. See comments under photo 9.

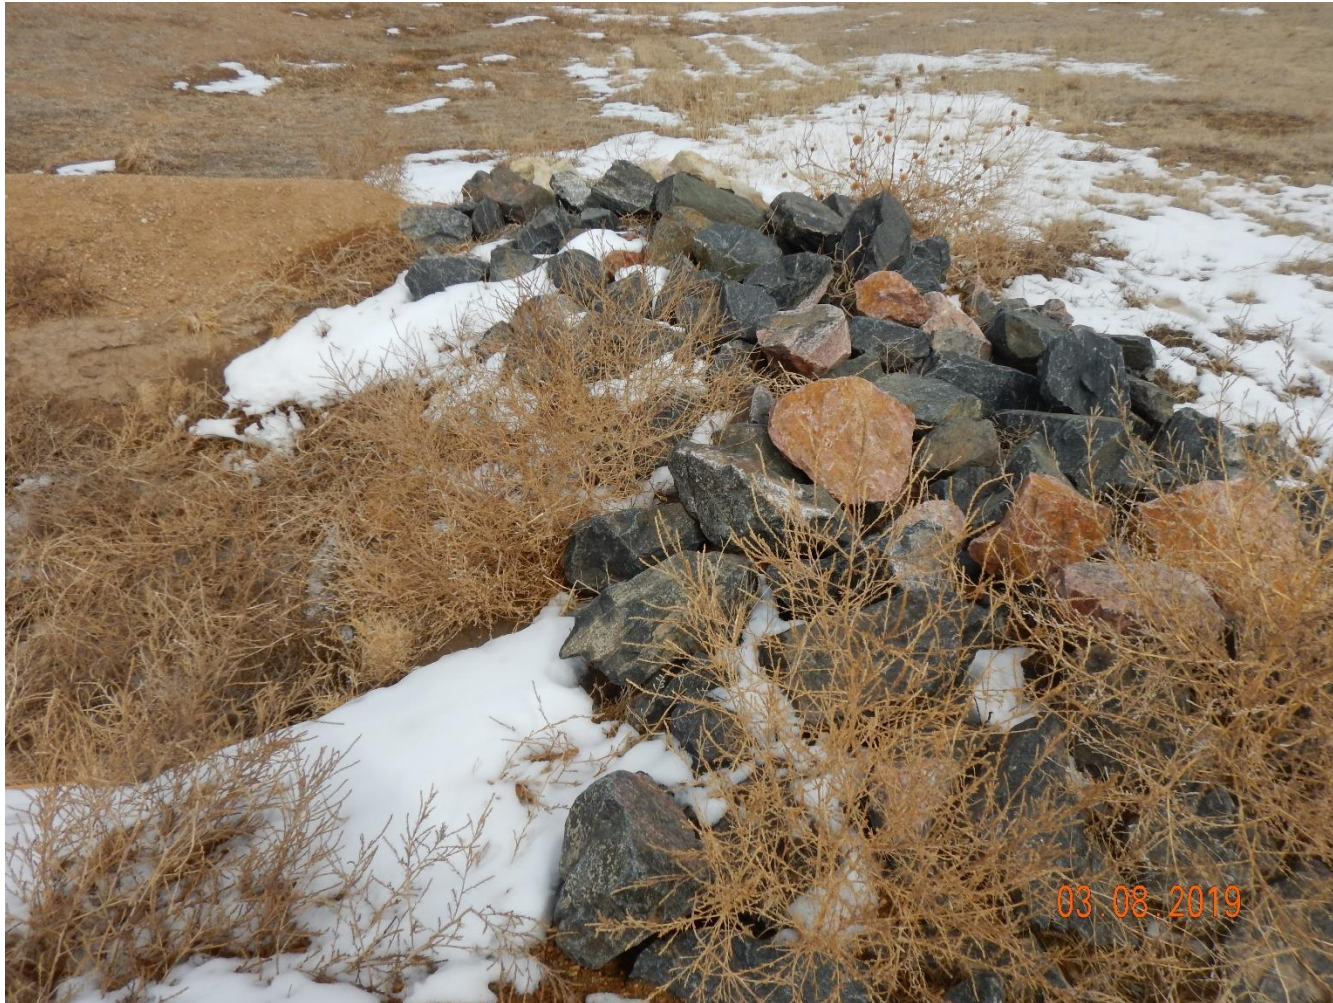
Photo 17: Photo taken from the sediment trap on the northeast corner of the location. See comments under photo 9.

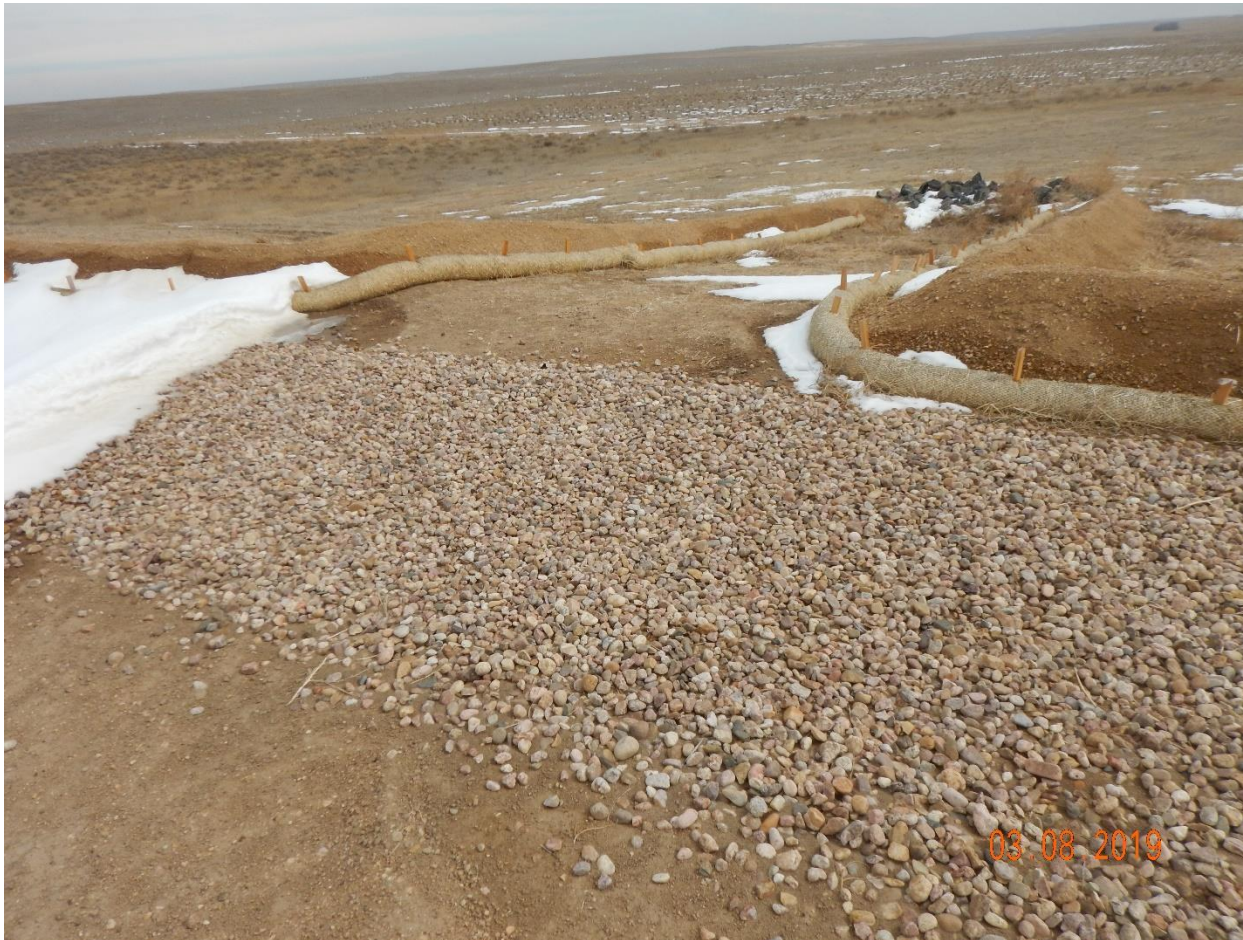
Photo 18: Photo taken from the sediment trap on the northeast corner of the location. See comments under photo 9.

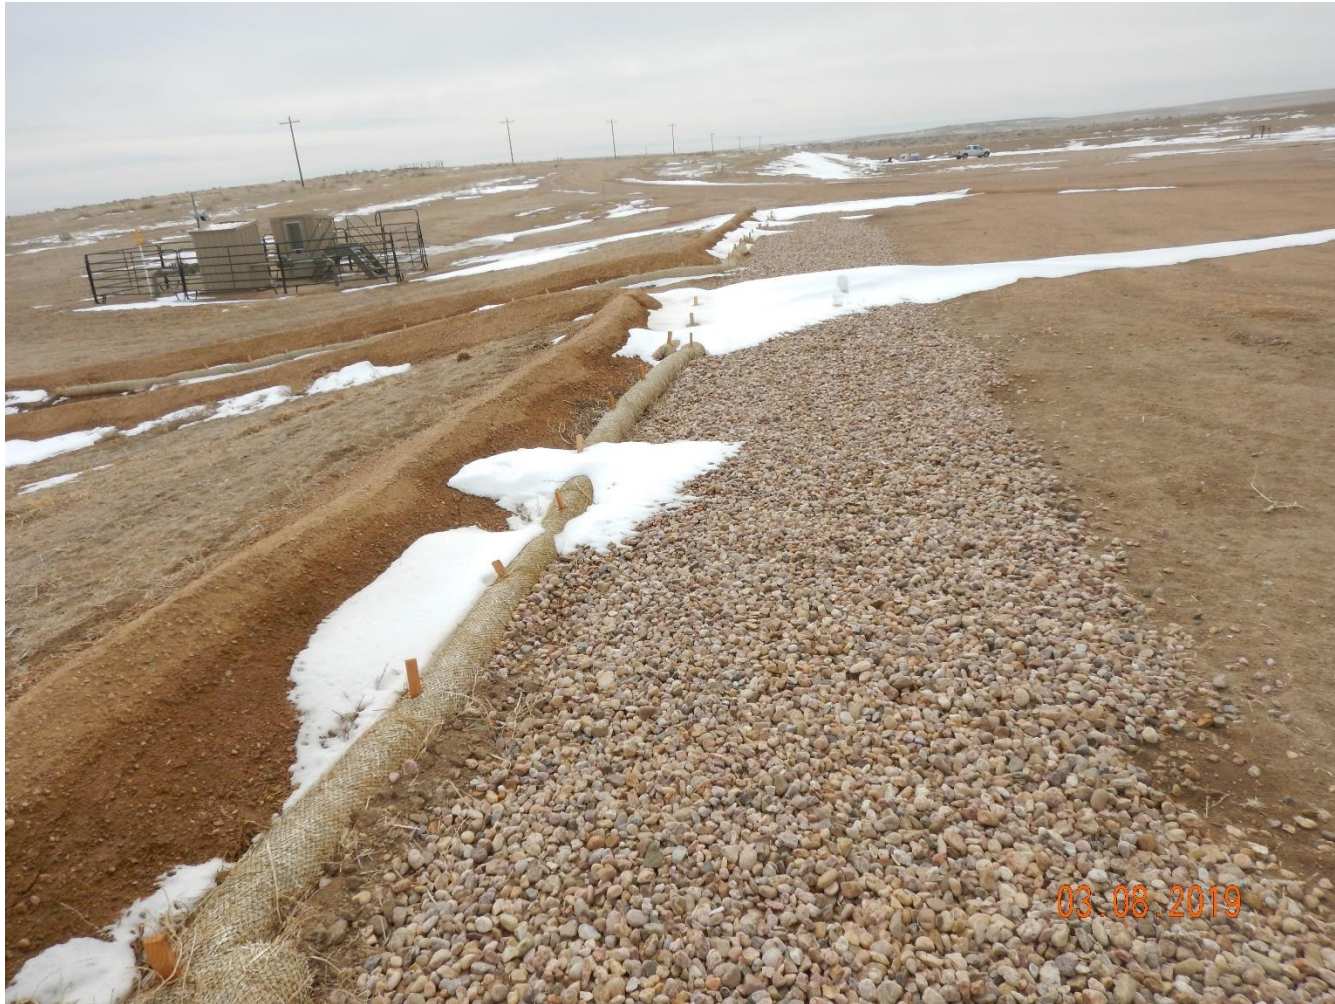
Photo 19: Photo taken from the northeast corner of the location, facing south. Photos 19-21 provide an overview of the location from south, southwest to west

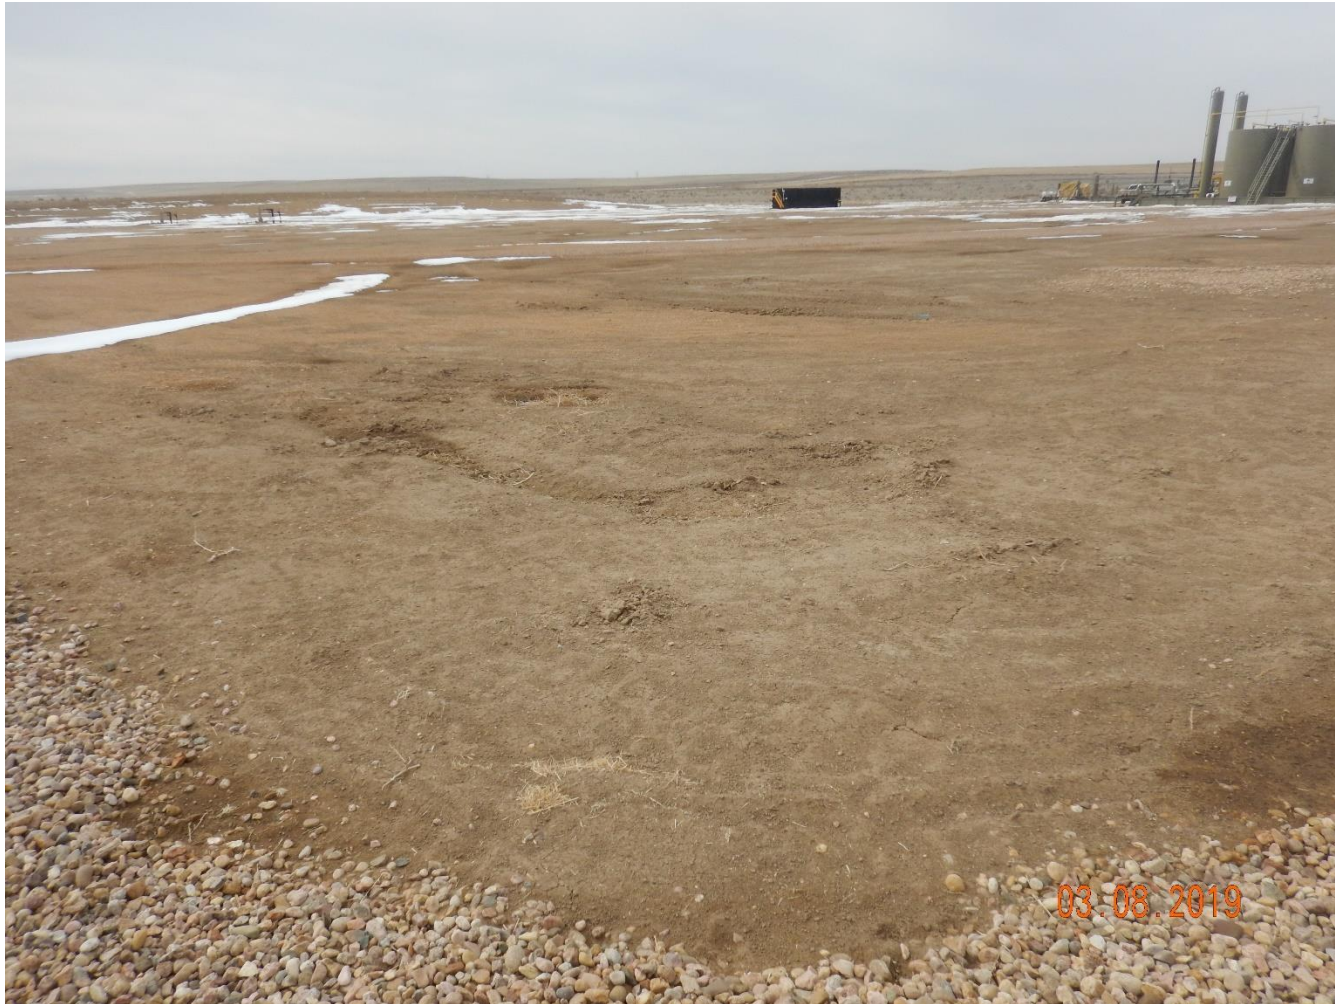
Photo 20: See comment under photo 19.

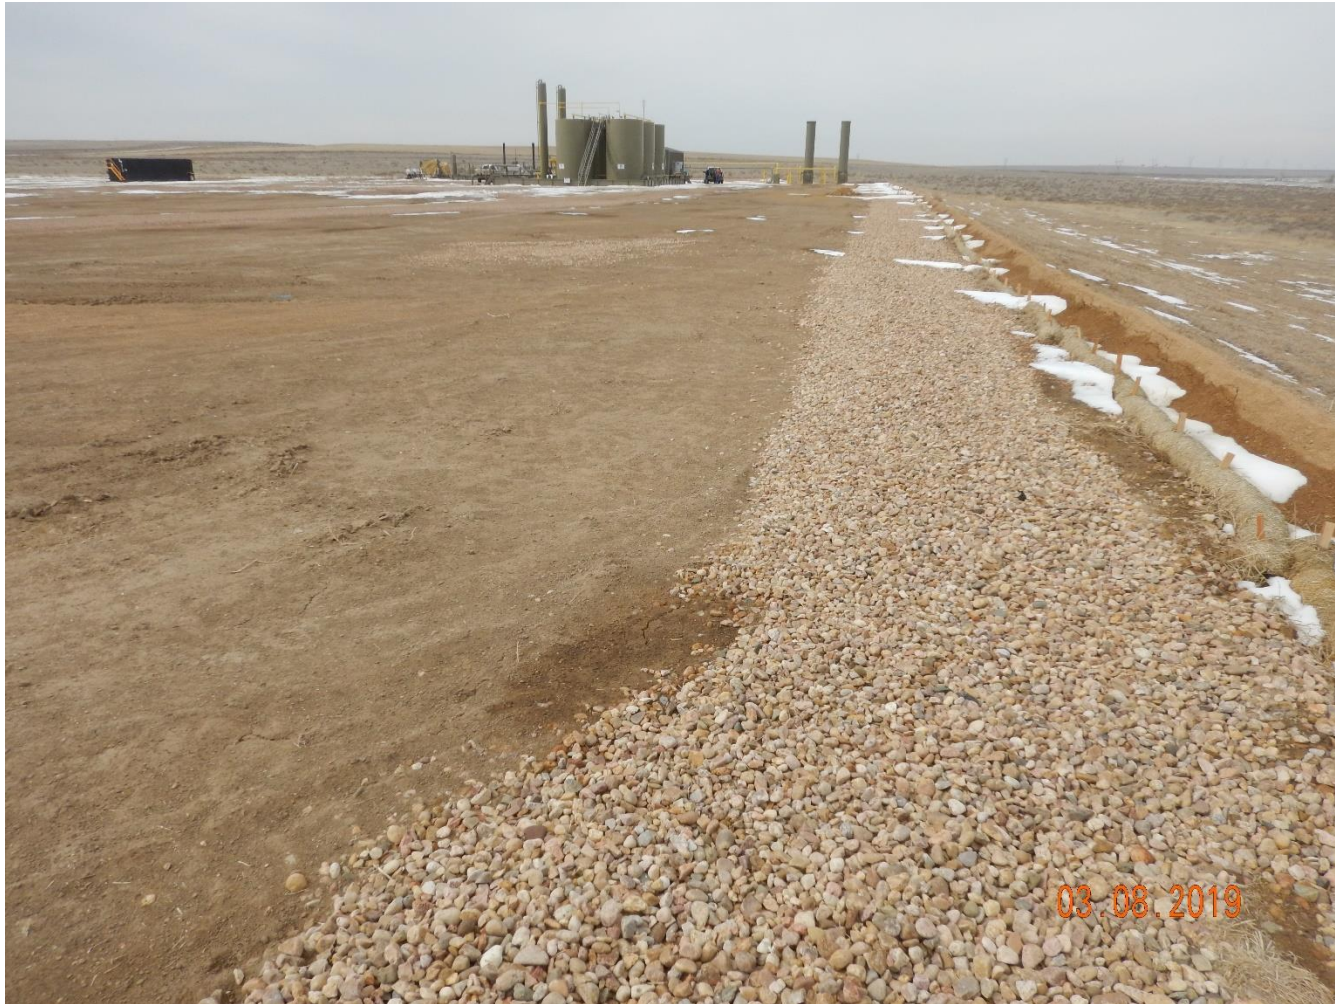
Photo 21: See comment under photo 19.

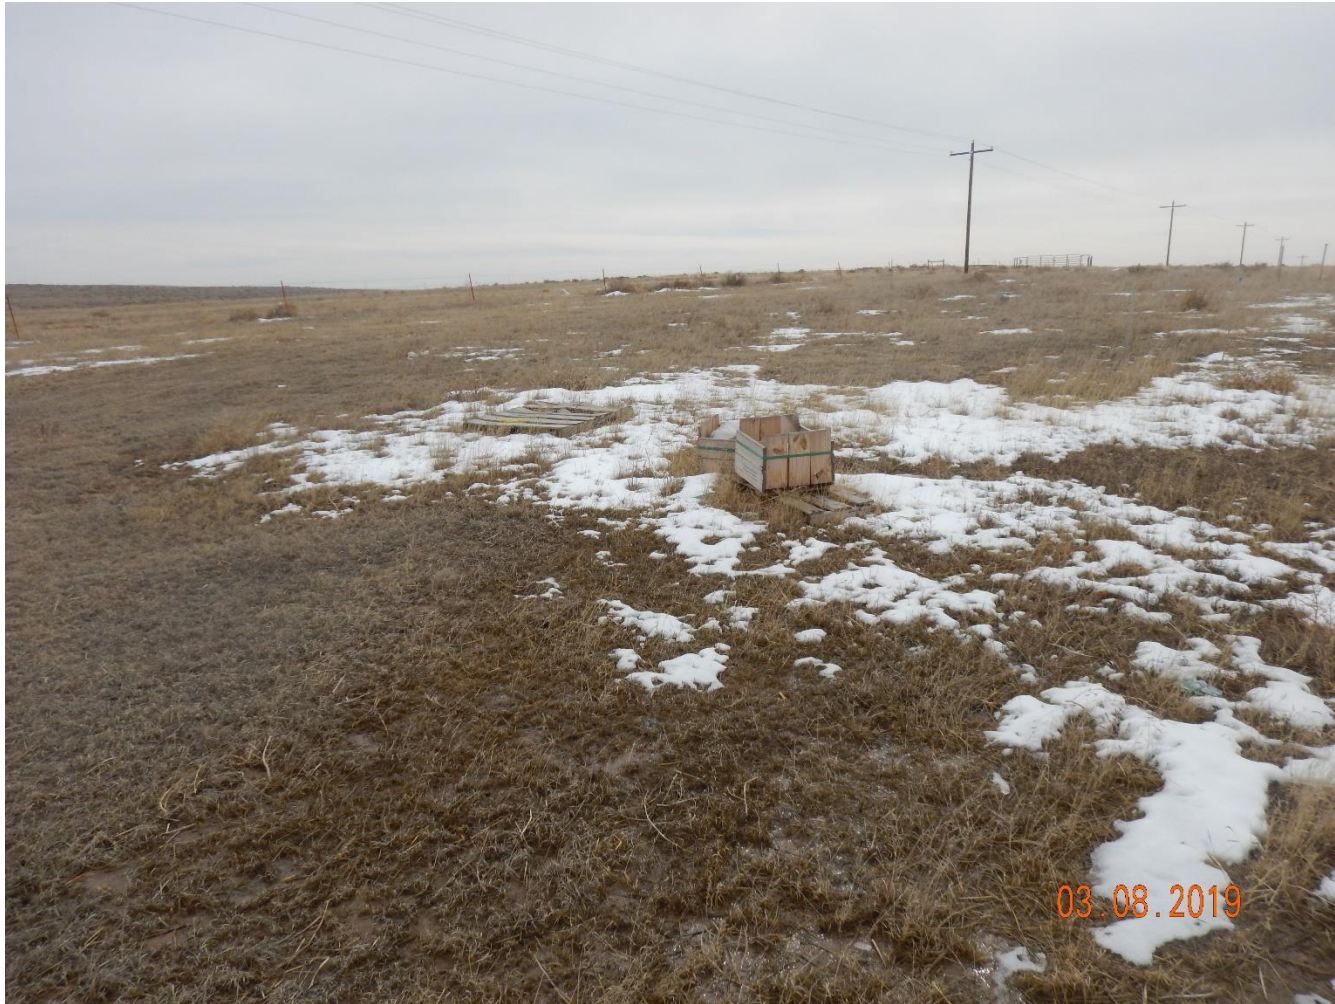
Photo 22: Photo taken from the east end of the location, facing southeast. Photo shows various trash debris/materials being stored off location.

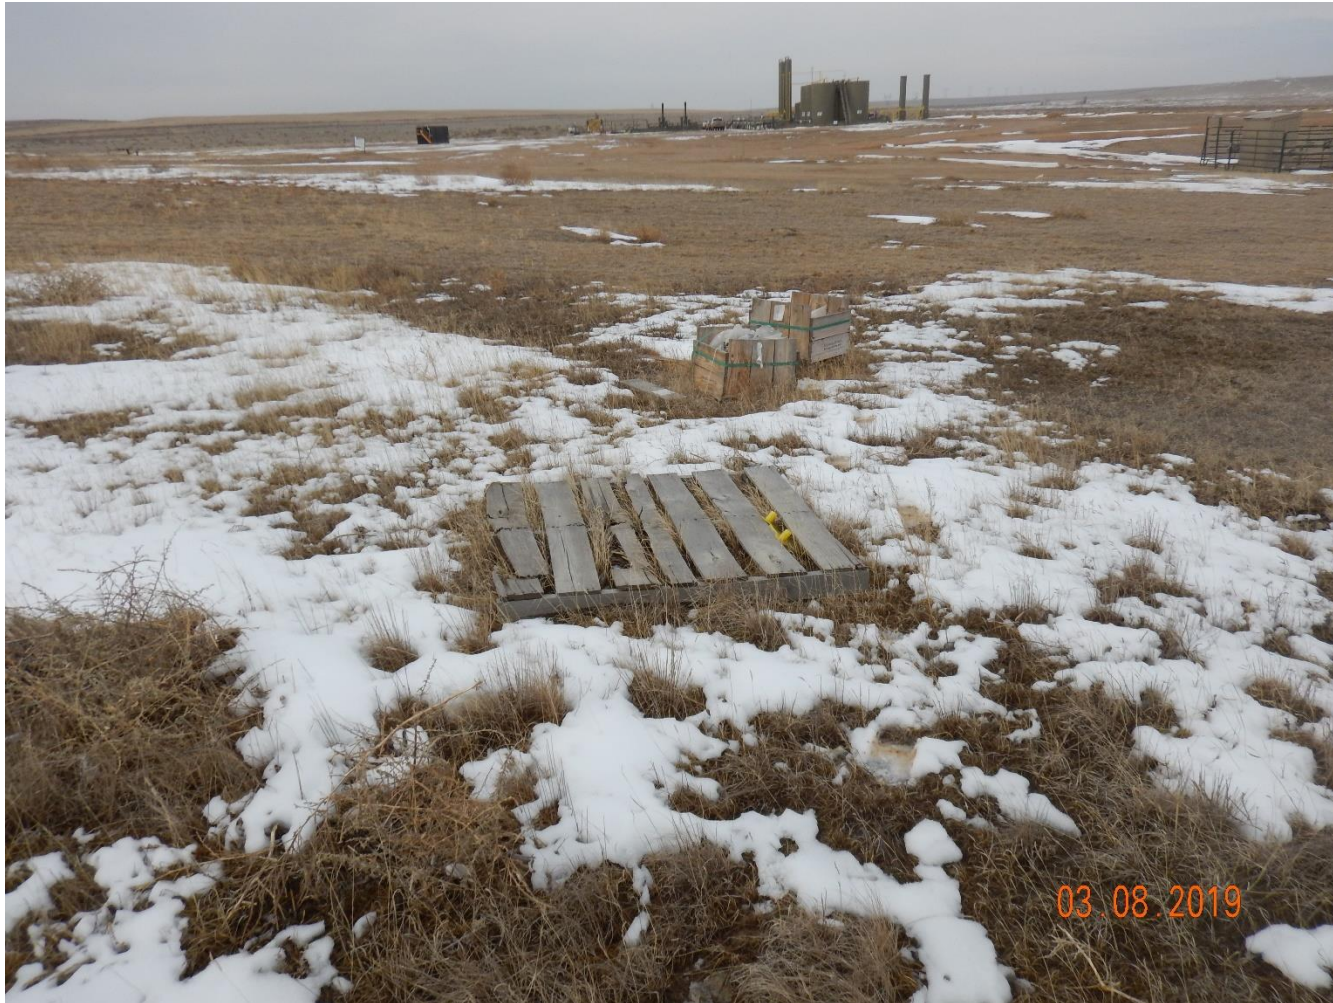
Photo 23: Photo taken from the east end of the location, facing west. Photo shows various trash debris/materials being stored off location.

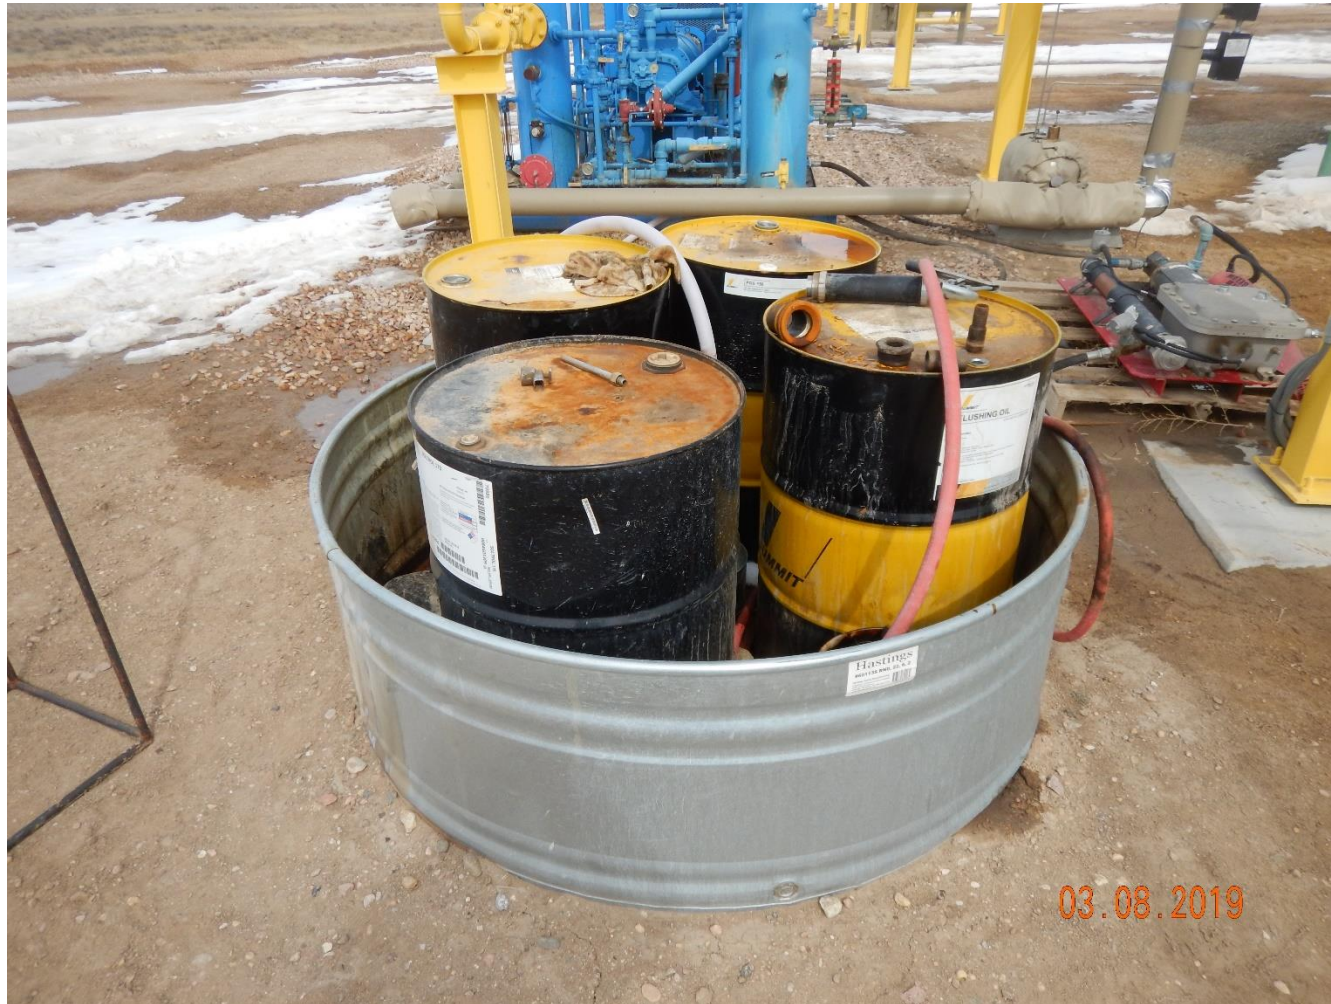
Photo 24: Photo shows barrels on location properly stored in sufficient secondary containment. This is proper materials management.

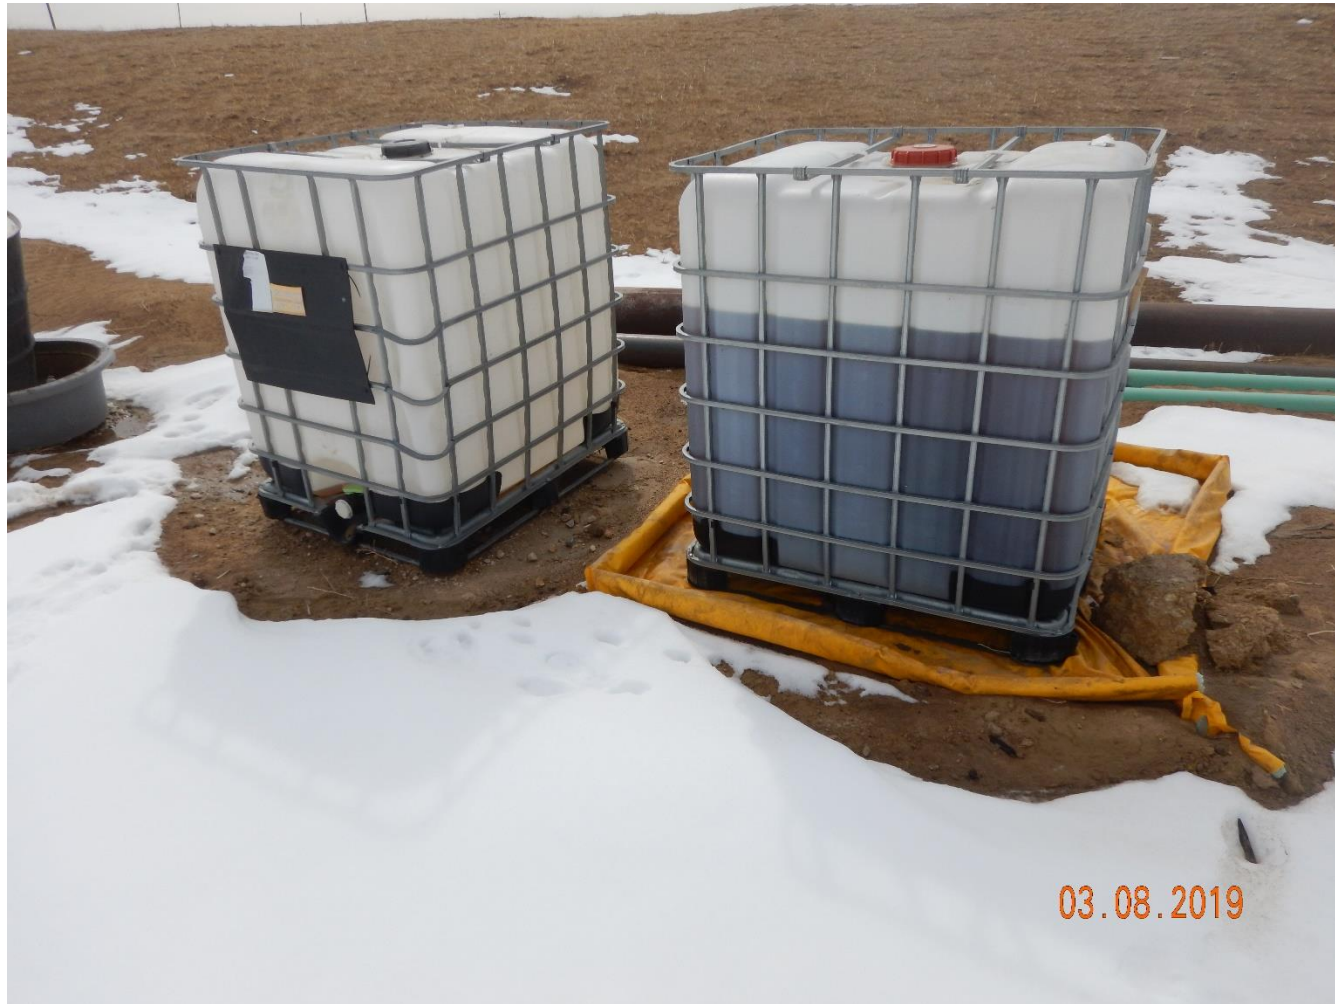
Photo 25: Photo taken from the southeast corner of the pad. Photo shows two (2) 300 gallon tanks. Tanks have not been properly stored in sufficient secondary containment. This is not proper materials management.

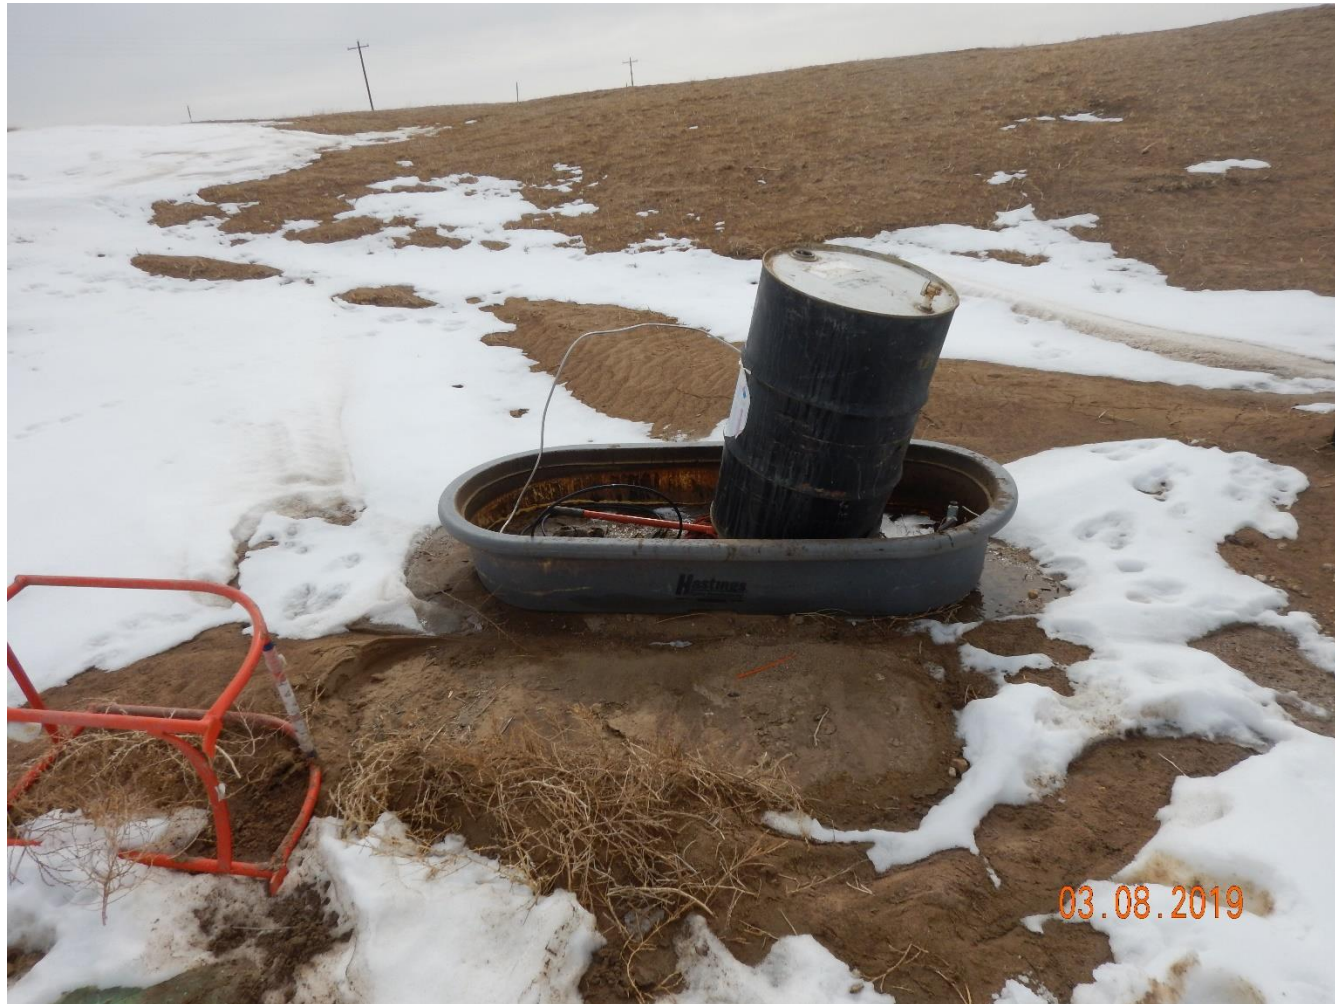
Photo 26: Photo shows barrels on location properly stored in sufficient secondary containment.

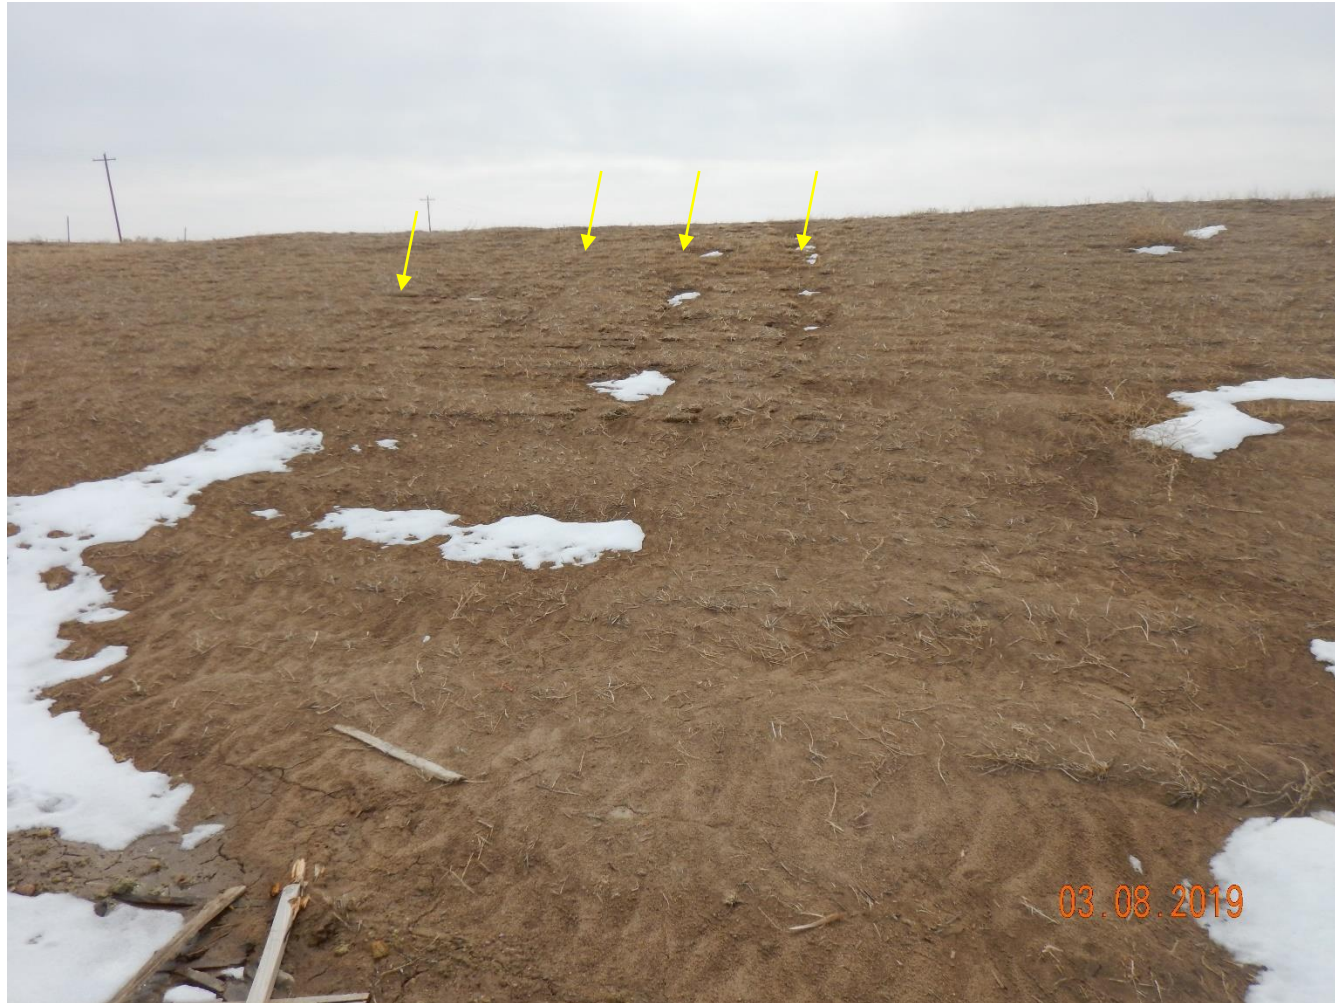
Photo 27: Photo taken from the cut slopes on the south end of the location. Photo shows slopes are predominantly bare and exposed soil. Aeolian deposition evident and appear to have covered any vegetation that has germinated. Stormwater erosion degradation is becoming evident.

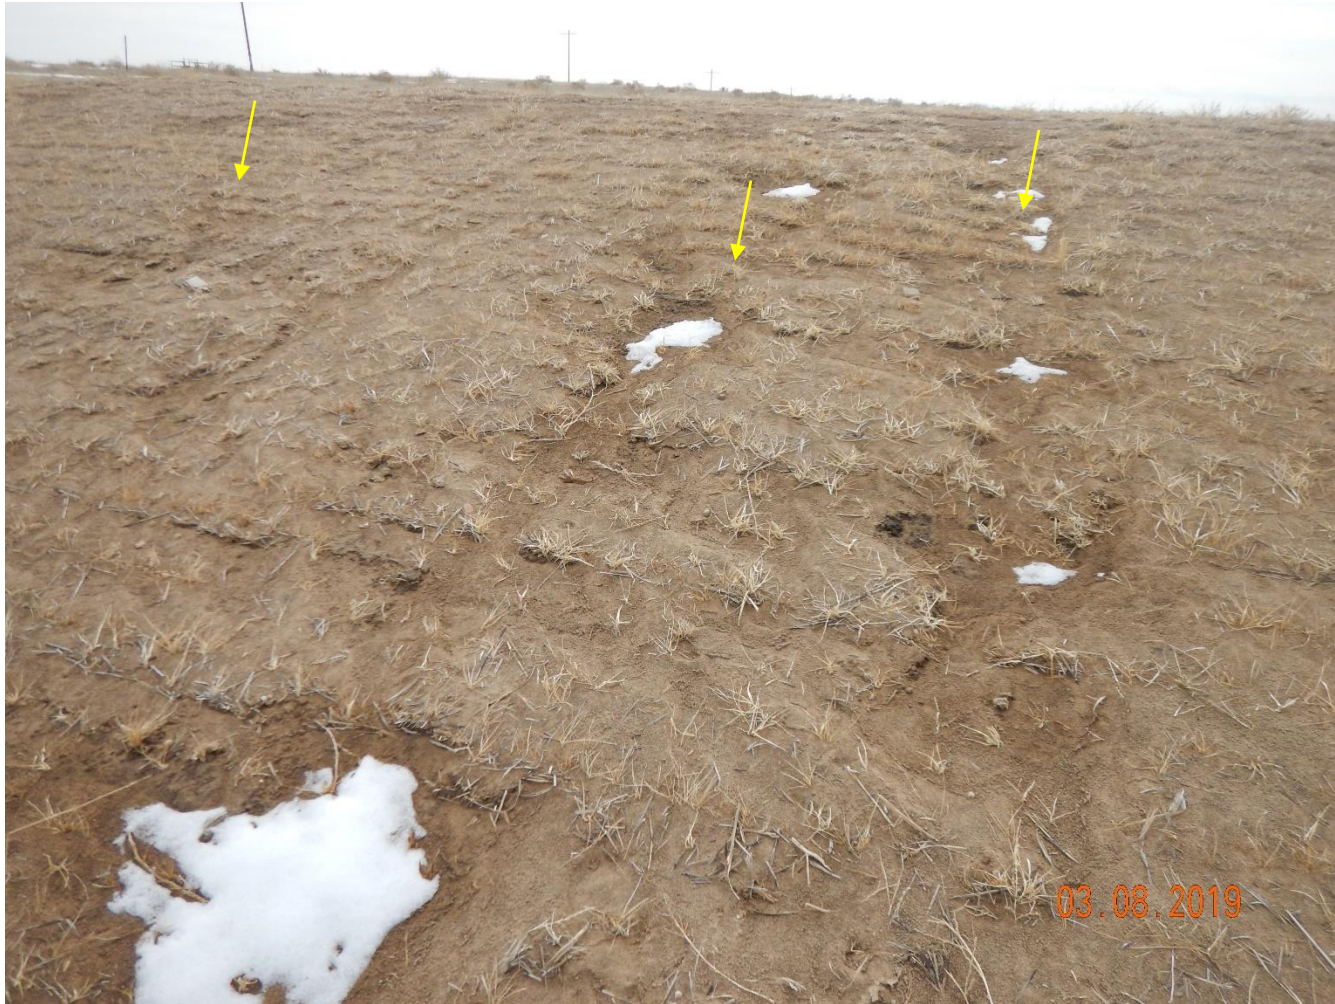
Photo 28: See comments under photo 27.
