Inspection Photos
Operator: Javernick Oil
Location/API #: 043-40025
Date: 2/28/2019

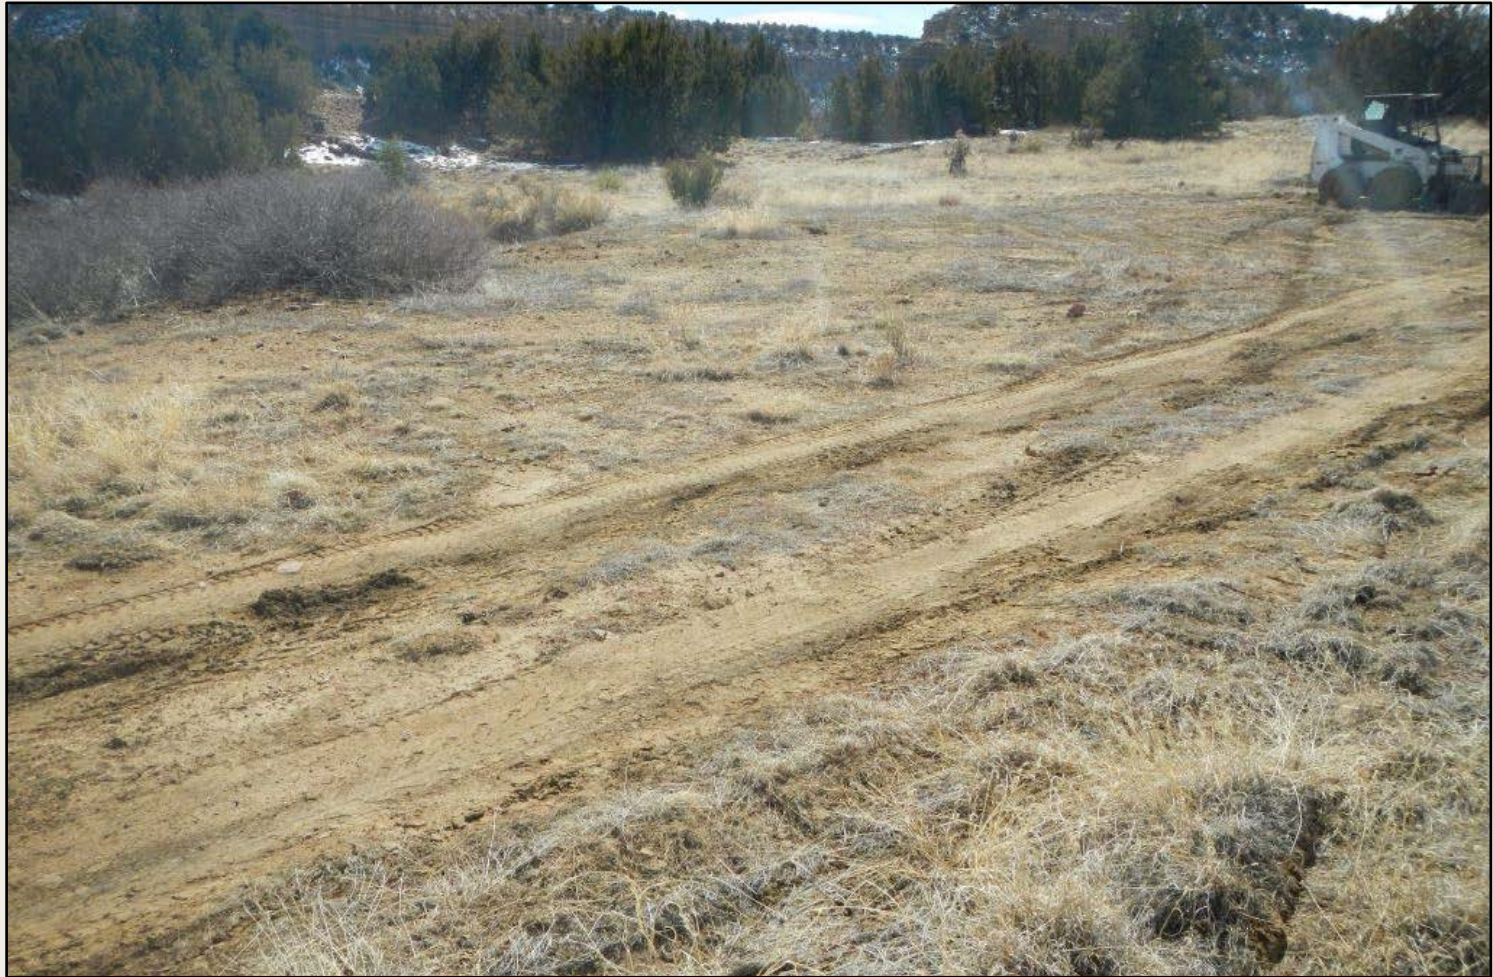
Photo 1. View of the project area from the northern edge facing southeastward. Project area and secondary road are not reclaimed.

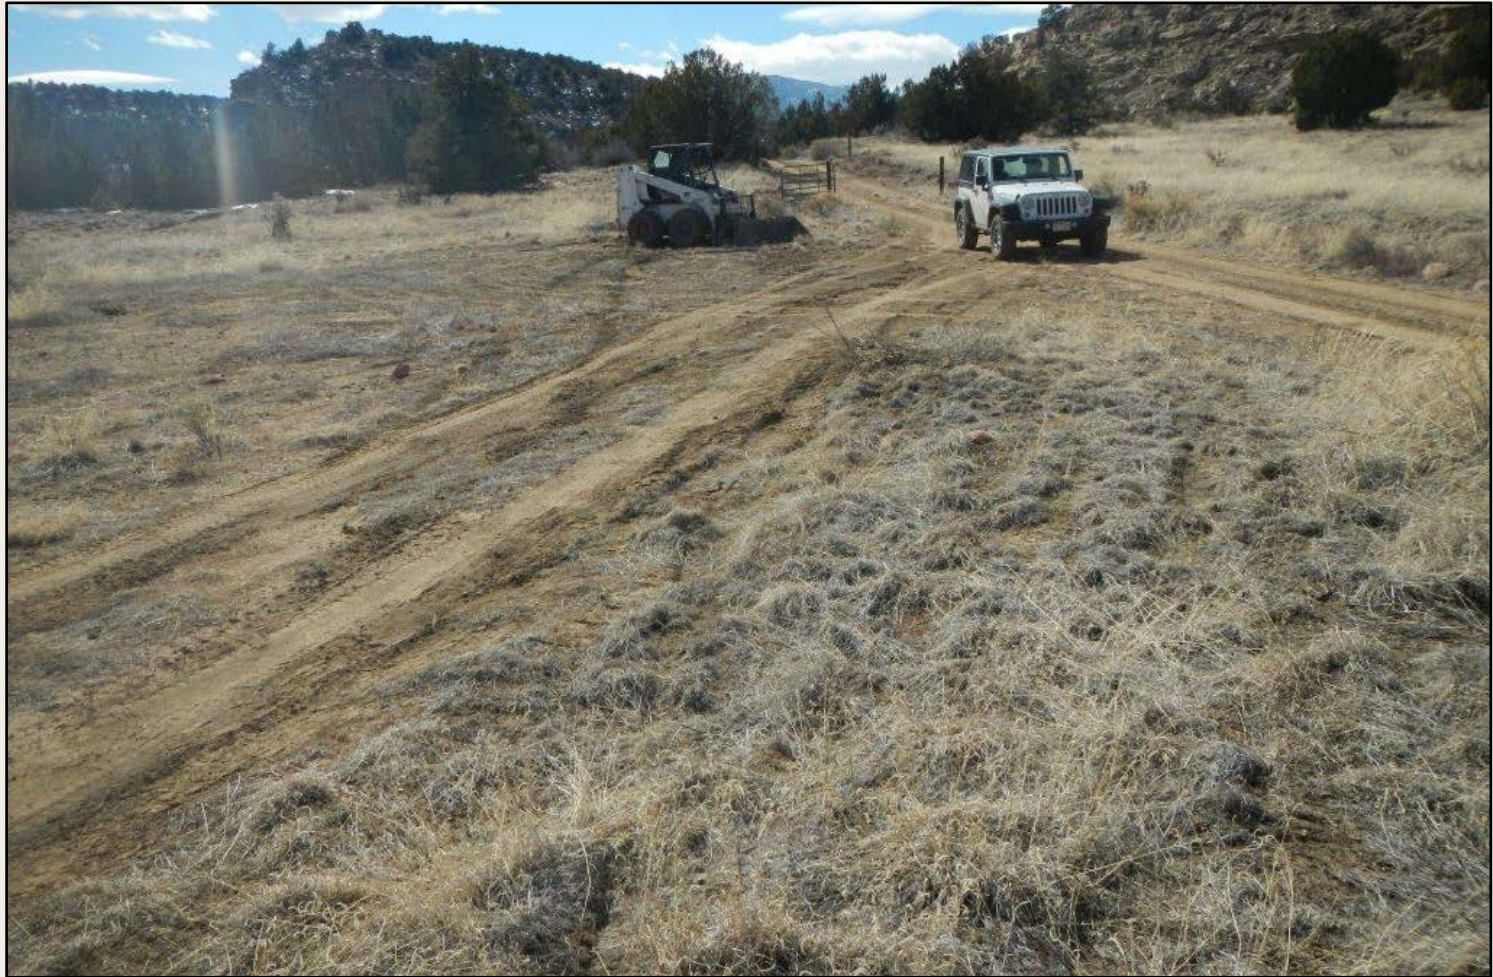
Photo 2. View of the western project area from the norther edge facing southwestward. Secondary road needs to be reclaimed along with the production area.

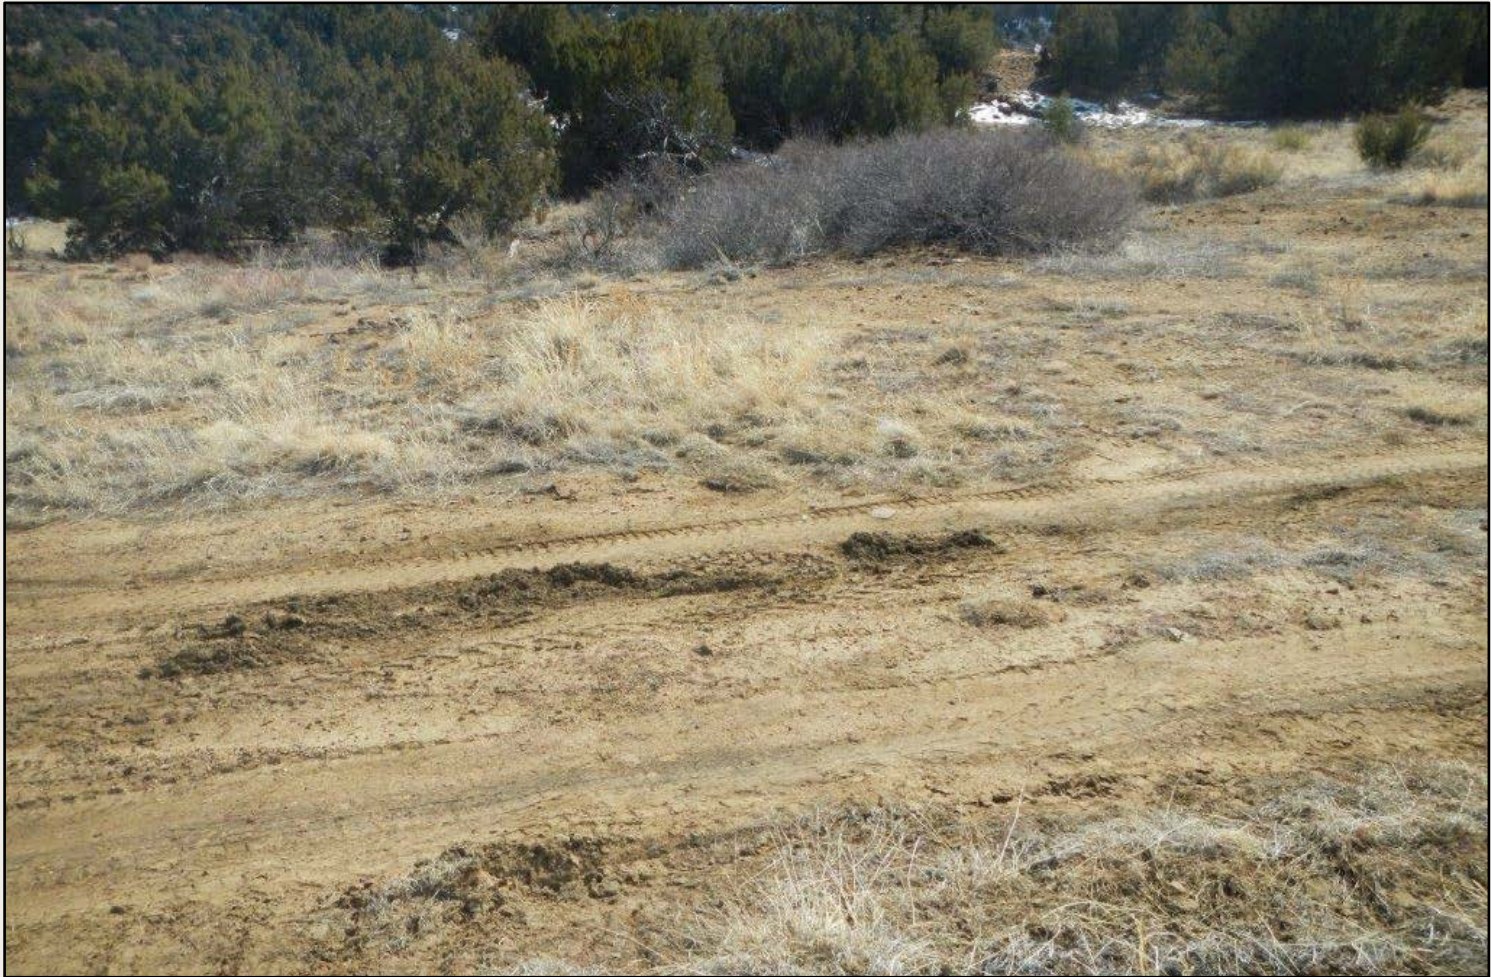
Photo 3. View of the eastern project area from the northern edge facing eastward.

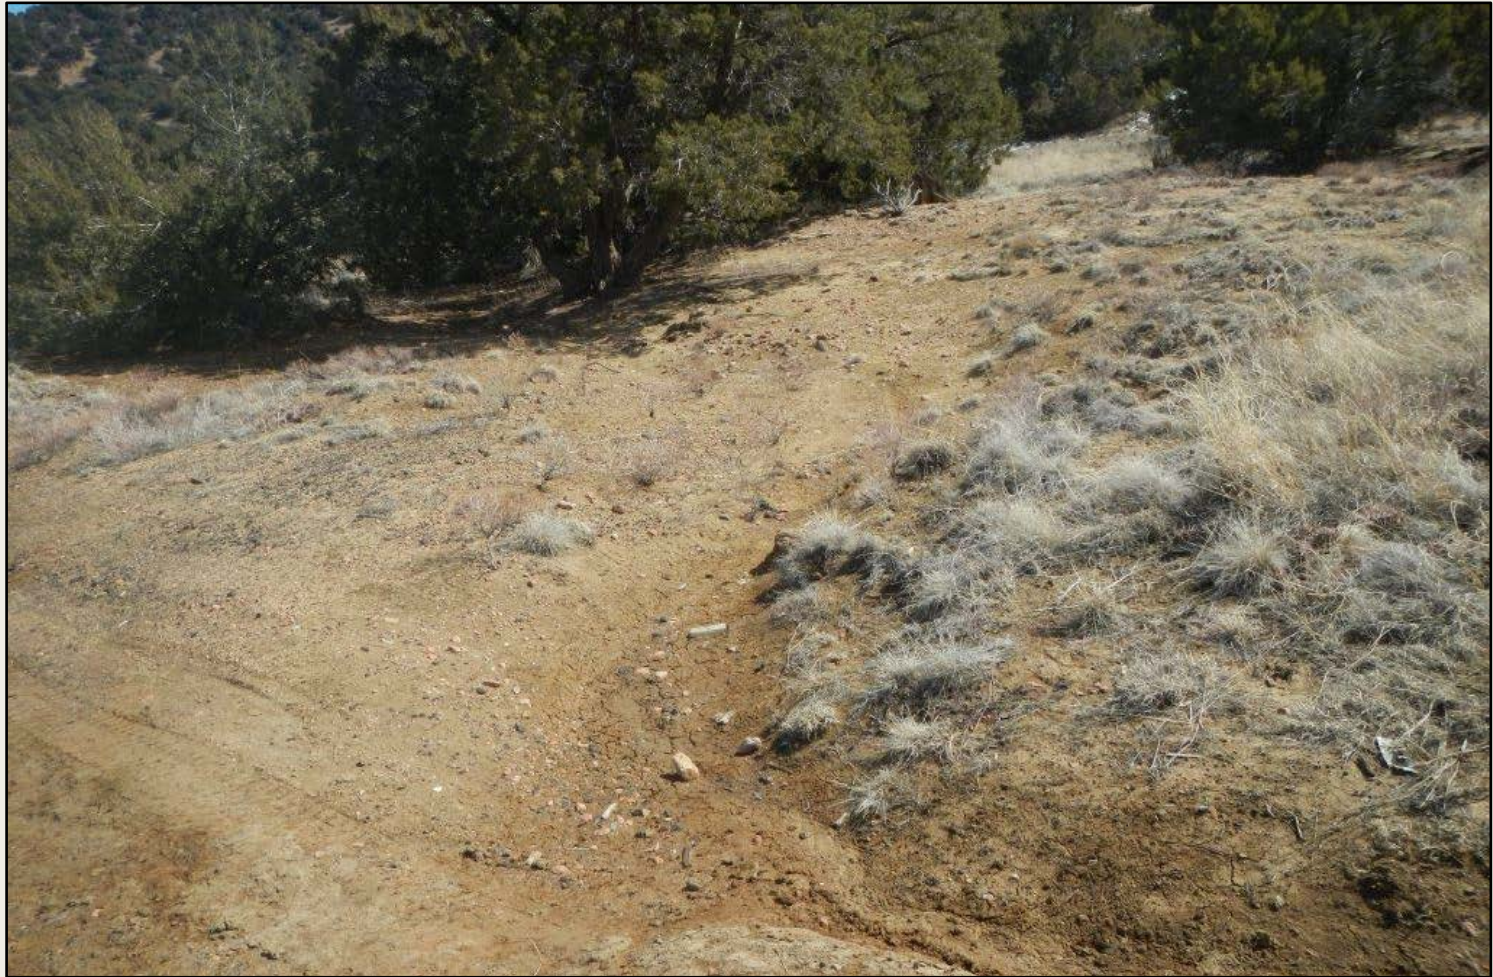
Photo 4. View of area within the northeastern project area where erosional channel is forming due to concentrated stormwater flows.

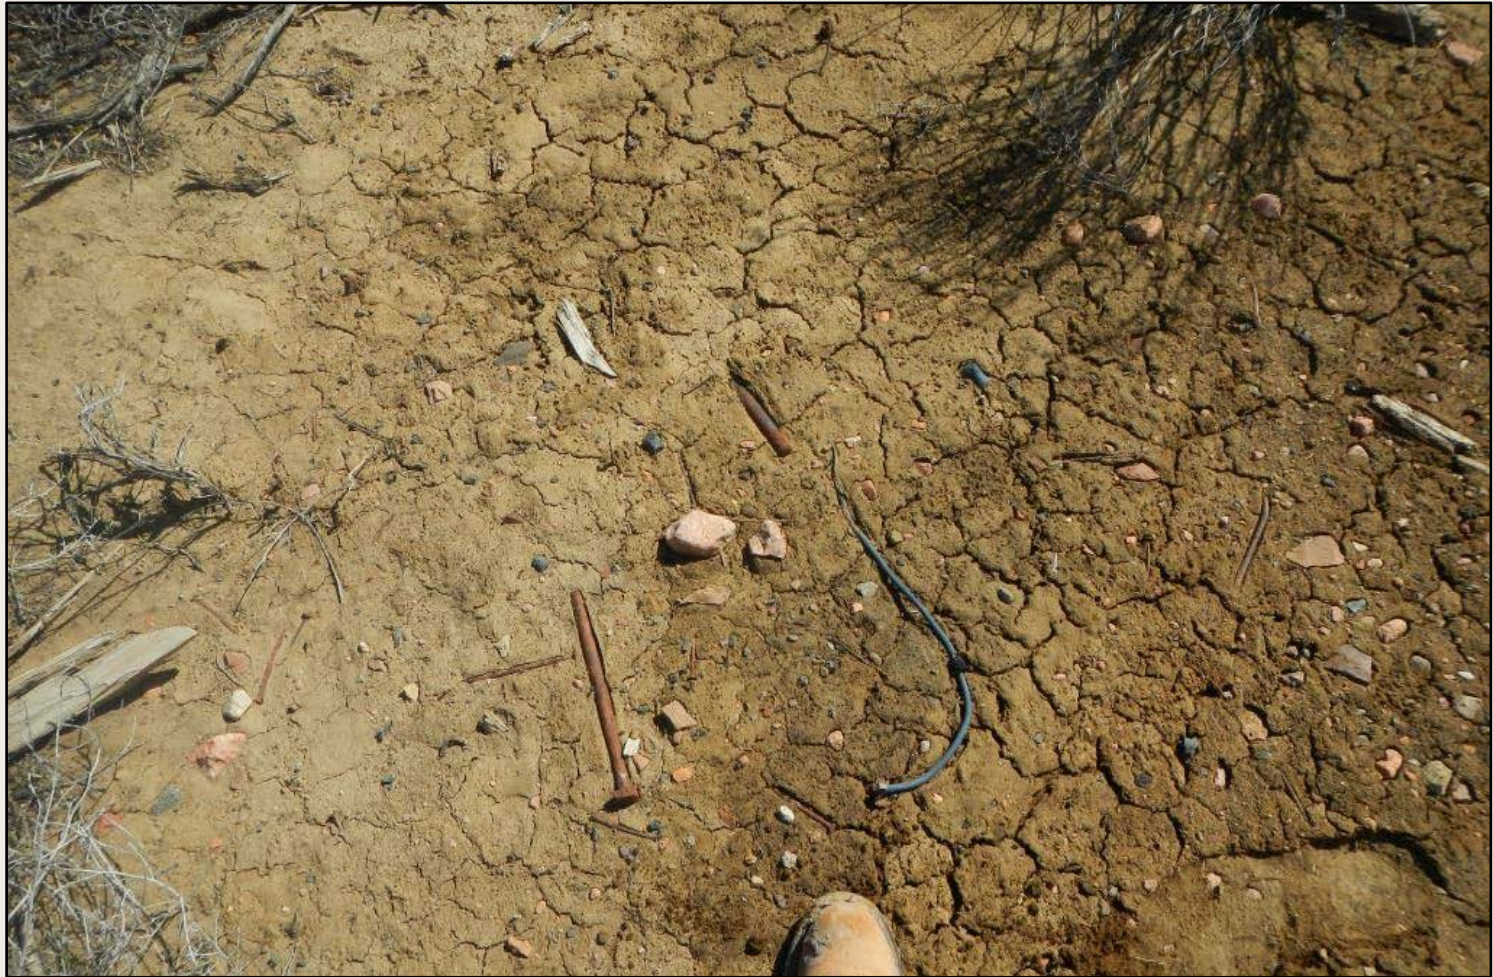
Photo 5. View of metal debris and darkened soils that may indicate stained soils from historic release.

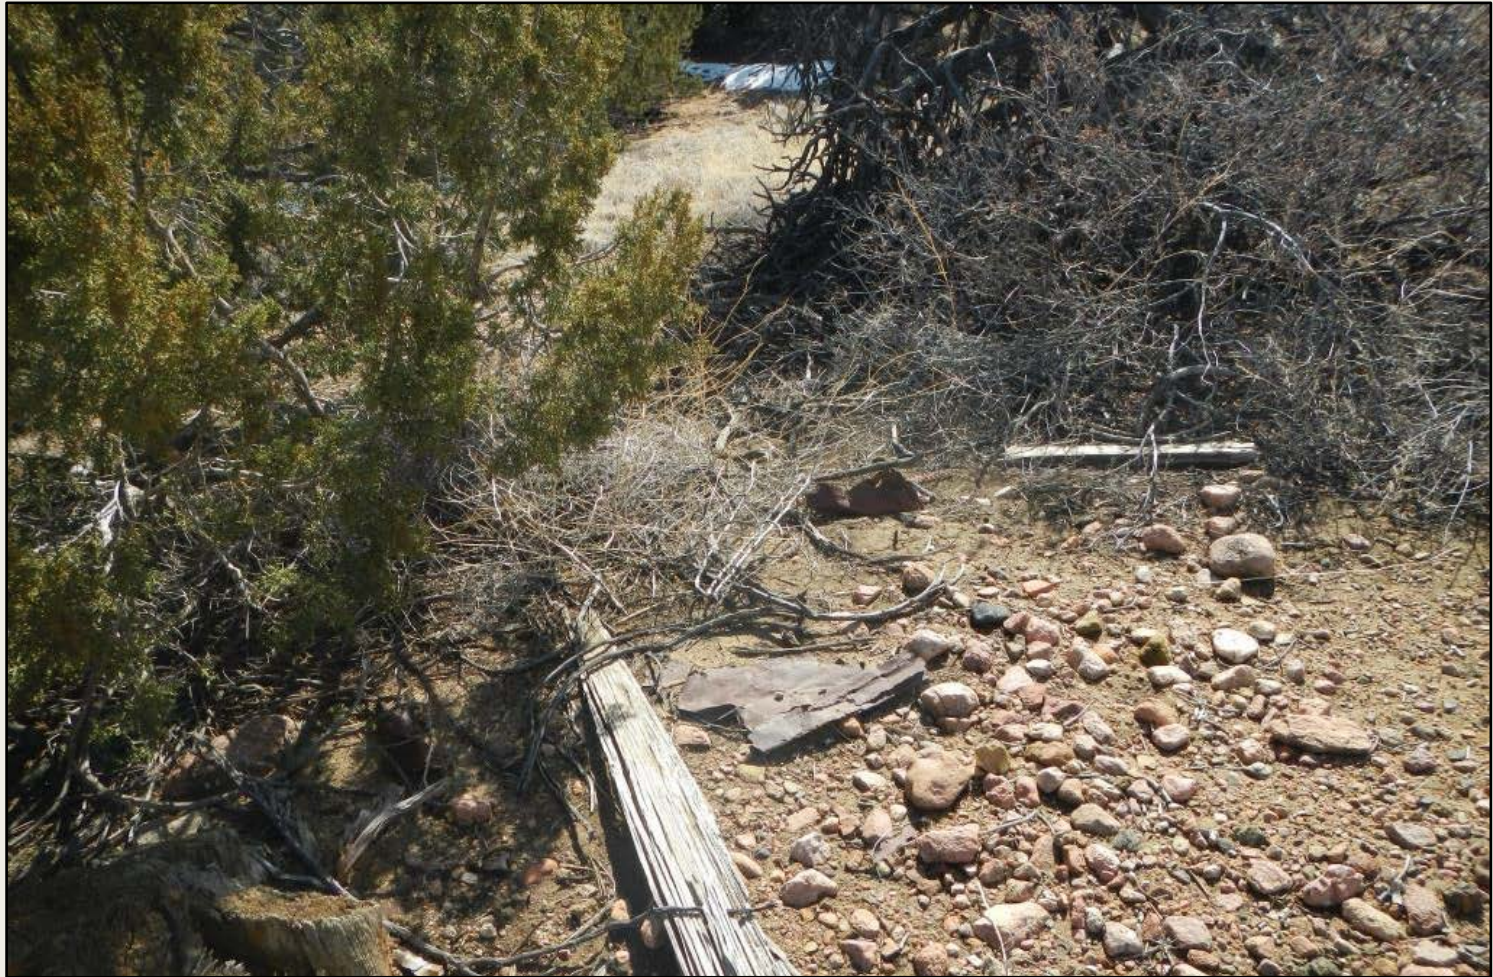
Photo 6. View of more debris within the project area.
