Inspection Photos

Operator: MALLARD EXPLORATION LLC - 10670

Location ID: 447898

Inspection Doc. Number: 682504588

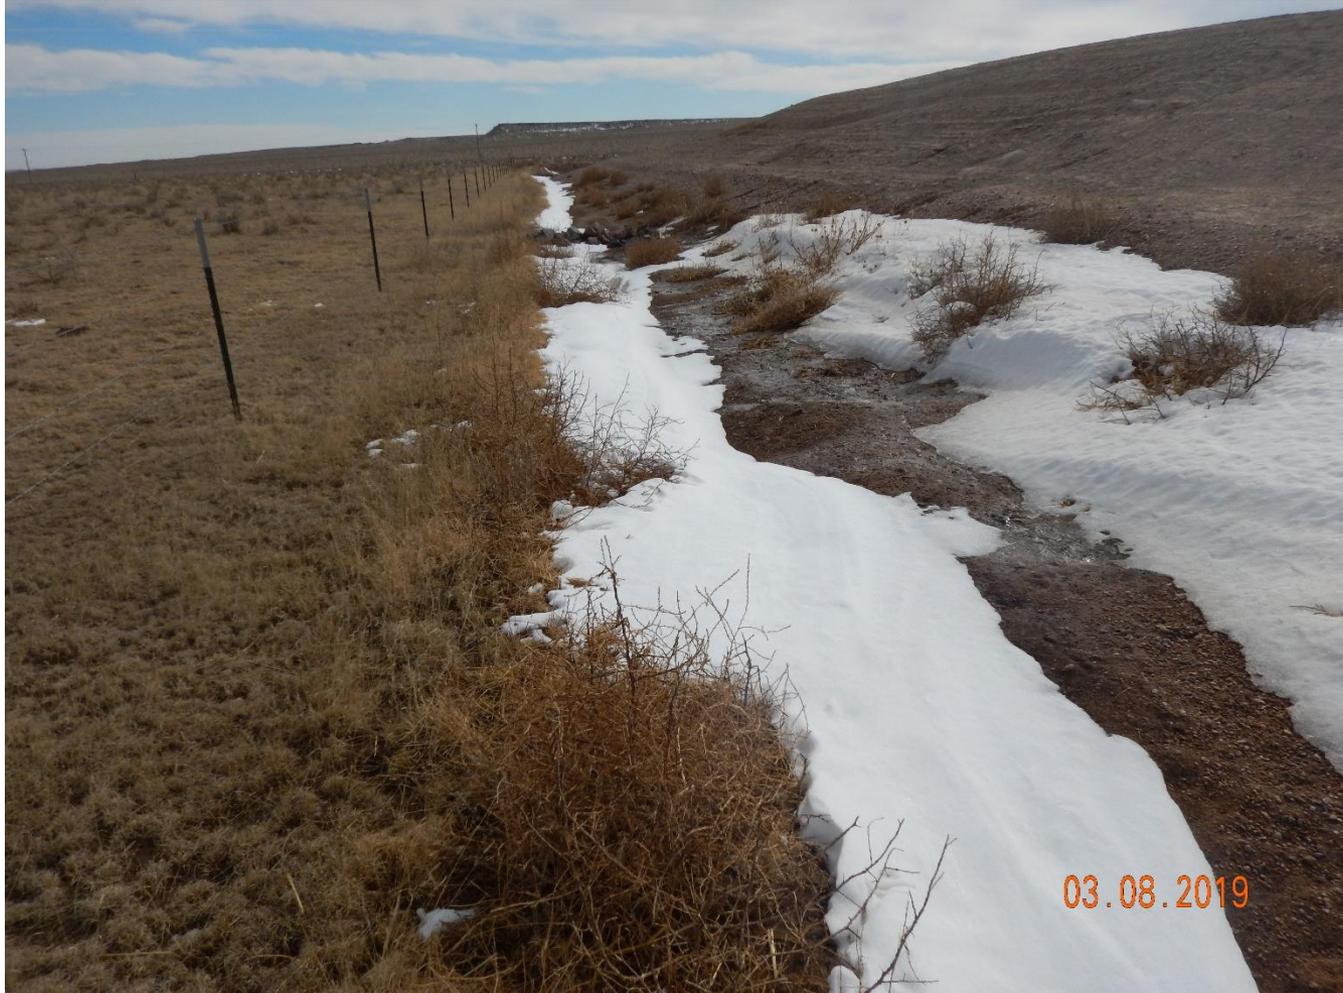
Photo 1: Photo taken from the ditch along the eastern perimeter of the location. Areas of the stormwater ditch appears to have filled with sediment. Advise maintenance.

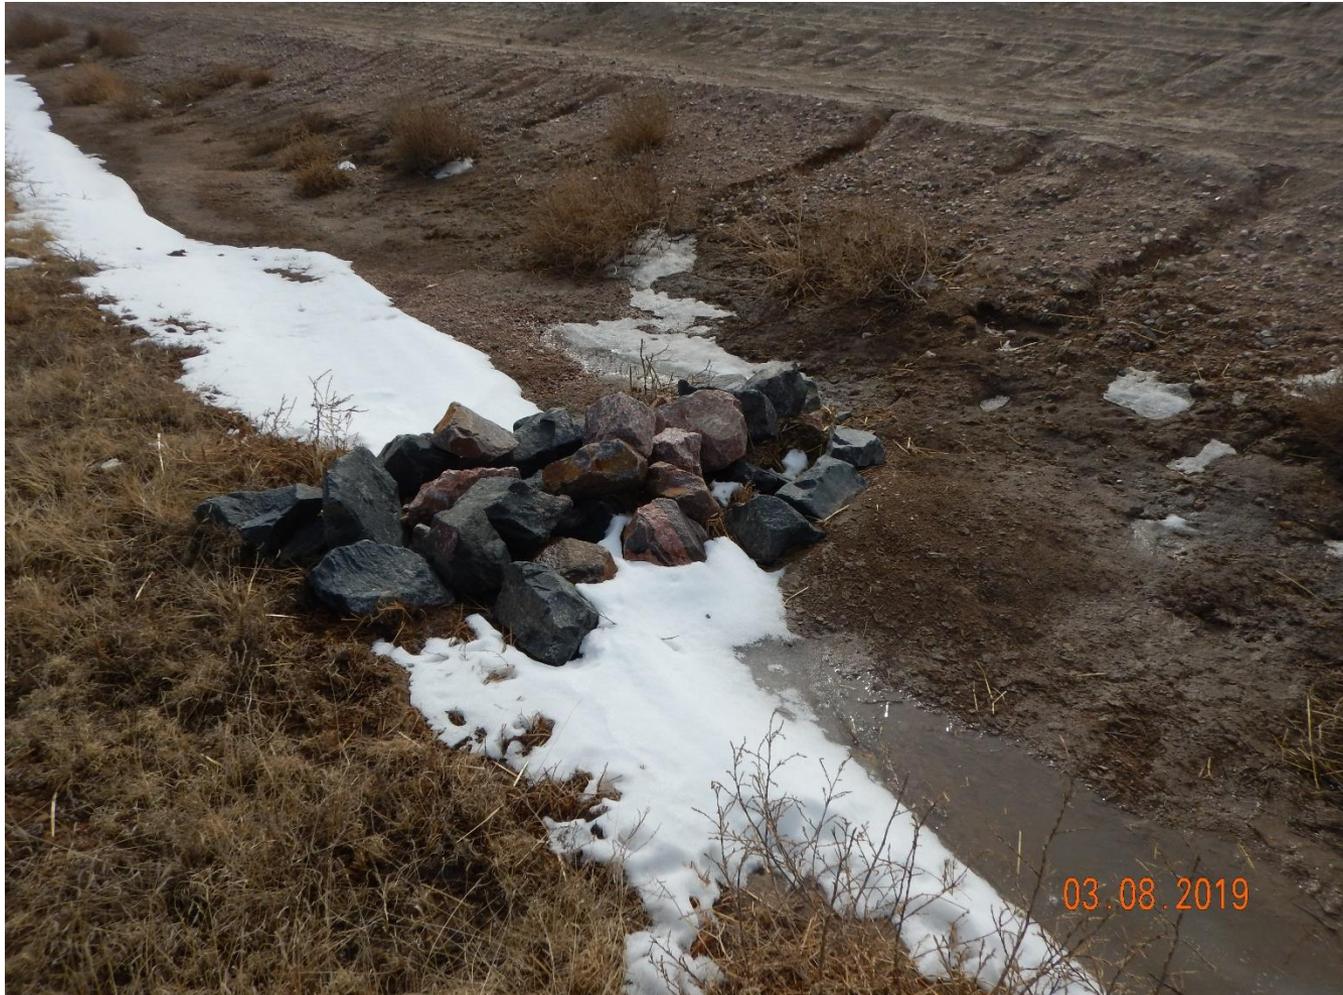
Photo 2: Velocity checks within stormwater ditch. Erosion degradation at soil stockpile.

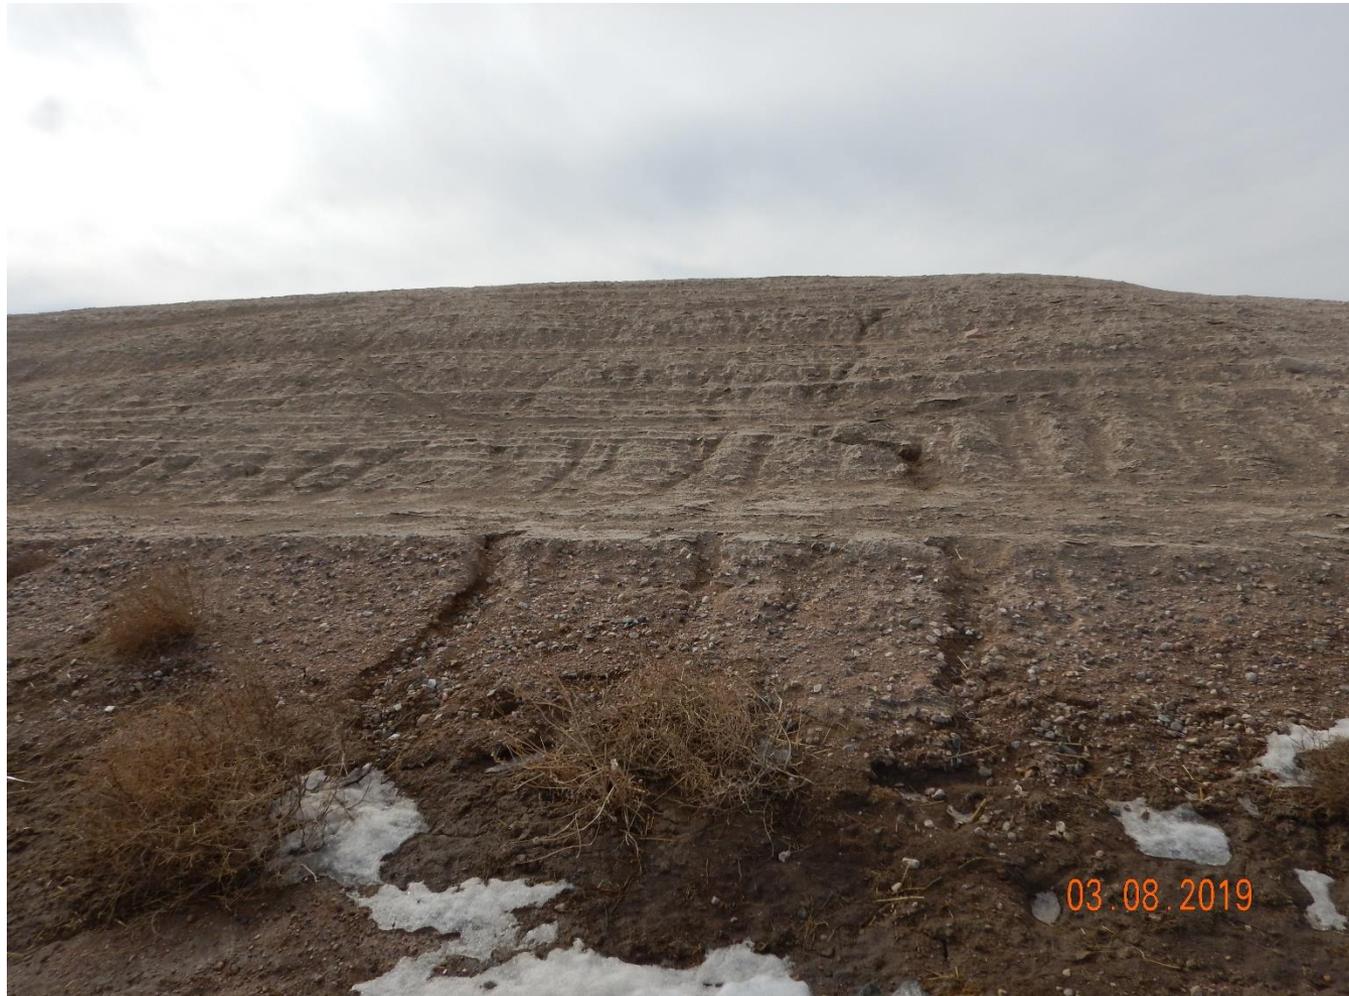
Photo 3: Photo taken from the northeast corner of the location, facing west. Photo shows erosion degradation on the soil stockpile.

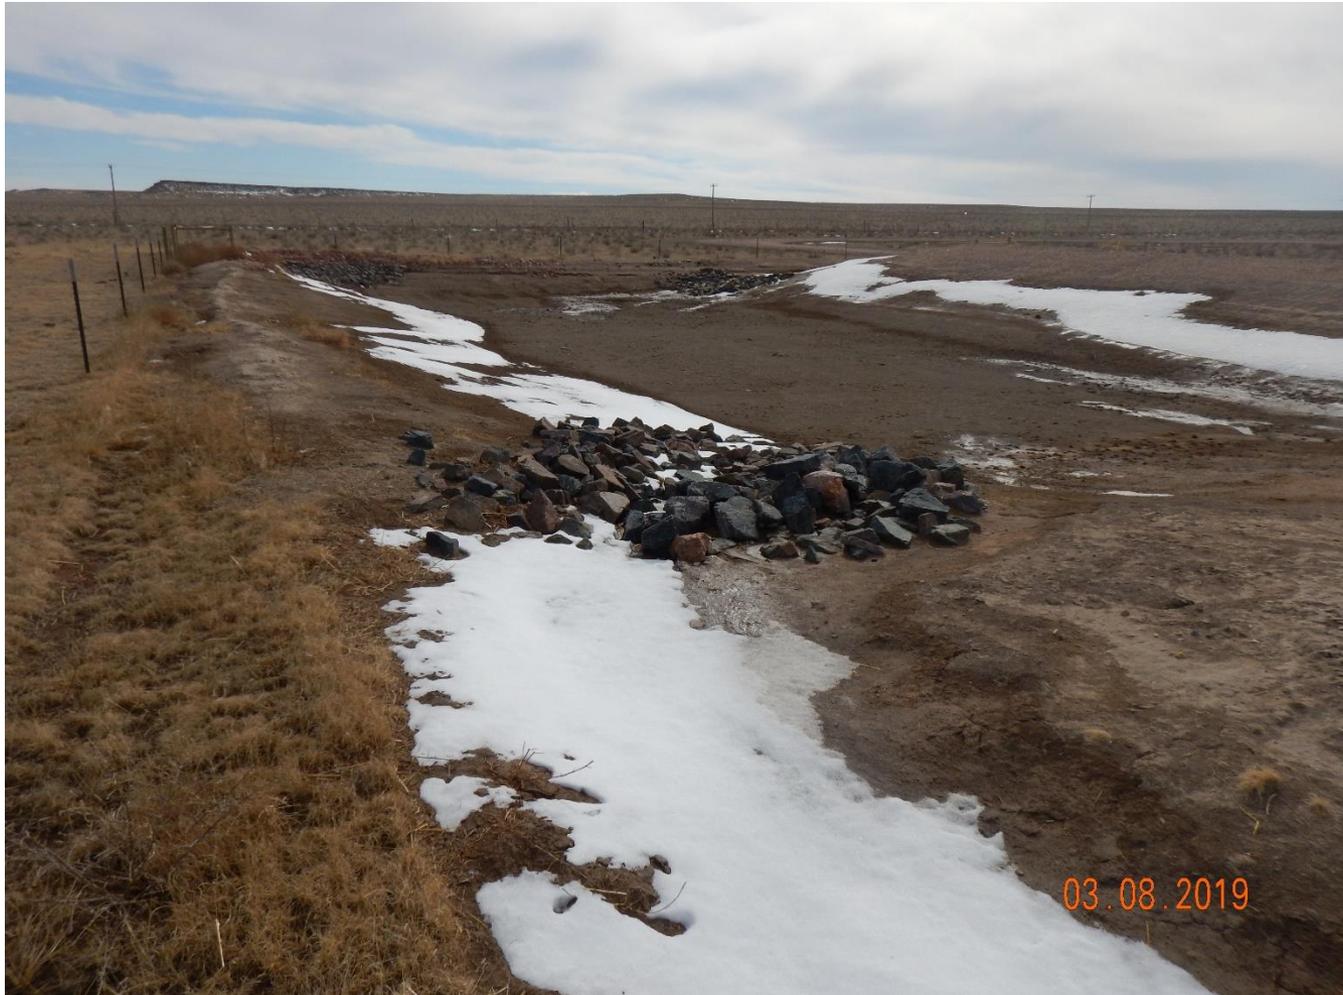
Photo 5: Photo taken from northeast corner of the sediment trap.

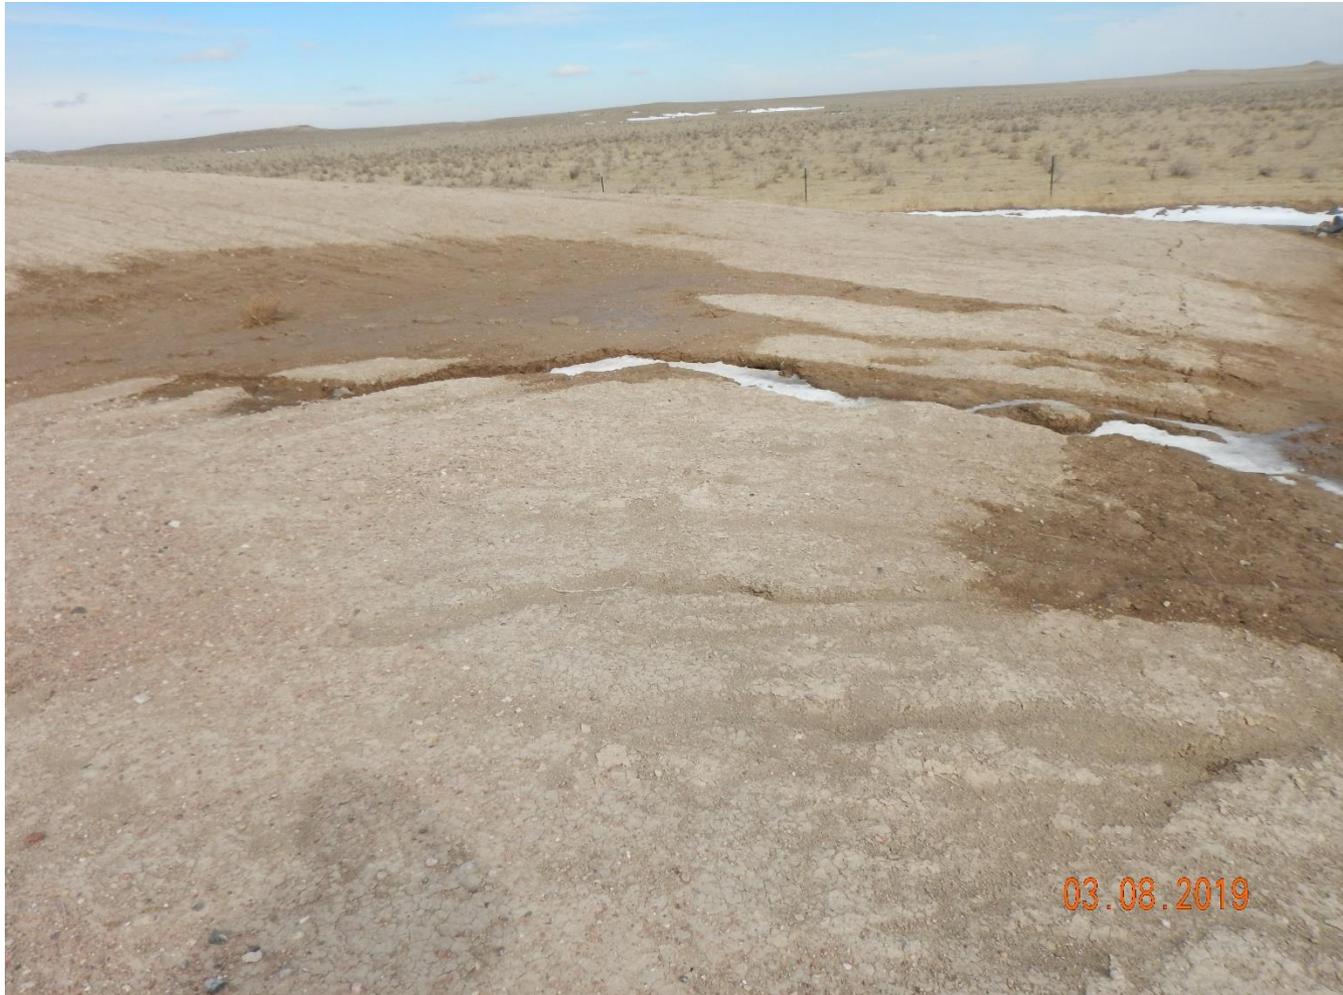
Photo 6: Photo taken from northwest corner of the sediment trap. Photo shows insufficient inlet protection. Gully erosion evident at trap.

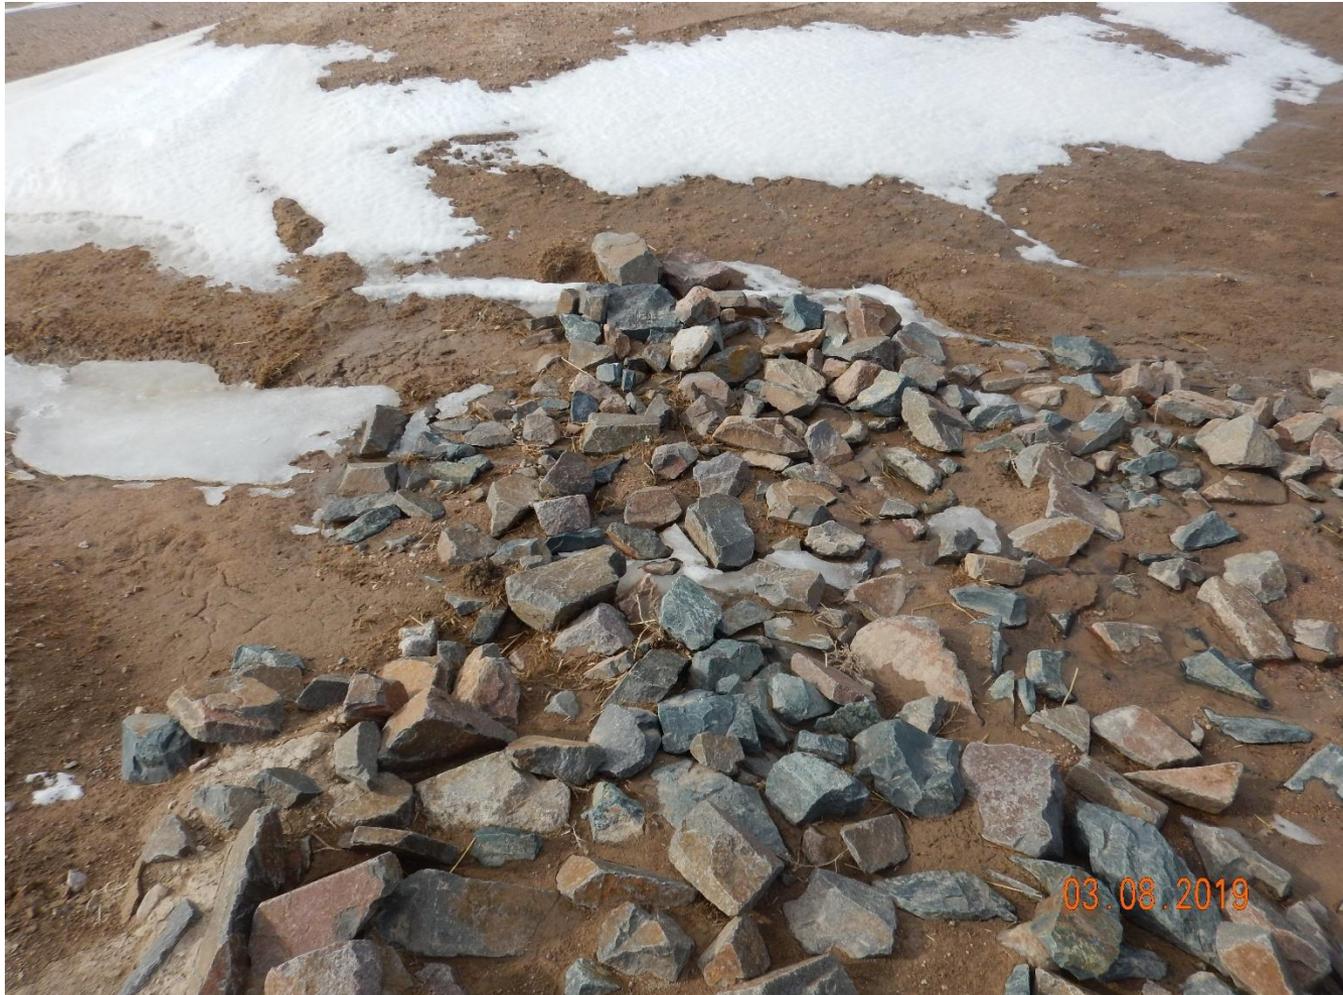
Photo 8: Photo taken from southwest corner of the sediment trap. Photo shows inlet is filling with sediment. Advise maintenance.

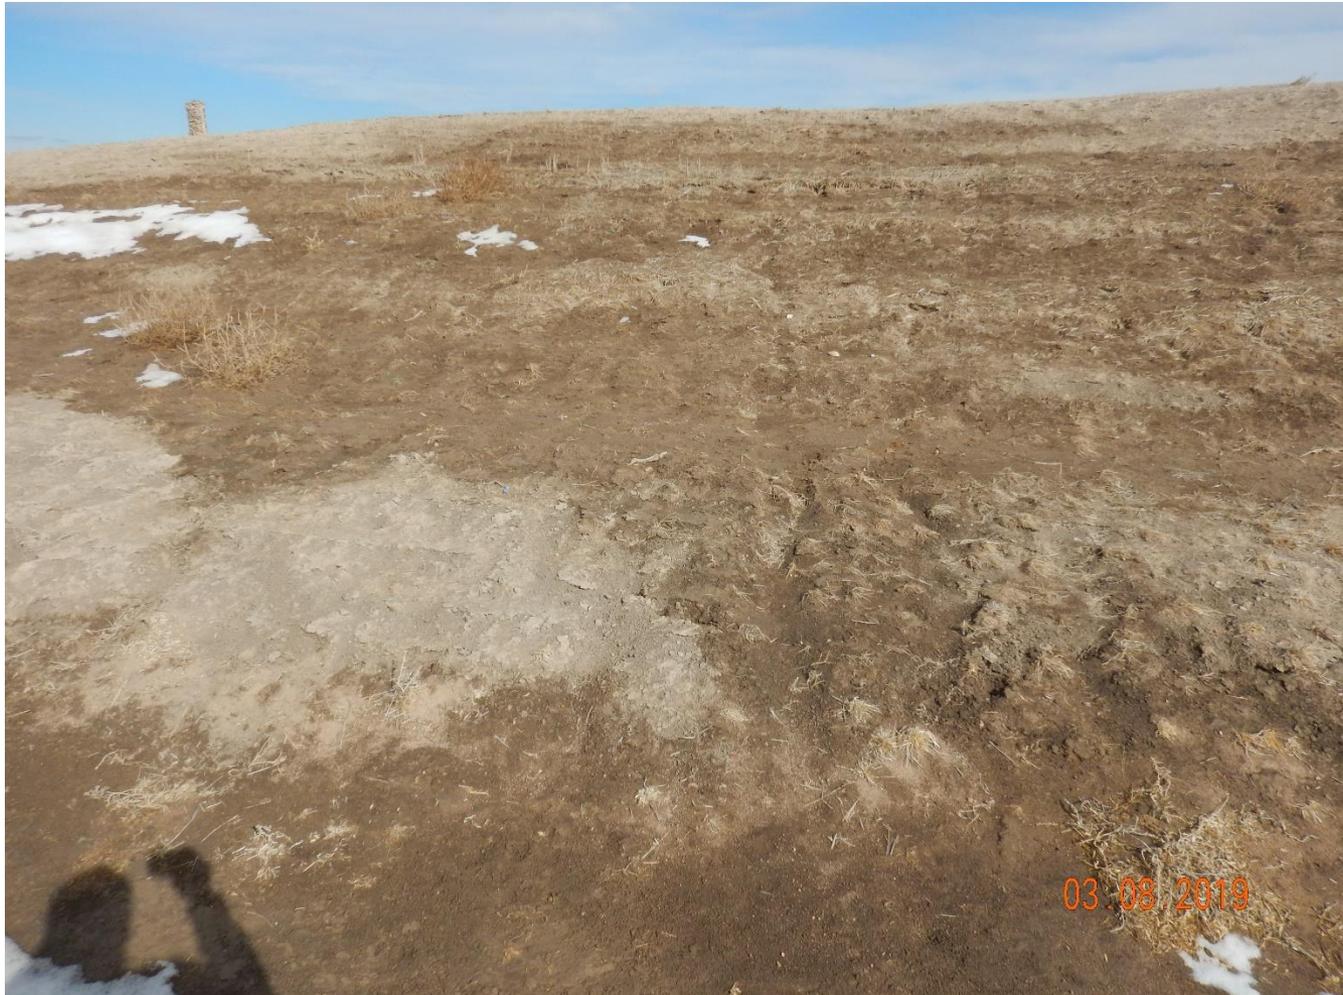
Photo 10: Photo taken from topsoil stockpile on the east end of the location. Photo shows stormwater degradation becoming evident.
