Inspection Photos

API: 05-025-06020

Operator: CRAZY 8 ENERGY LLC

Inspection Date: 3/11/2019

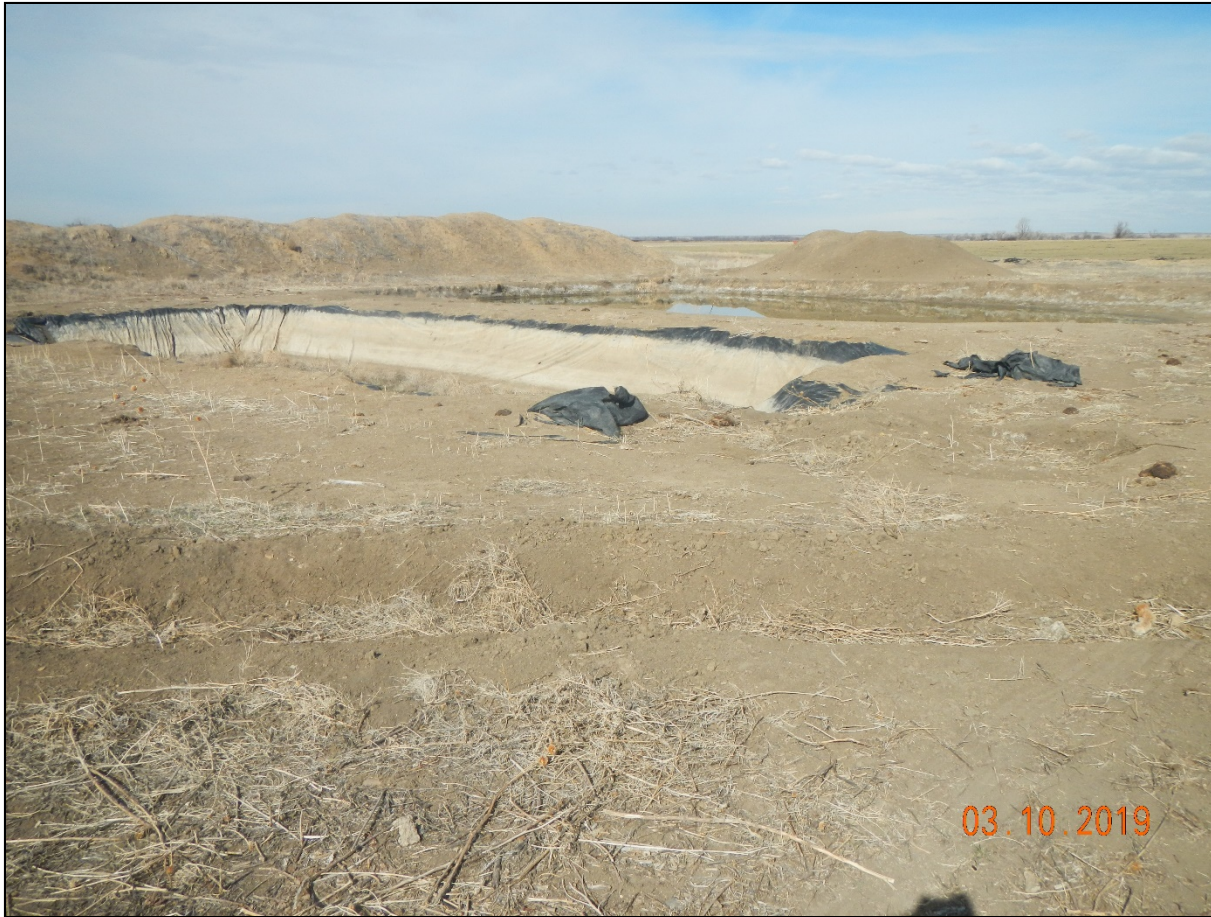
Photo 1. Facing northwest at the location. Two drilling pits remain. The location has not been recontoured and reclaimed.

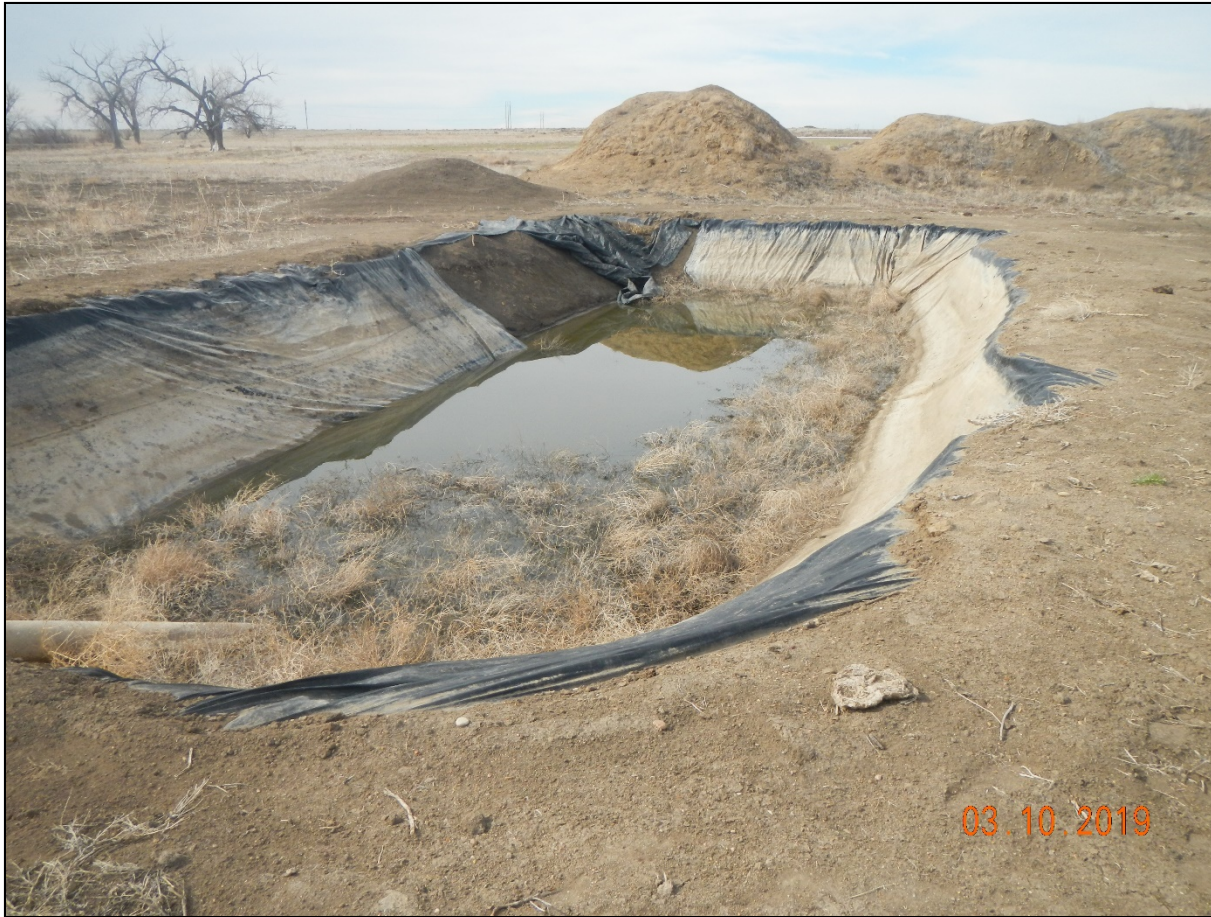
Photo 2. Pit liner remains in the south pit. The liner is torn and not maintained.

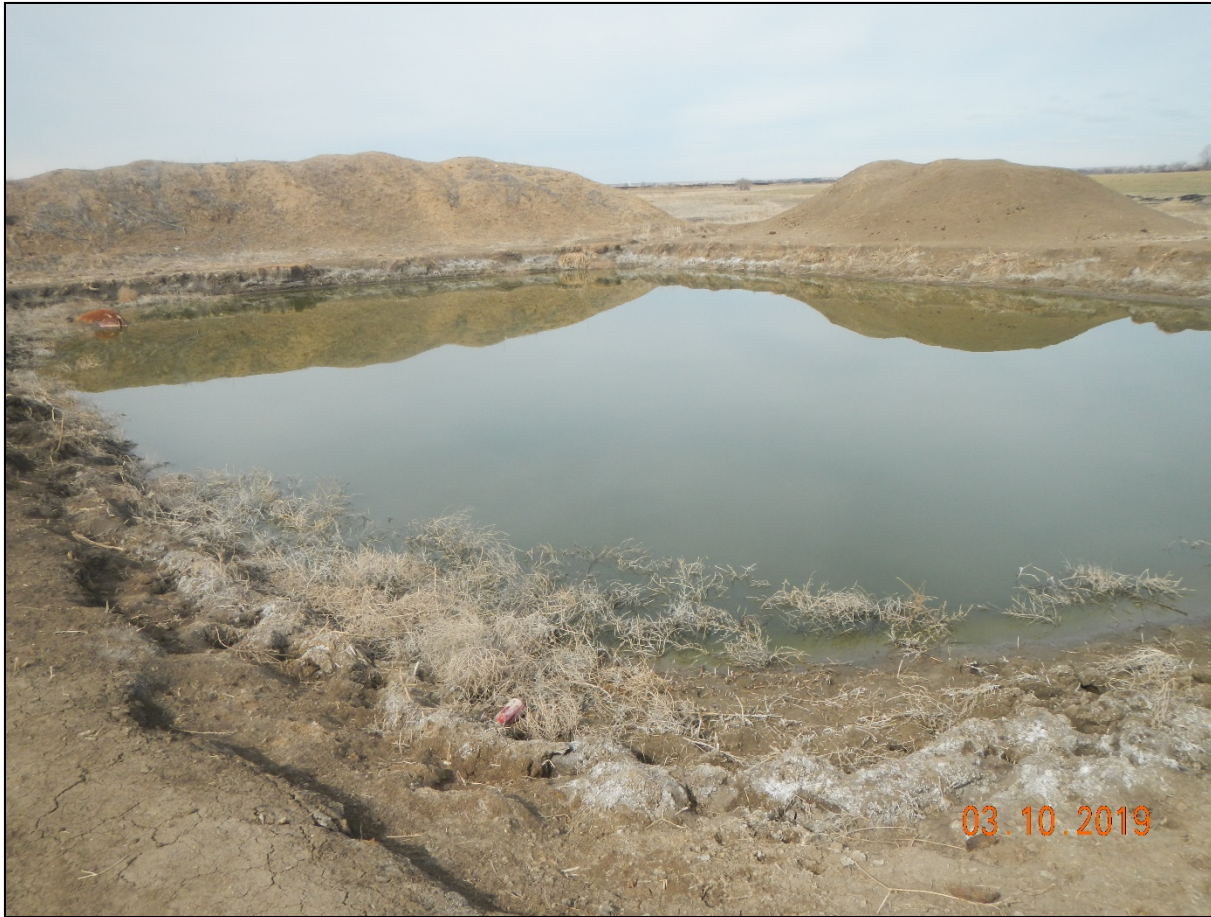
Photo 3. The north pit is full of water. Water will need to be pump out and drained.

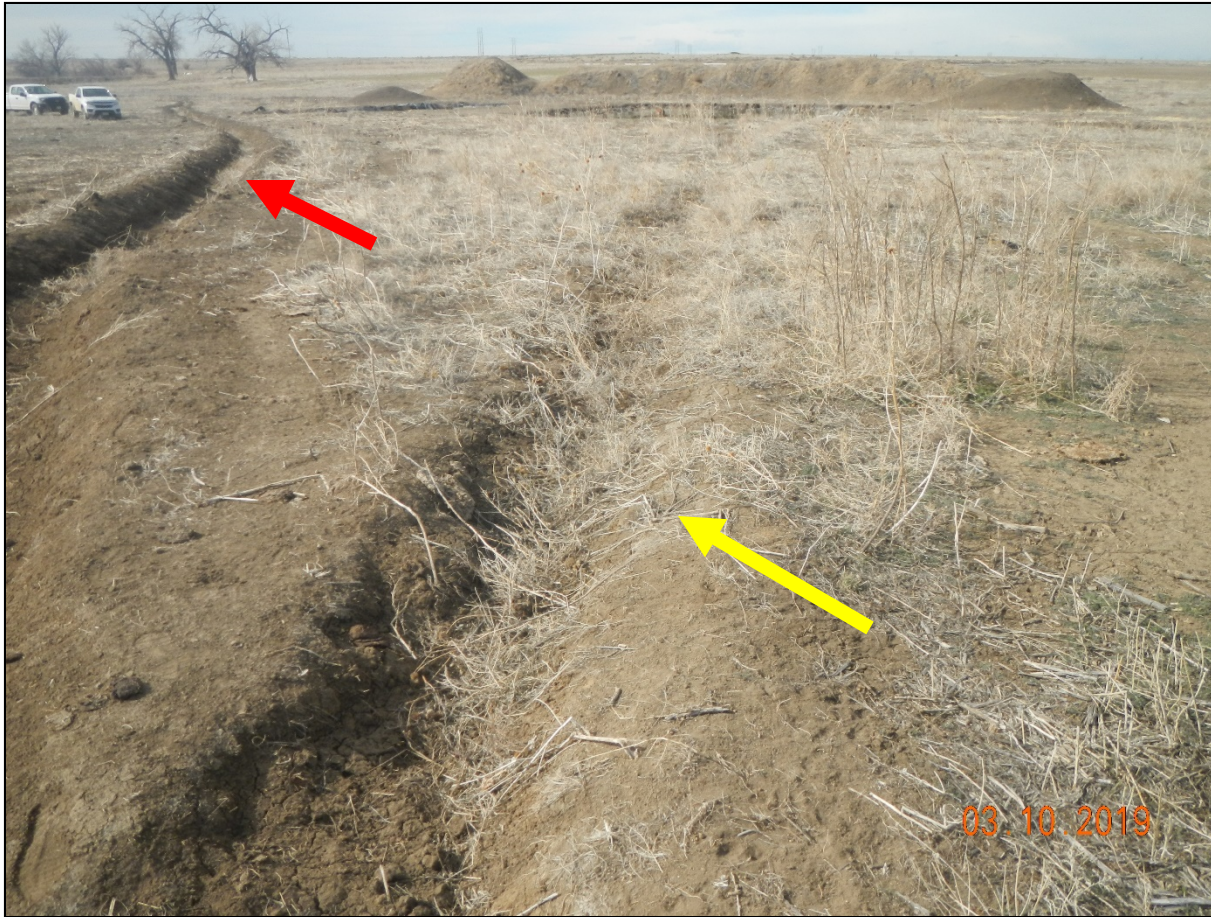
Photo 4. Facing southwest toward the location. The ditches directed toward the pit will need to be filled in and reclaimed (Yellow arrow). The ditch at the eastern perimeter (red arrow) can remain.

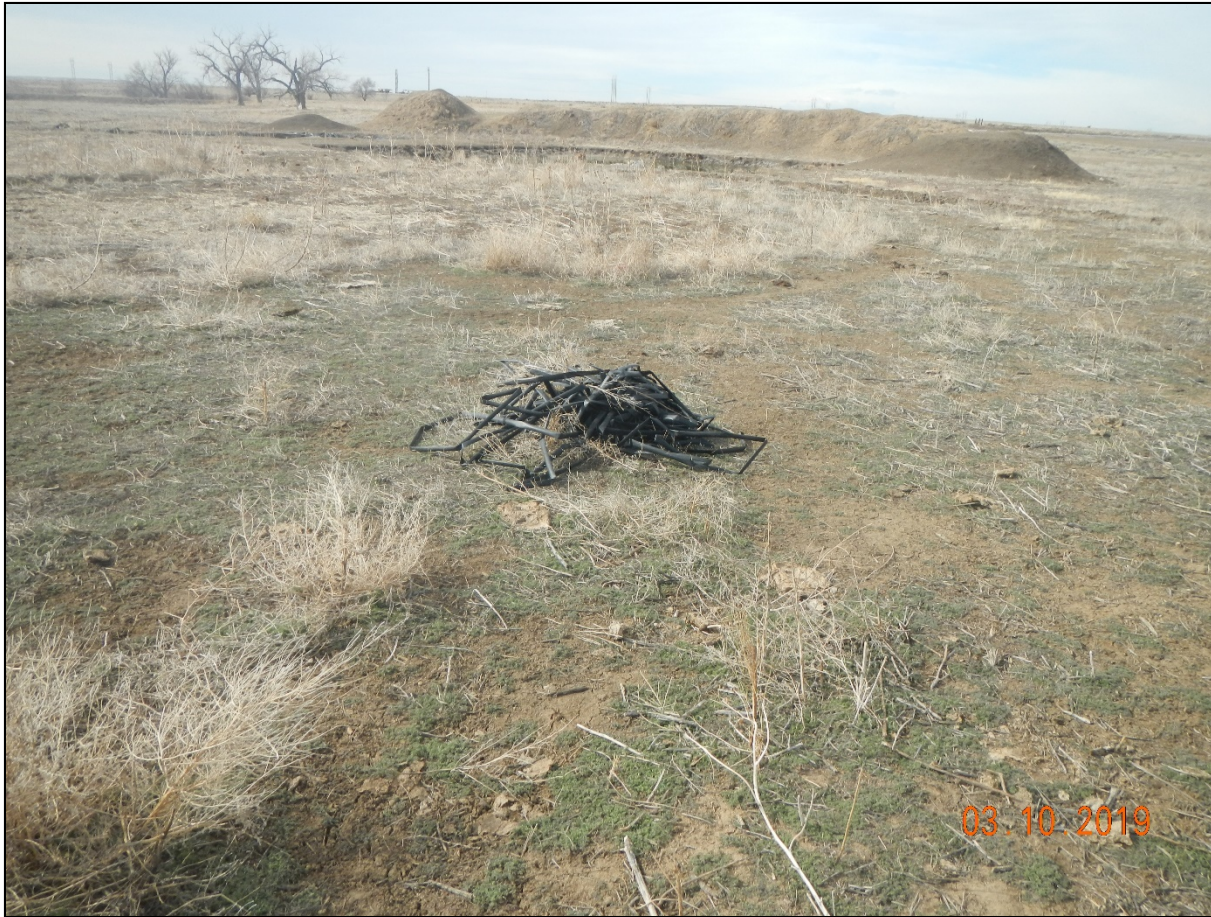
Photo 5. Plastic trash debris needs to be removed.

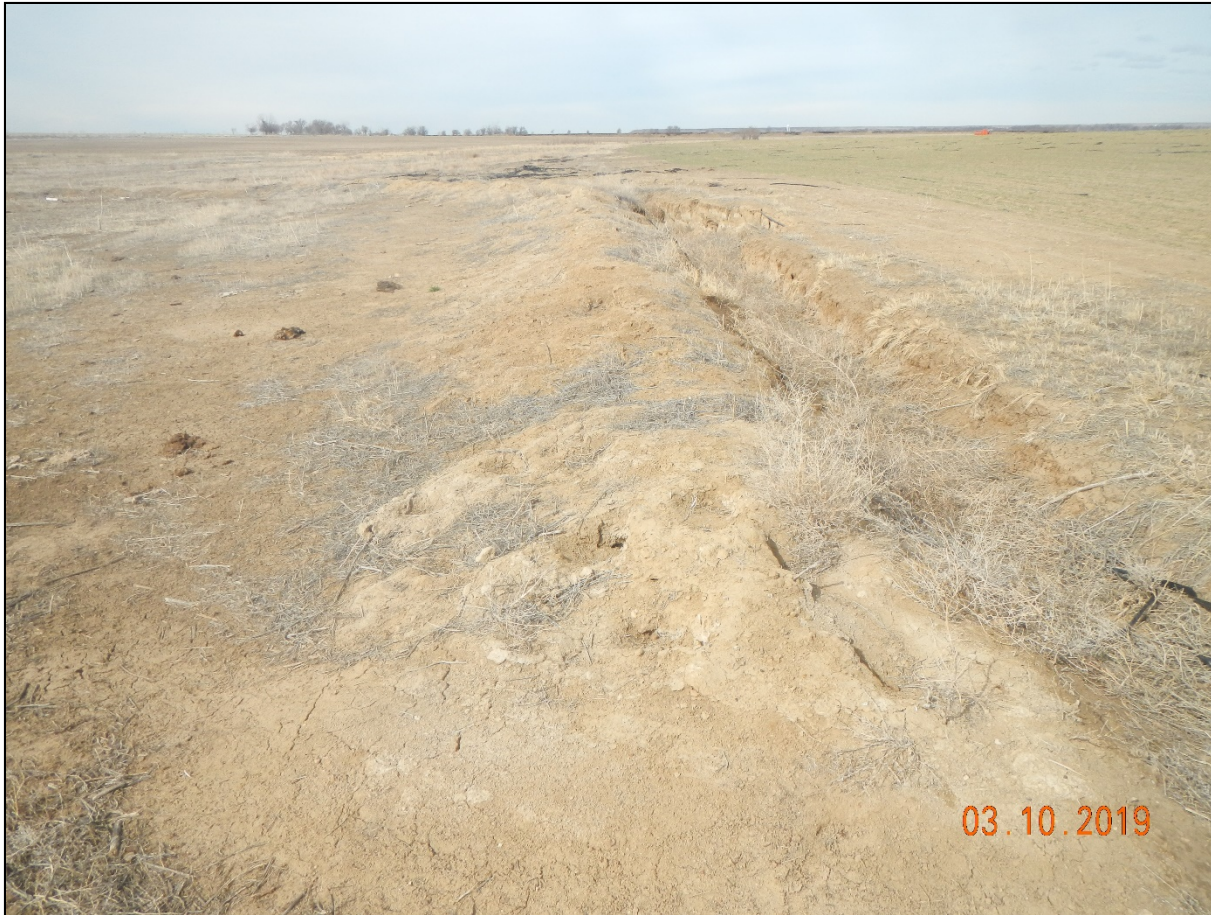
Photo 6. The northern ditch needs to be filled in and reclaimed.

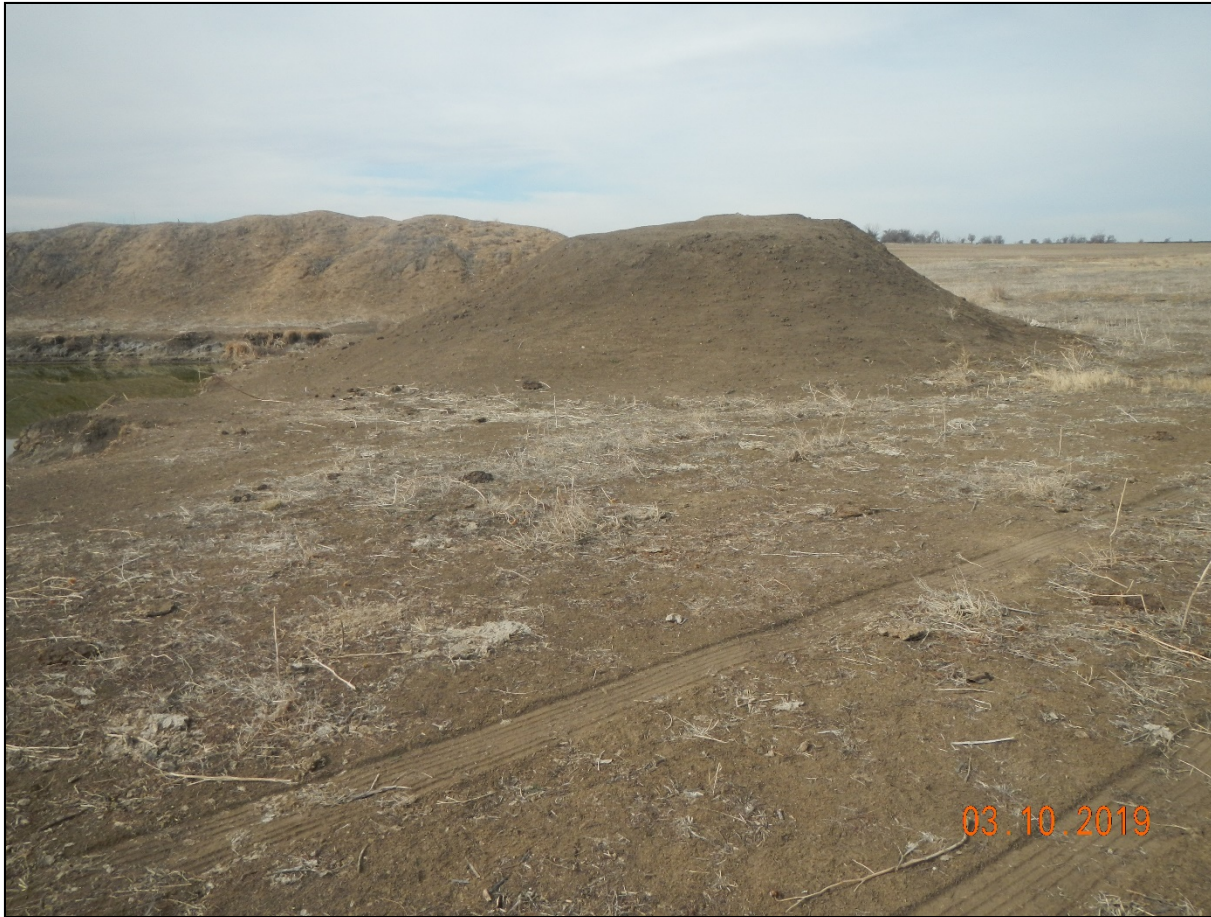
Photo 7. There very little vegetation establishment at the location. Soil is susceptible to erosion.

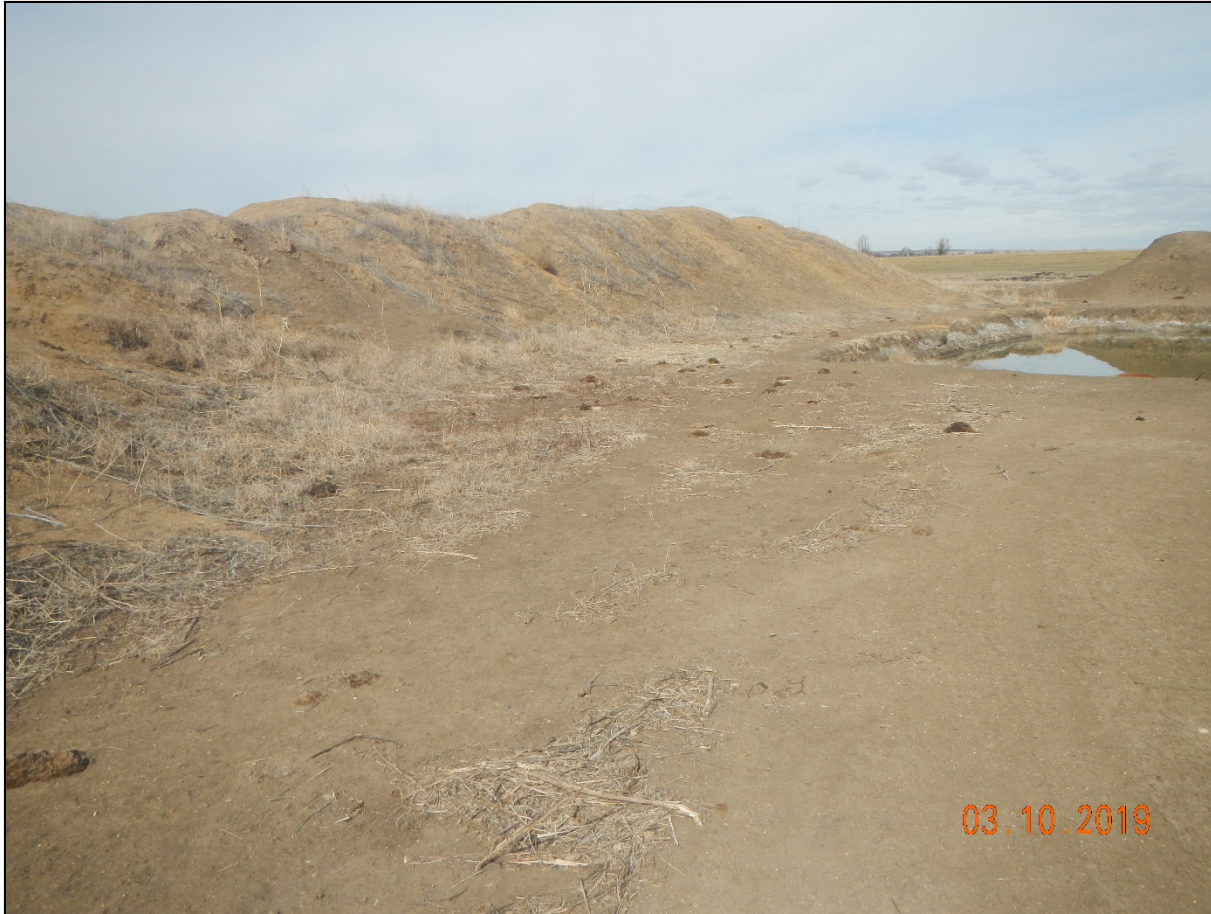
Photo 8. There very little vegetation establishment at the location. Soil is susceptible to erosion. There are weeds throughout the location.
