Inspection Photos
Operator: Javernick Oil
Location/API #: 043-06059
Date: 2/28/2019

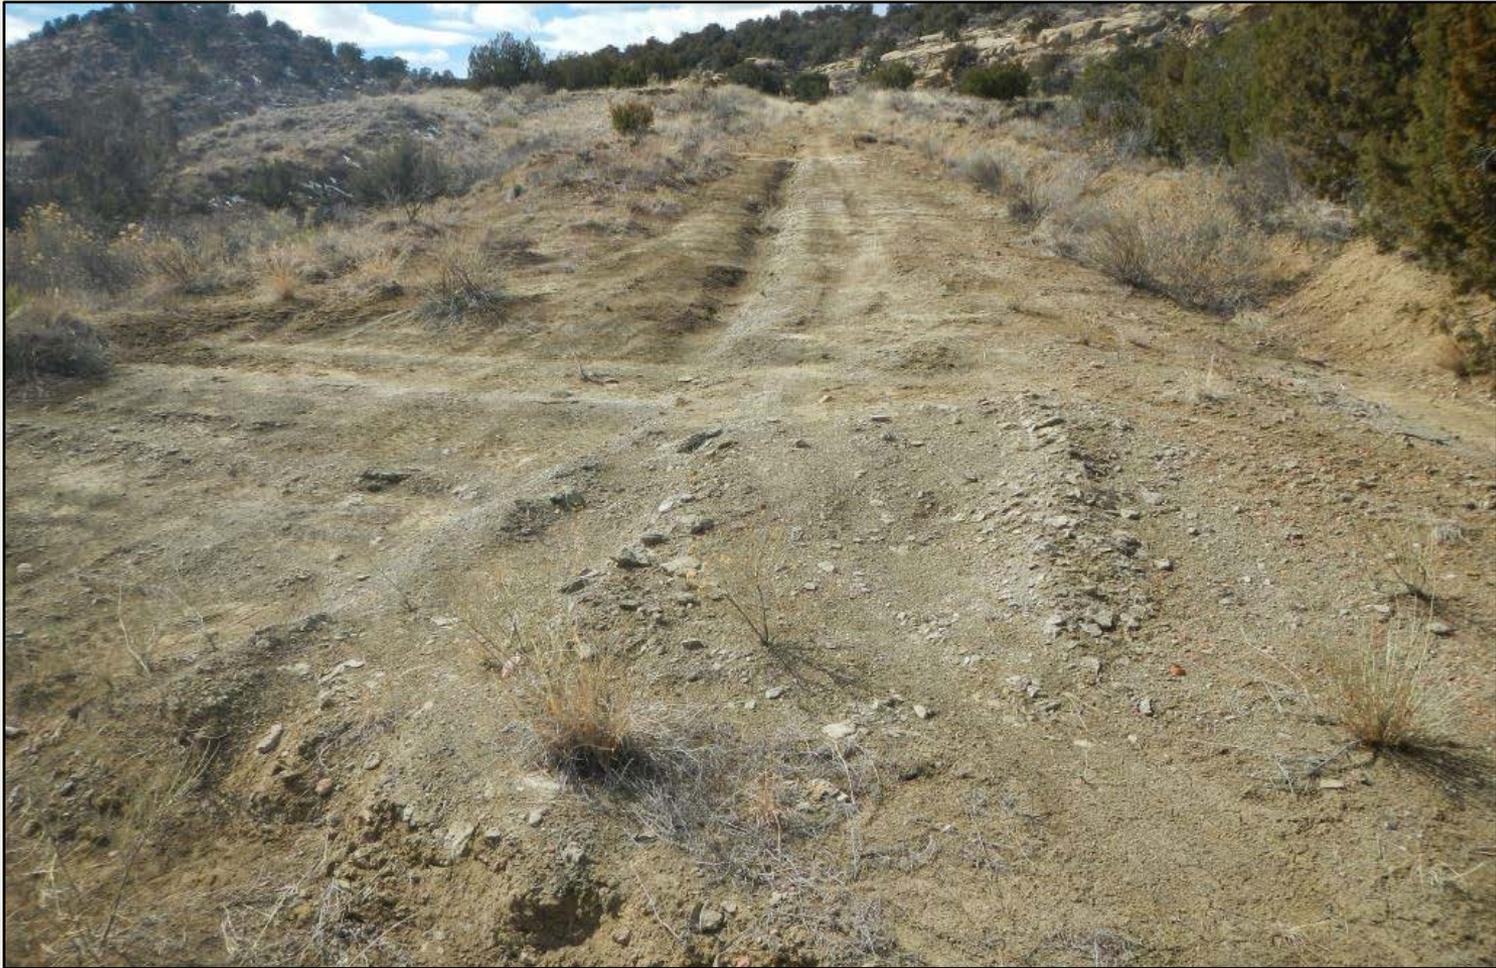
Photo 1. View of the access road from the beginning of the road facing upslope toward the well pad. Access road is not reclaimed.

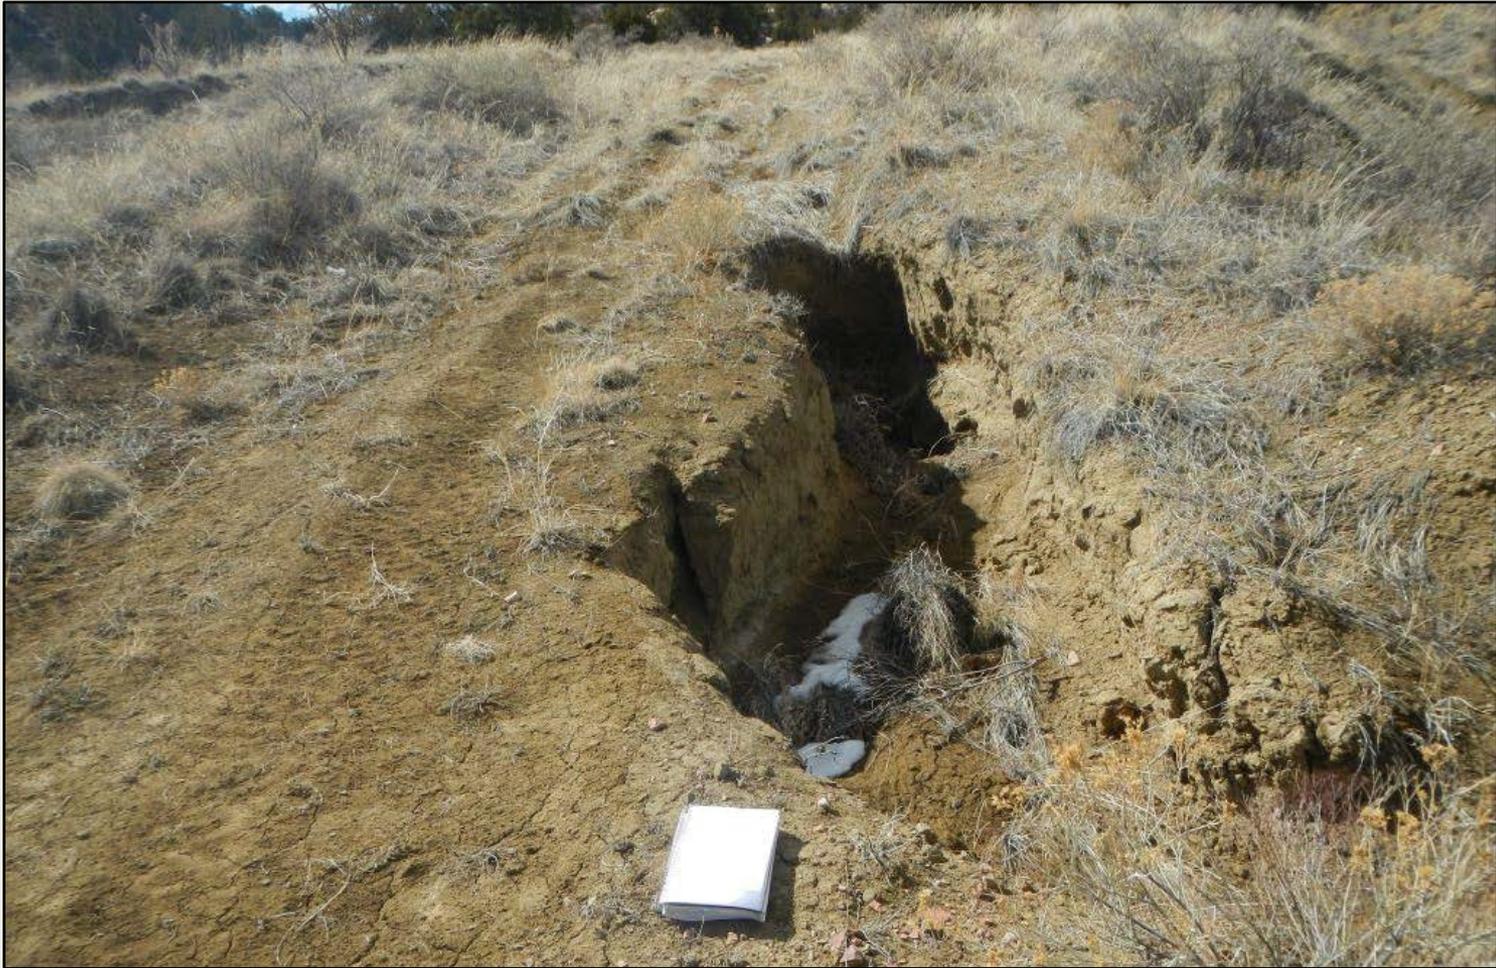
Photo 2. View of erosional headcut approximately 3-4 feet wide and deep along the access road that needs to be reclaimed.

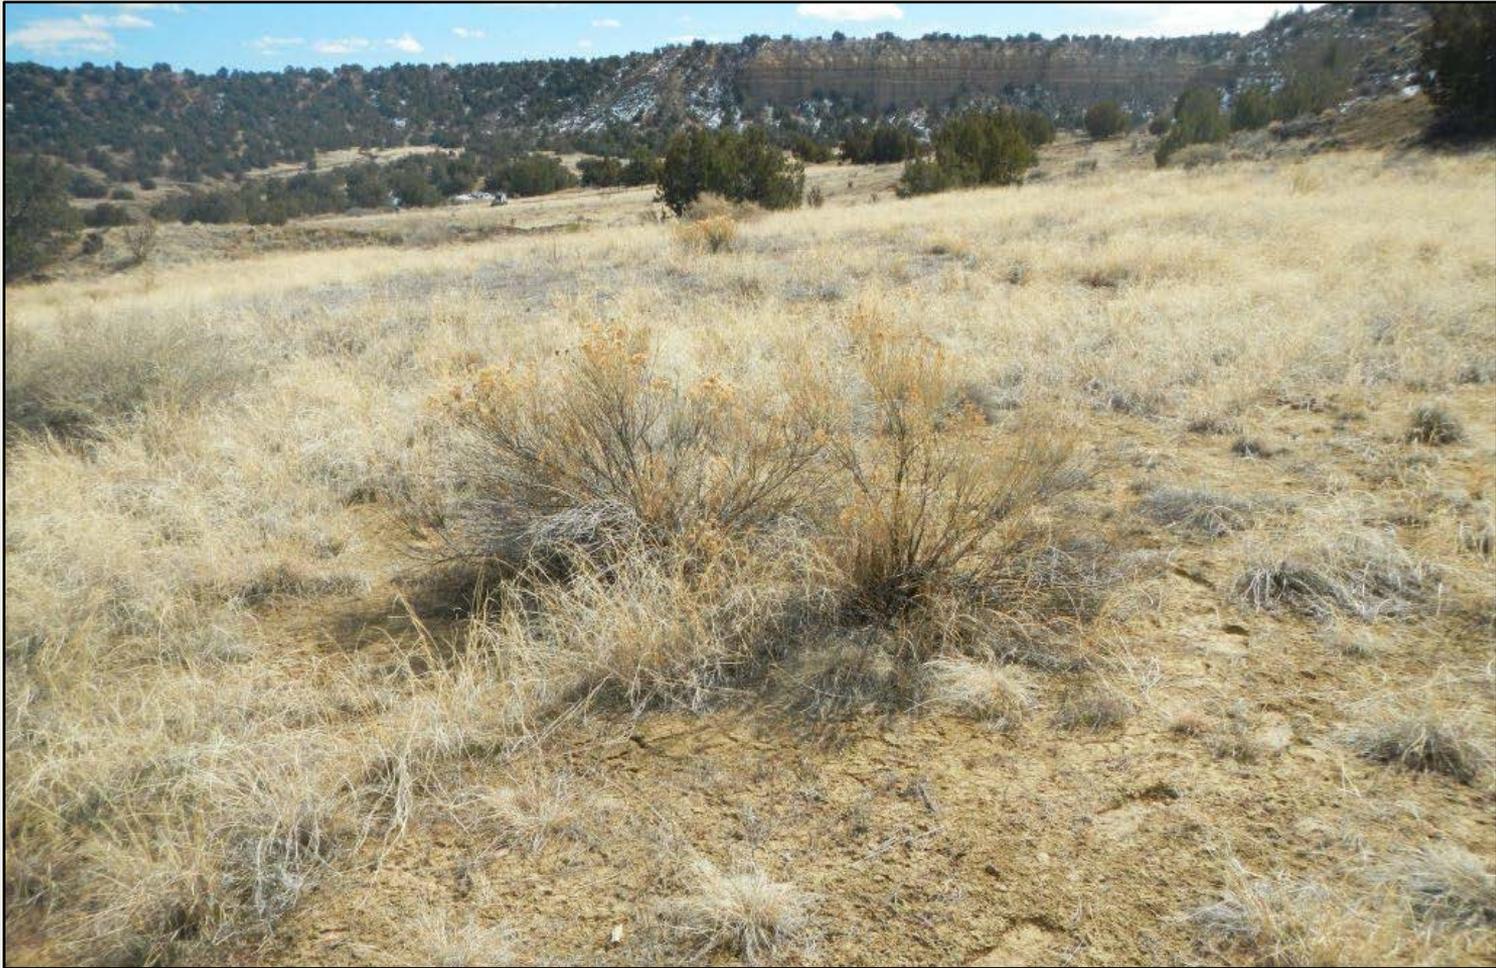
Photo 3. View of the project area from the northern corner facing center. Revegetation with desirable species is present within portions of the former well pad area.

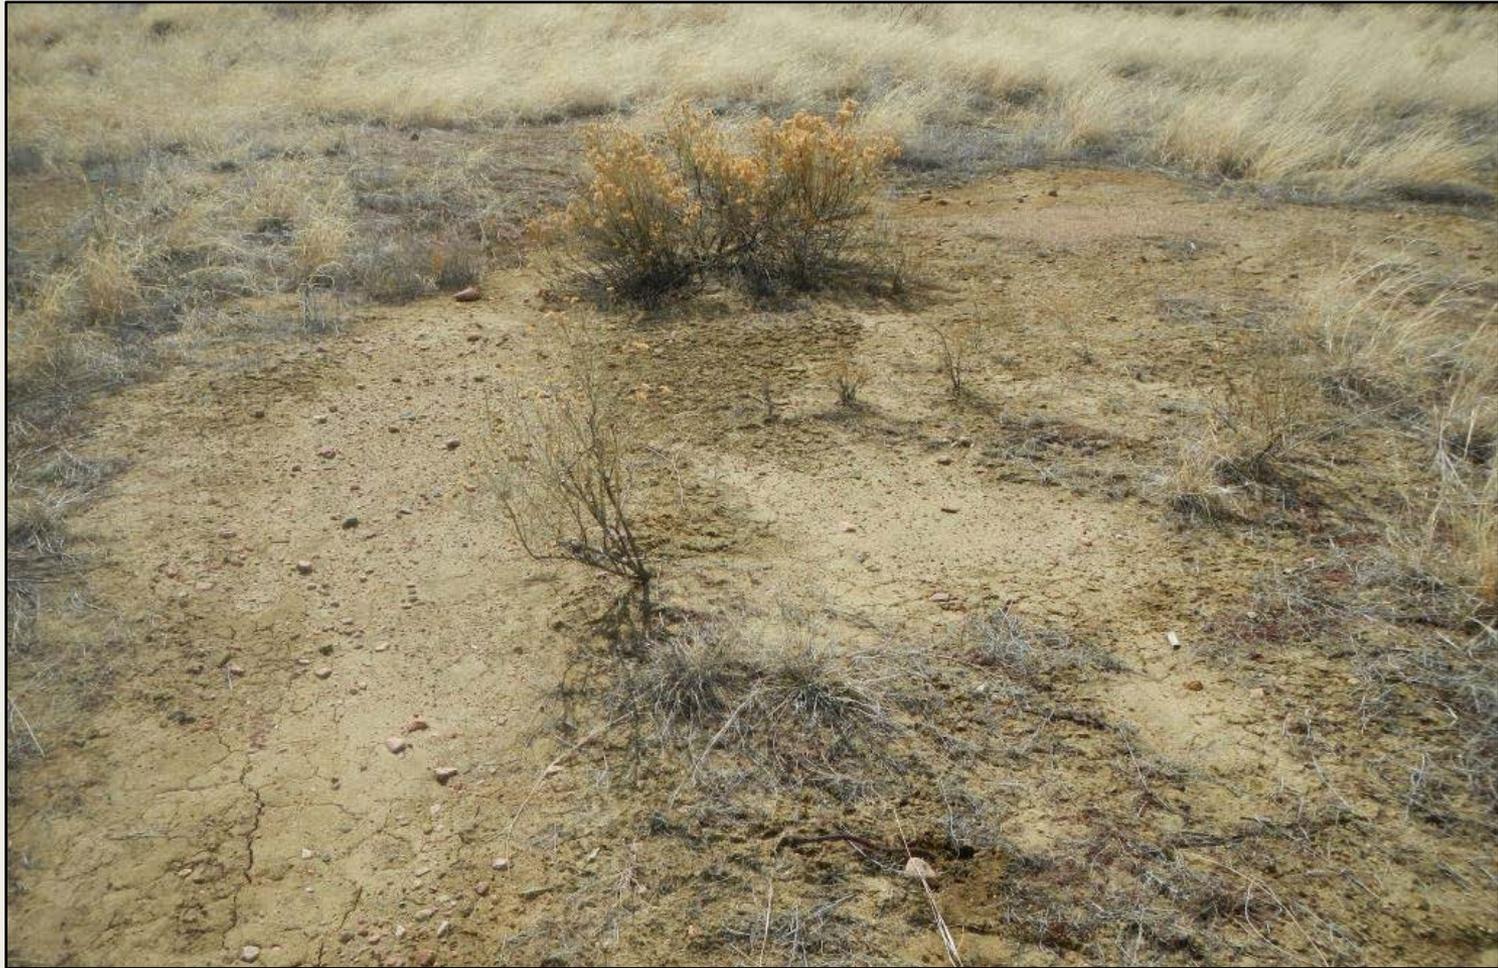
Photo 4. View of area approximately 10 feet wide and 20 feet long on the former well pad area, where vegetation is not becoming established. This area likely needs additional decompaction, soil testing, and amendments (as determined during soil testing) for successful revegetation.
