**Inspection Photos**  
**Location Name: Chaplin Danford #44-32**  
**Location ID:320609**

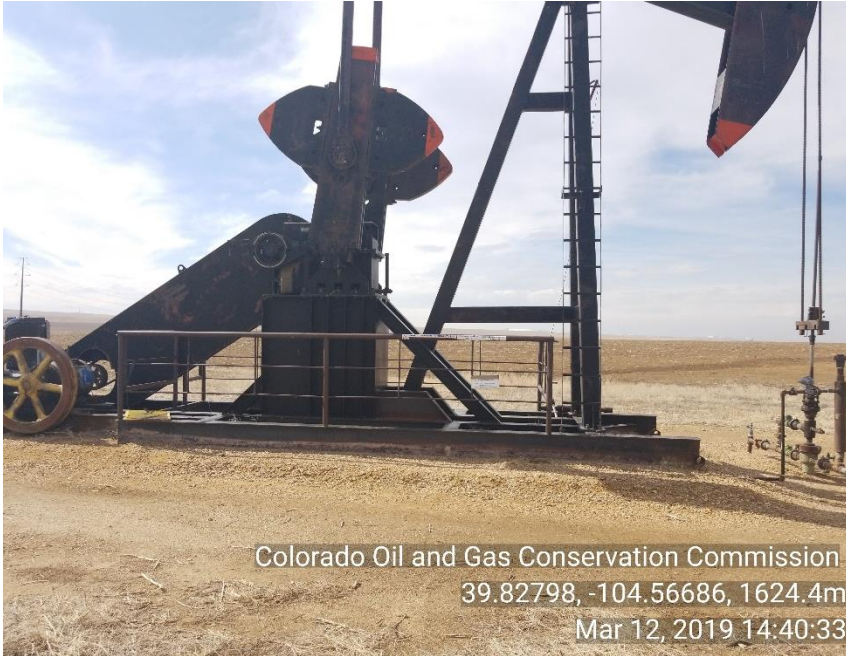
**Photo 1 PH and WH**

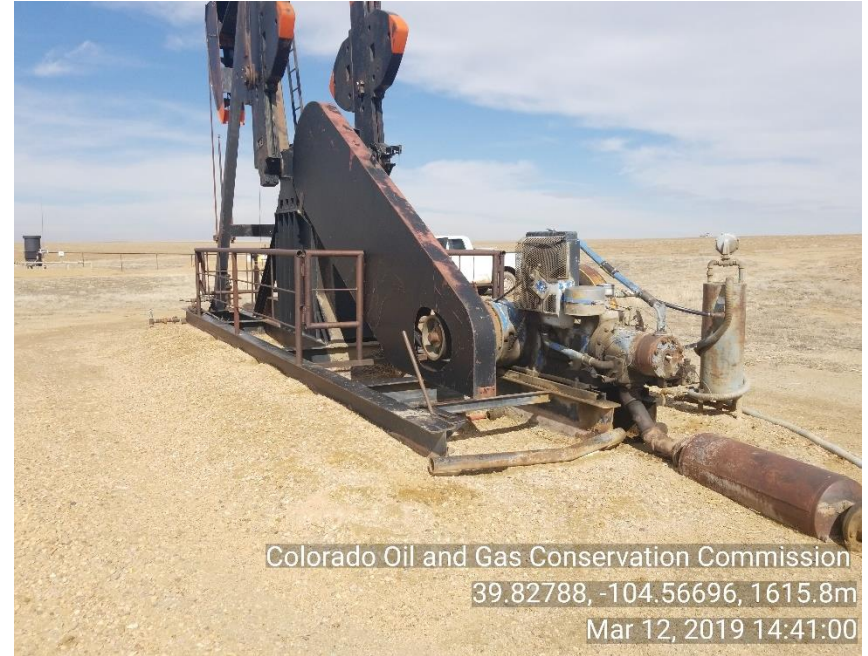
**Photo 2 stained soil remove from around PU**

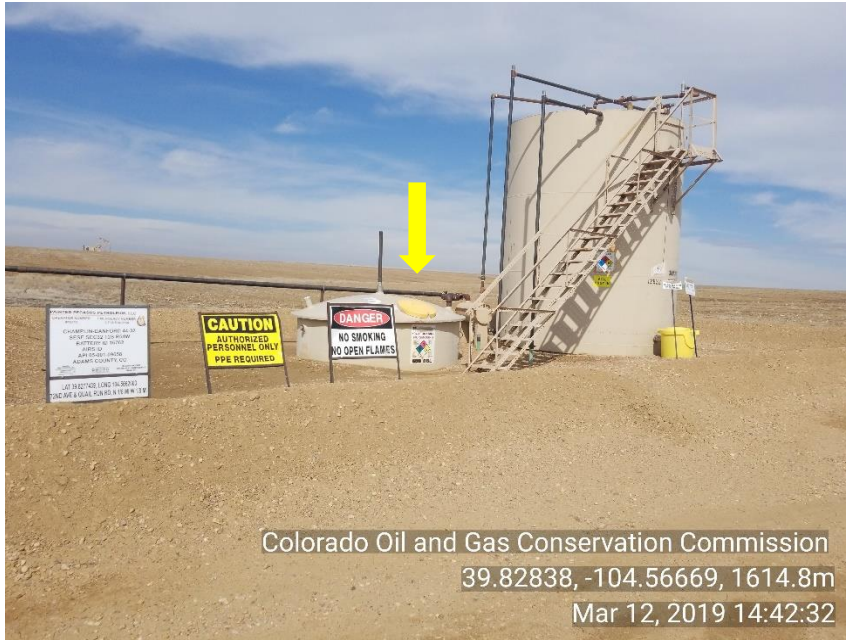
**Photo 3 Hatch on H2O tank has been installed**
