# Construction and Stormwater Inspection

March 12, 2019

Operator: BAYSWATER EXPLORATION AND PRODUCTION LLC - #10261

Location ID: 455456

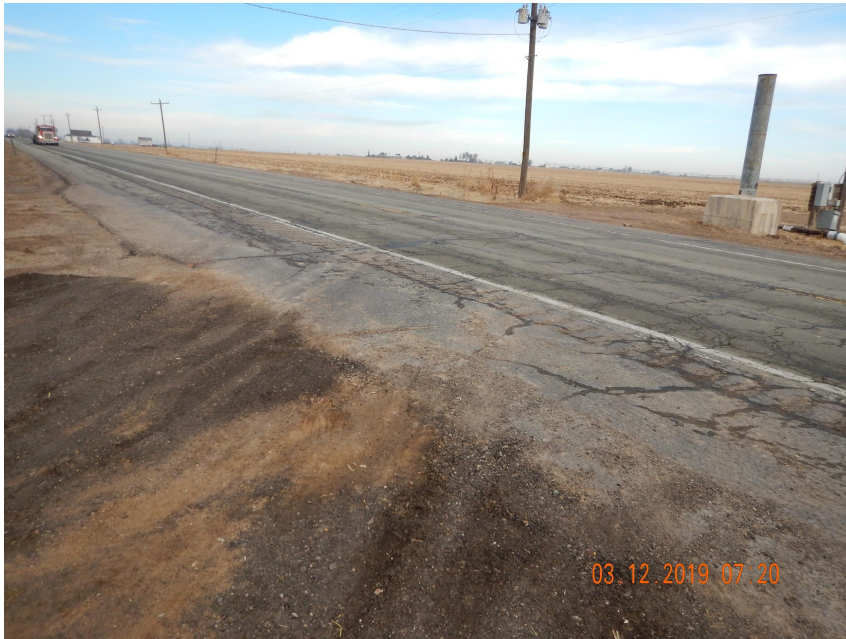
**Photo 1.** Photo taken from the entrance of the location, facing Northwest. The track out issue has been resolved.

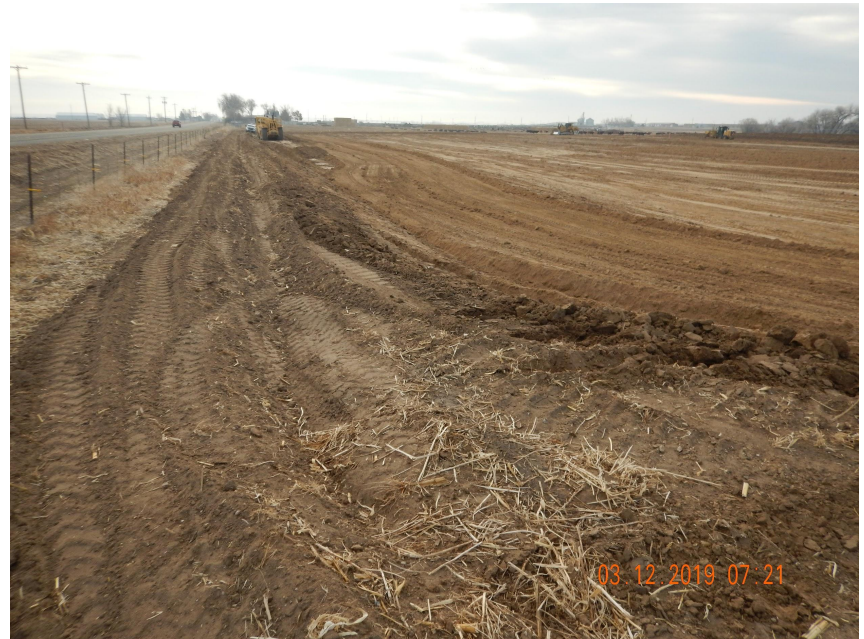
**Photo 2.** Photo taken from the northwestern location, facing East. Photo illustrates a ditch and berm BMP.

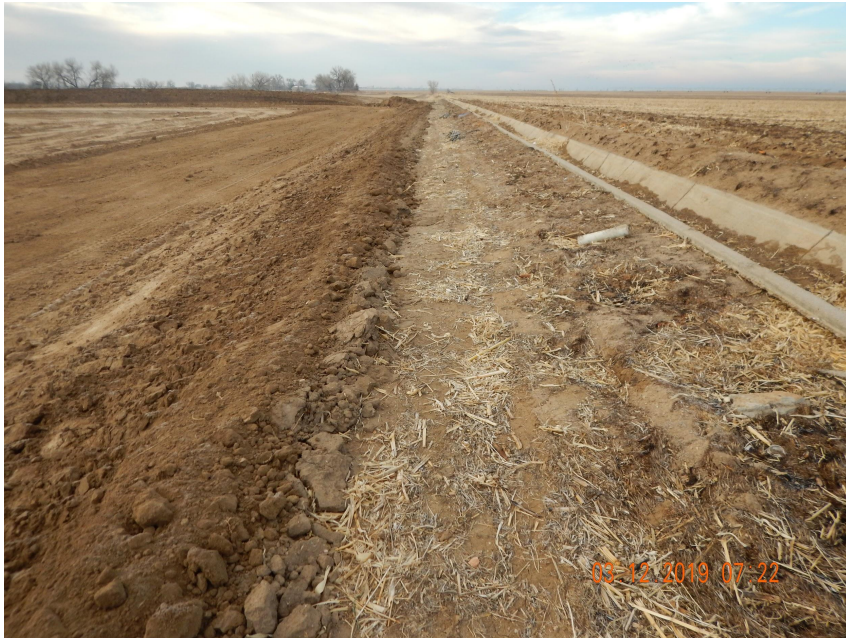
**Photo 3.** Photo taken from the northwestern location, facing South. Photo illustrates a berm BMP which has been installed along the western perimeter of the location. Berm BMP appears to be unconsolidated along portions of the location. An unconsolidated berm BMP is not a proper functioning BMP.

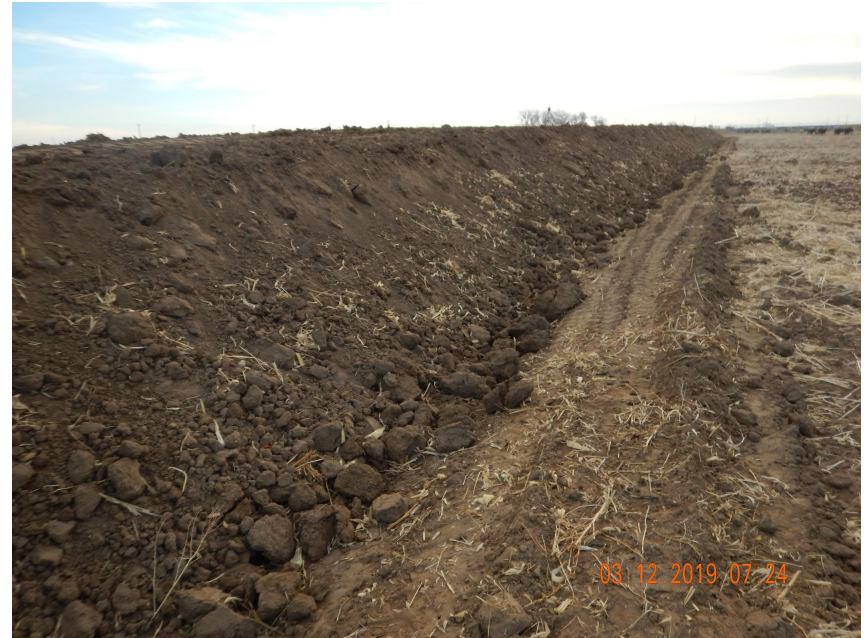
**Photo 4.** Photo taken from the southwestern location, facing East. Photo illustrates the topsoil stockpile. Also, the ditch BMP has topsoil which needs to be cleared out and the berm BMP needs to be re-installed, as it doesn't appear to be built to a sufficient height.

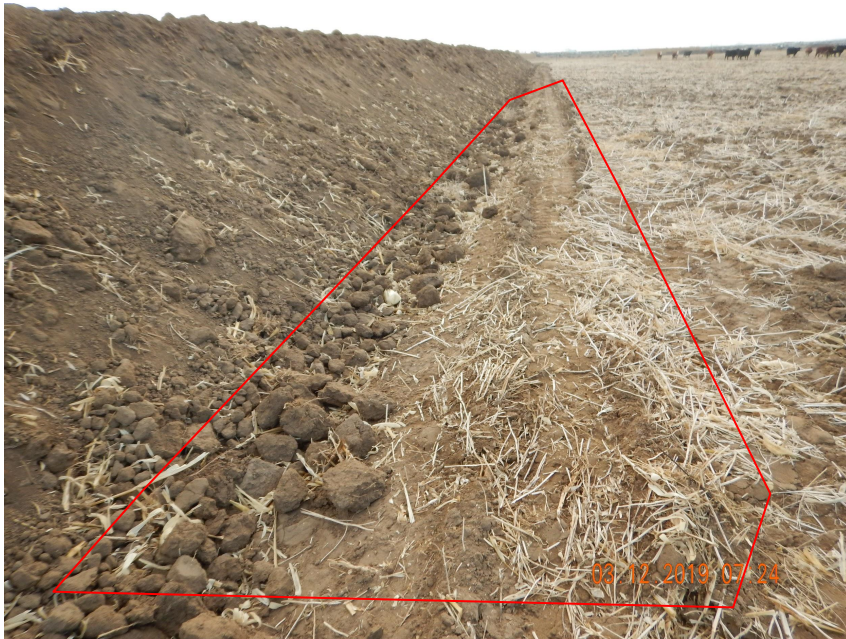
**Photo 5.** Photo taken along the southern location, facing East. See comments under Photo 4.

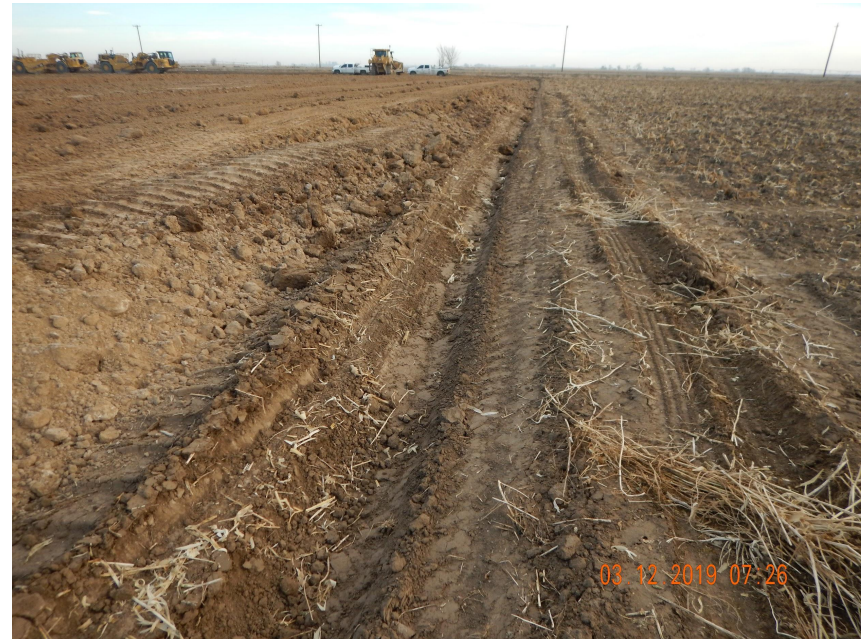
**Photo 6.** Photo taken from the southeastern location, facing North. Photo illustrates a ditch and berm BMP. Berm BMP needs to be re-installed, as it doesn't appear to be built to a sufficient height.

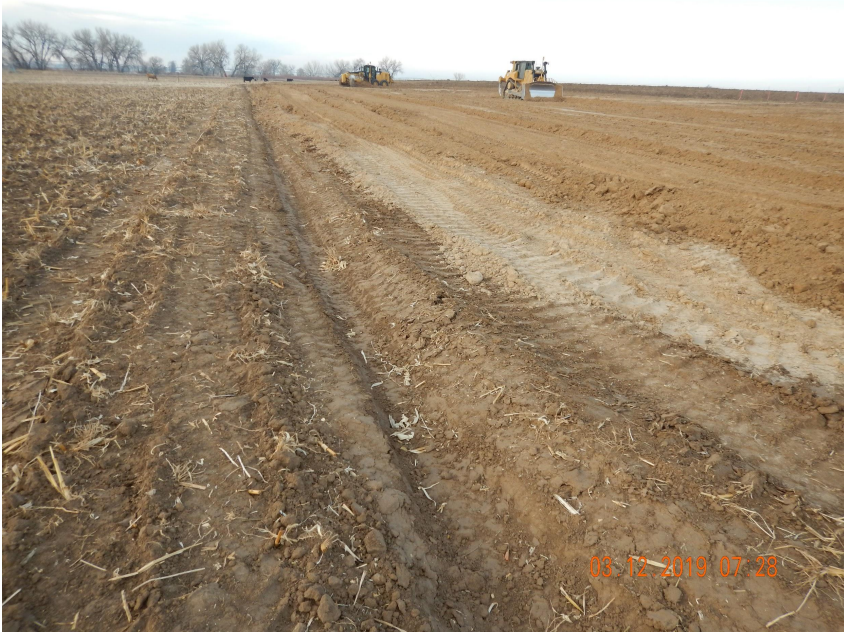
**Photo 7.** Photo taken along the eastern location, facing South. See comments under Photo 6.

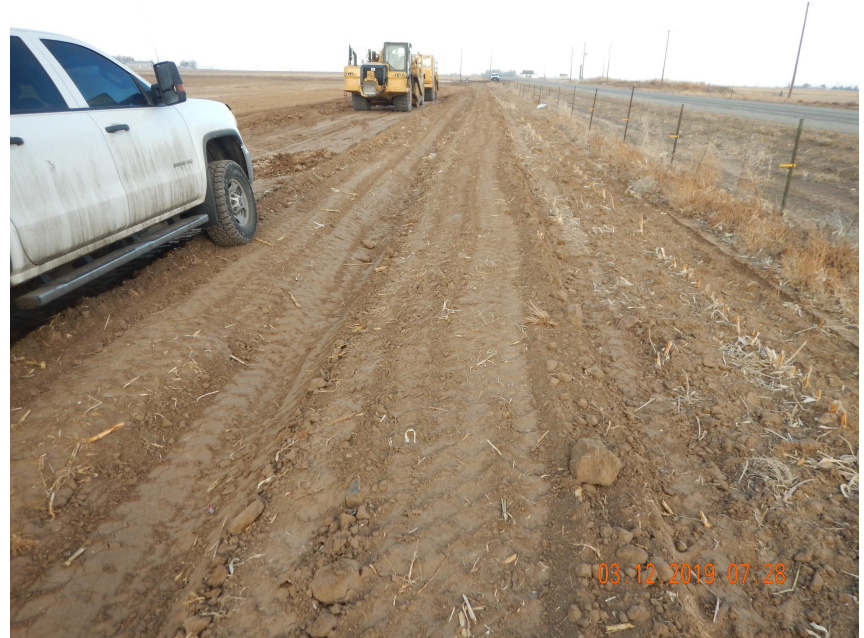
**Photo 8.** Photo taken from the northeastern location, facing West. See comments under Photo 1.
