Inspection Photos

API: 05-073-06739

Operator: K3 OIL & GAS OPERATING COMPANY

Inspection Date: 3/11/2019

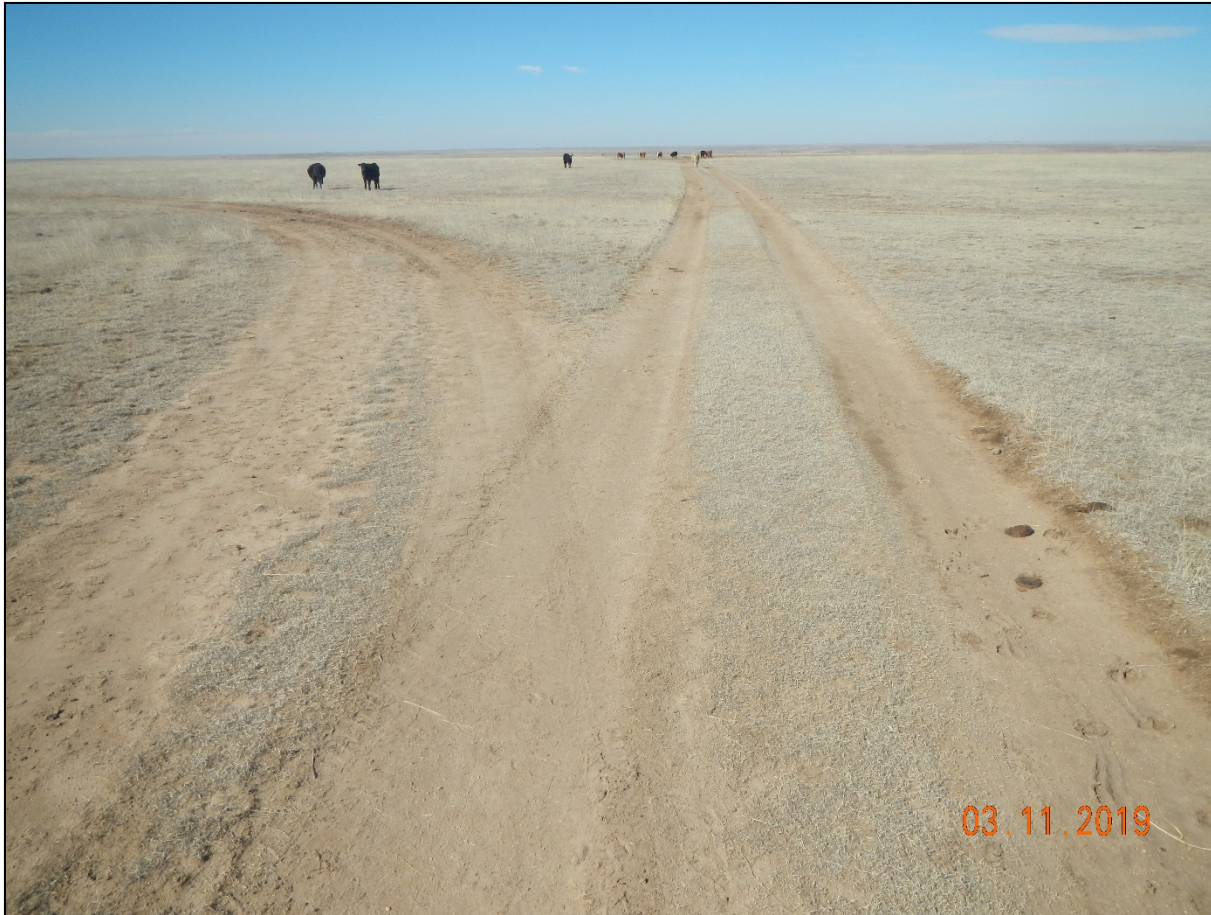
Photo 1. Facing north along the access road. Landowner road turns to the left. Pre-existing road goes north toward the location.

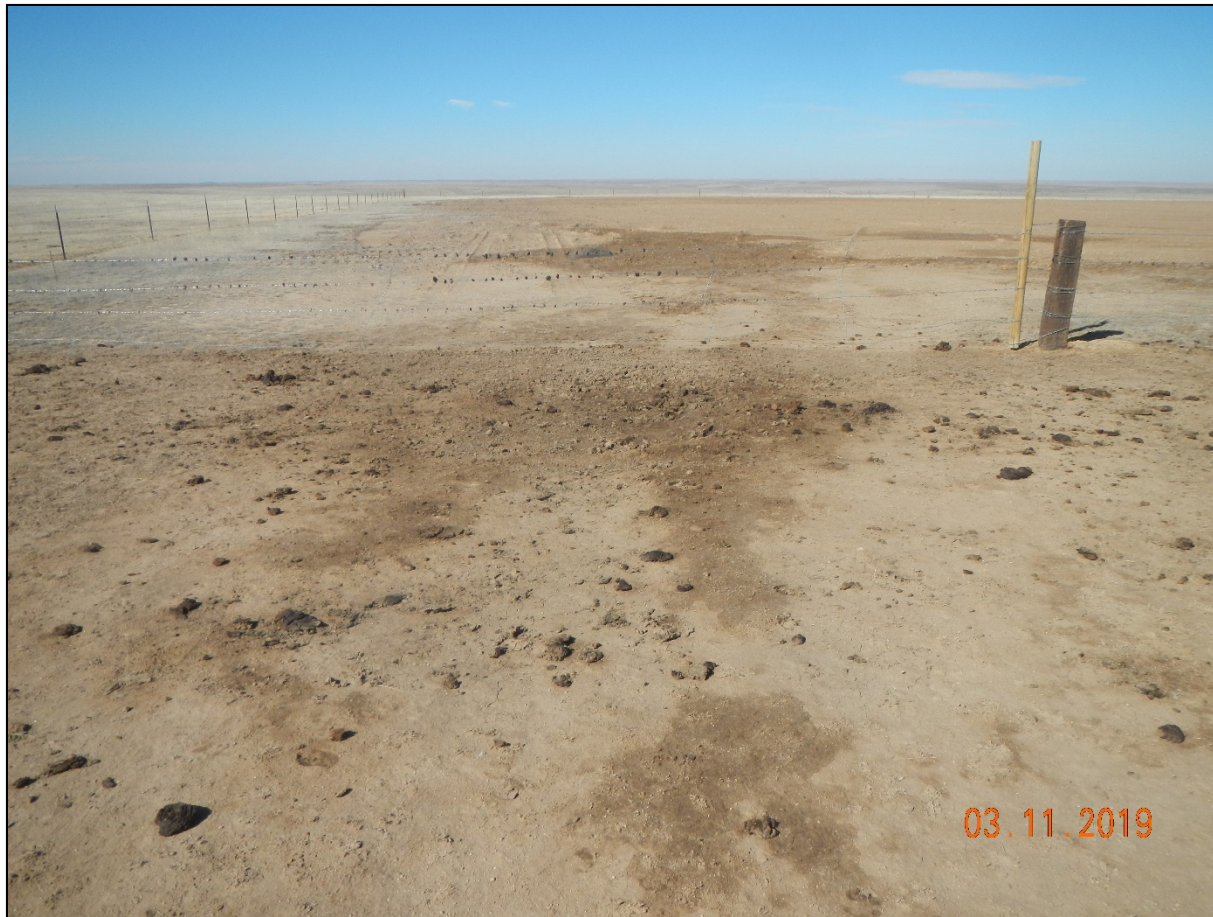
Photo 2. Facing north toward the location. The location is fenced. This area outside of the fence may need soil decompaction.

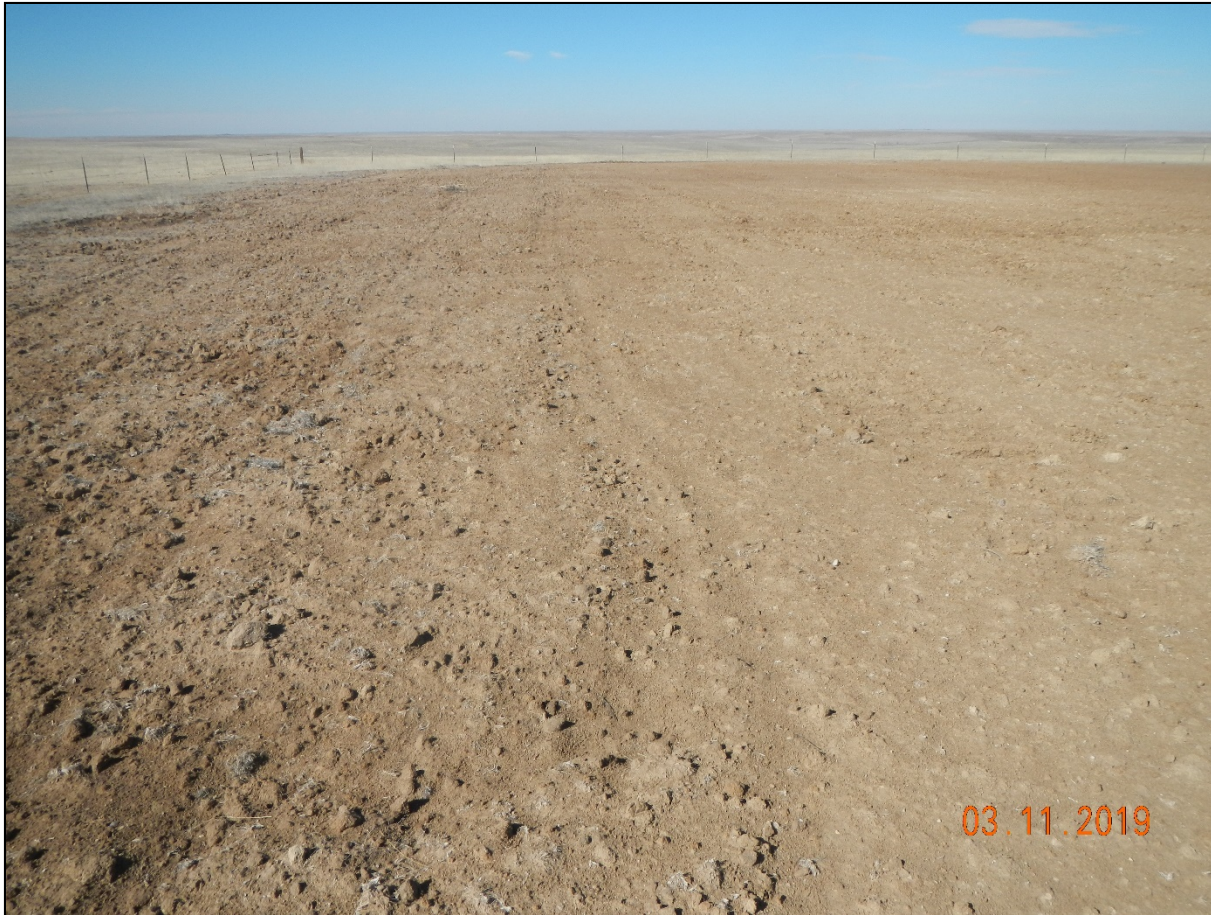
Photo 3. Facing north at the west side of the location. The soil has been recontoured and decompacted.

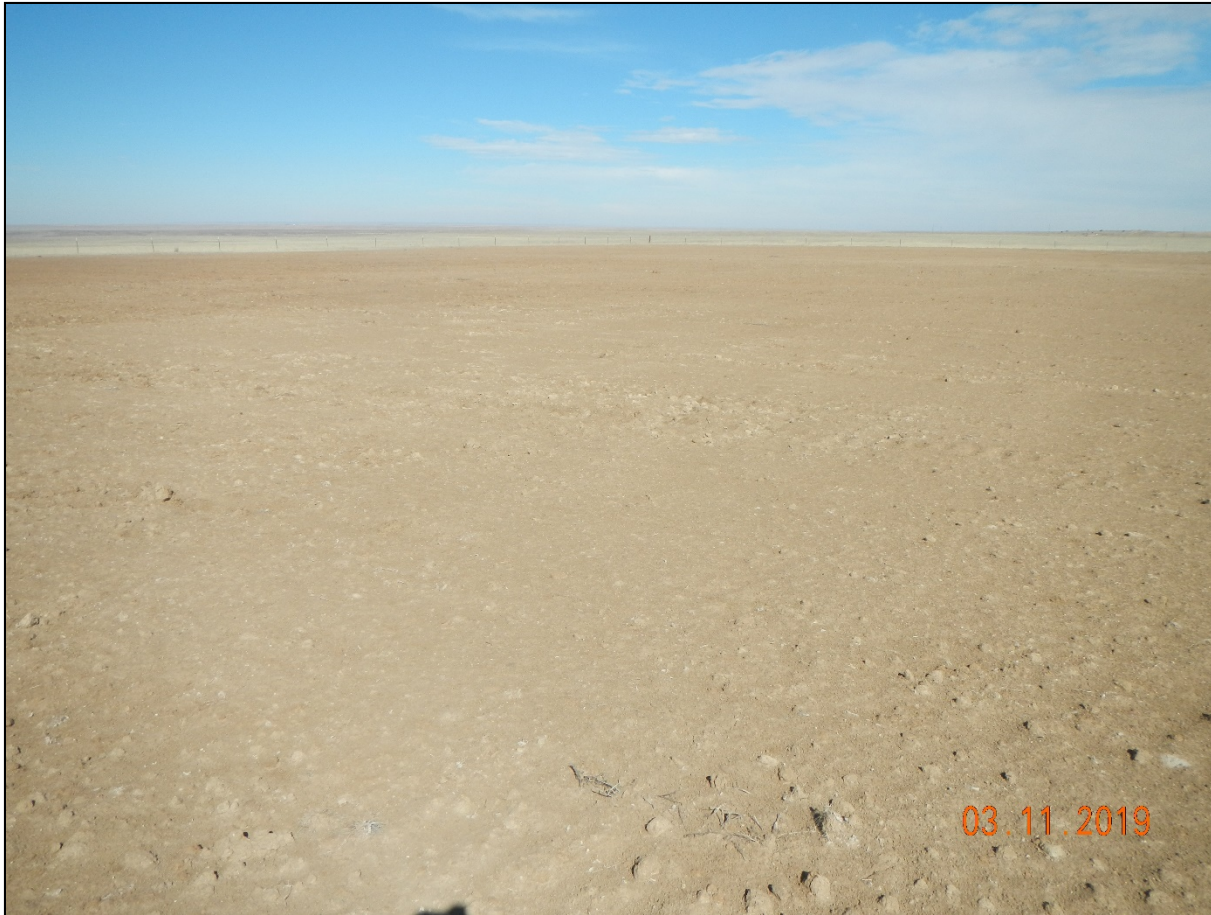
Photo 4. Facing northeast toward the location. The soil has been recontoured and decompacted.
