ALL Photos taken by Kris Neidel on 3/14/2019

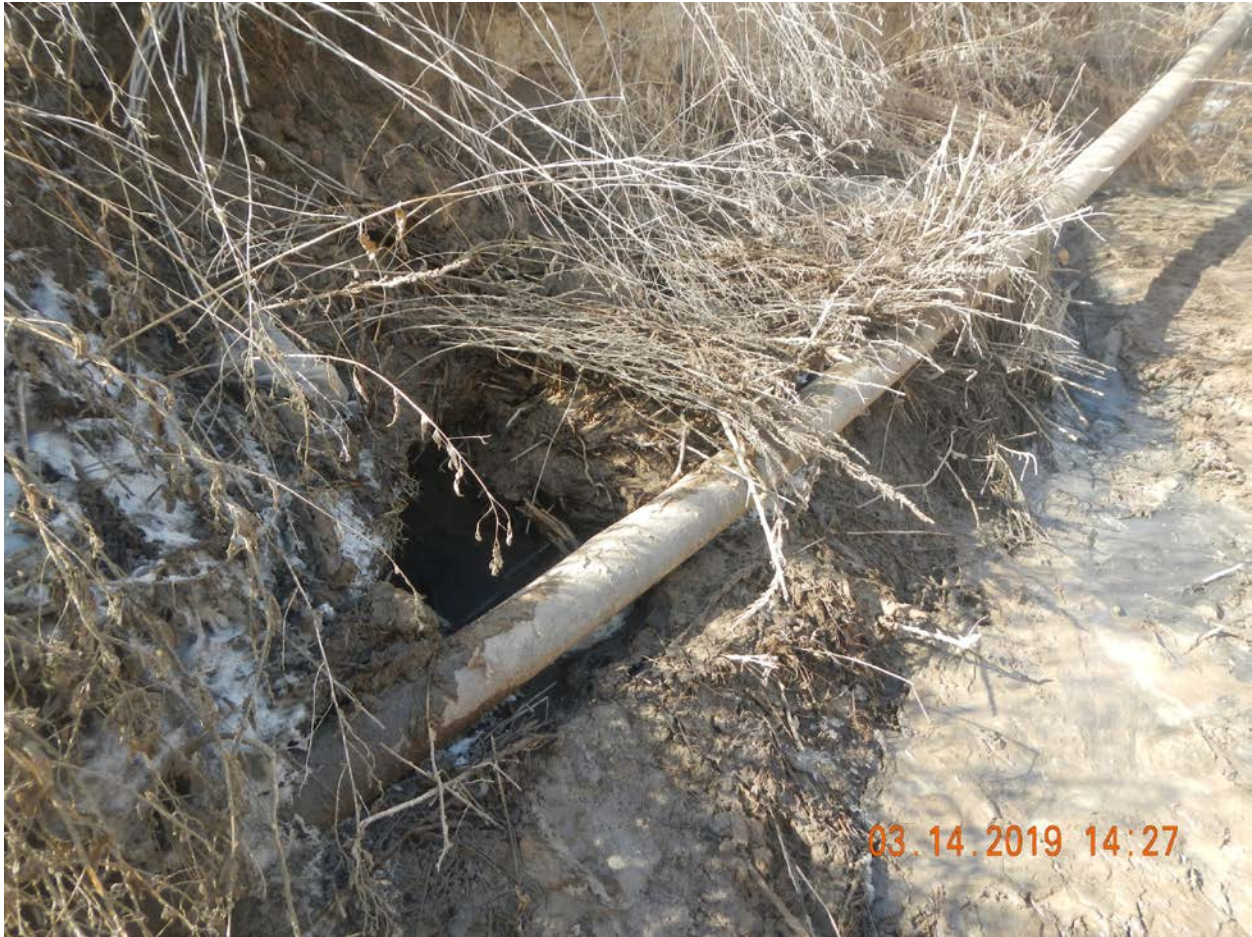
Spill Point, note area of erosion, the pipe failed on the underside forcing fluid to erode the side bank of creek.

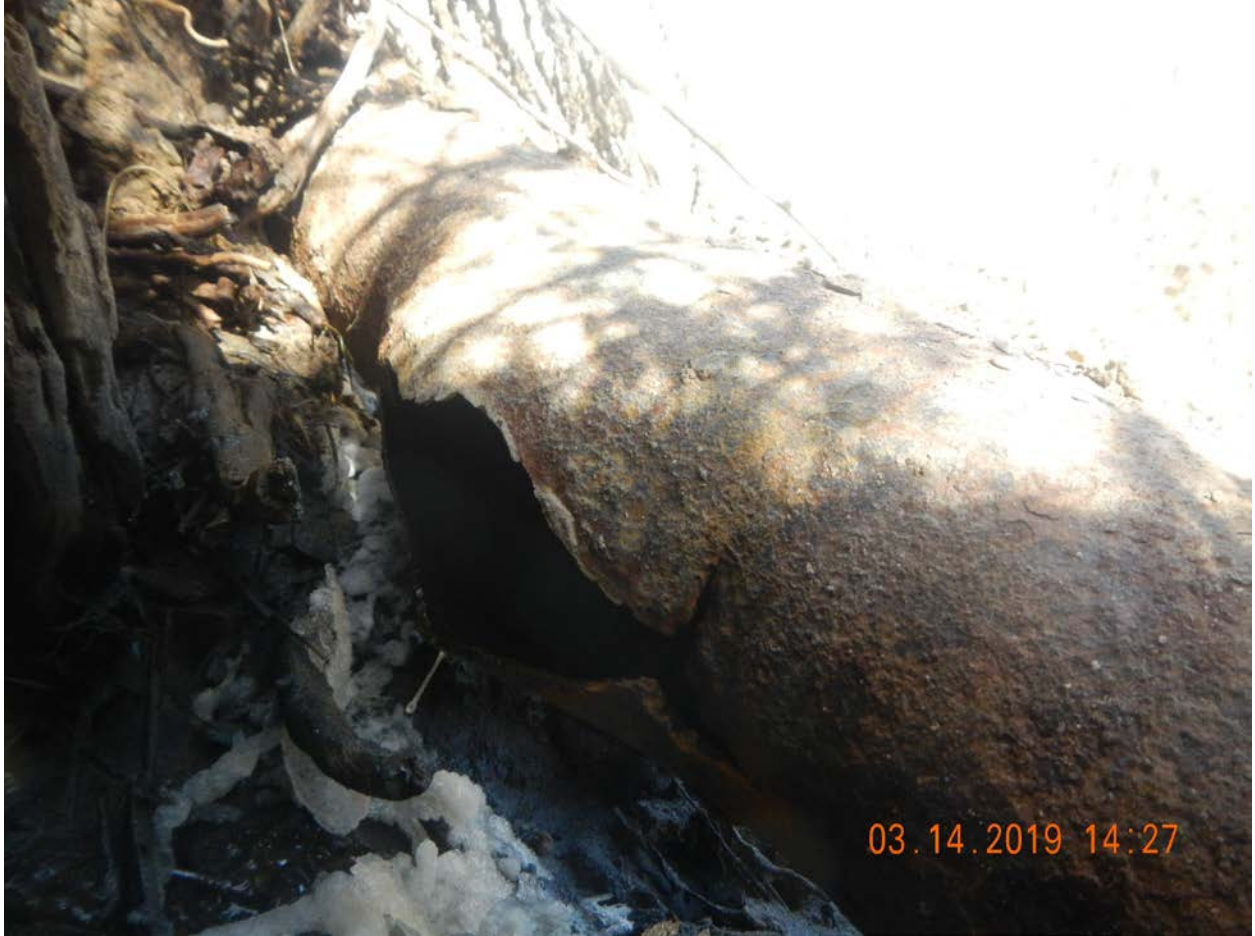
Spill point, pipe failure.

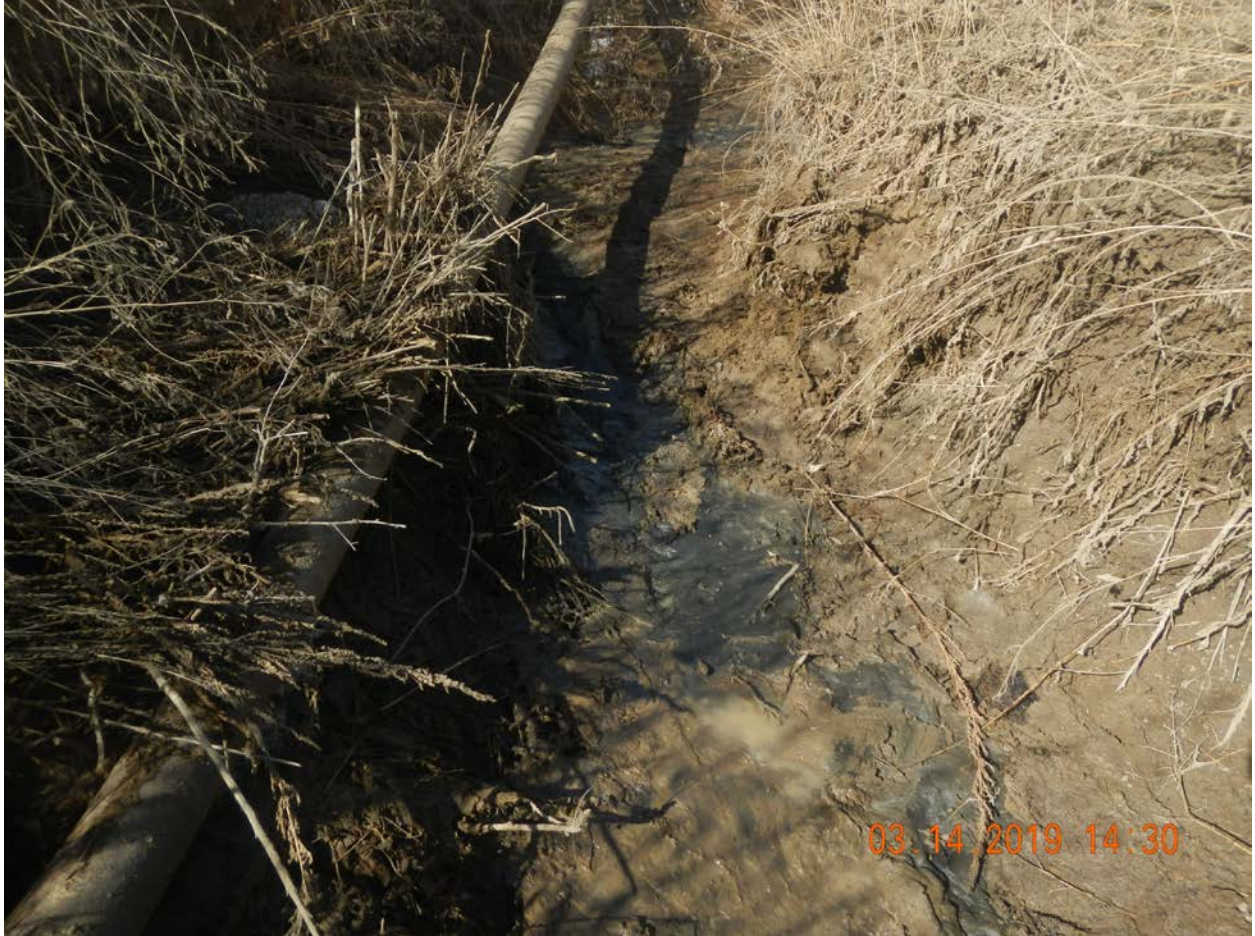
Evidence of recent surface flow in creek bed from spill.

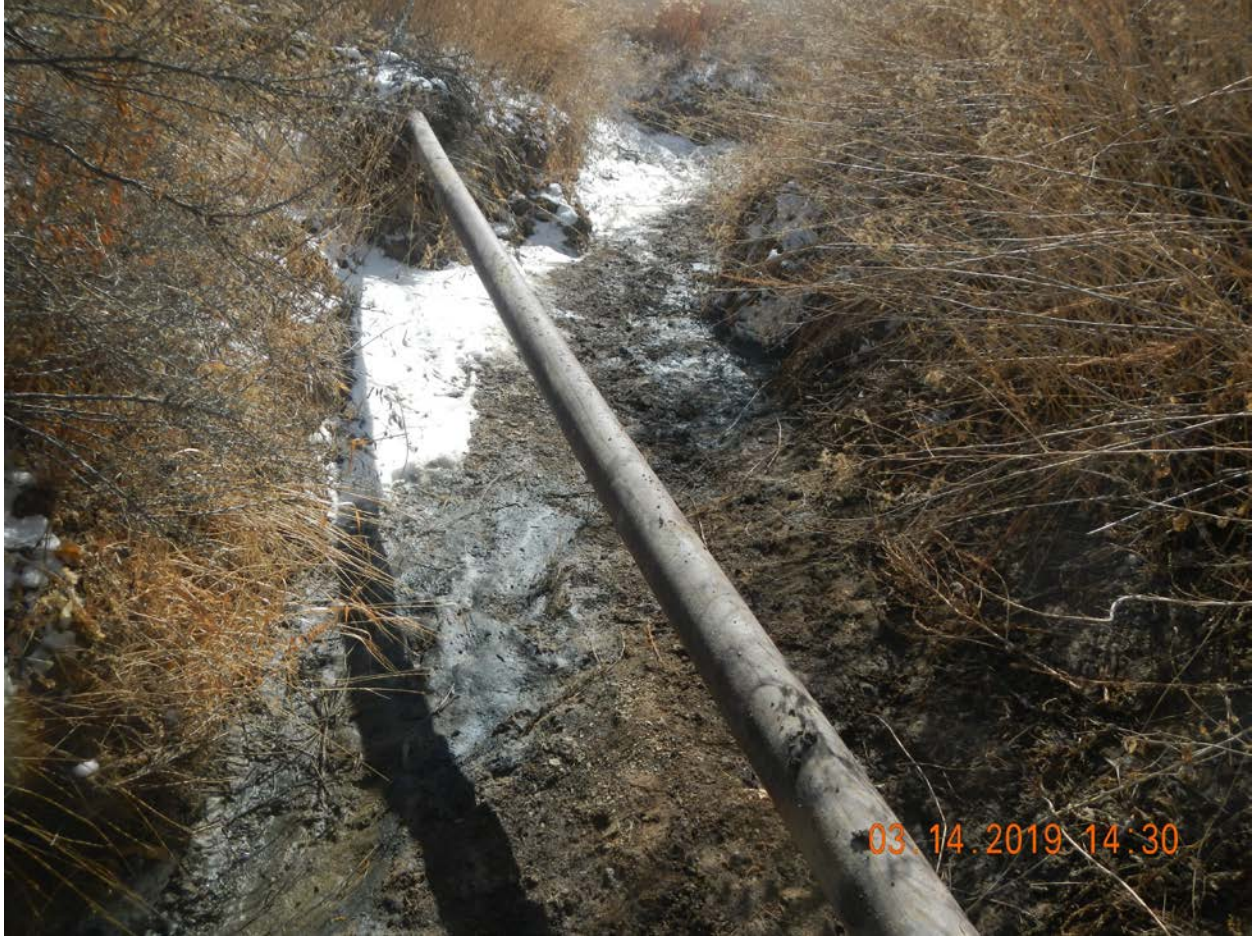
Flowline crossing creek bed.

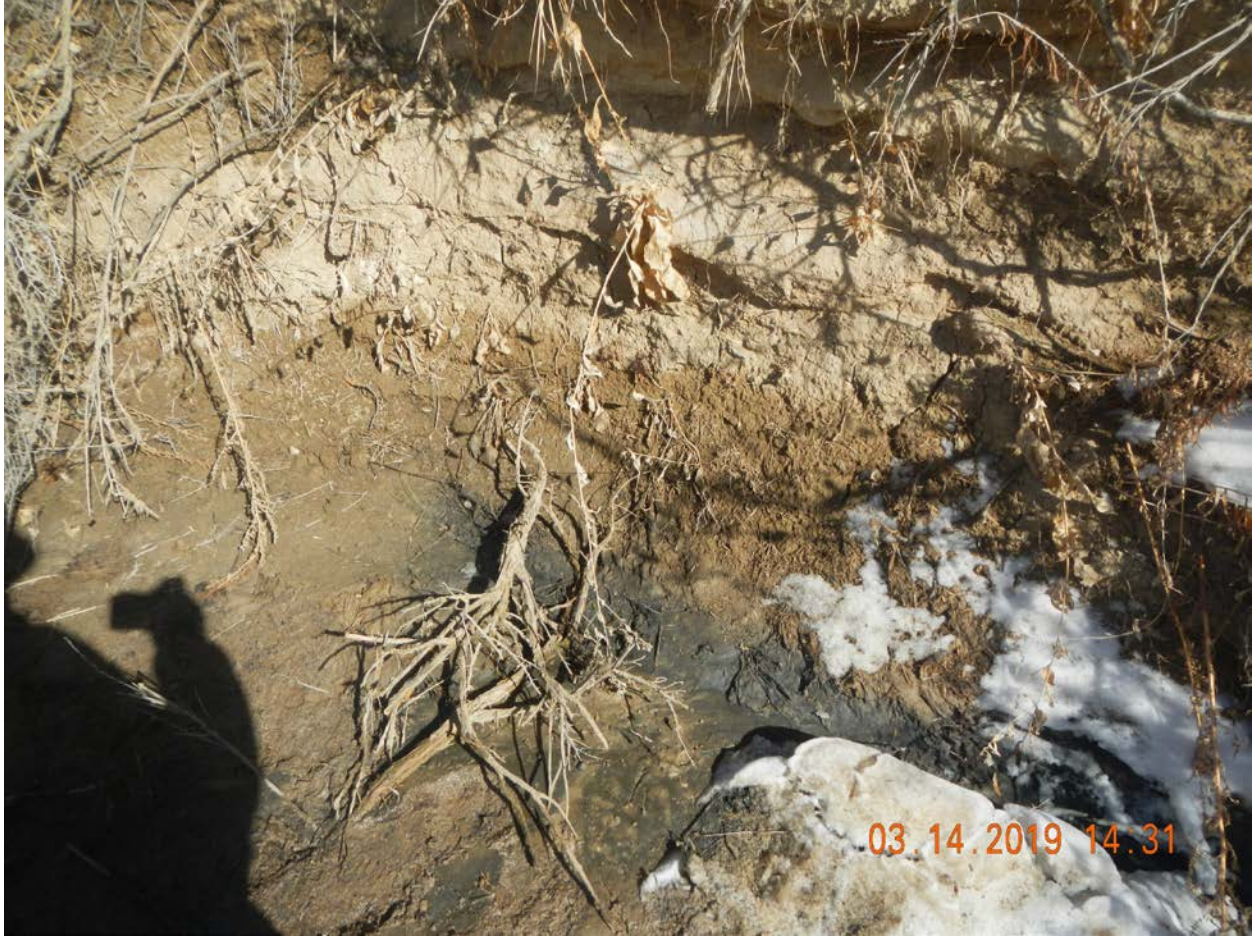
Impacted creek bed, dark staining had hydrocarbon smell and reflective surface .

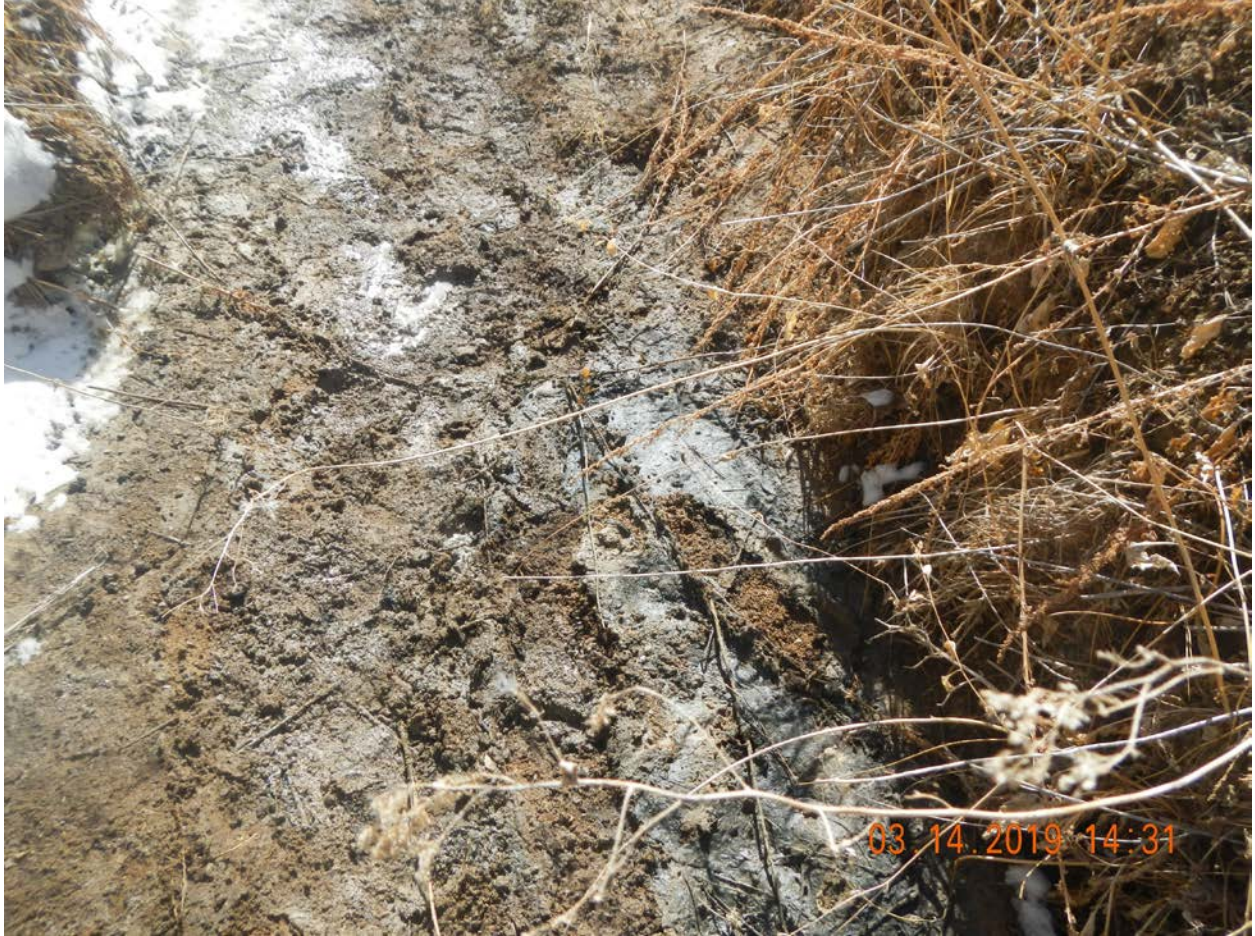
Impacted creek bed, dark staining had hydrocarbon smell. Photo of impacted area.

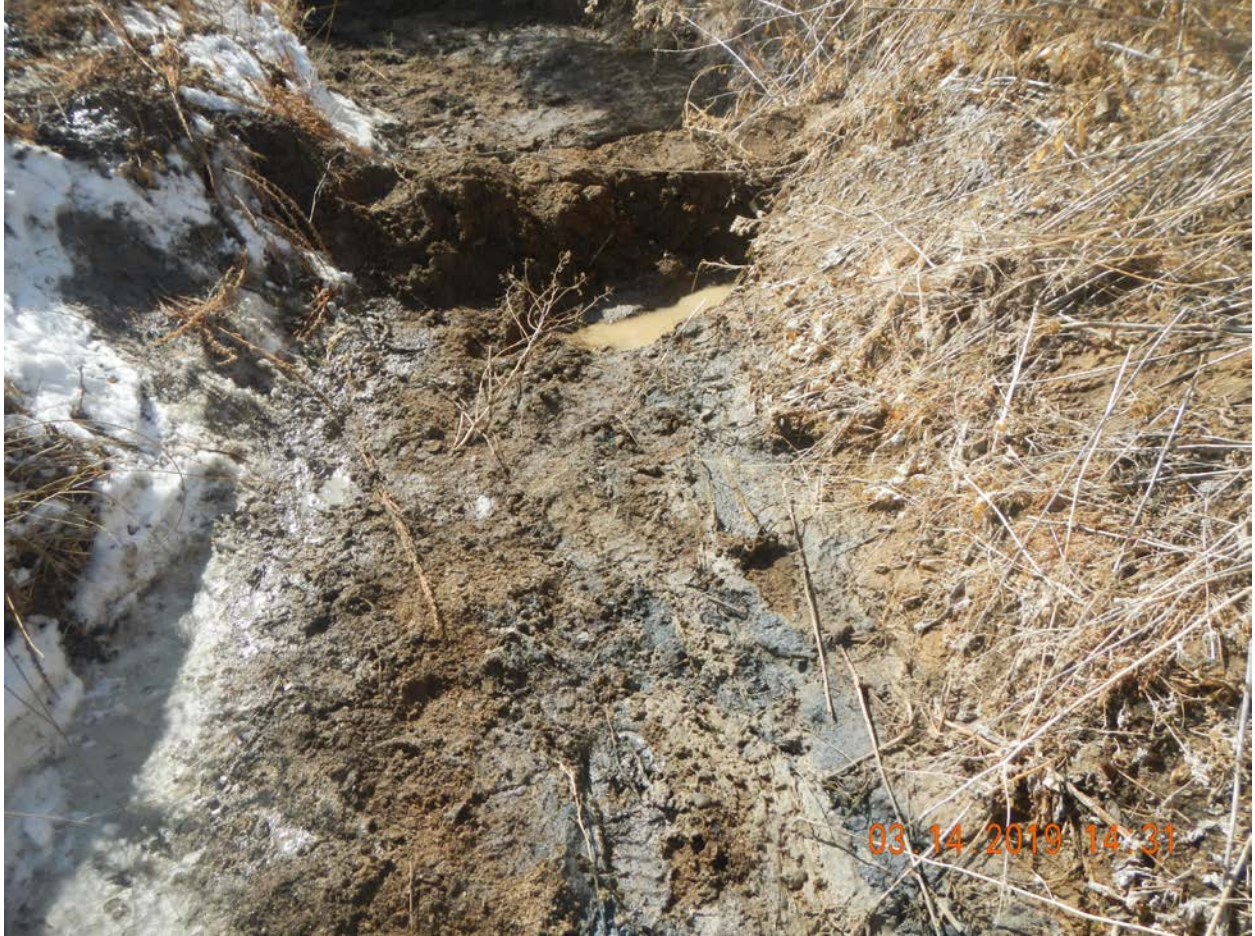
Two Potholes were dug in creek bed, downstream from spill point. One pothole visible here, one approximately five feet below (near shadow)..

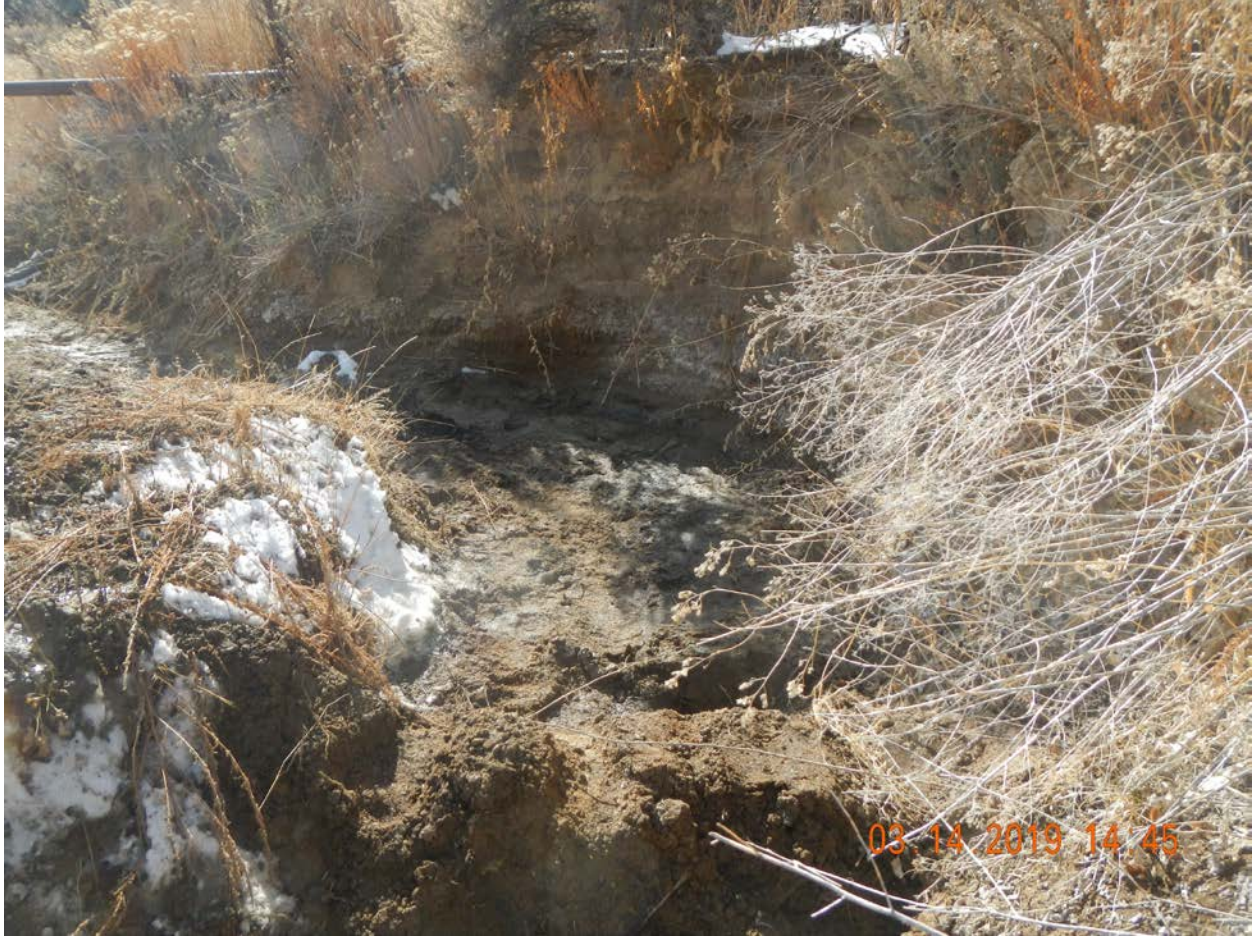
Two Potholes were dug in creek bed, downstream from spill point. This appears to be the end point.

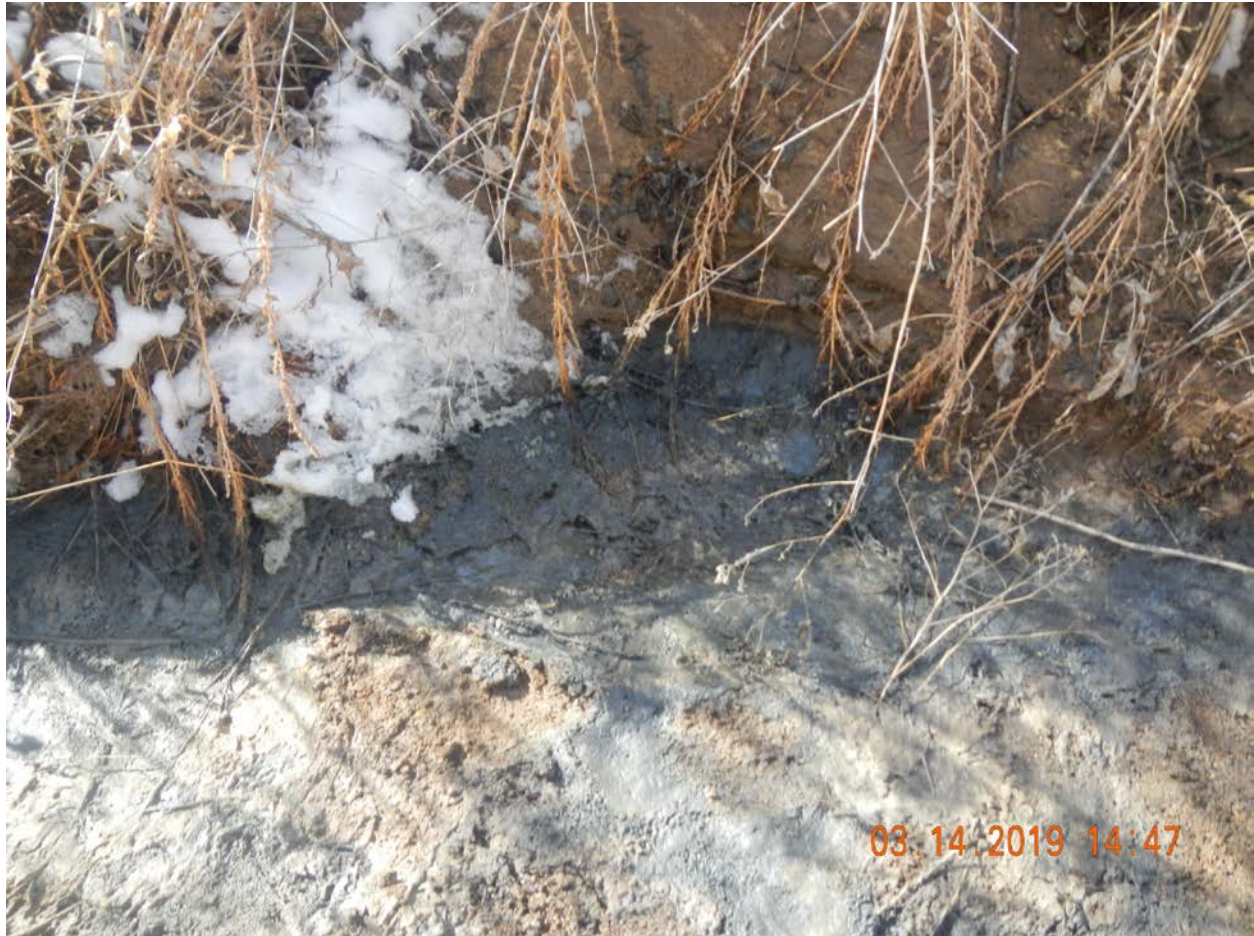
Observed staining in creek bed. The staining that has a reflective shine to it appears to be remaining impact from spill, it had a strong hydrocarbon smell. Some black particles in creek bed is believed to be coal fines and small pieces of coal that have washed out of hills, this was present in the non-impacted part of creek.

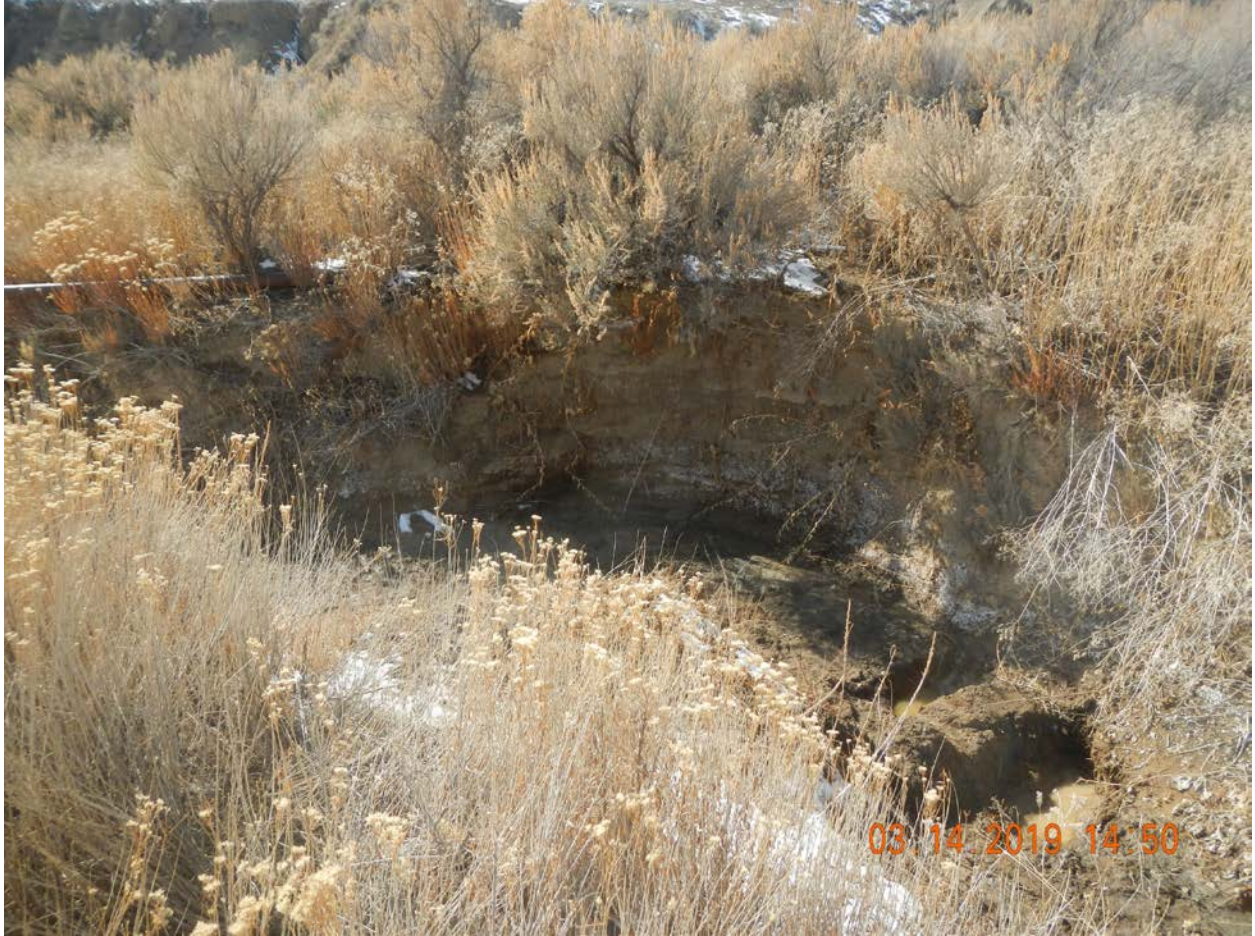
Potholes and end of spill area.

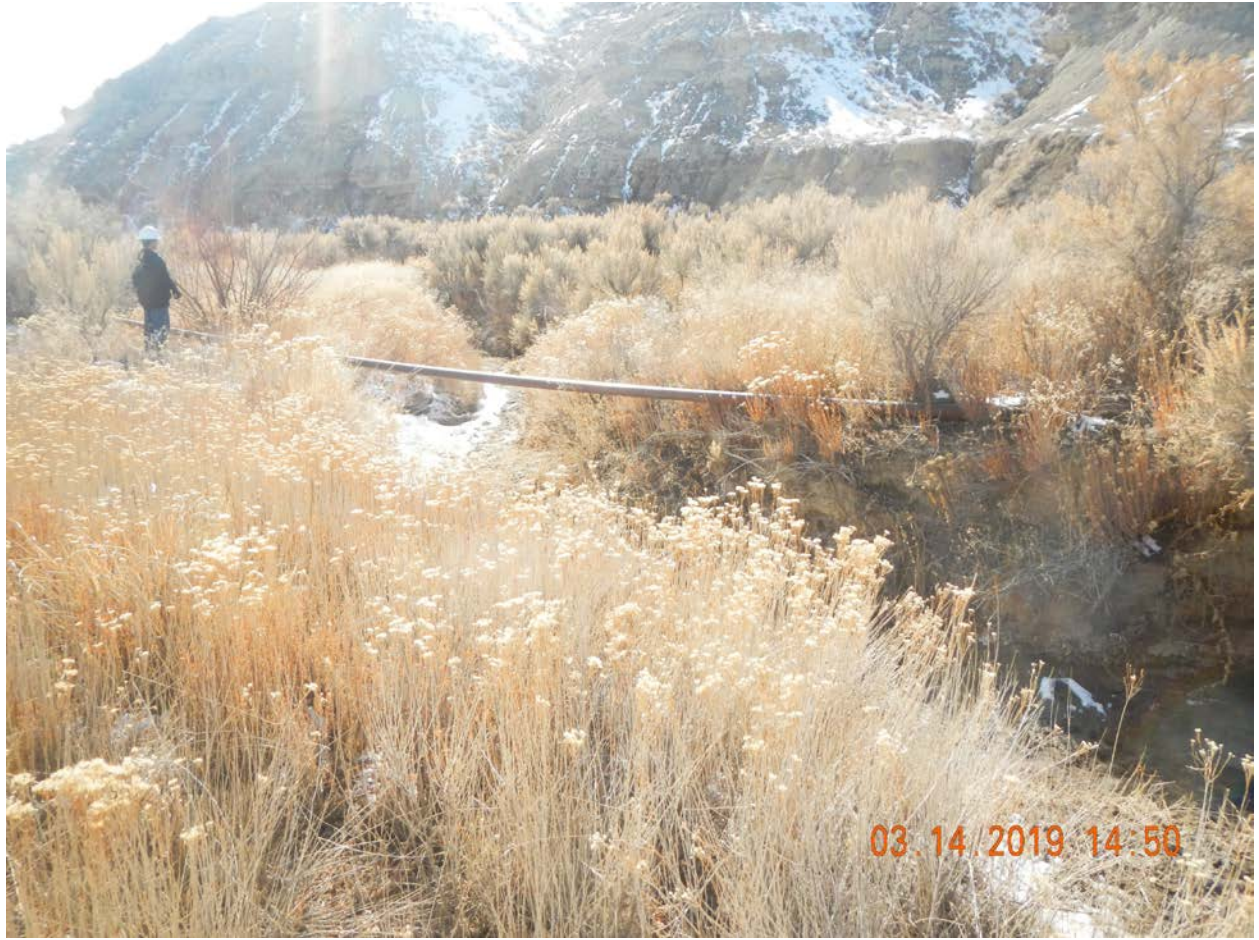
Flowline that was crossing part of Vermillion Creek.

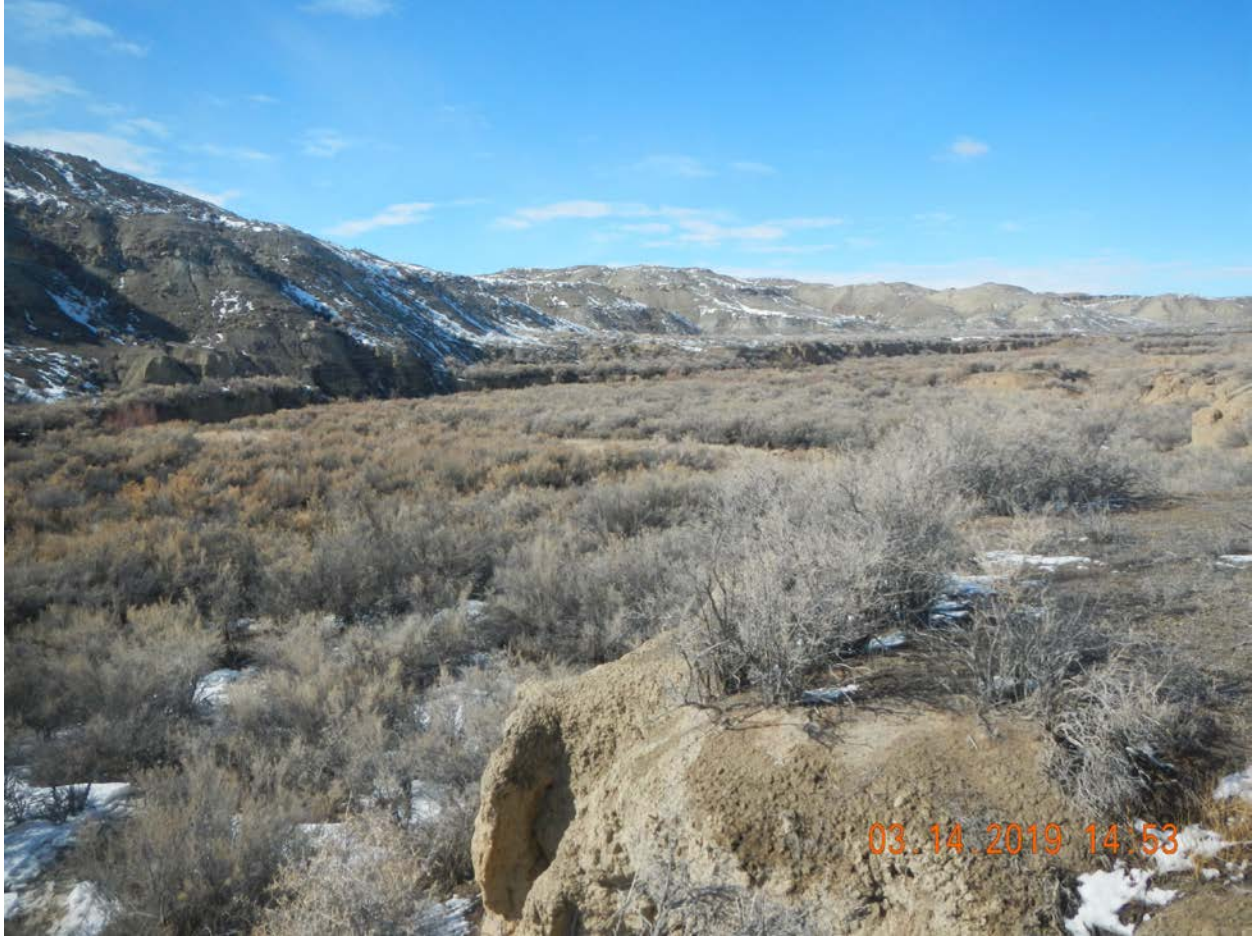
Vermillion Creek, spill area is just to the left of this photo, (spill area not in photo).

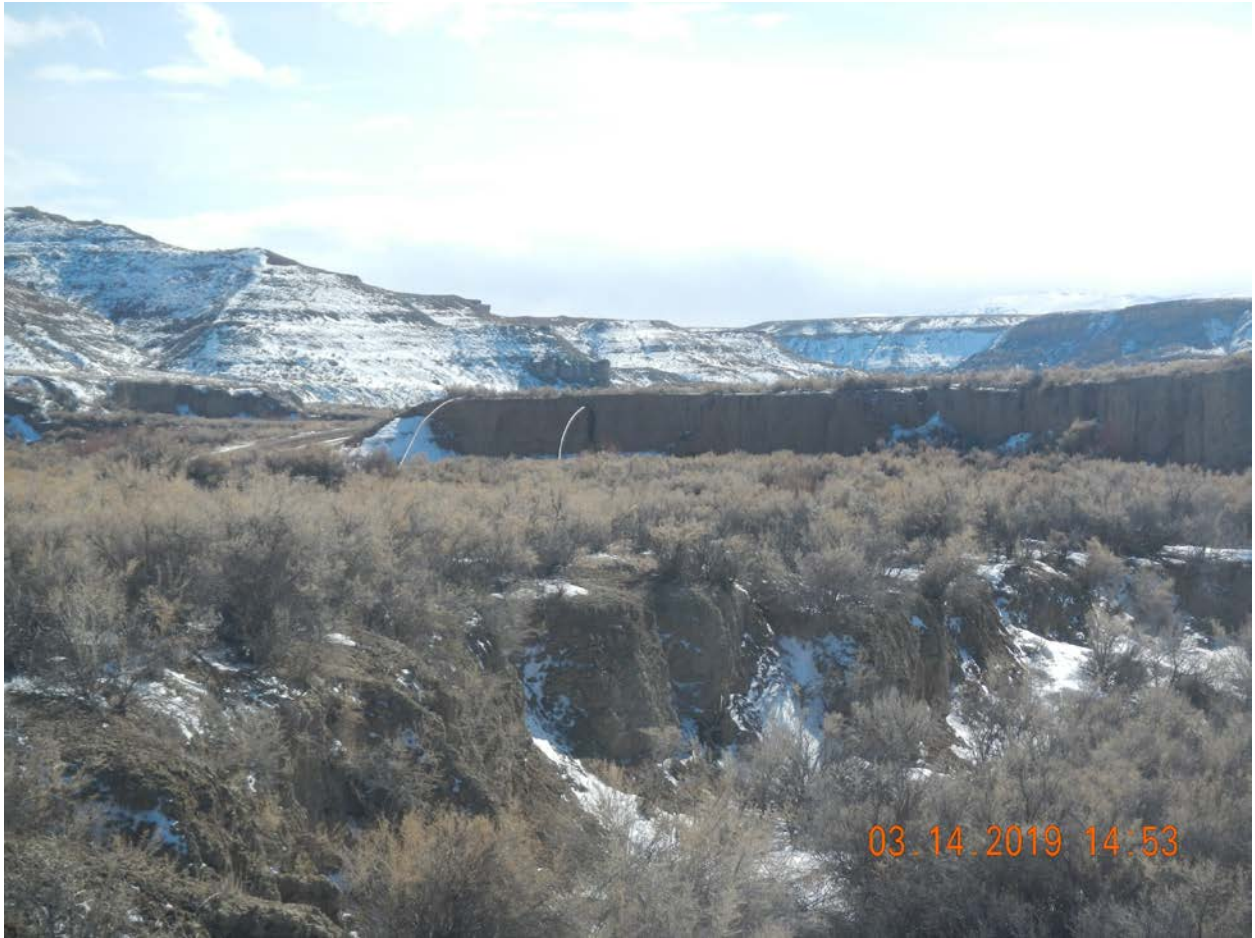
Note: two flowlines coming out of hillside. It was reported that the failed line is the one on left of photo.
