**PIT STATUS EVALUATION FORM**

Facility ID: 115128  
 Pit Name: MAPLE UPRR 2

Status: NR Owner: ROCK OIL CORP  
 T: 7S R: 63W Sec: 11 QQ: NENW 6th Meridian  
 Latitude: 39.460728 Longitude: -104.415503 NAD83

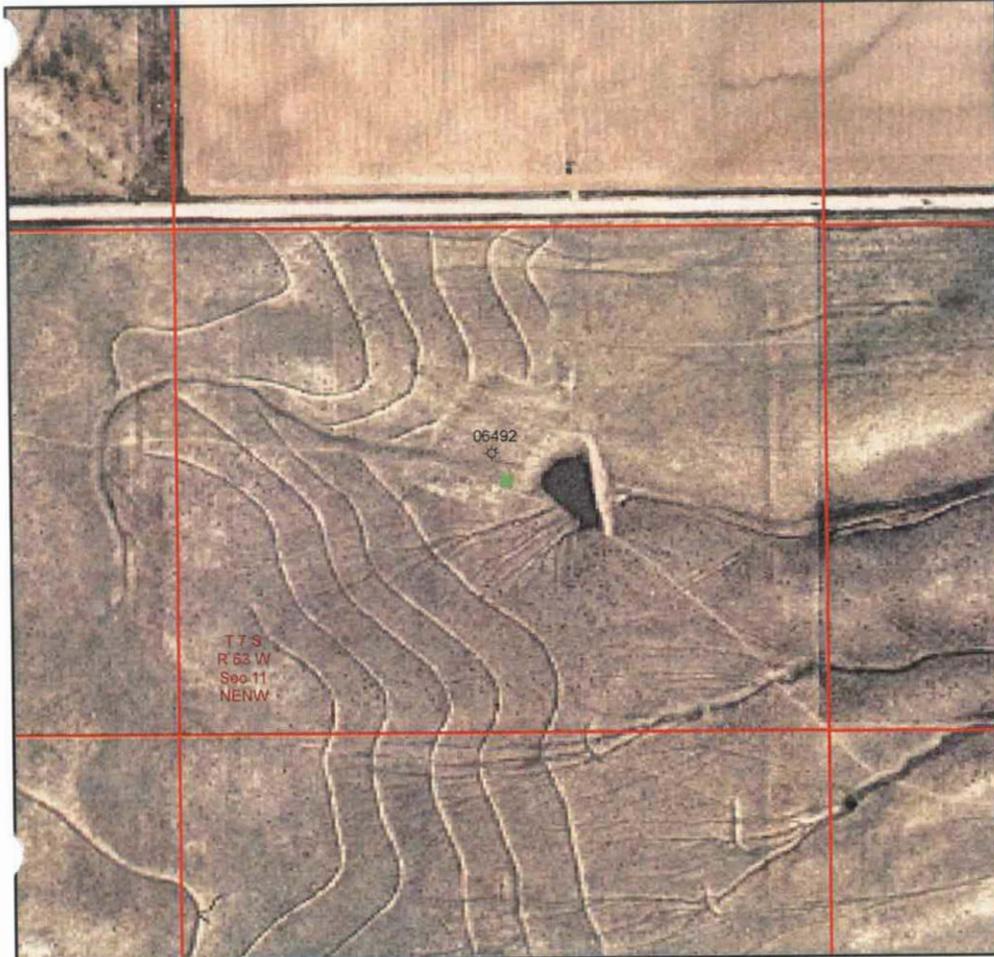
Notes: No Form 15. LIF(1985) open & wet pits, LIF(1986) "good surface rehab; earthen dam + East for watering pond for cattle"
