Inspection Photos
Operator: BP America
Location/API #: 067-05144
Date: 2-18-2019

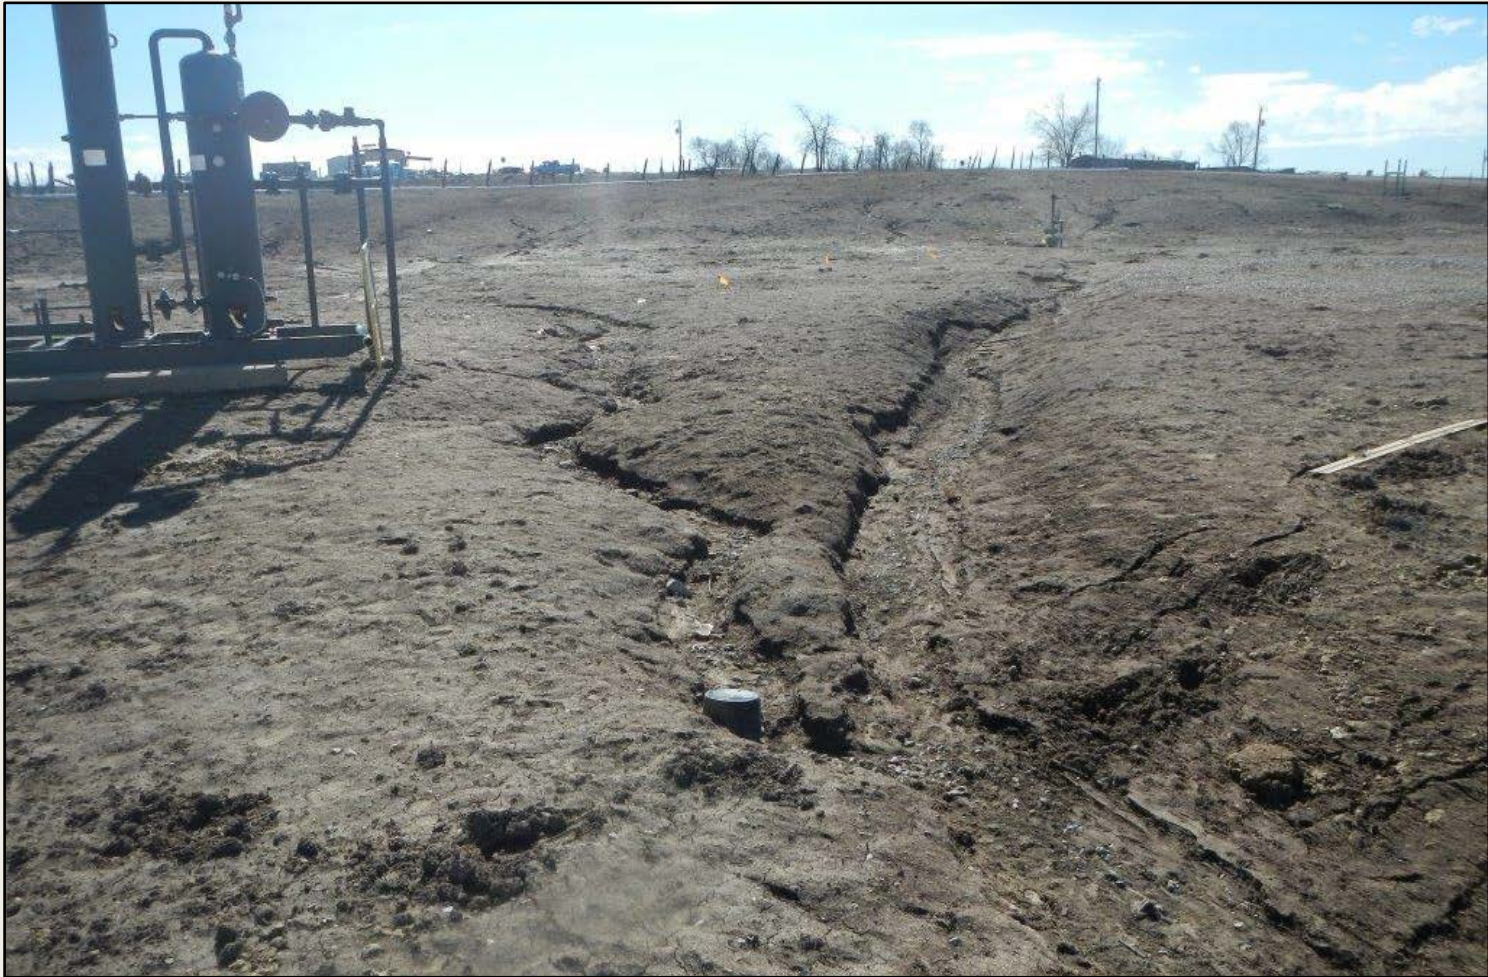
Photo 1. View of the northern project area from the northern edge of the driving surface facing eastward. An erosional channel that is approximately 2-4 feet wide and 2 feet deep is eroding the northern project area.

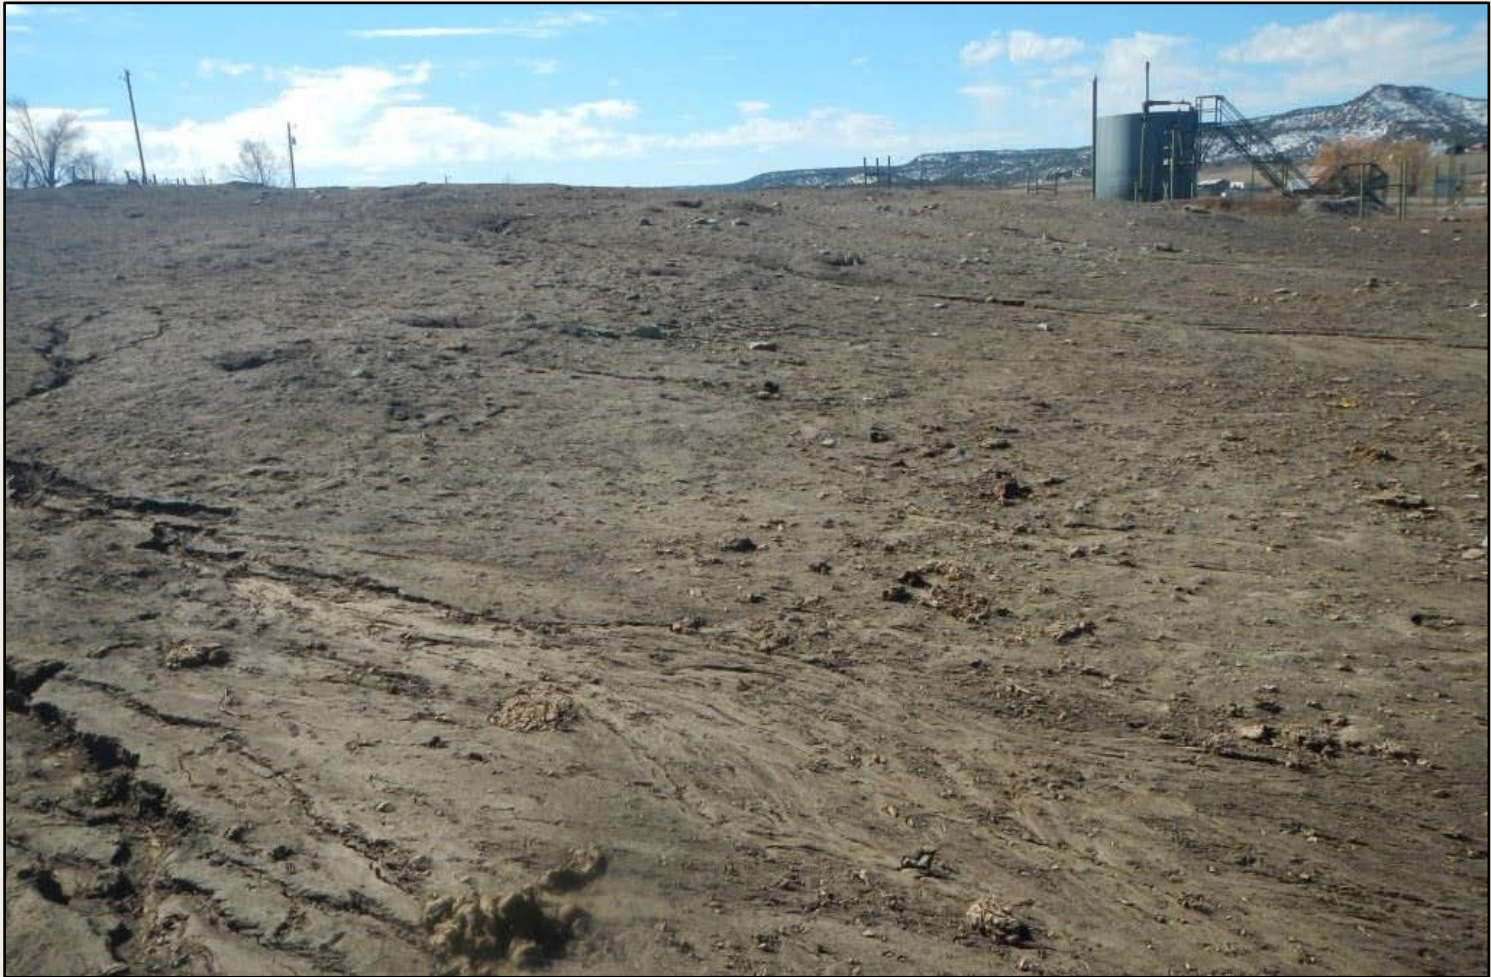
Photo 2. View of the eastern project area from the northeastern project area facing southward. Little to no vegetation observed. Erosion is occurring across the bare soil surface.

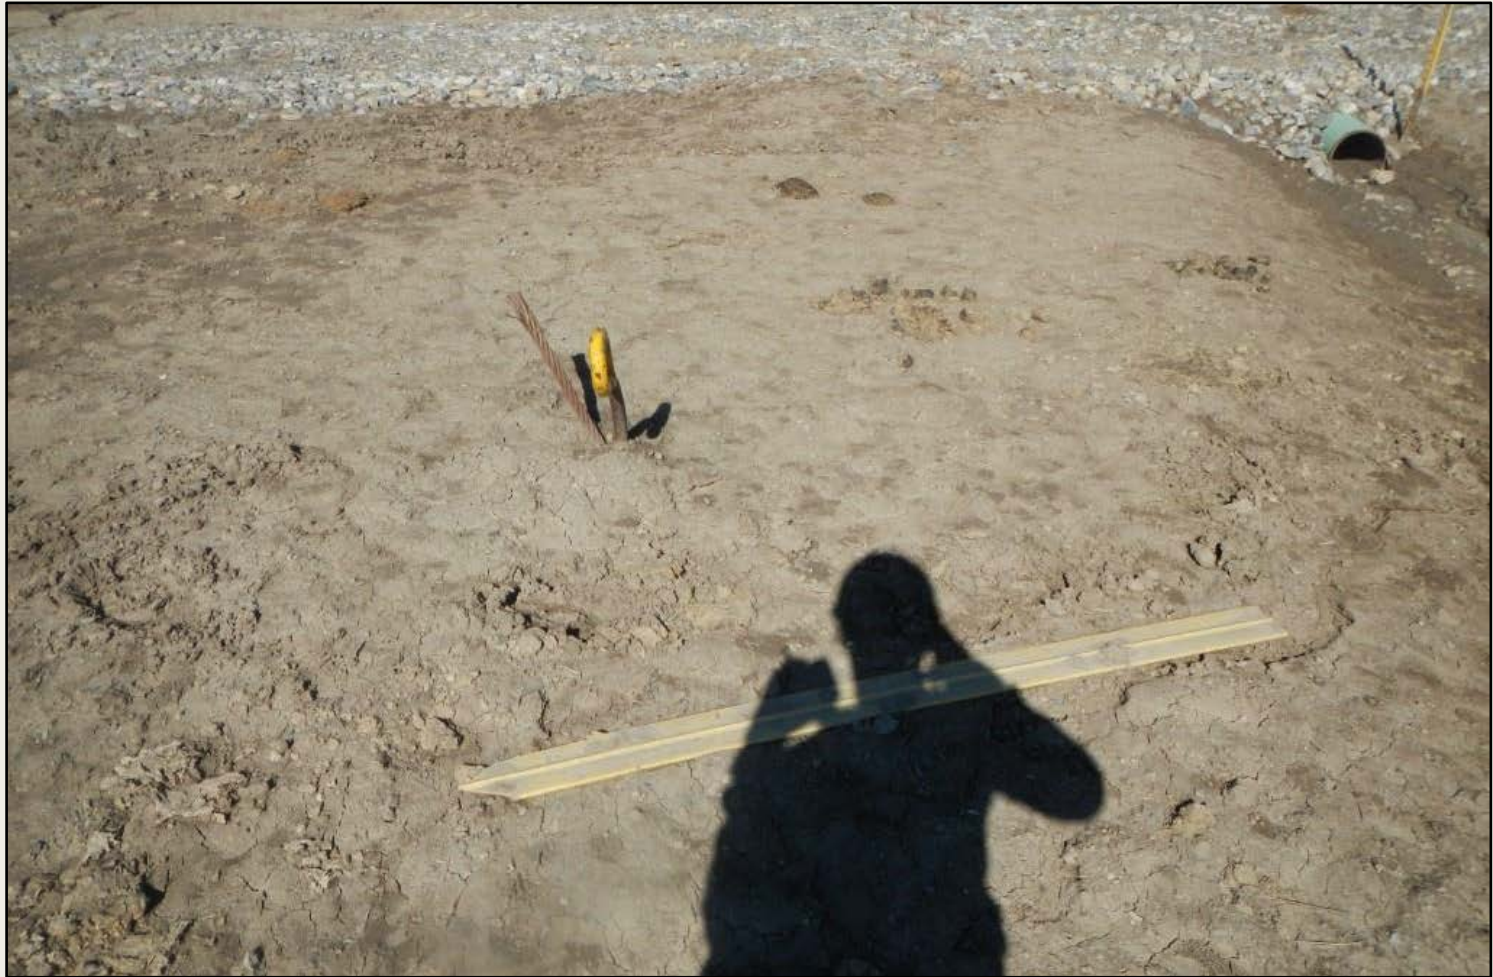
Photo 3. View of unmarked rig anchor within the northern project area.

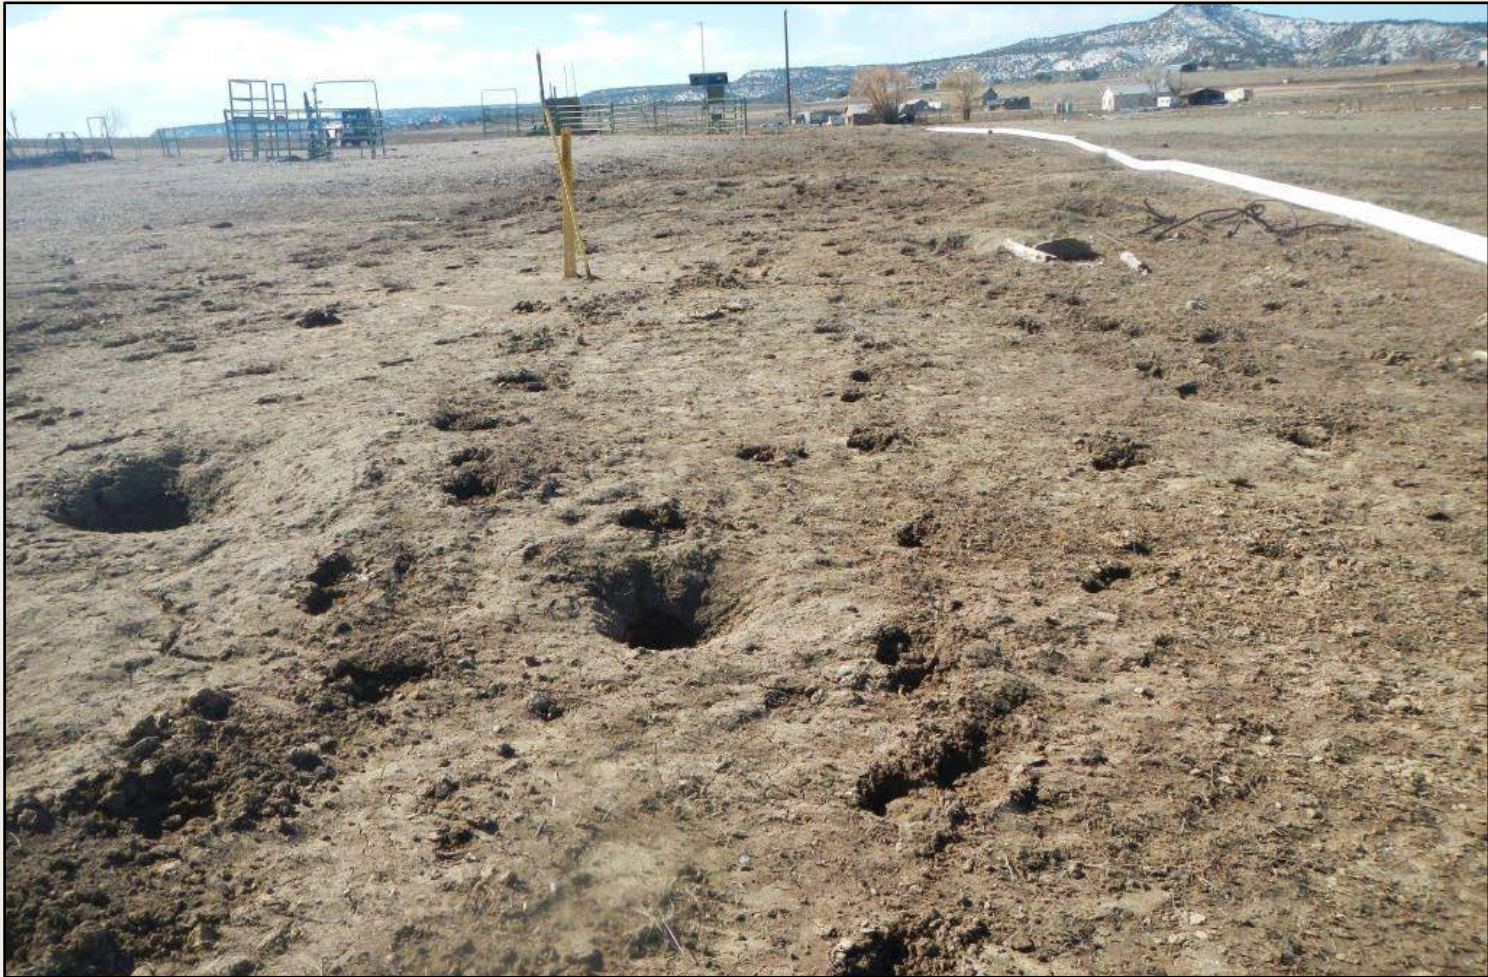
Photo 4. View of the western project area from the northwestern corner facing southward. Little desirable vegetation present here.

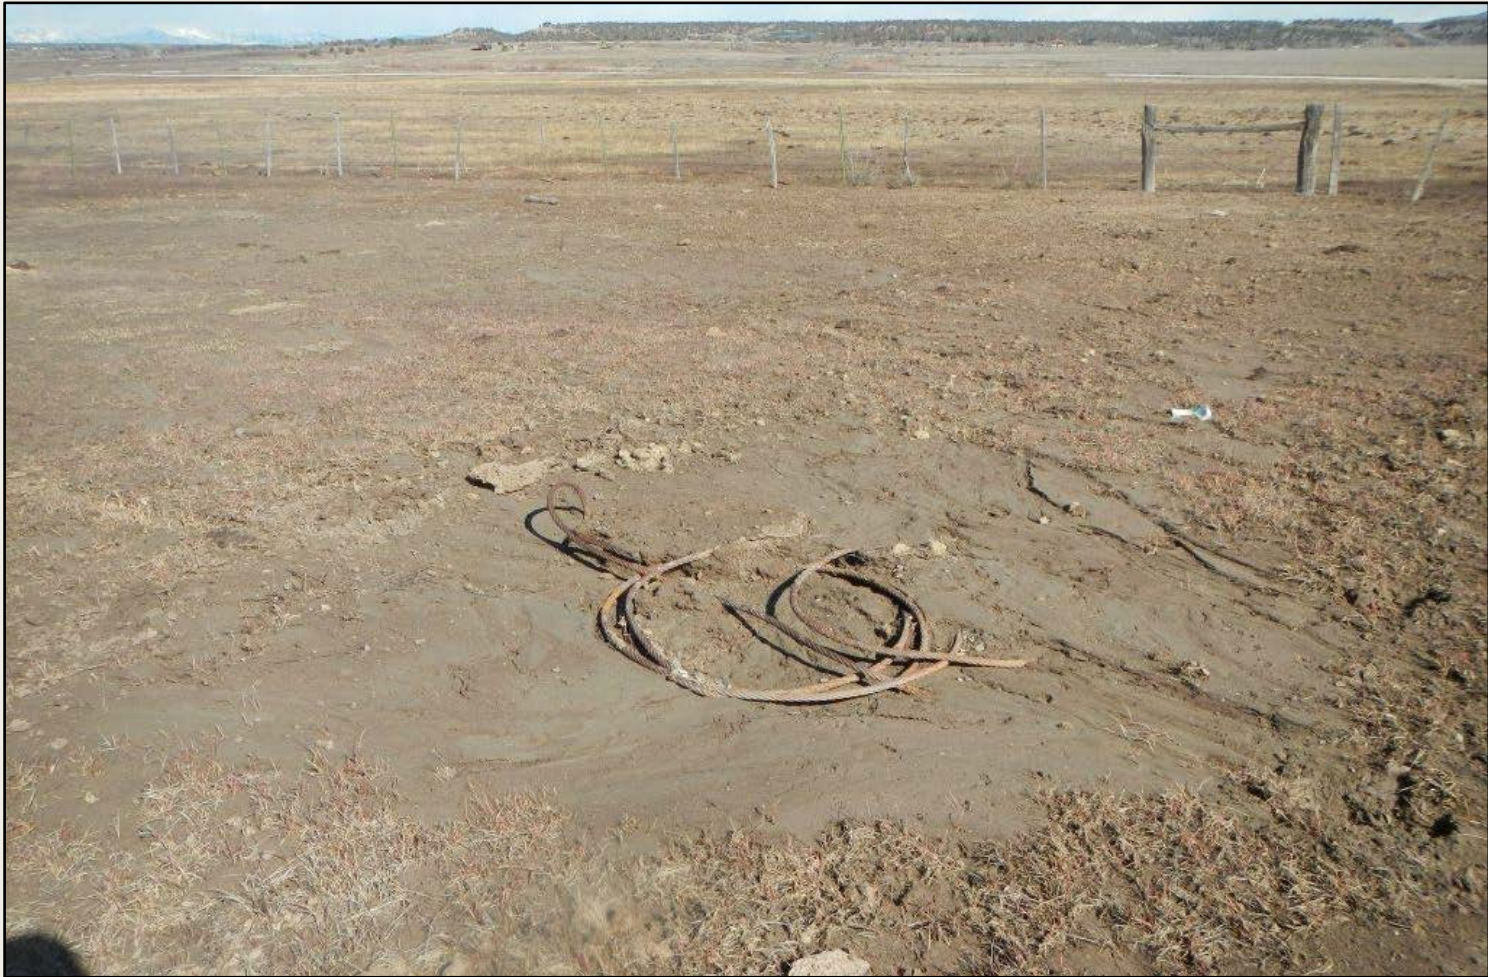
Photo 5. View of cable debris that appears to be exposed by erosion.

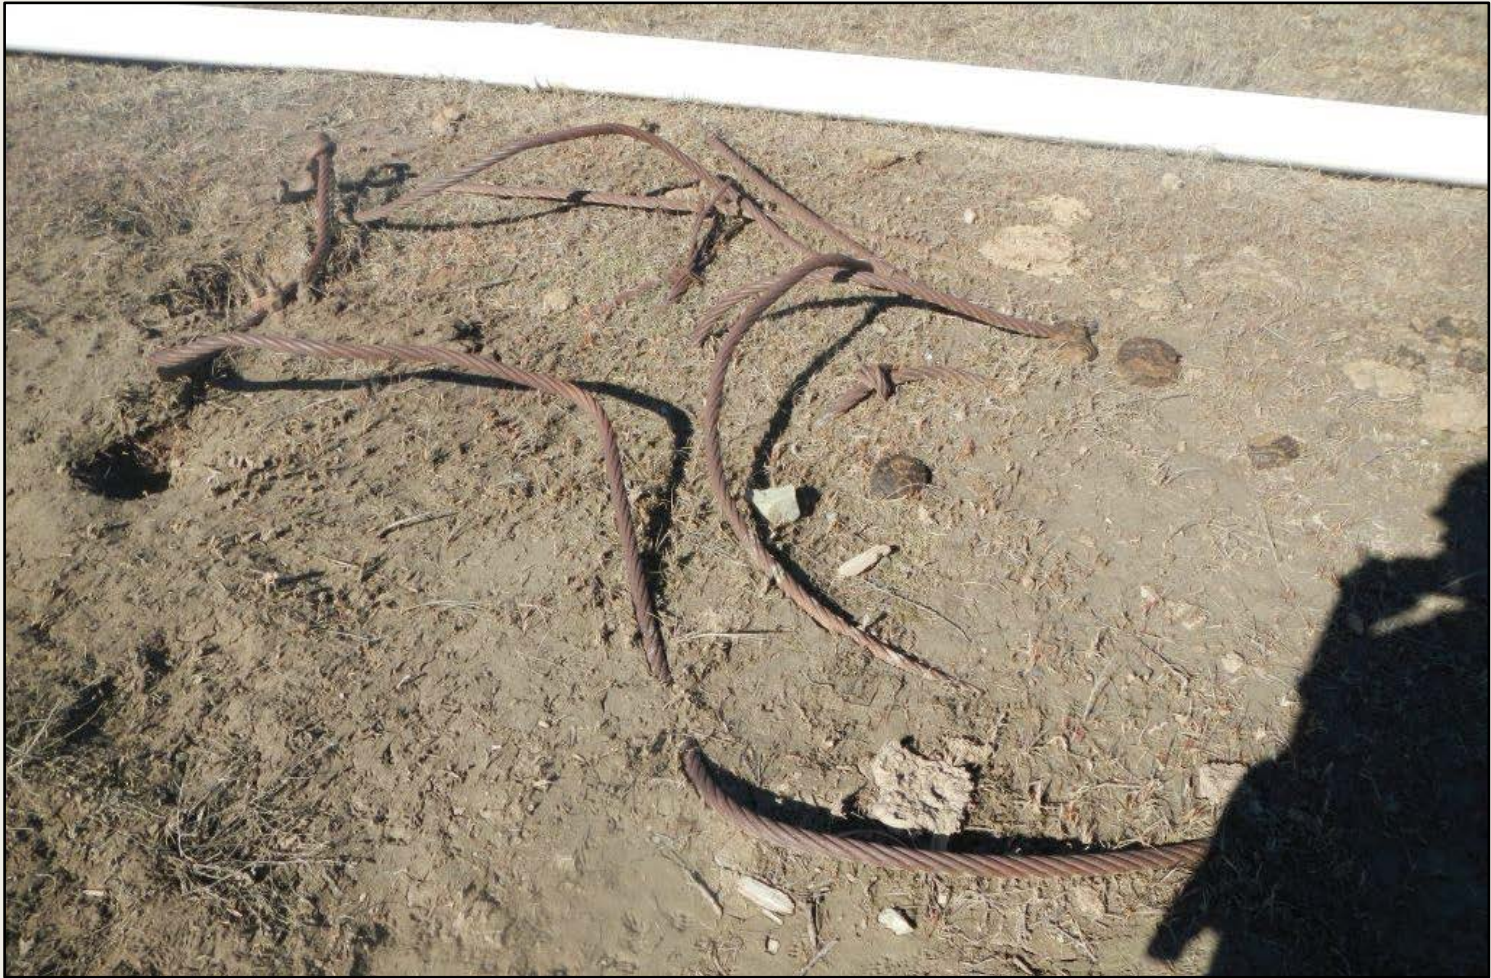
Photo 6. View of cable debris within the western project area.

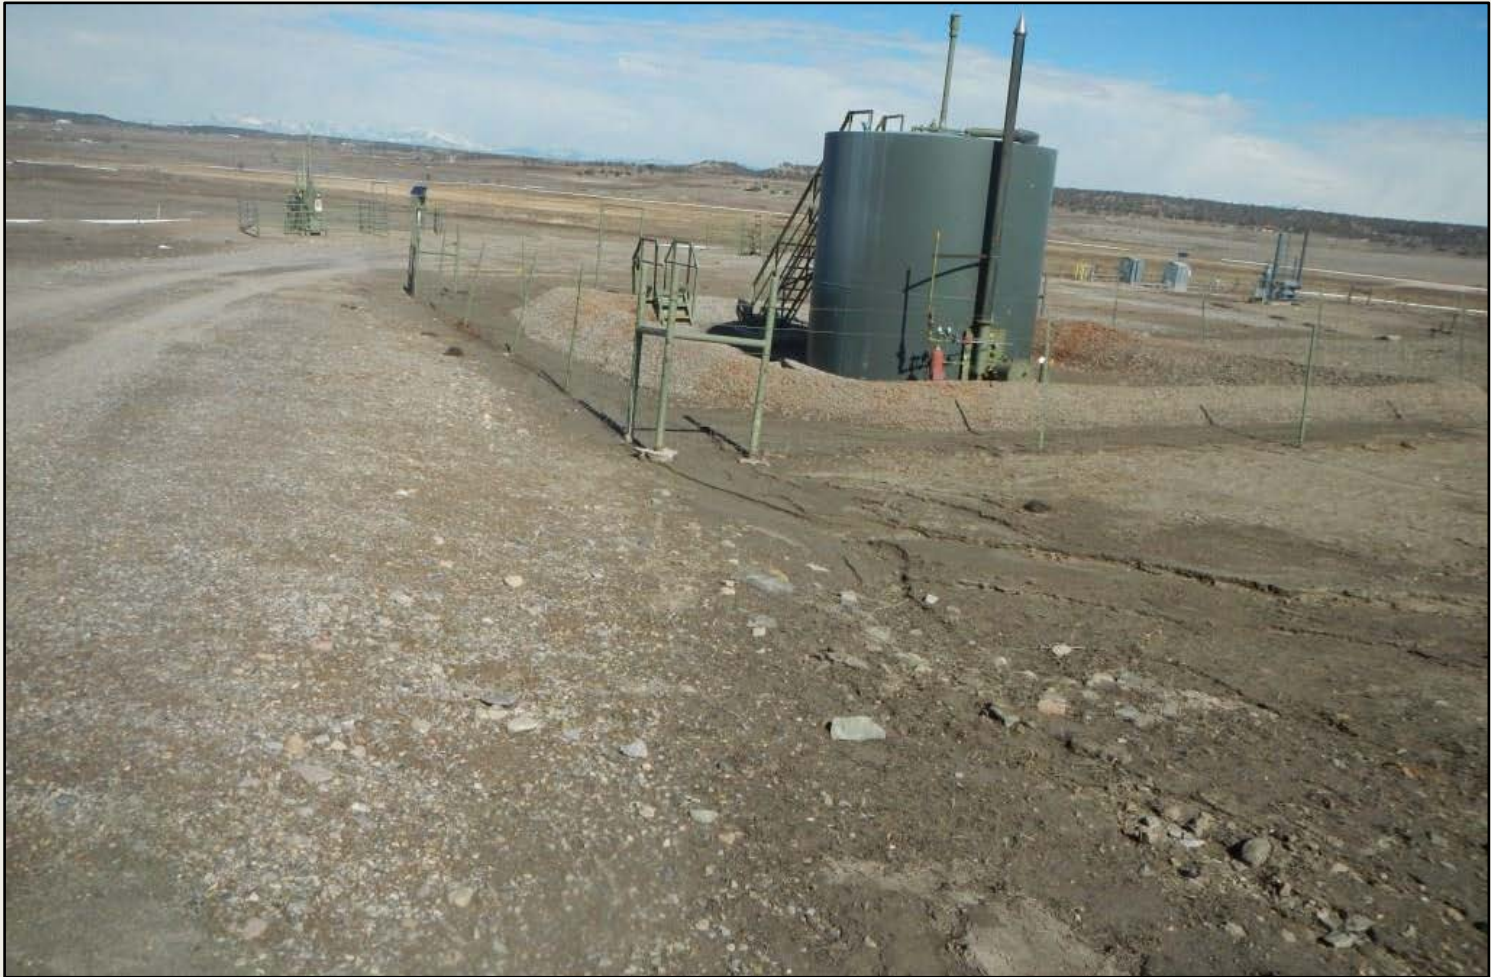
Photo 7. View of erosion occurring along the access road and onto the project area within the southeastern project area.
