**Inspection Photos**  
**Location Name: Adam George GU1**  
**Location ID: 318150**

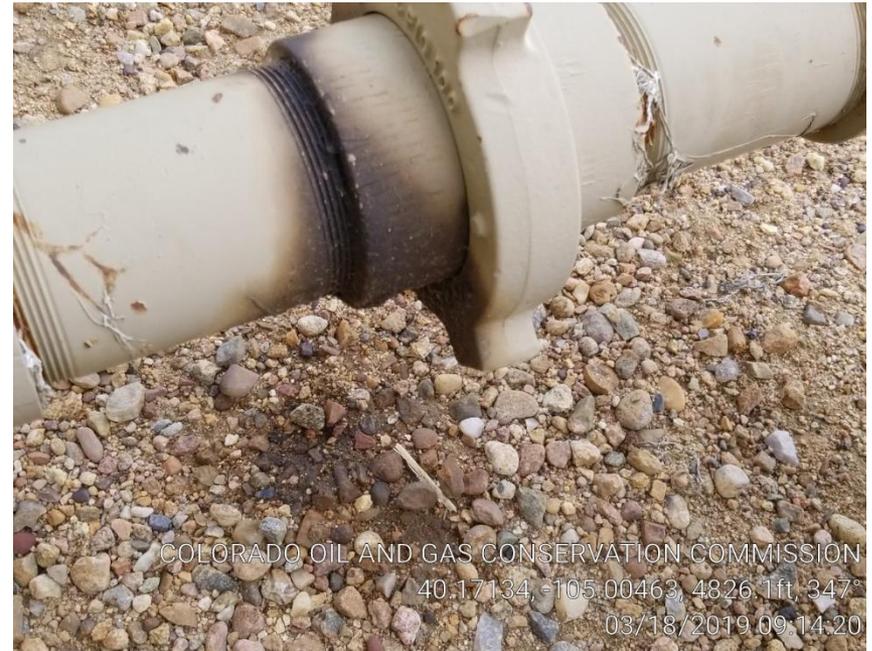
Pic 6 Possible leak

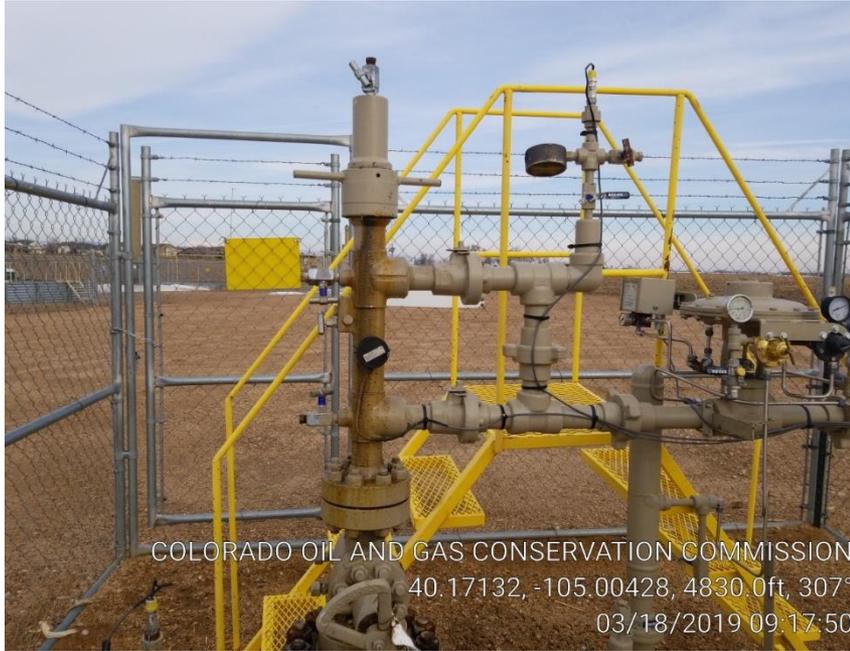
Pic 9. Possible leak on lubricator cap.

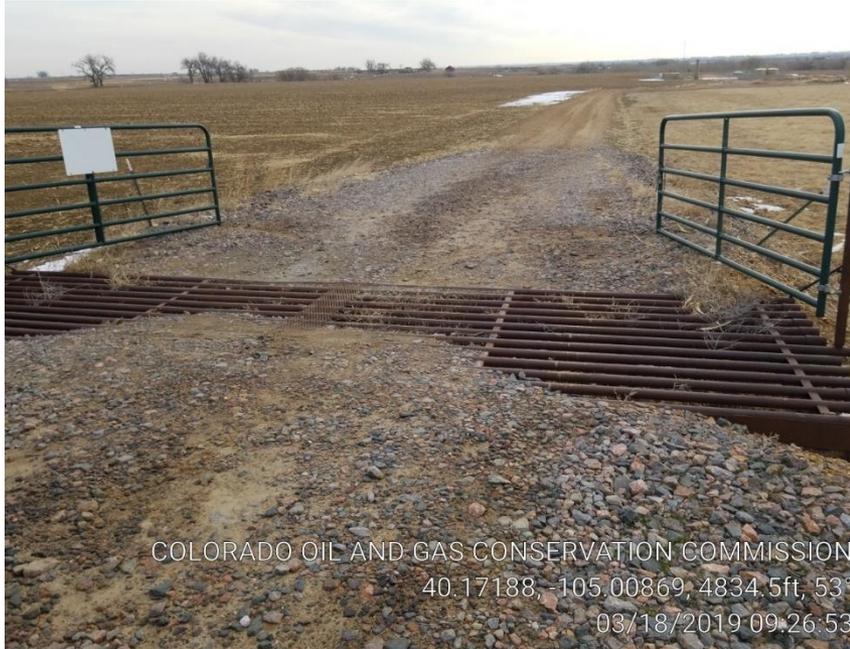
**Lease Road Entrance. Pic 19**
