Interim Reclamation Inspection

Operator: RED HAWK PETROLEUM LLC - #10503

Location ID: 428225

Inspection Photos
Location: Leggett #1-5H
Location ID: 428225

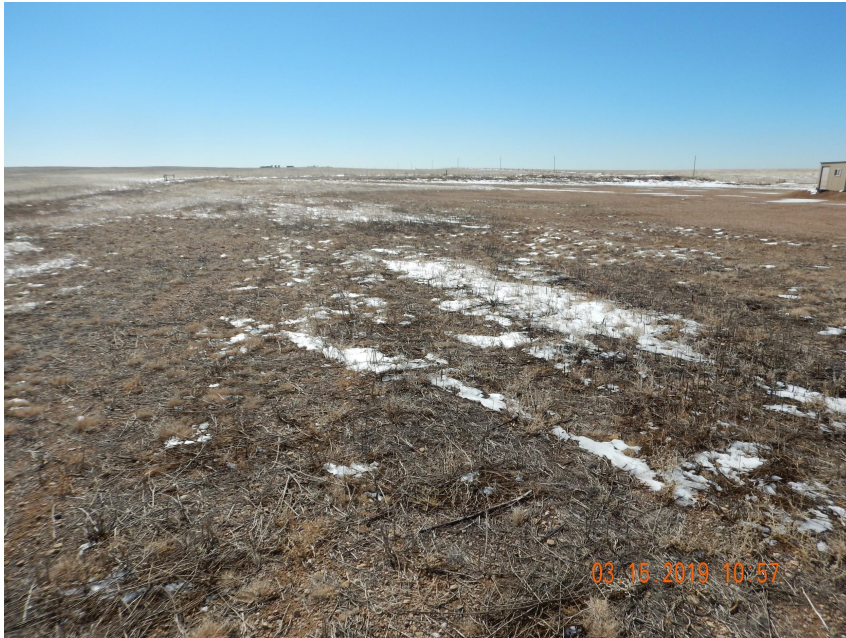
Photo 1. Photo taken from the northeastern well pad, facing South. Operator has failed to perform interim reclamation per Rule 1003.b. to reduce disturbance areas only reasonably needed for production operations.

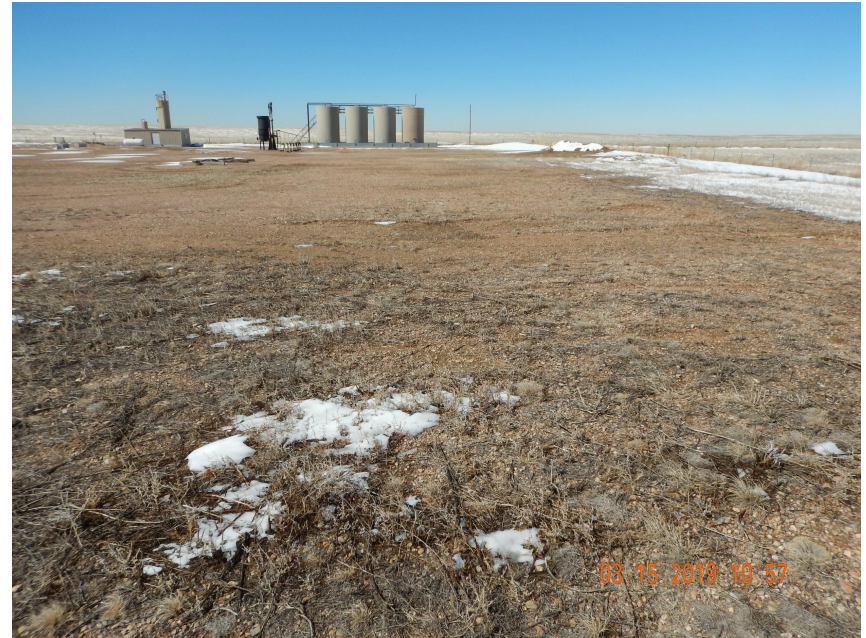
Photo 2. Photo taken from the northeastern well pad, facing West. See comments under Photo 1.

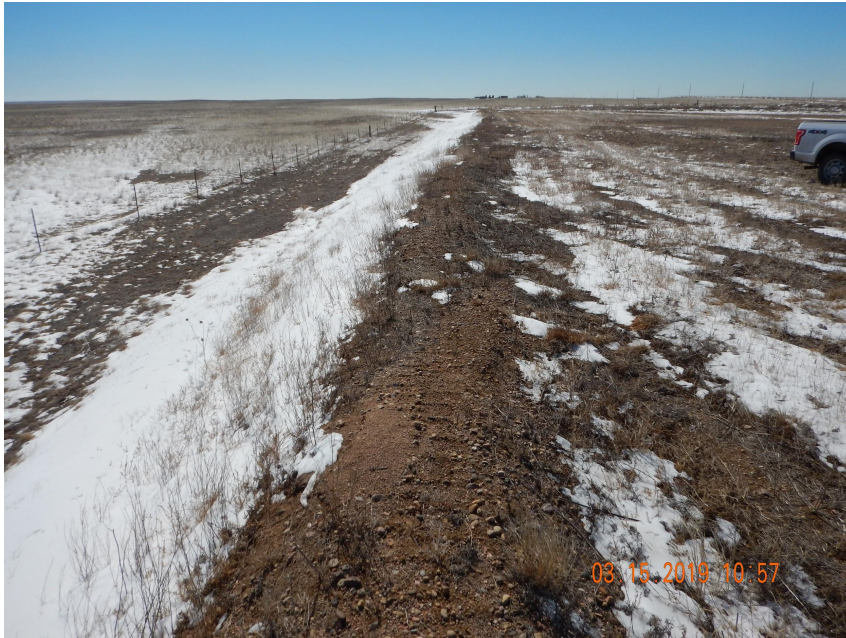
Photo 3. Photo taken from the northeastern well pad, facing South. See comments under Photo 1.

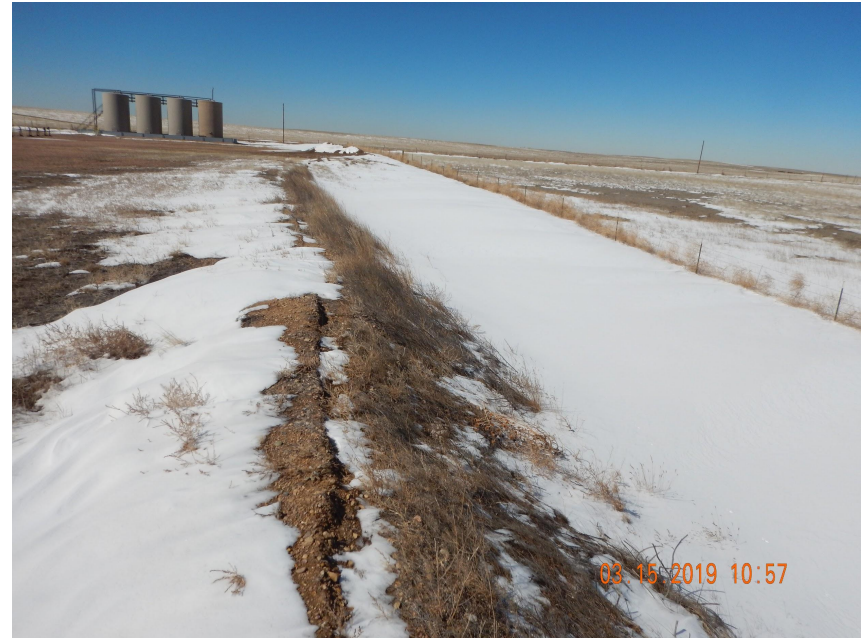
Photo 4. Photo taken from the northeastern well pad, facing West. See comments under Photo 1.

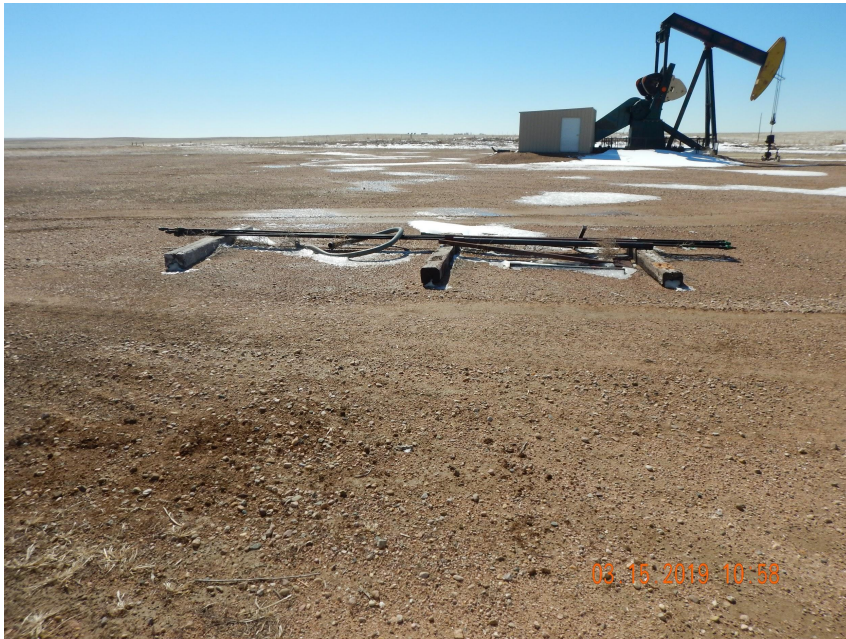
Photo 5. Photo taken from the well pad, facing South. Operator has failed to remove equipment from the previous inspection.

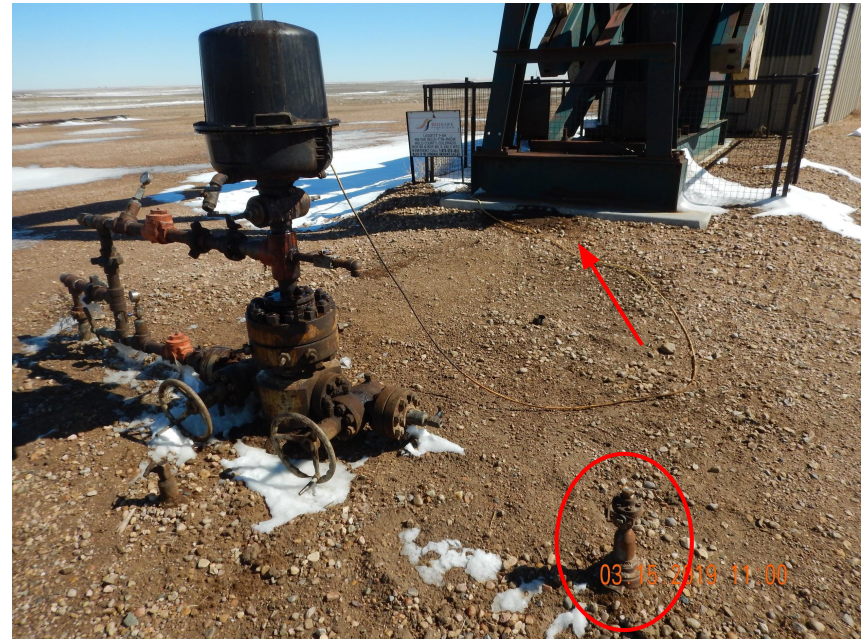
Photo 6. Photo taken from the wellhead, facing East. Appears the Operator has cleaned stained soil around the wellhead but has failed to remove the unused riser and stained soil was observed at the base of the pumpjack.

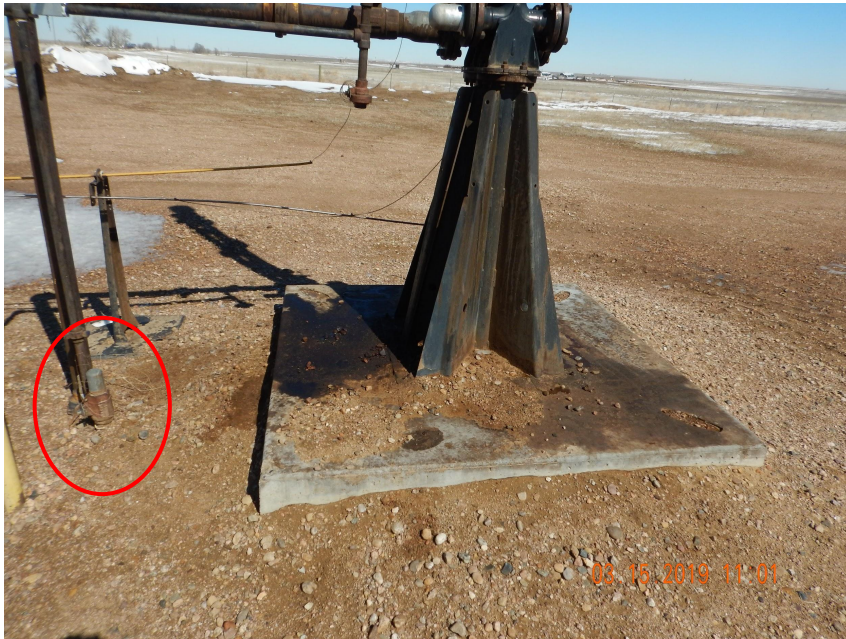
Photo 7. Photo taken from the flare, facing North. Operator has failed to inspect at regular intervals and maintain in good mechanical condition per Rule 605.d. Also, unused riser observed.

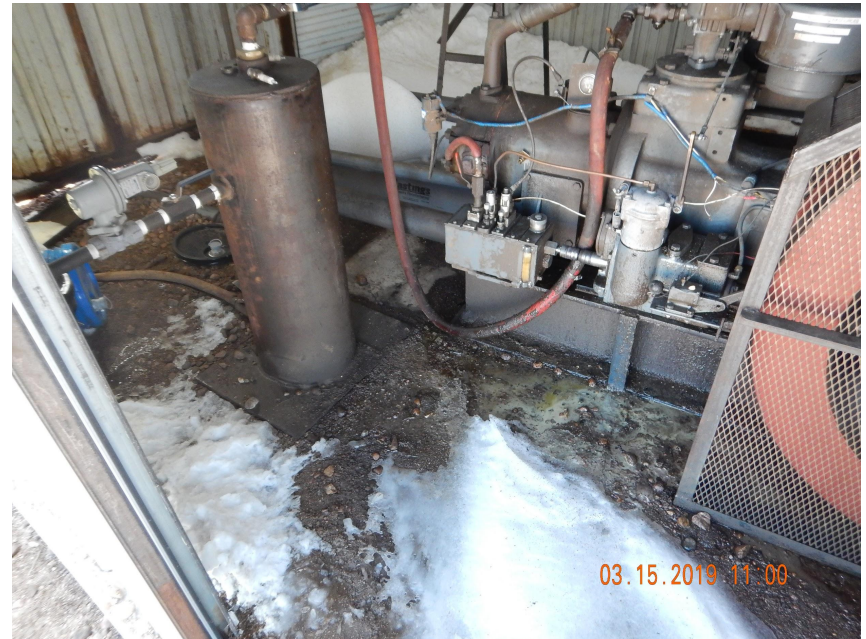
Photo 8. Photo taken from the engine. See comments under Photo 7.

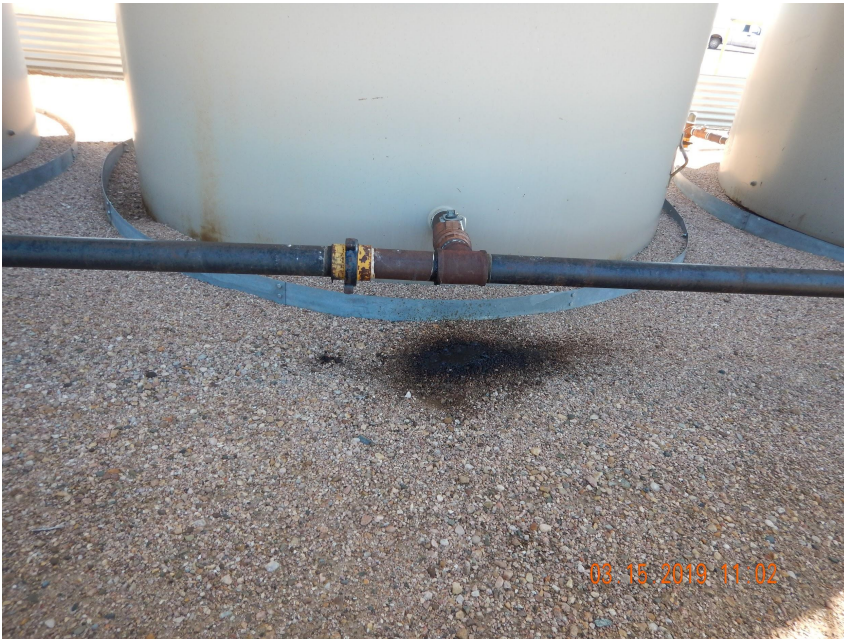
Photo 9. Photo taken from the loadout. See comments under Photo 7.

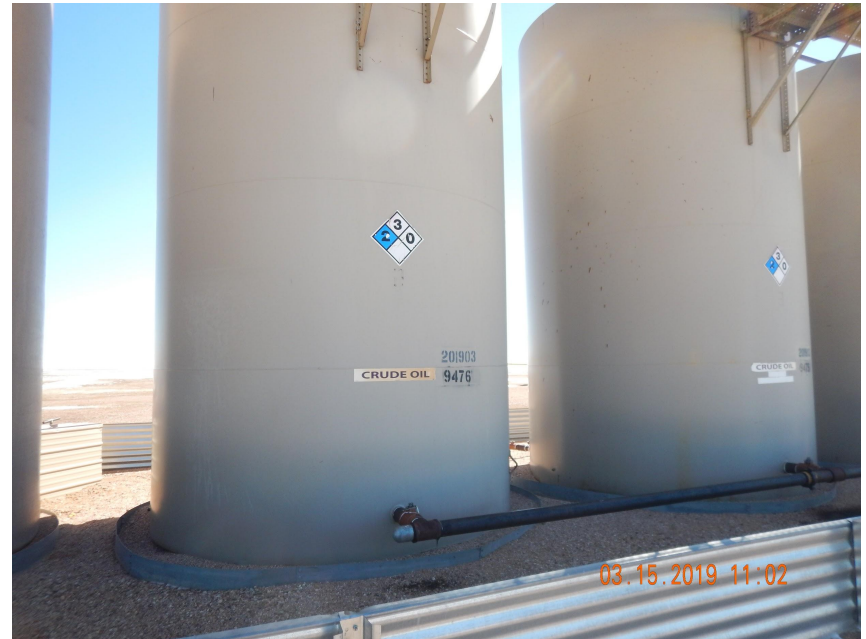
Photo 10. Photo taken from the production tanks, facing East. Operator has failed to perform the previous corrective action. No capacities on production tanks.

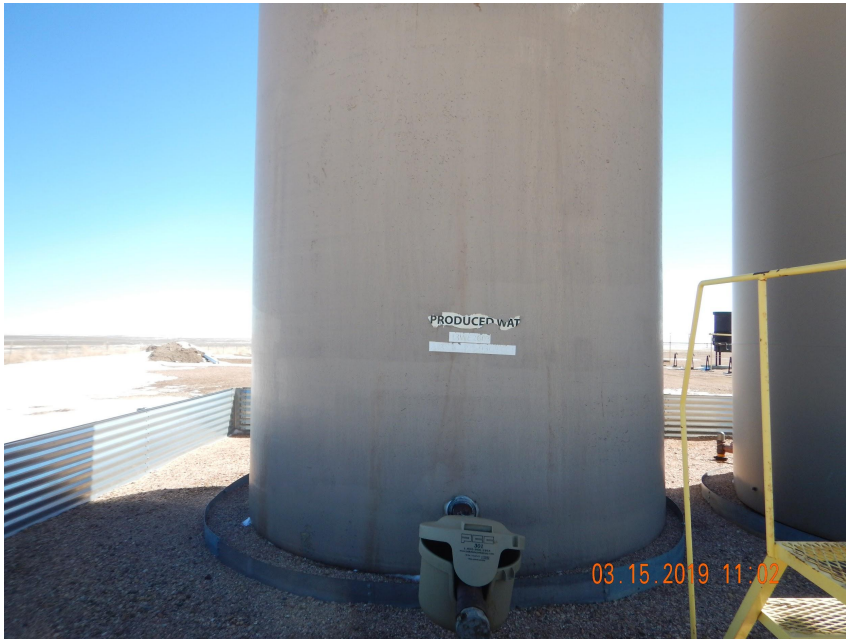
Photo 11. Photo taken from the produced water tank, facing East. Operator has failed to perform the previous corrective action. No safety placarding.
