# Interim Reclamation and Stormwater Inspection

March 5, 2019

Operator: SRC ENERGY INC - 10311

Location ID: 436152

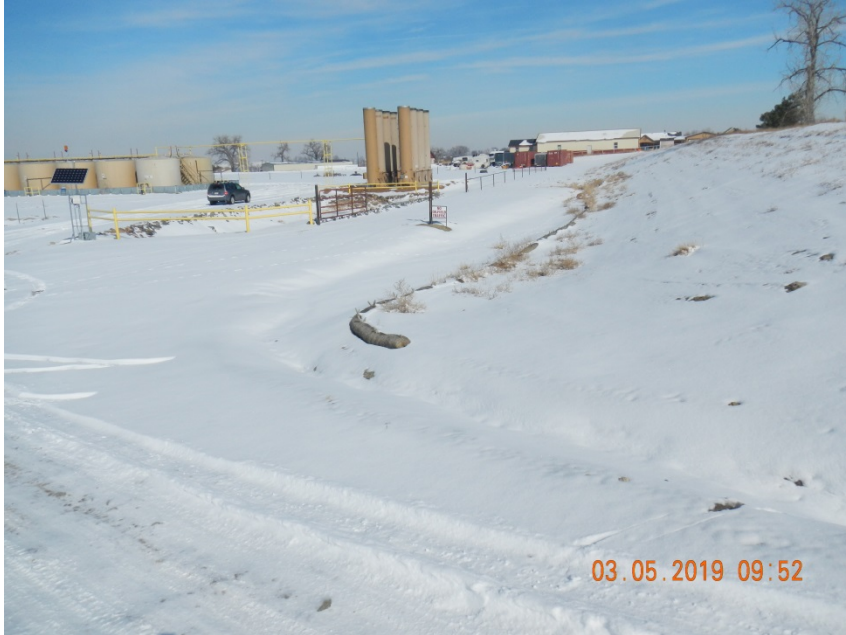
**Photo 1.** Photo taken from the eastern perimeter of the location, facing Northwest. Appears the Operator has not performed interim reclamation activities to reduce disturbance areas only needed for production operations at the location.

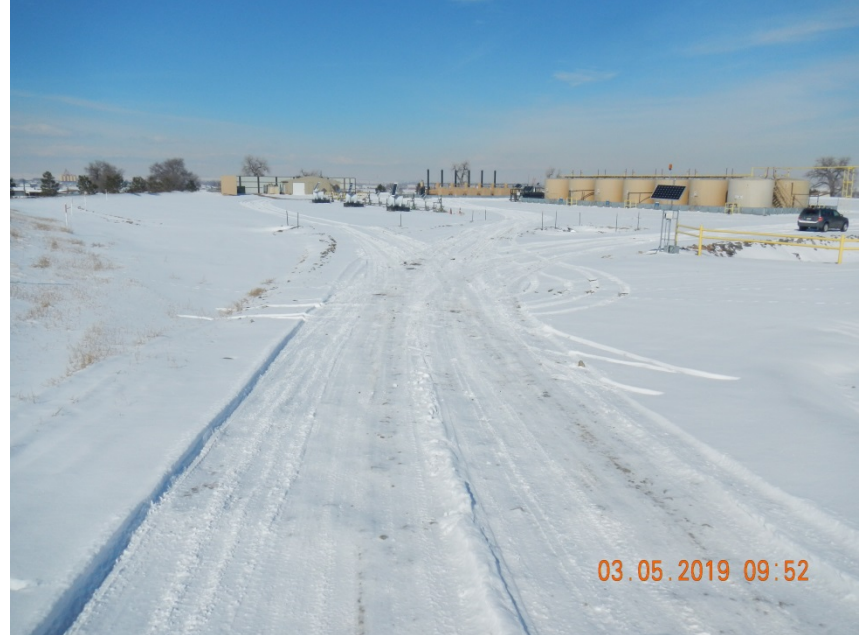
**Photo 2.** Photo taken from access road looking into the location, facing West. See comments from Photo 1.

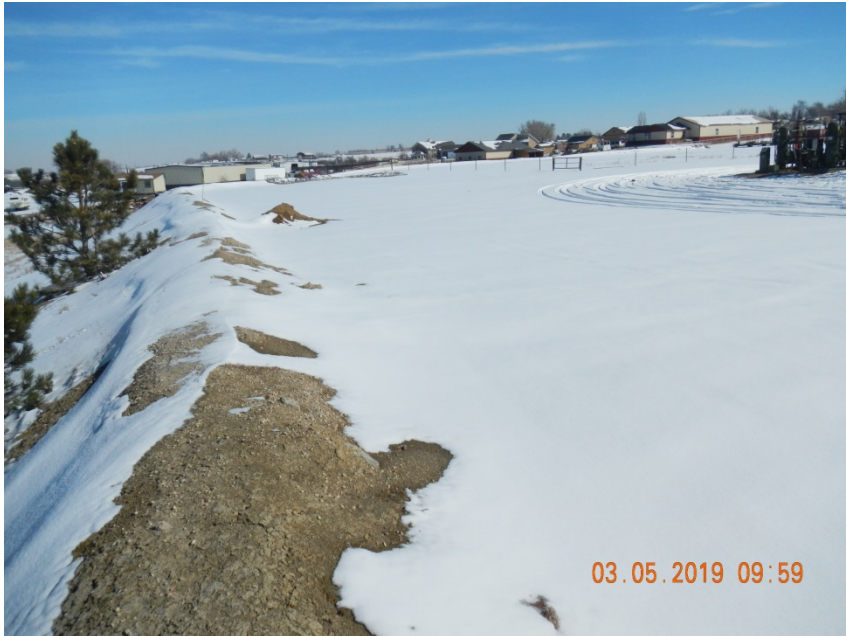
**Photo 3.** Photo taken from the location, facing West. See comments from Photo 1.

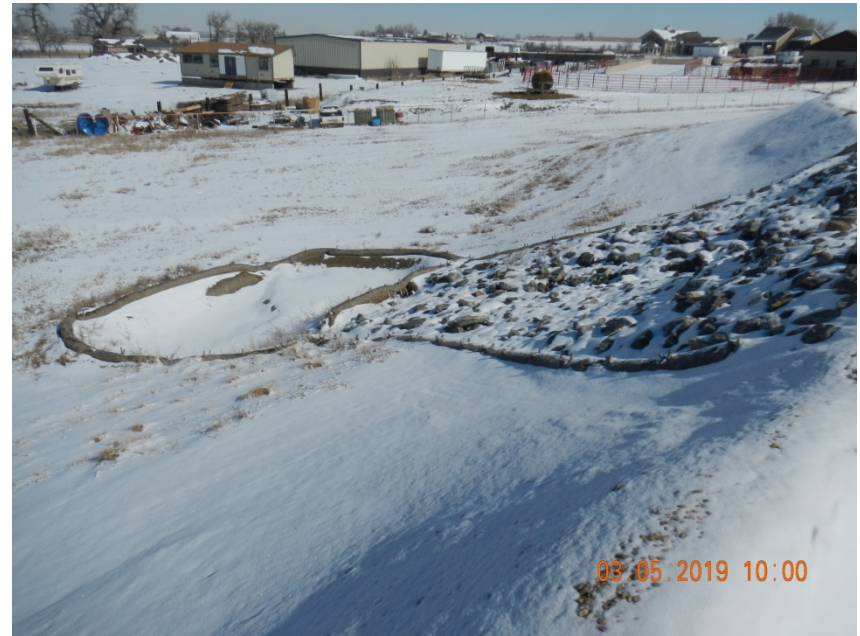
**Photo 4.** Photo taken from the northwestern perimeter of the location, facing North. Appears the Operator installed sediment trap with a temporary stabilized outlet.

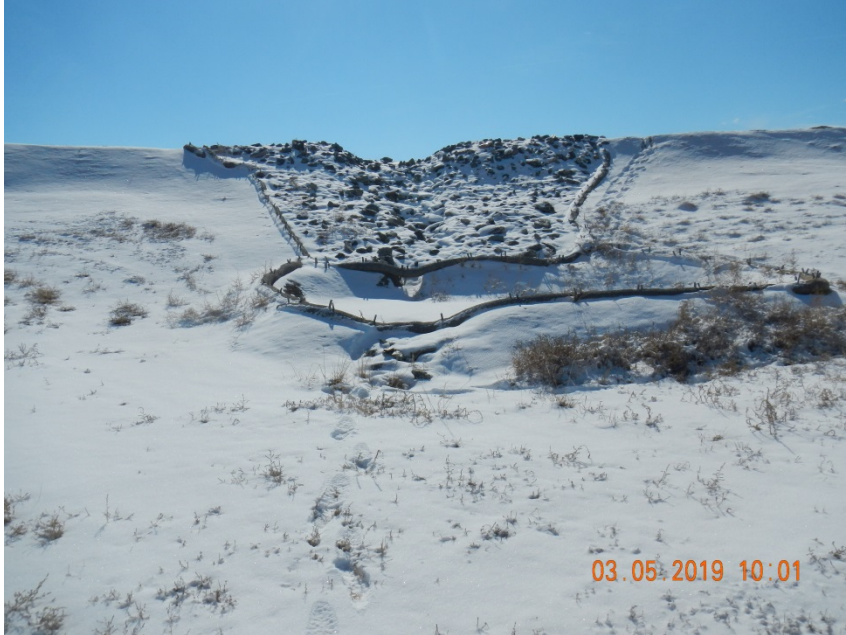
**Photo 5.** Photo taken from the location, facing East. See comments from Photo 4. At the time of this inspection, it appears the Operator has installed sufficient stormwater and erosion control BMPs in accordance to Rule 1002.f. standards.

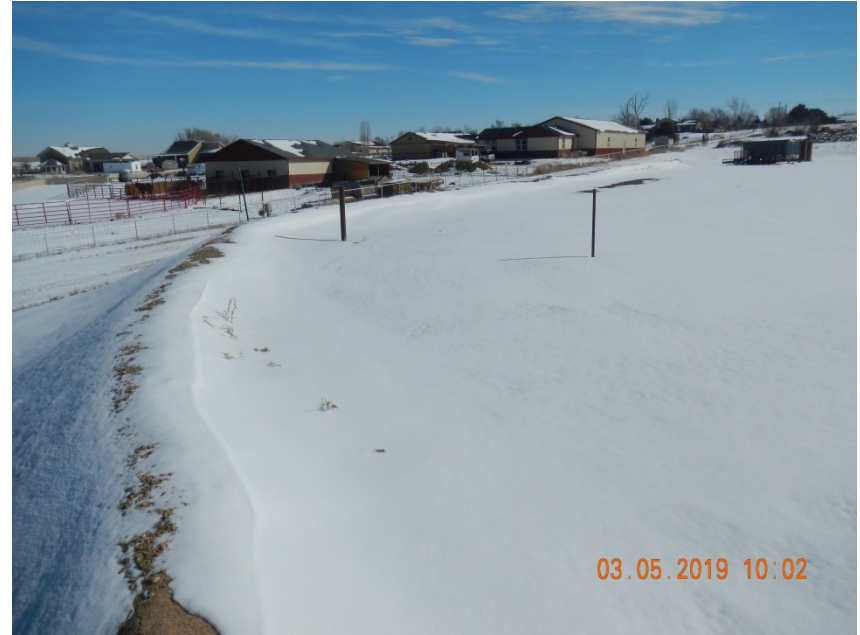
**Photo 6.** Photo taken from the northwestern perimeter of the location, facing North. See comments from Photo 1.

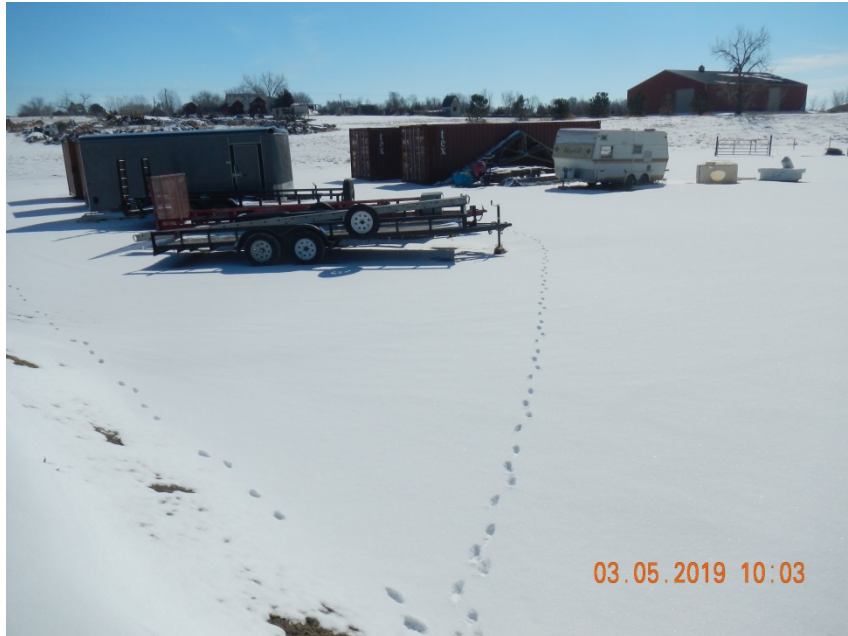
**Photo 7.** Photo taken from the northeastern perimeter of the location, facing East. Appears land owner potentially is storing equipment on location.

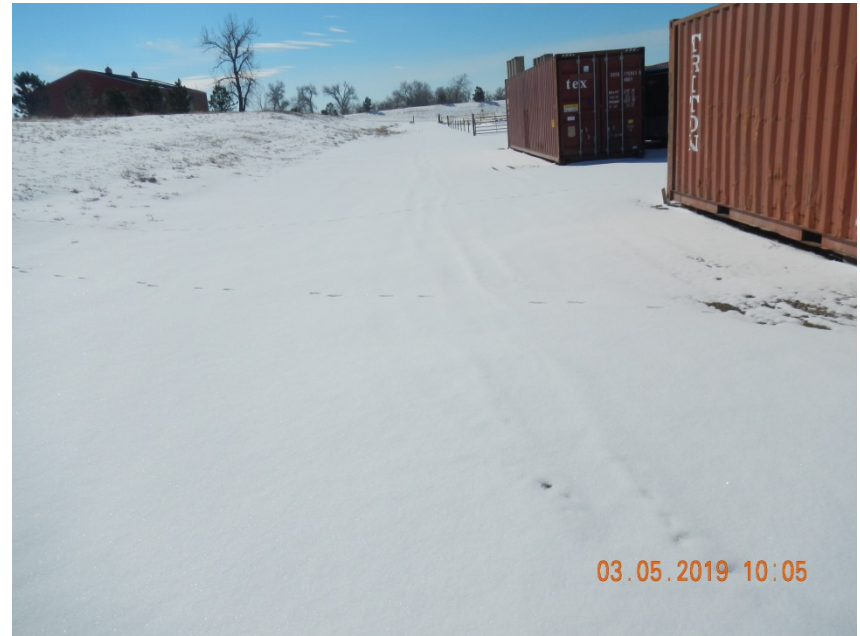
**Photo 8.** Photo taken from the northern perimeter of the location, facing South. See comments from Photo 7.

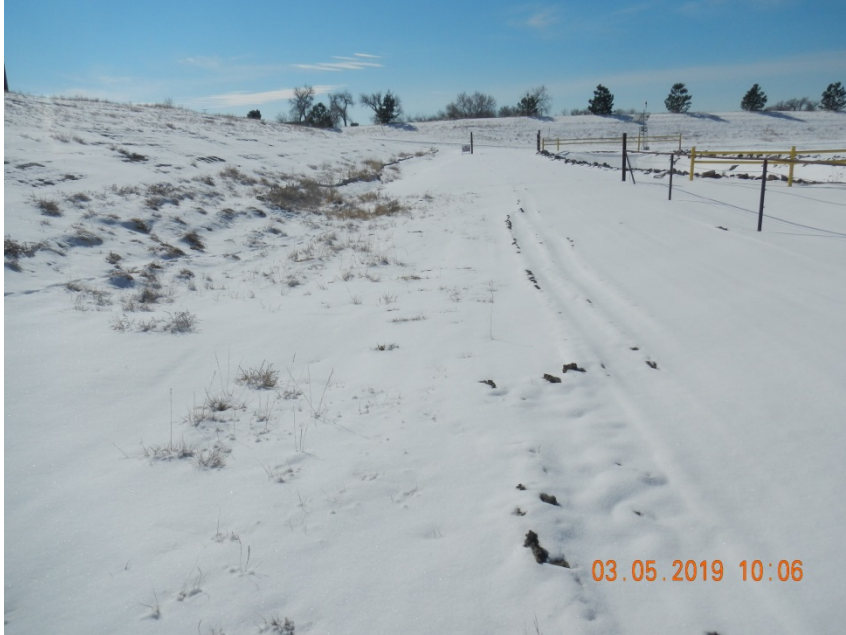
**Photo 9.** Photo taken from the eastern perimeter of the location, facing South. See comments from Photo 1.

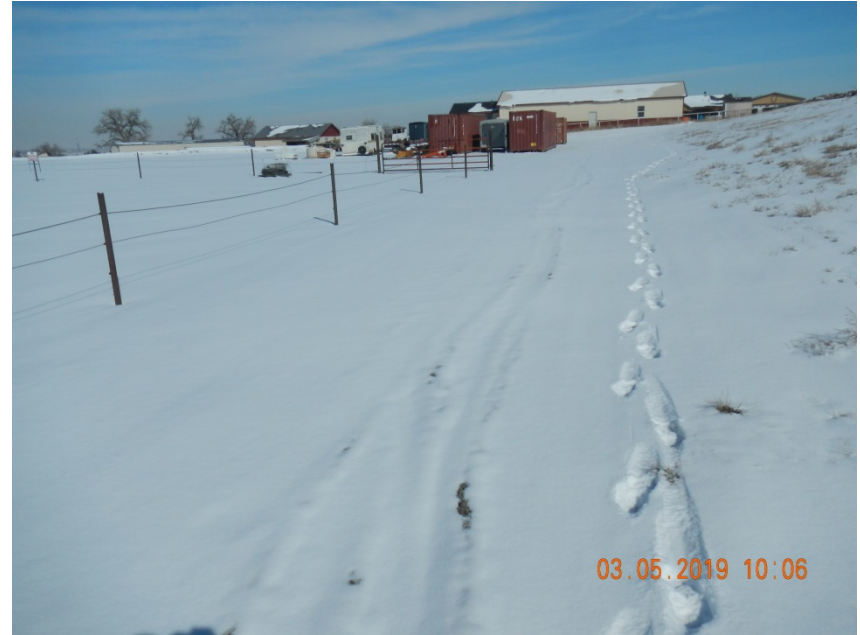
**Photo 10.** Photo taken from the eastern perimeter of the location, facing North. See comments from Photo 1

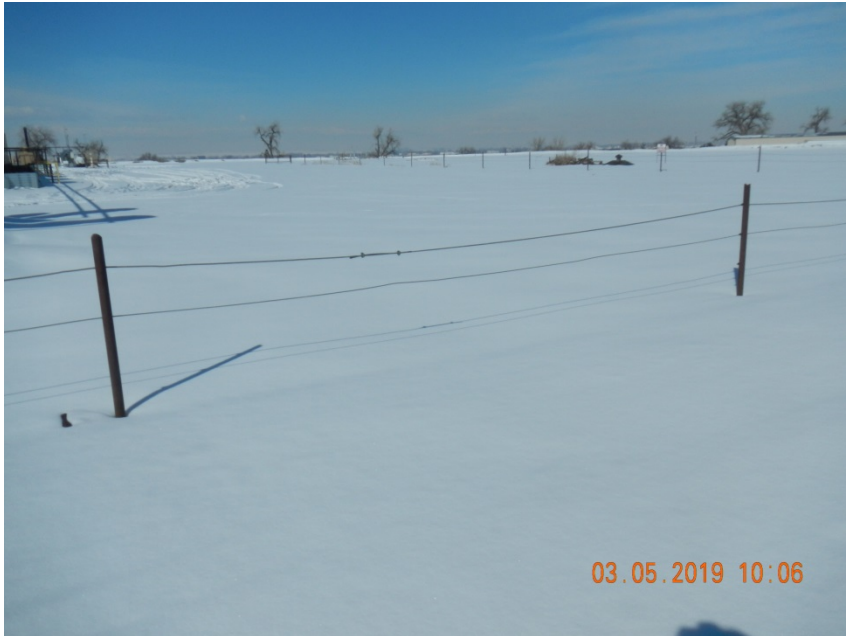
**Photo 11.** Photo taken from the eastern perimeter of the location, facing West. See comments from Photo 1.

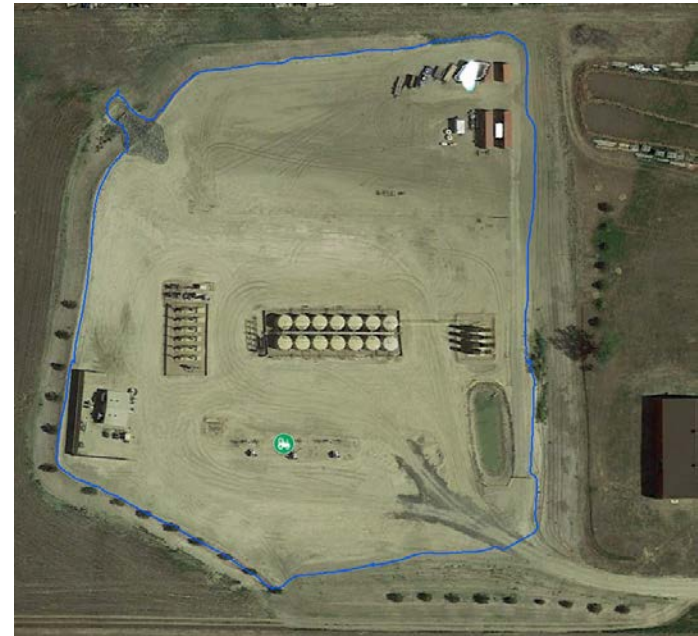
**Photo 12.** Aerial imagery showing the current 5.35 acre disturbance area in the blue polygon. The approved 2A stated a disturbance area of 4.8 acres during construction and 1.6 acres after interim reclamation, which should have been completed by 1/28/2018 (6 months after production of the last well on location which was 7/28/2017).
