Inspection Photos

API: 05-071-06396

Operator: TIMBER CREEK OPERATING LLC

Inspection Date: 3/20/2019

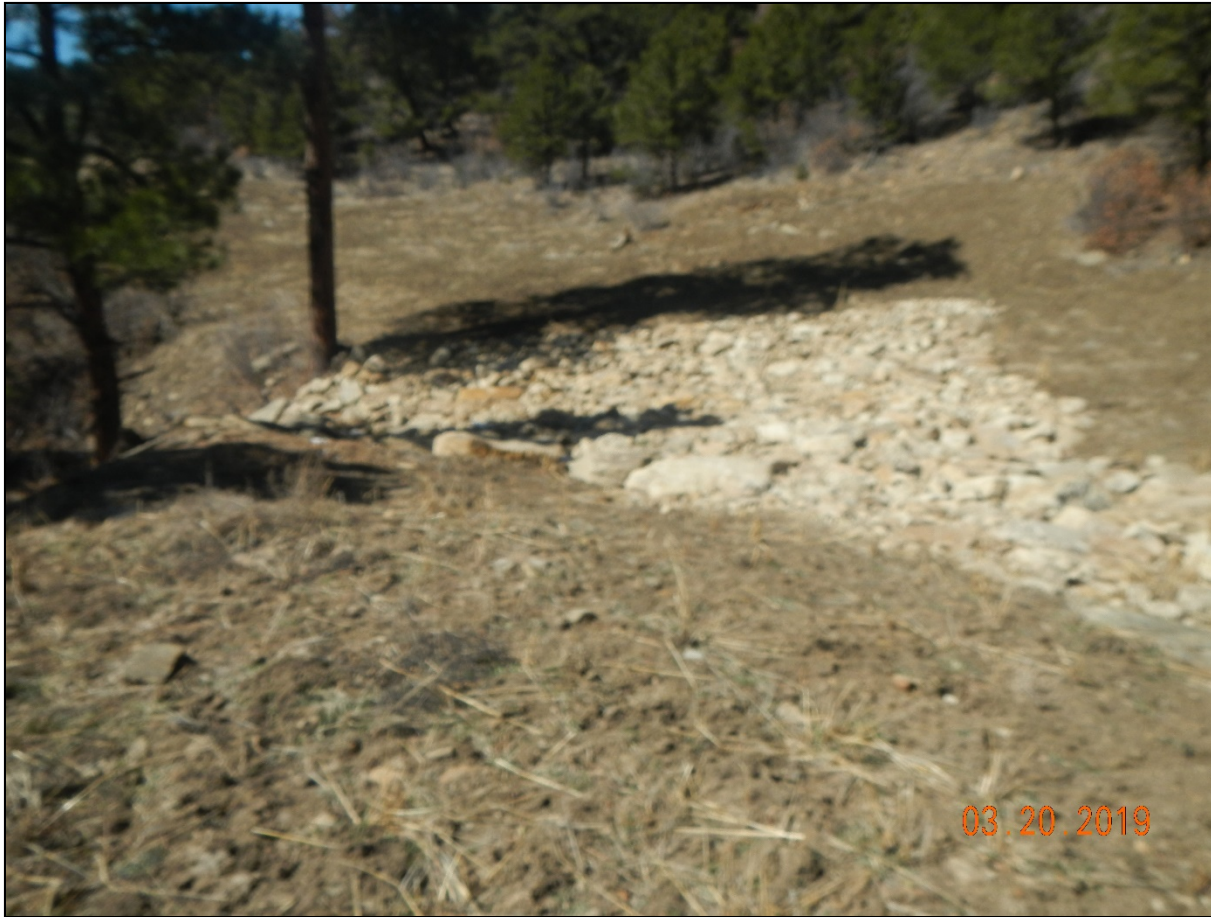
Photo 1. Facing toward the beginning of the reclaimed access road. Rock rip/rap has been placed in the drainage channel for erosion control.

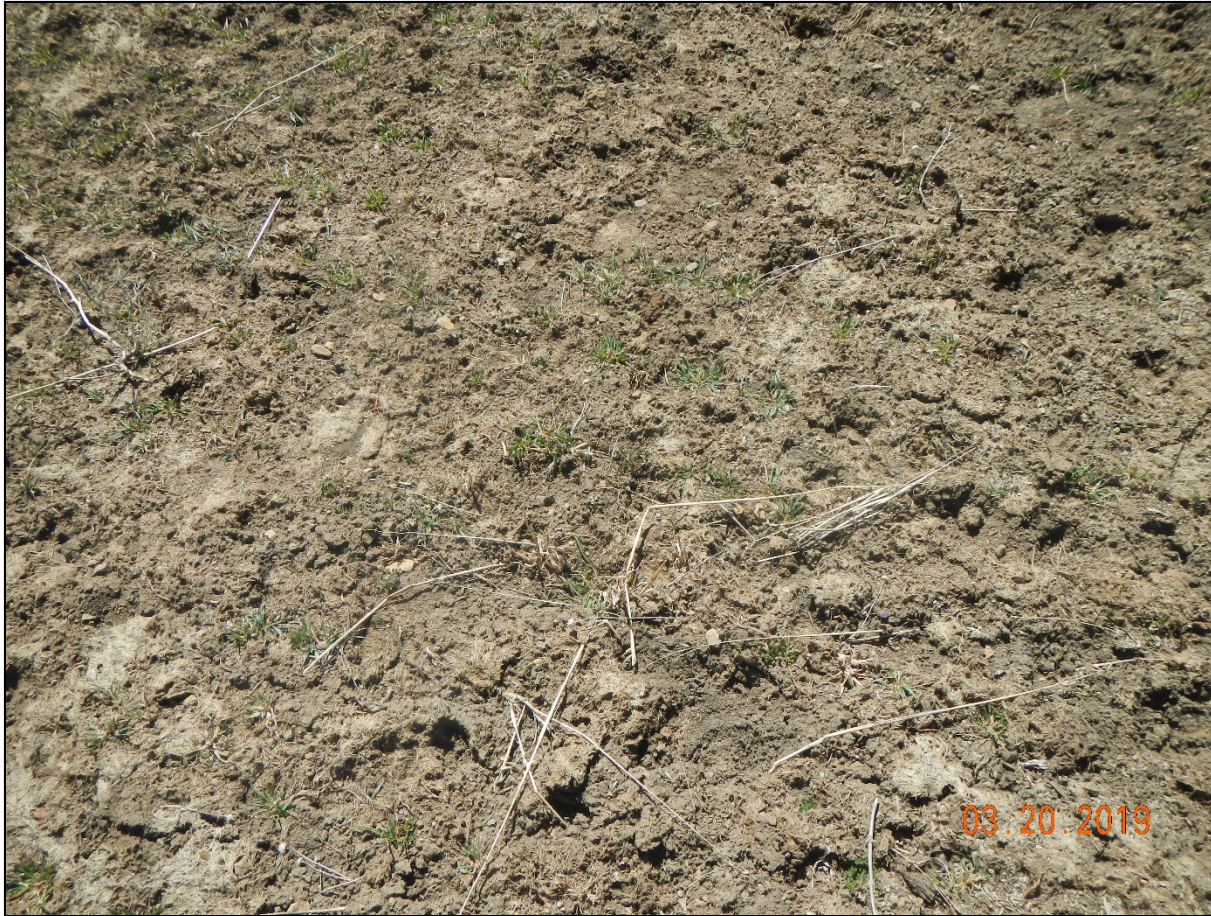
Photo 3. There is vegetation beginning to establish an areas along the road.
