Inspection Photos

API: 05-071-06399

Operator: TIMBER CREEK OPERATING LLC

Inspection Date: 3/20/2019

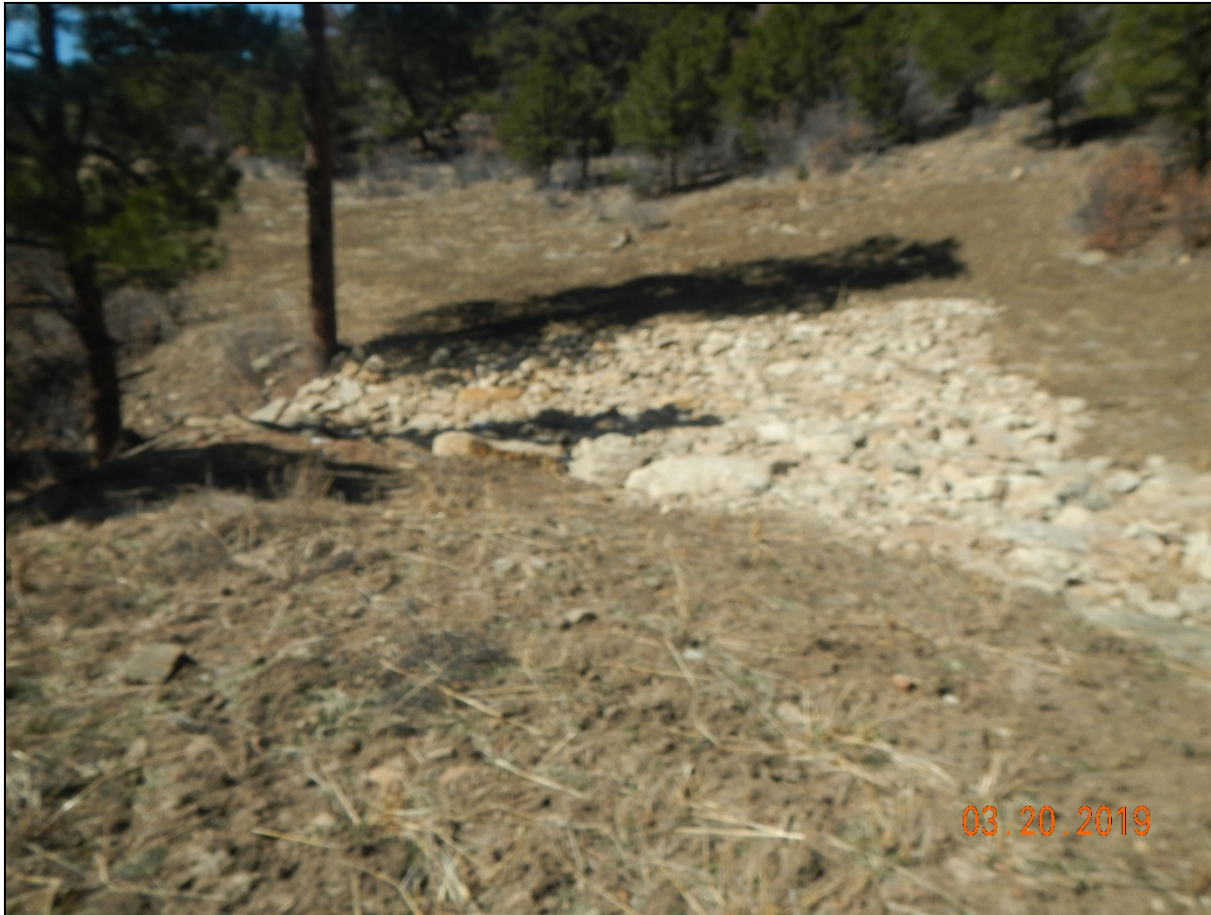
Photo 1. Facing toward the beginning of the reclaimed access road. Rock rip/rap has been placed in the drainage channel for erosion control.

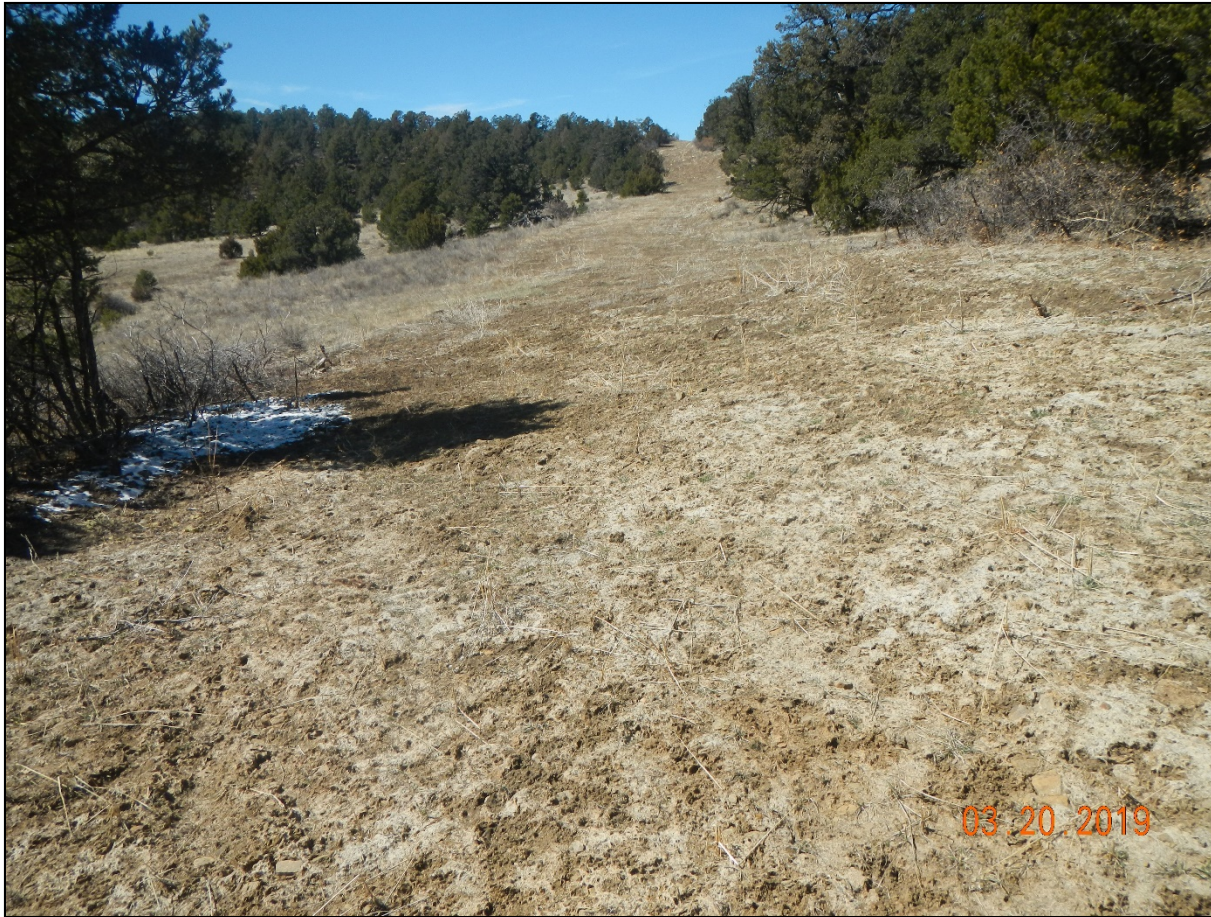
Photo 2. Facing west along the reclaimed access road.

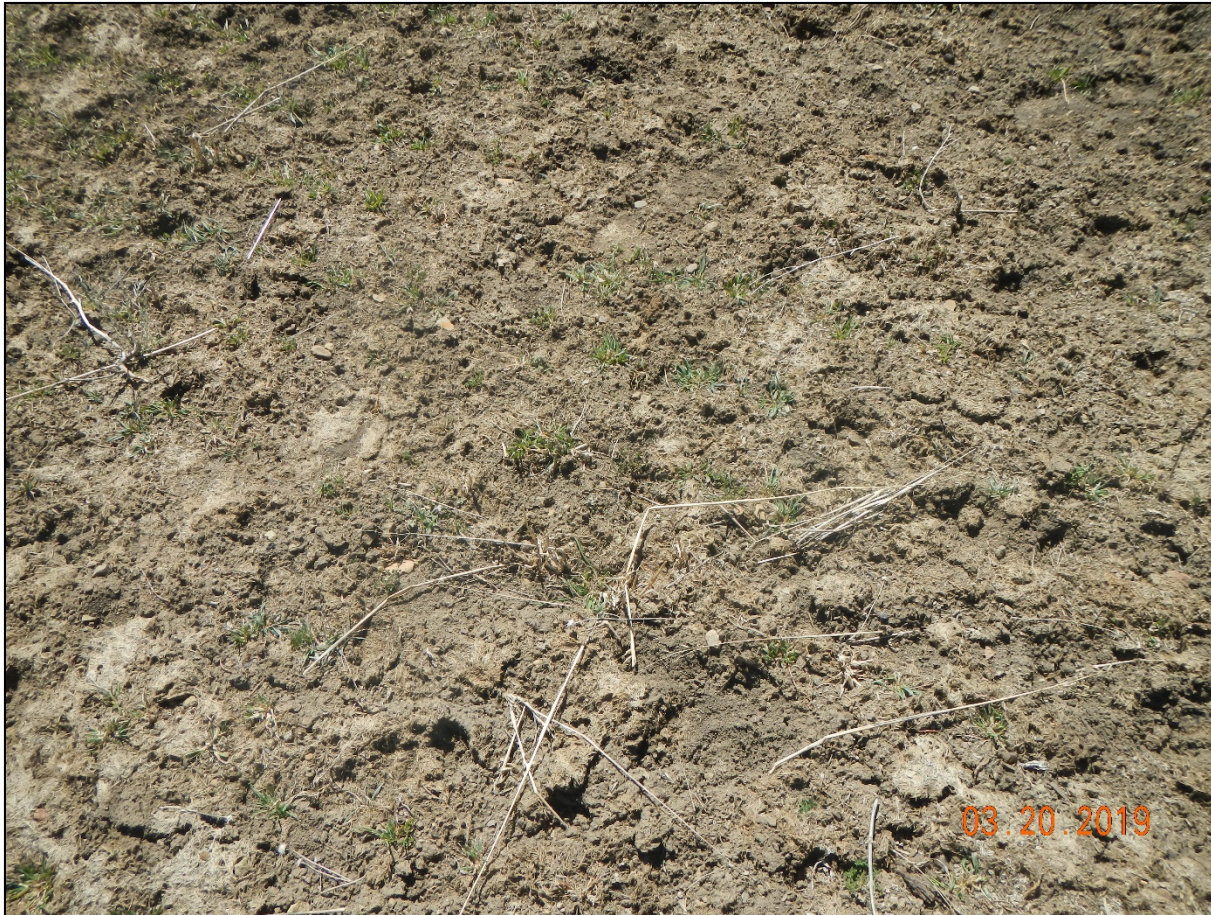
Photo 3. There is vegetation beginning to establish an areas along the road.

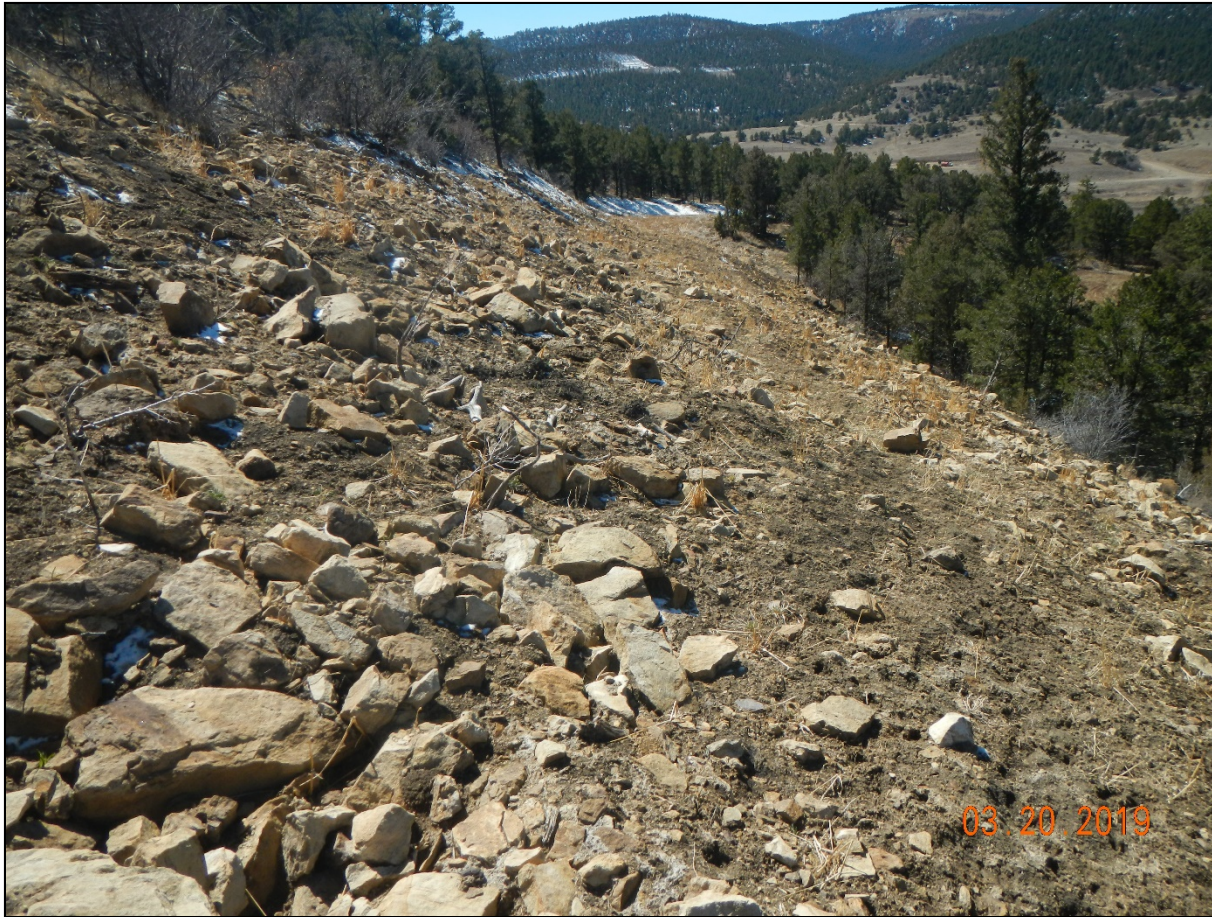
Photo 4. Facing southwest along the steep grade of the reclaimed road.

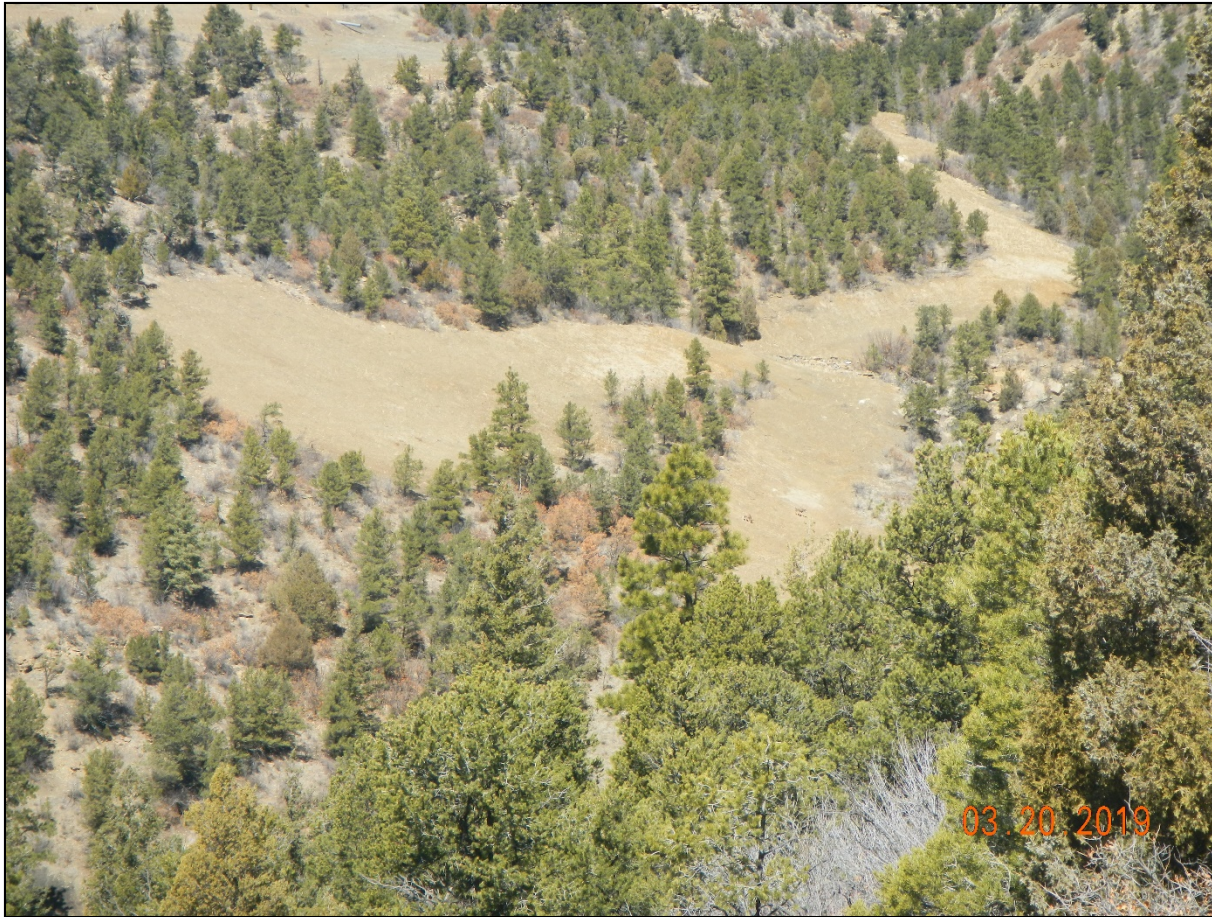
Photo 5. Facing northwest toward the GE-73-94 location from a distance.

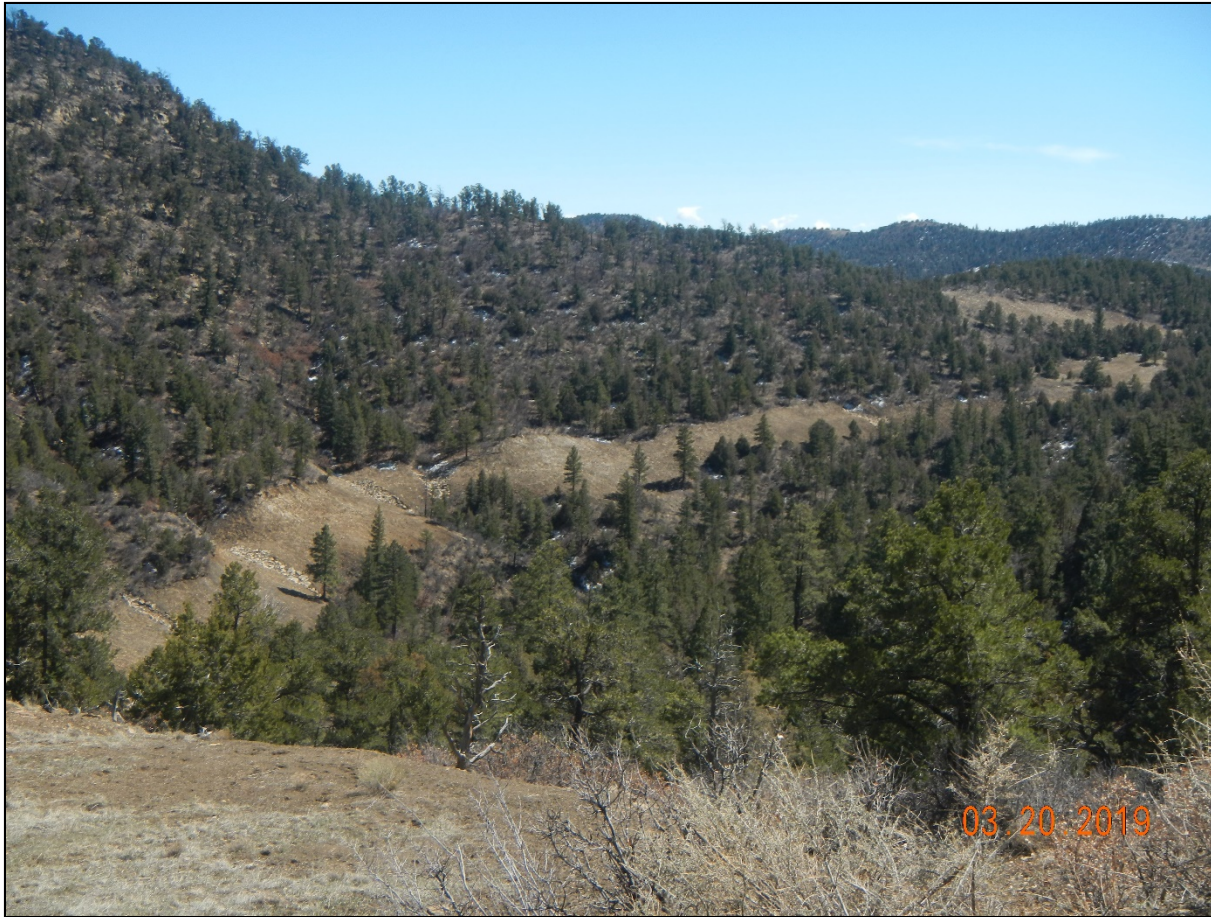
Photo 6. Facing southeast toward the GE-70-93 and GE-68-93 locations from a distance.
