Inspection Photos
Operator: Hilcorp Energy
Location/API #: 067-06663
Date: 2-18-2019

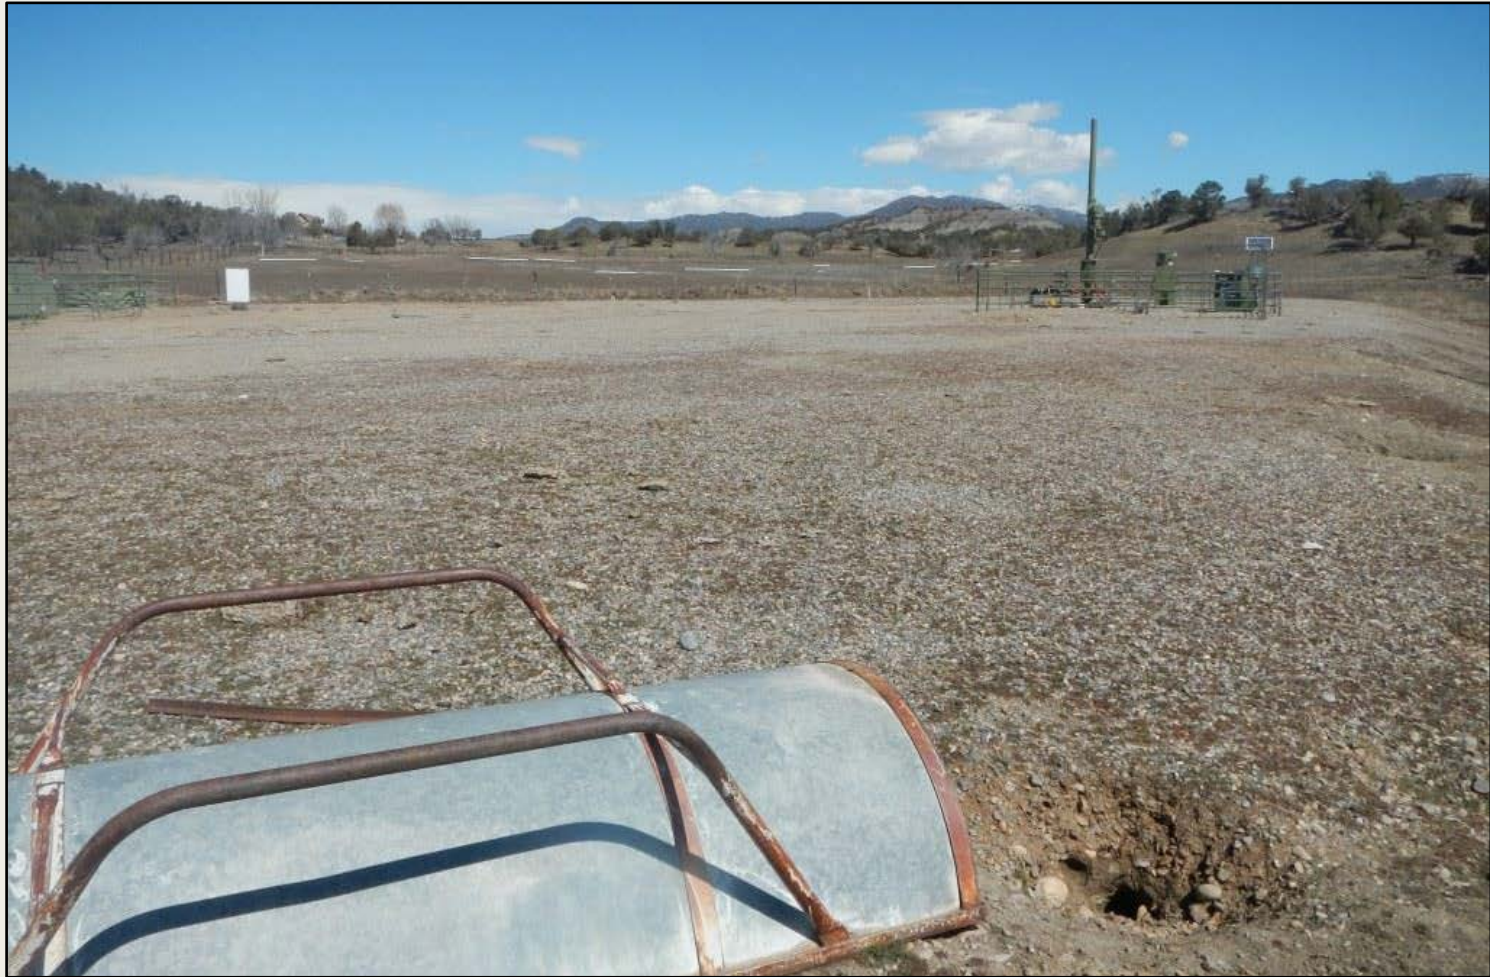
Photo 1. View of the project area from the southwestern edge facing center.

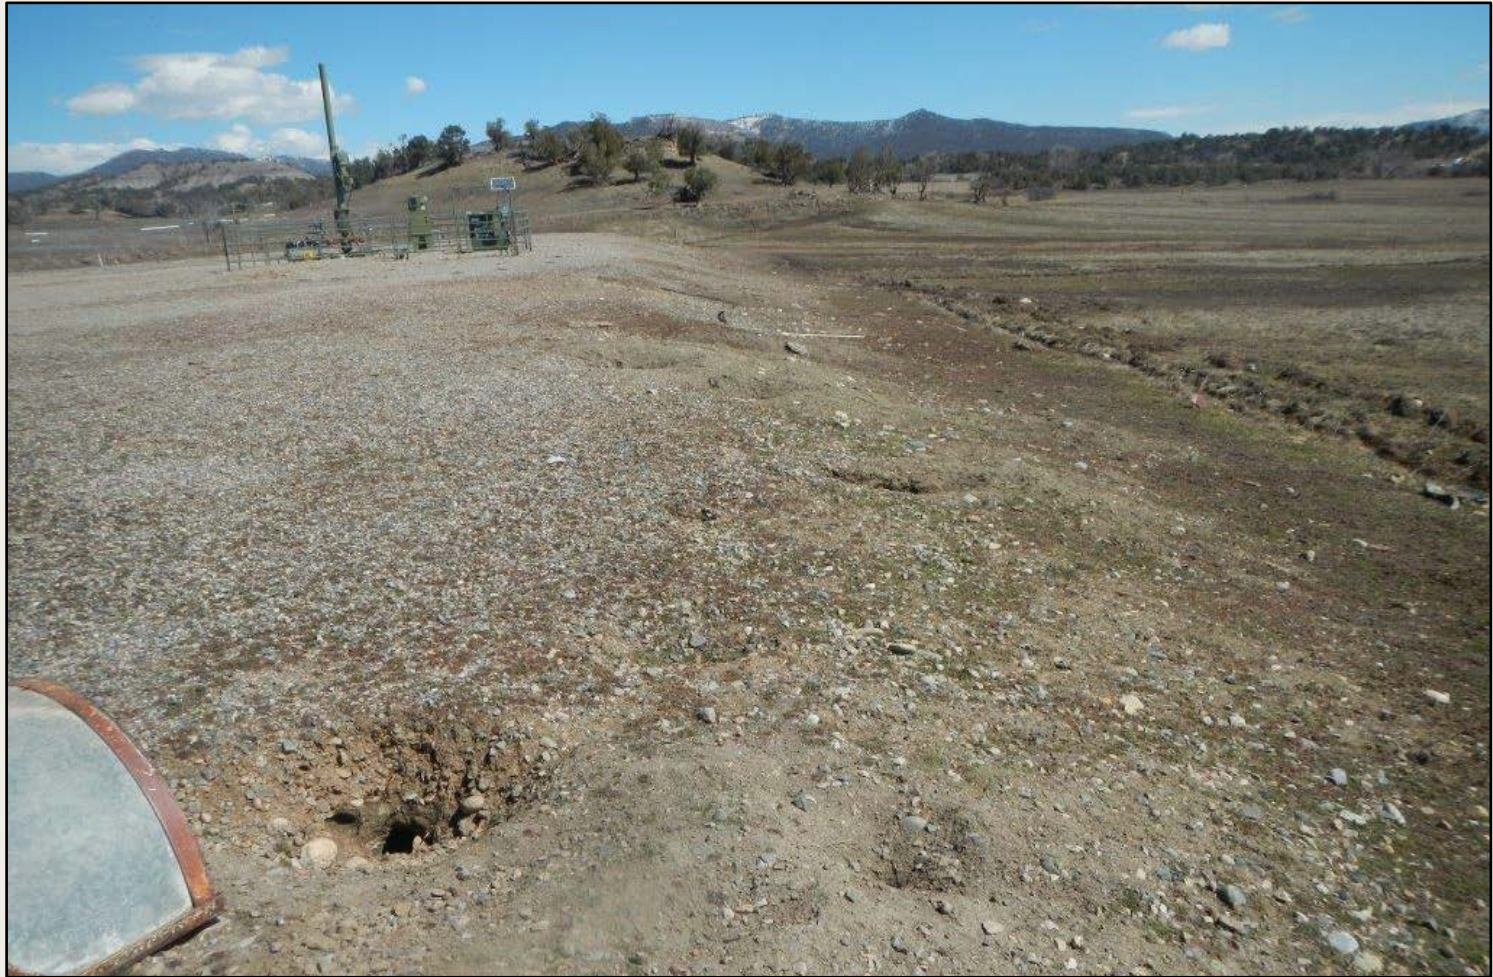
Photo 2. View of the southern project area from the southwestern edge facing eastward. Little desirable vegetation on fill slopes.

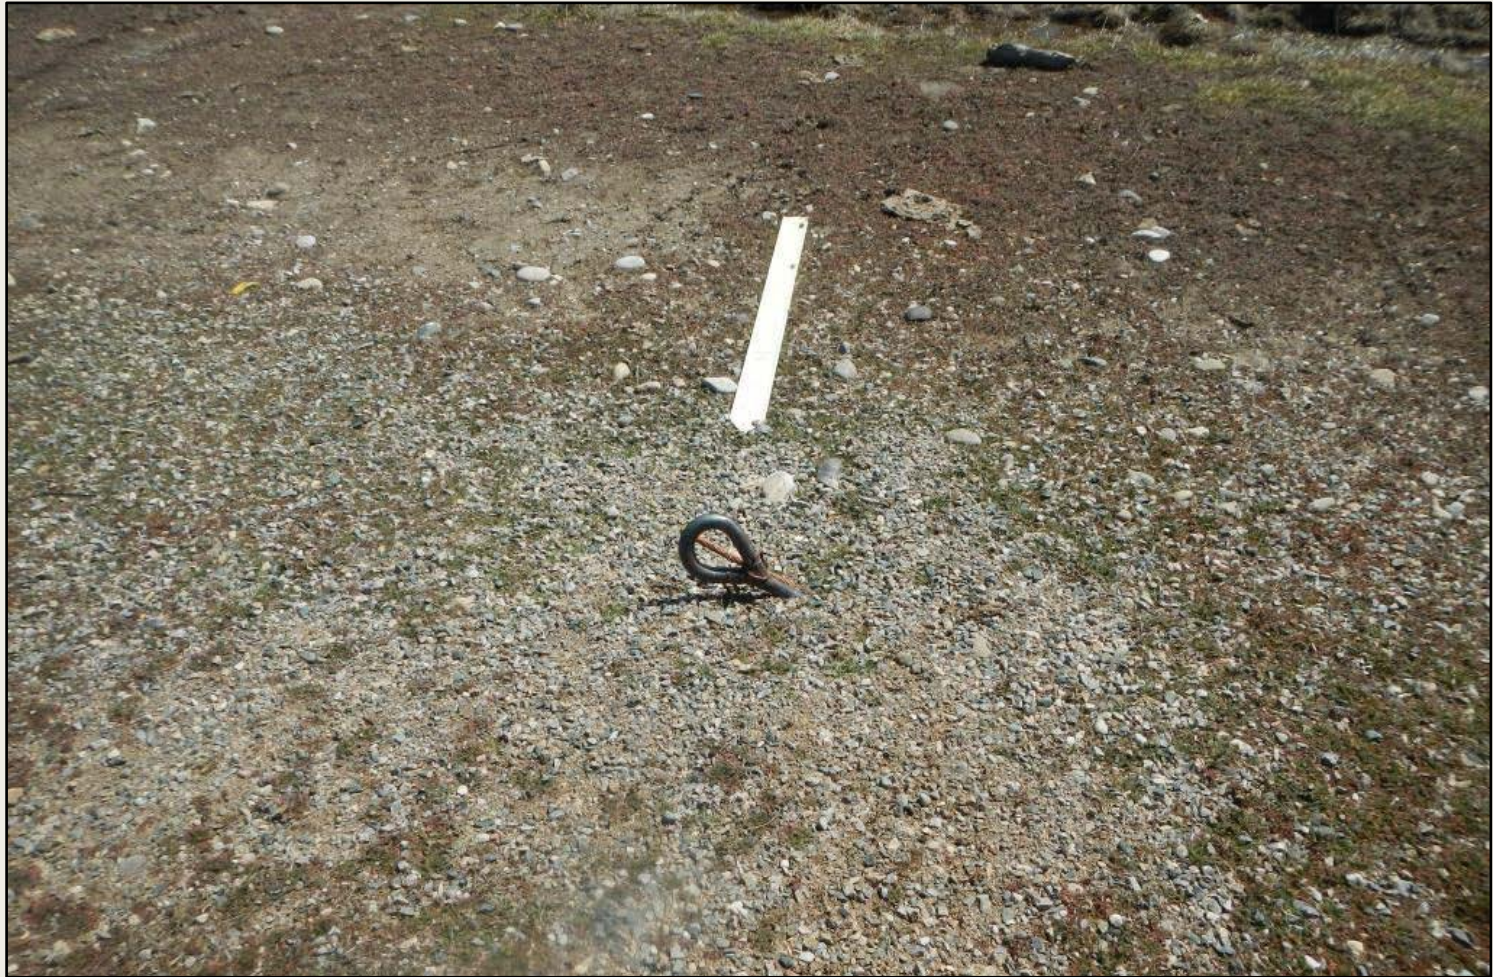
Photo 3. View of unmarked rig anchor within the project area.

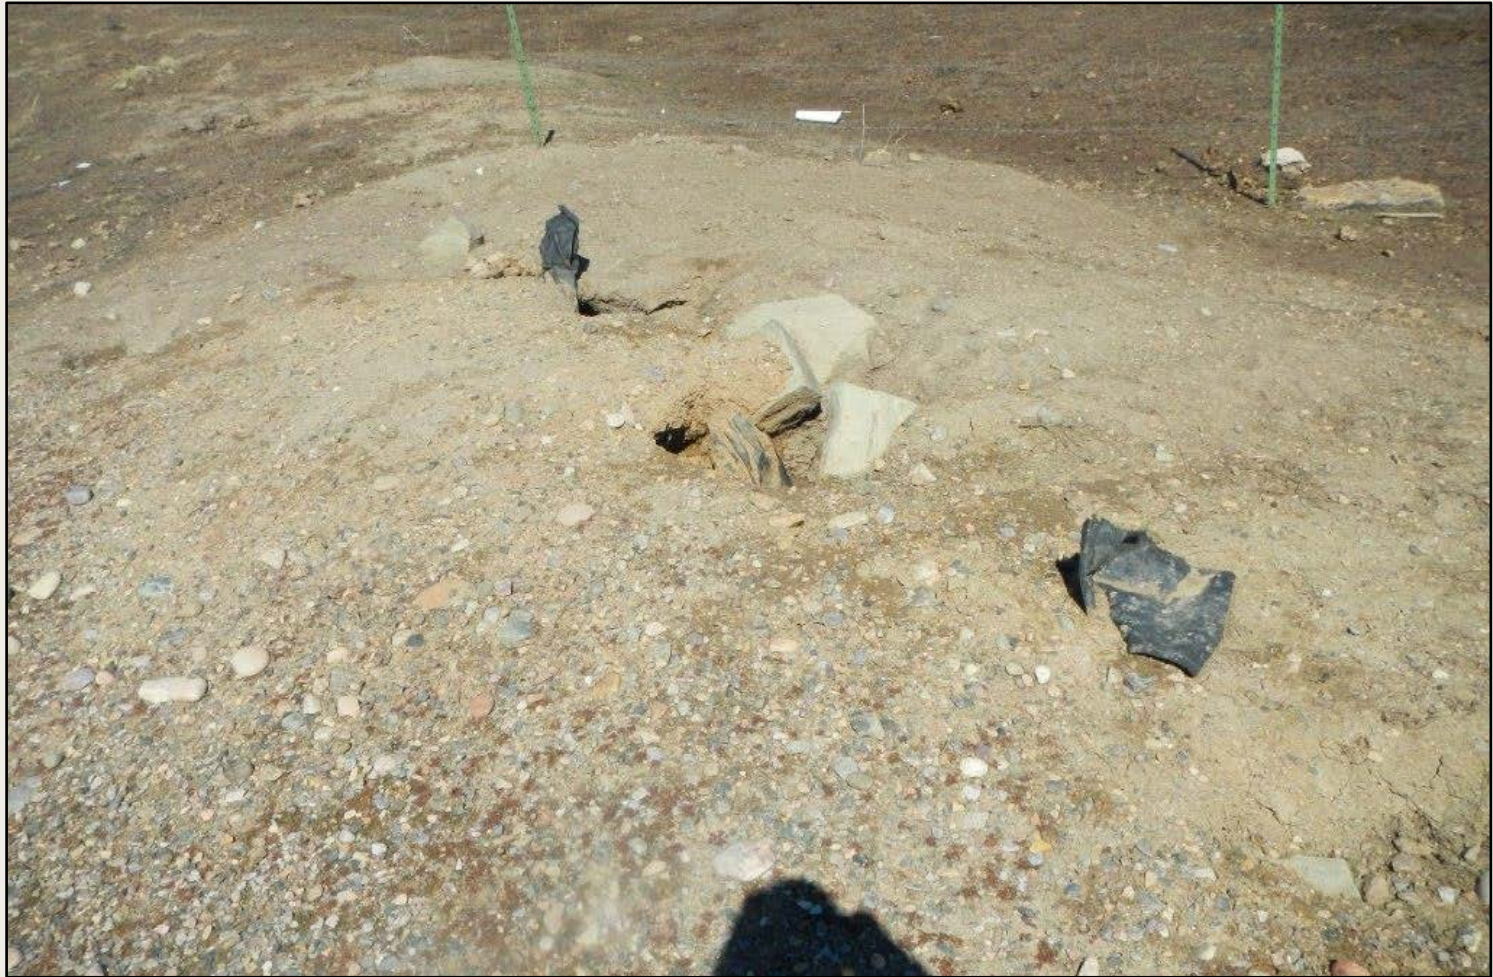
Photo 4. View black plastic debris and erosion within the northeastern project area.

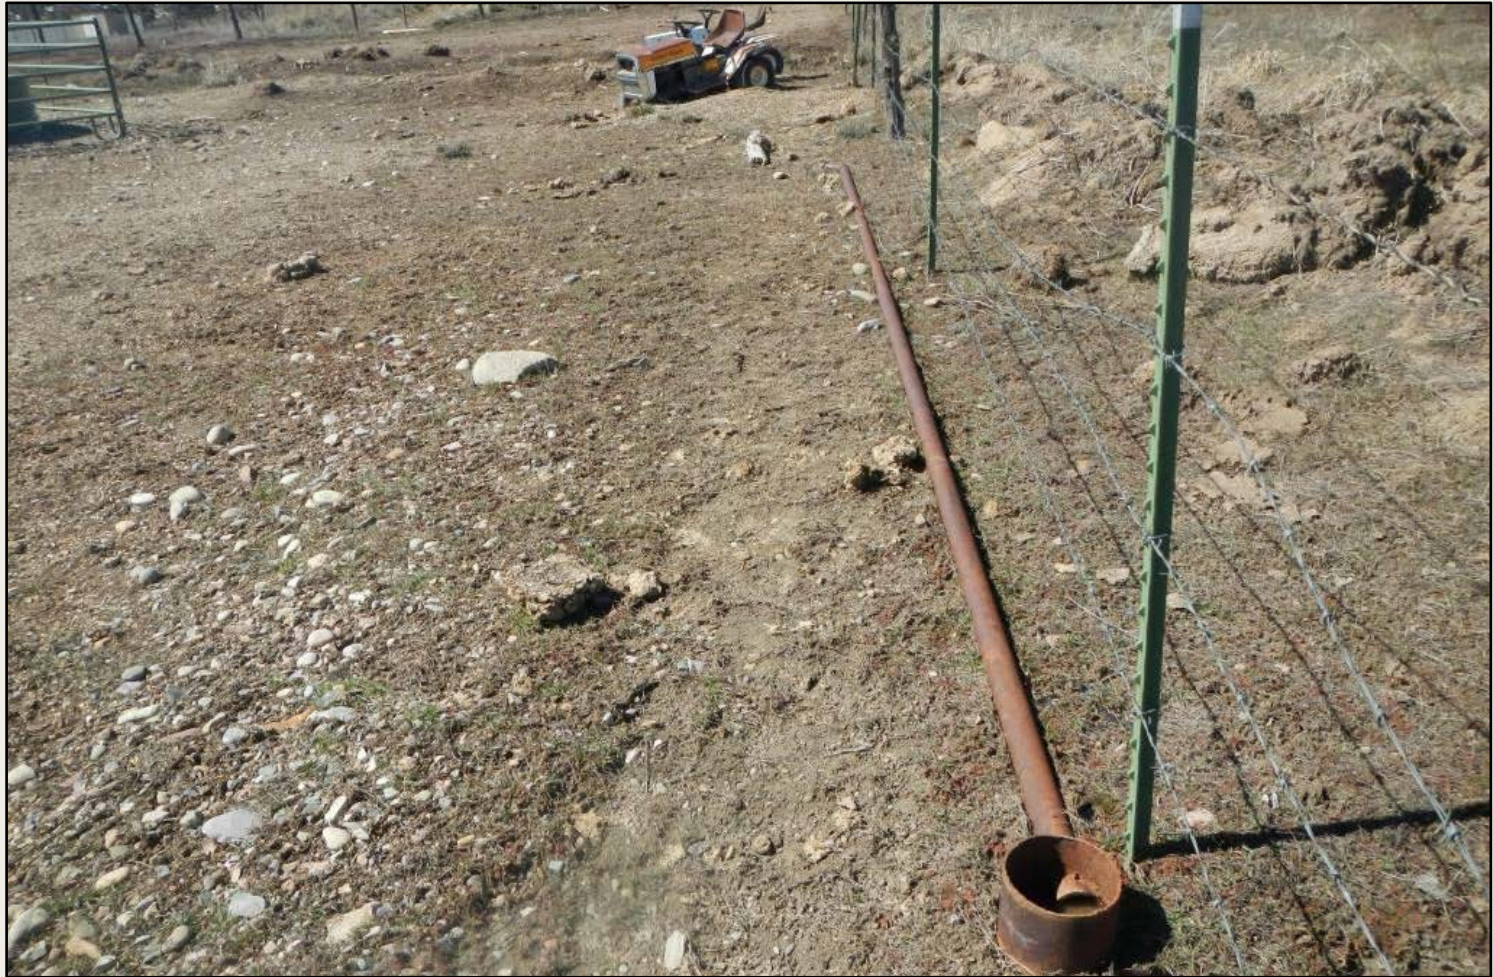
Photo 5. View of debris within the northwestern project area.
