Inspection Photos

Inspection Number: 692400813

Inspection Date: 3/19/2019

Inspection Photos: Ursa Burckle Cuttings Staging Area Loc#436196

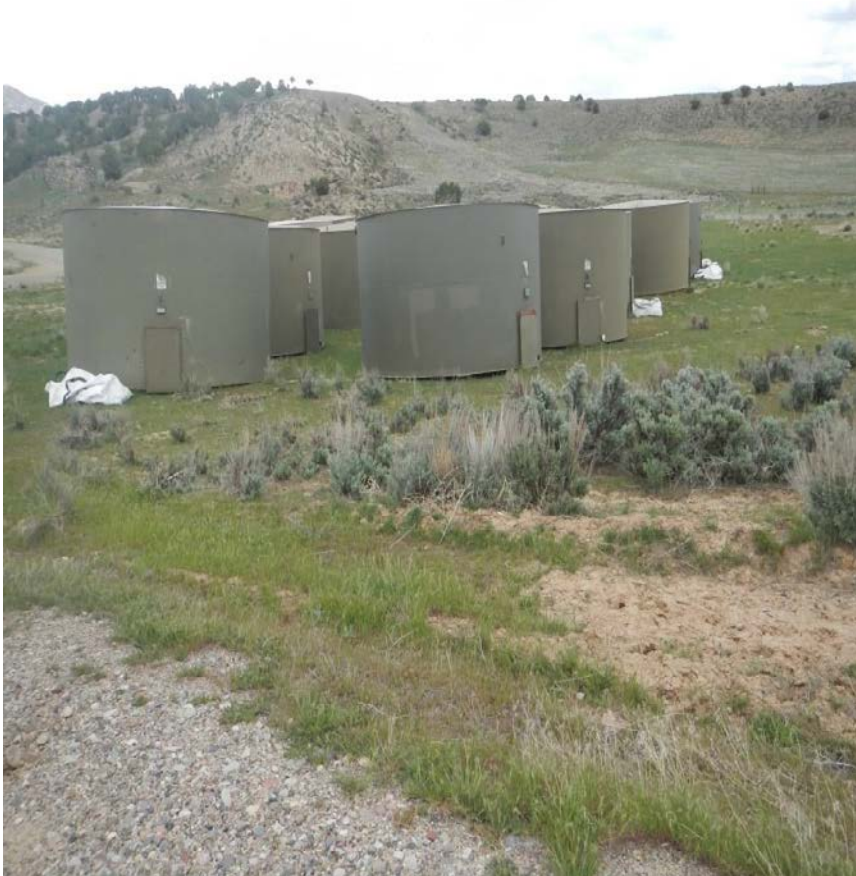
Photo#1: 4/30/18

Twenty tanks were noted stored in grassy area,
East of, & adjacent to access road entry.

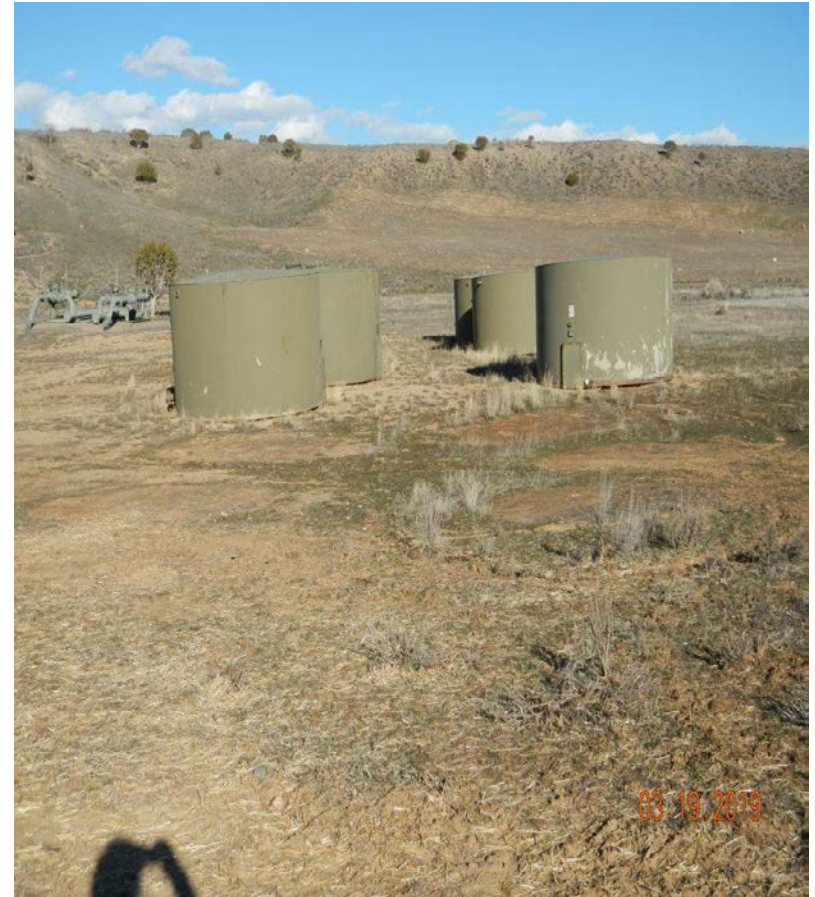
Photo#2: 3/19/19

Eight tanks were noted stored in grassy area,
East of, & adjacent to access road entry.

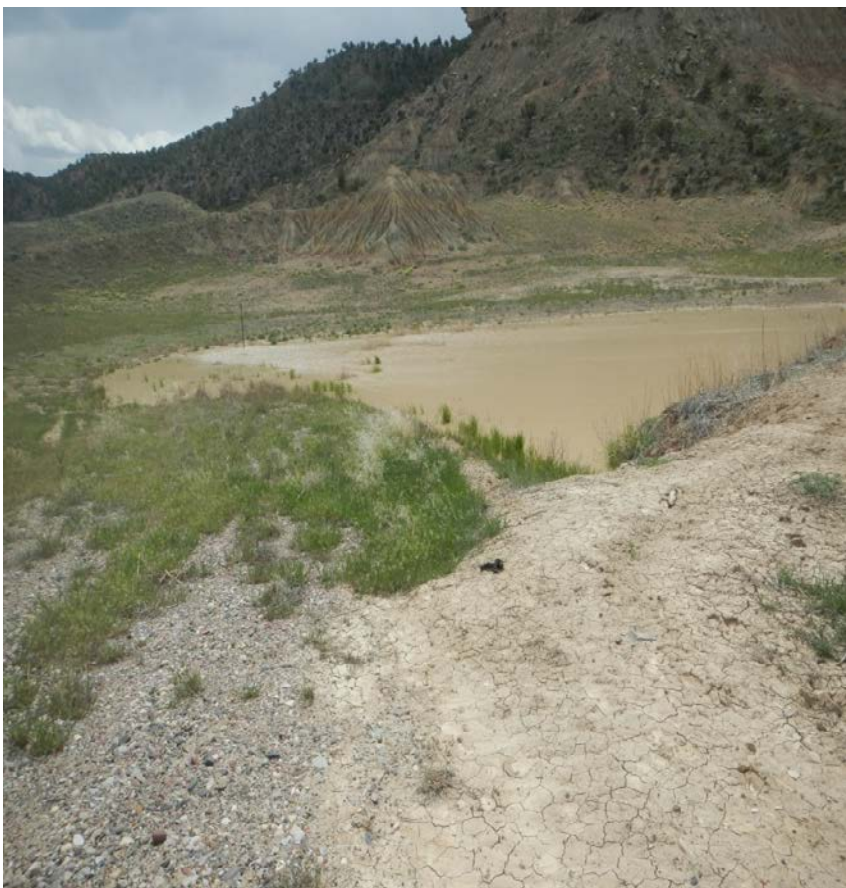
Photo#3: 4/30/18

View over Location from entry to South. Reclamation has been installed.

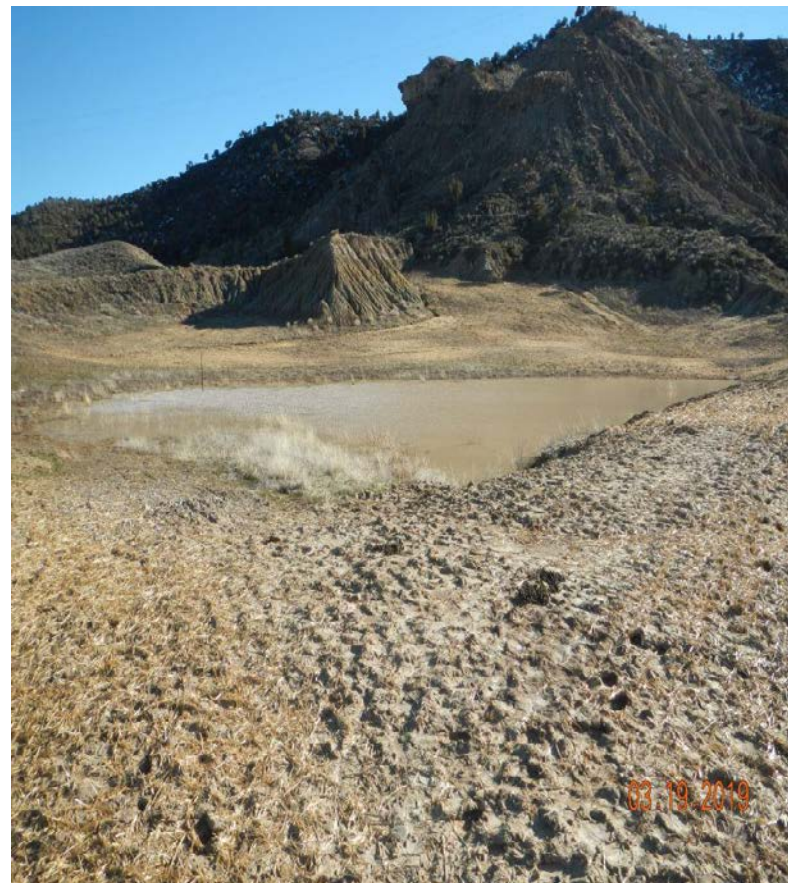
Photo#4: 3/19/19

View over Location from entry to South. Reclamation has been installed.

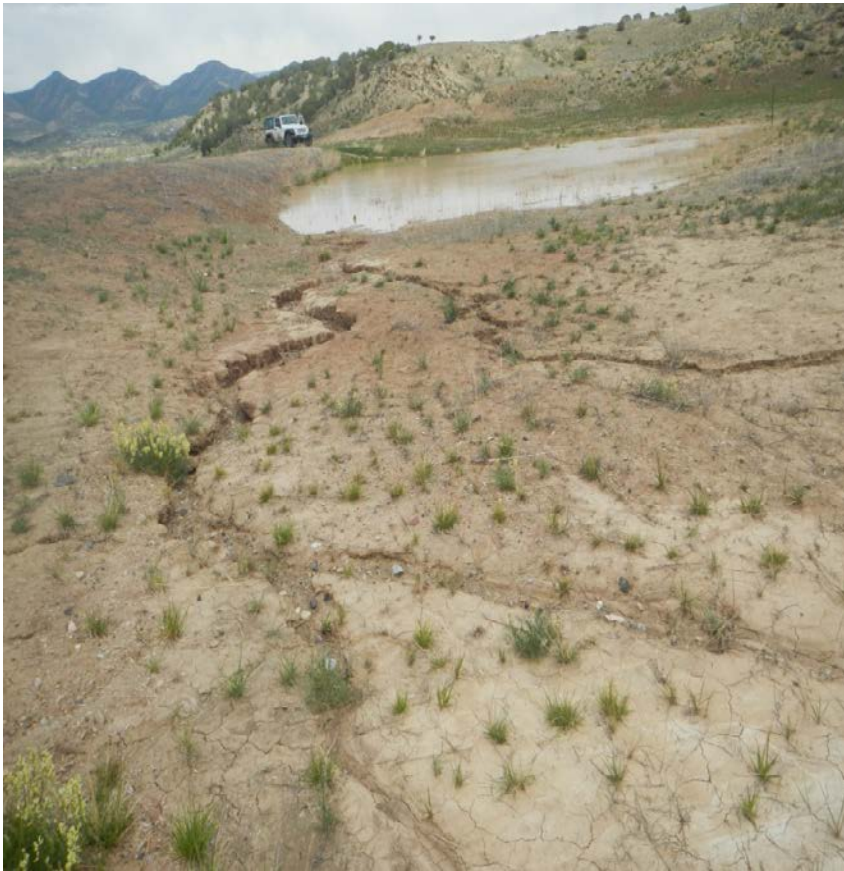
Photo#5: 4/30/18

View over Location to Southeast. Reclamation has been installed.

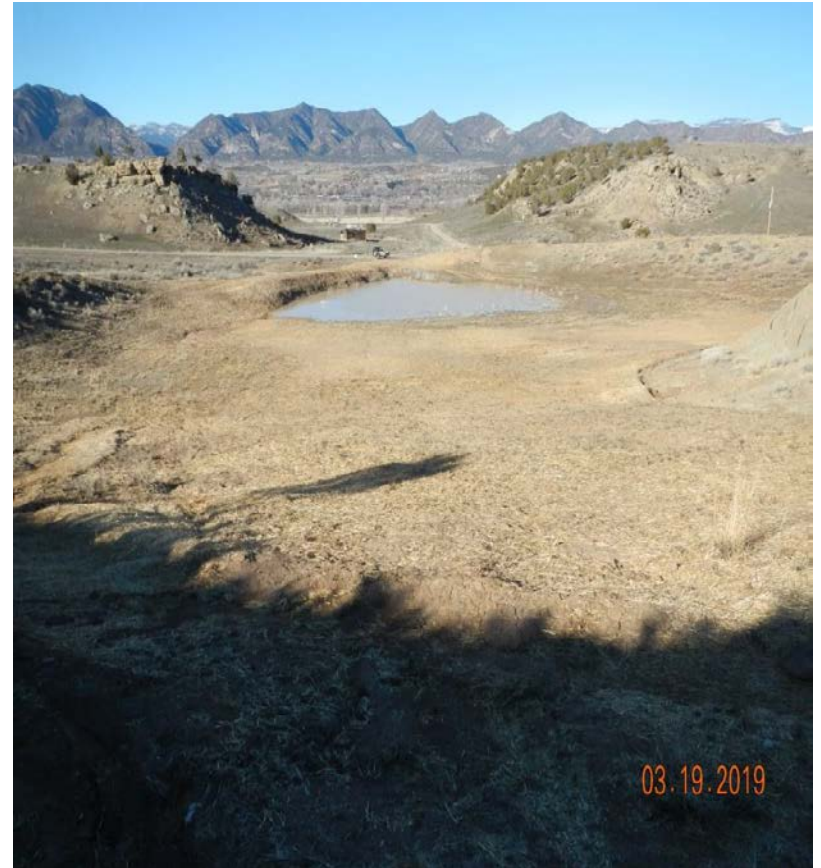
Photo#6: 3/19/19

View over Location to Southeast. Reclamation has been installed.

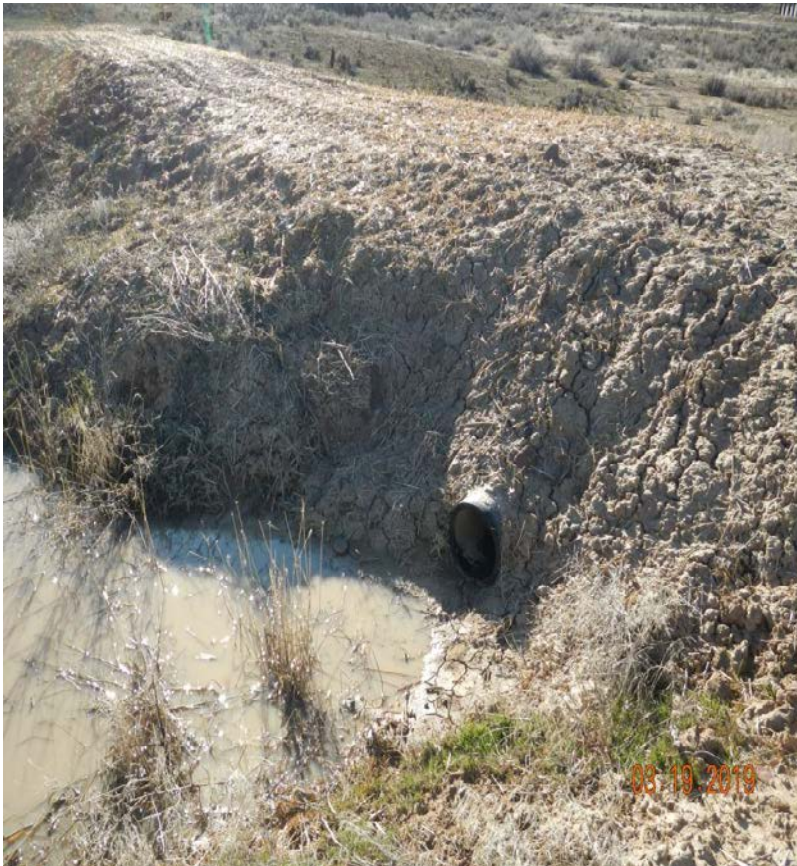
Photo#7:
Overflow point of pond; South side of berm.

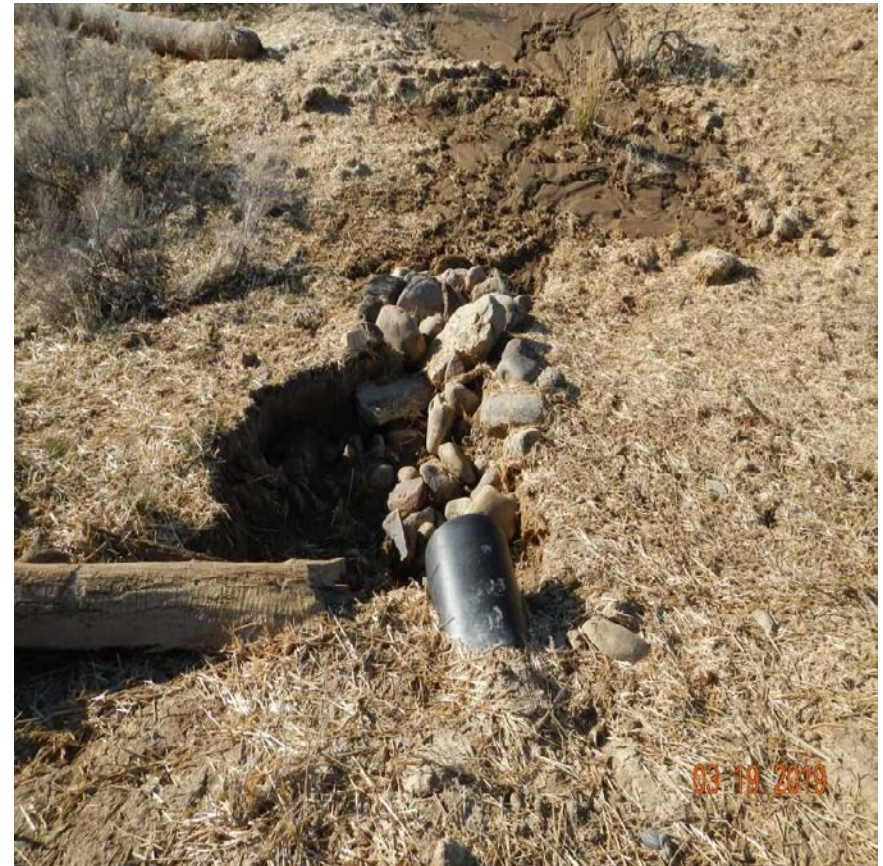
Photo#8:
North side of berm where overflow discharges,
needs repair, maintenance.

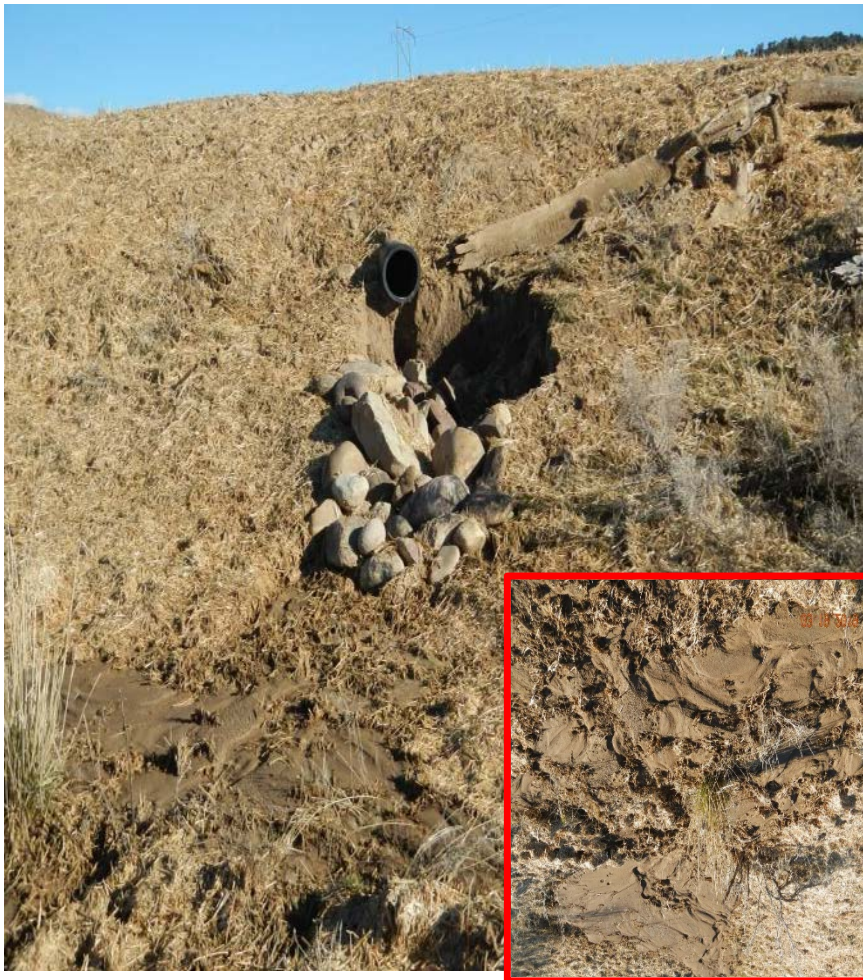
Photo#9:

North side of berm where overflow discharges, needs repair, maintenance.

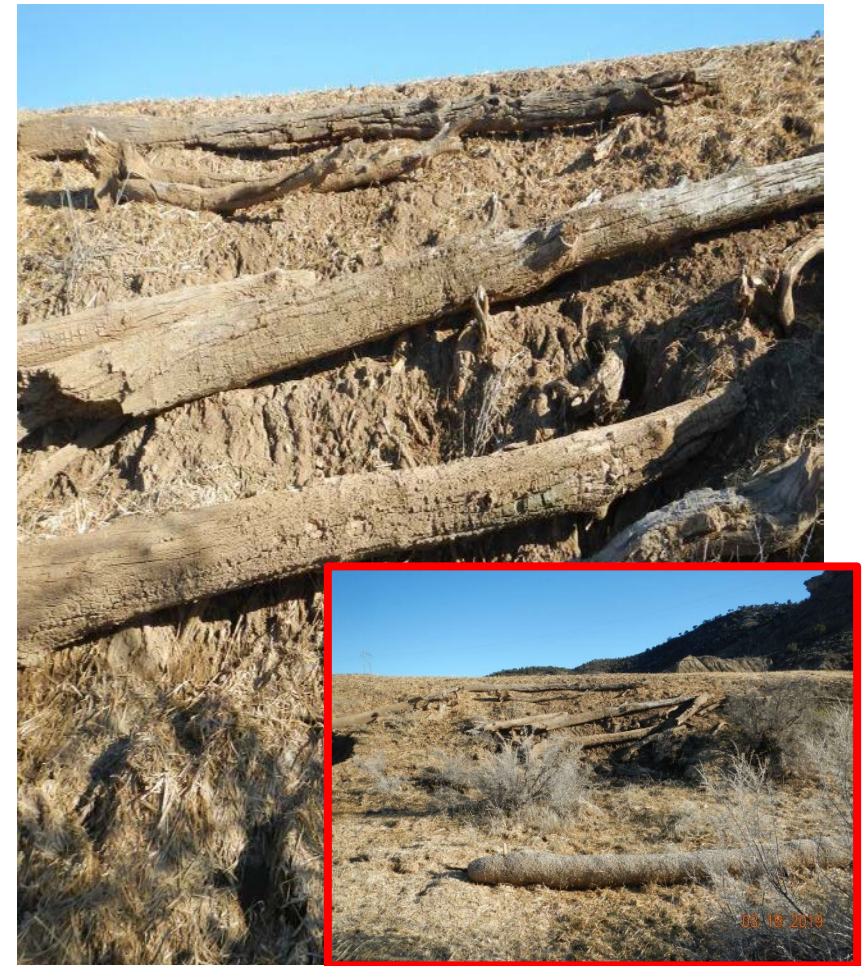
Photo#10:

North side of berm where overflow discharges, needs repair, maintenance.

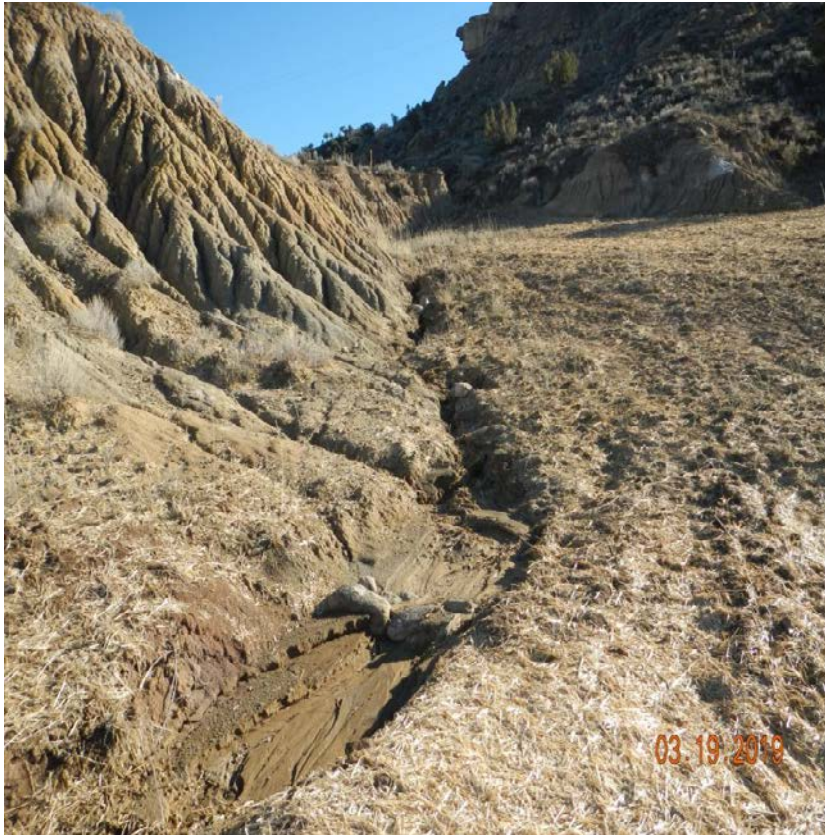
Photo#11:
Sediment flowing from off site into Location makes this site a challenge.

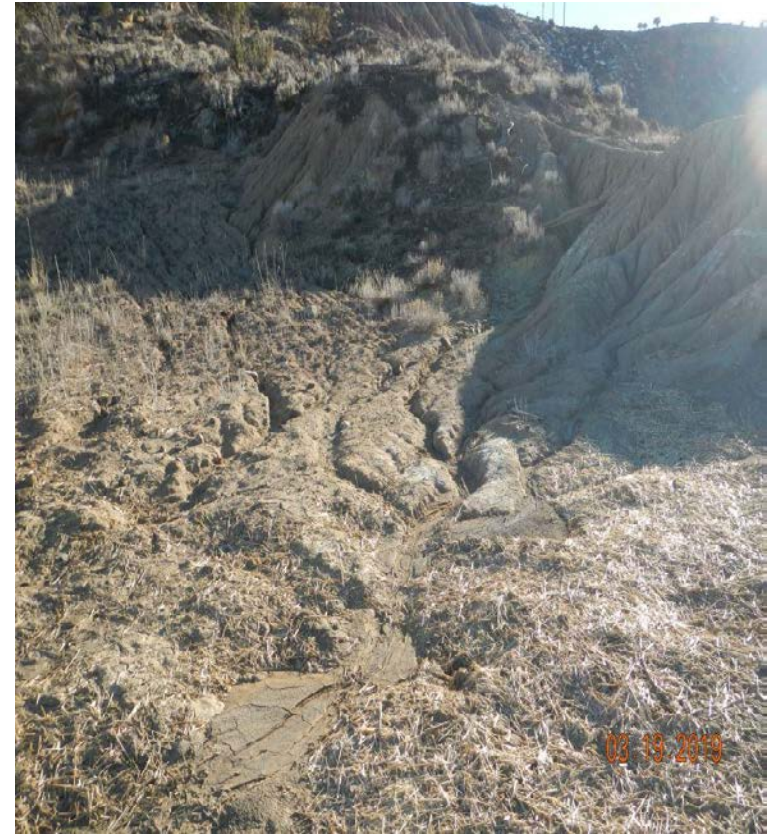
Photo#12:
Sediment flowing from off site into Location makes this site a challenge. .

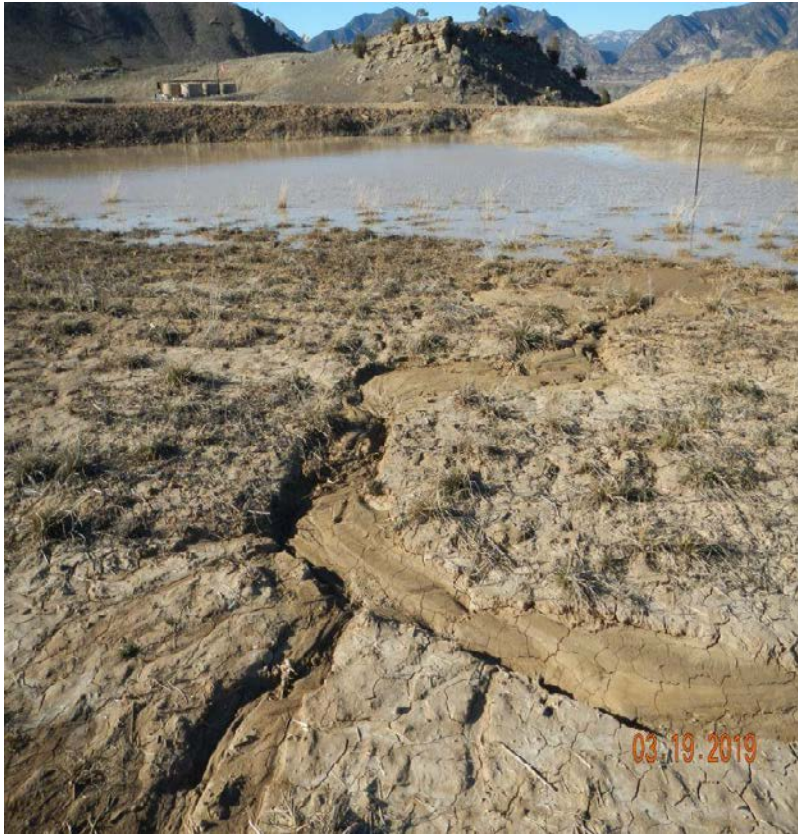
Photo#13:
Sediment flowing from off site into Location makes this site a challenge.

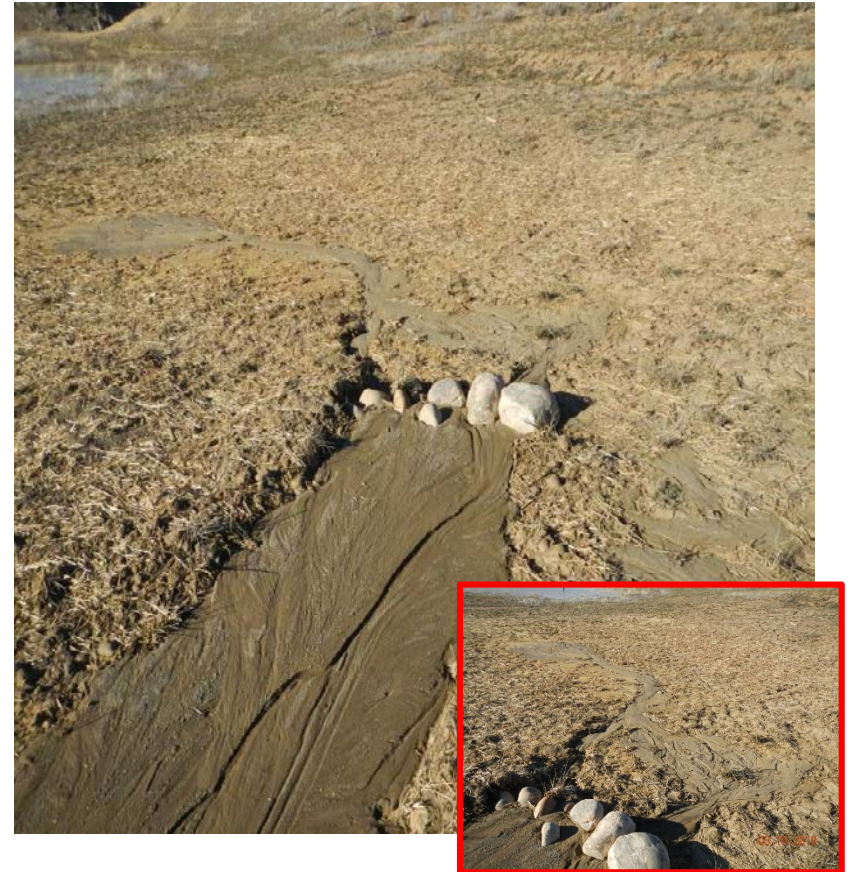
Photo#14:
Sediment flowing from off site into Location makes this site a challenge.

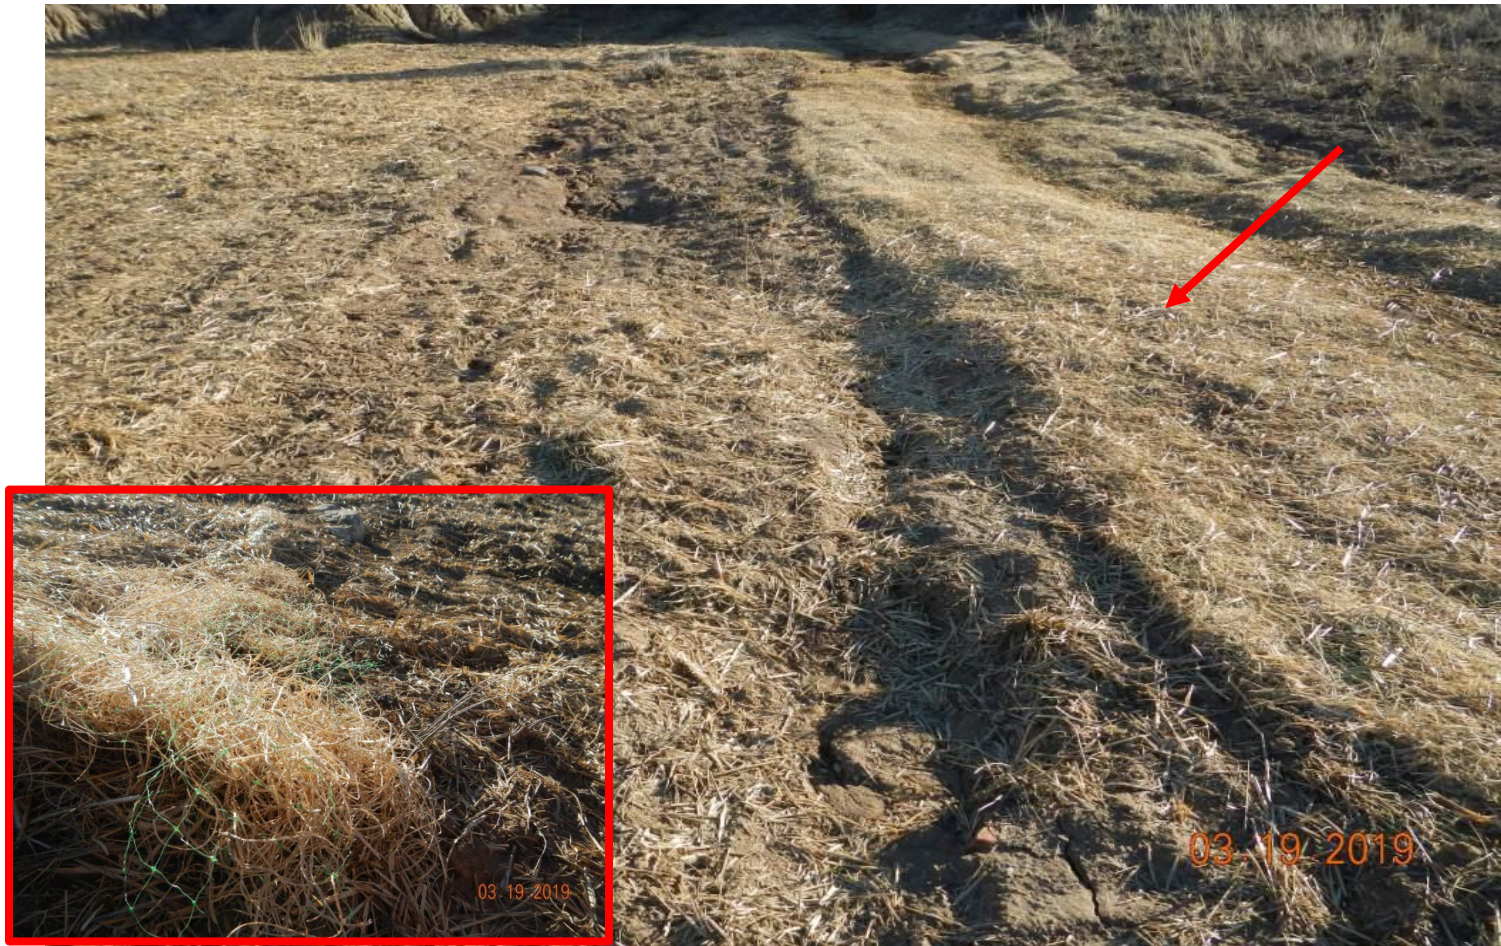
Photo#15:

View of South west area of site; arrow indicates where two strips of erosion blanket (with plastic netting) were installed; insert is close up view of blanket.

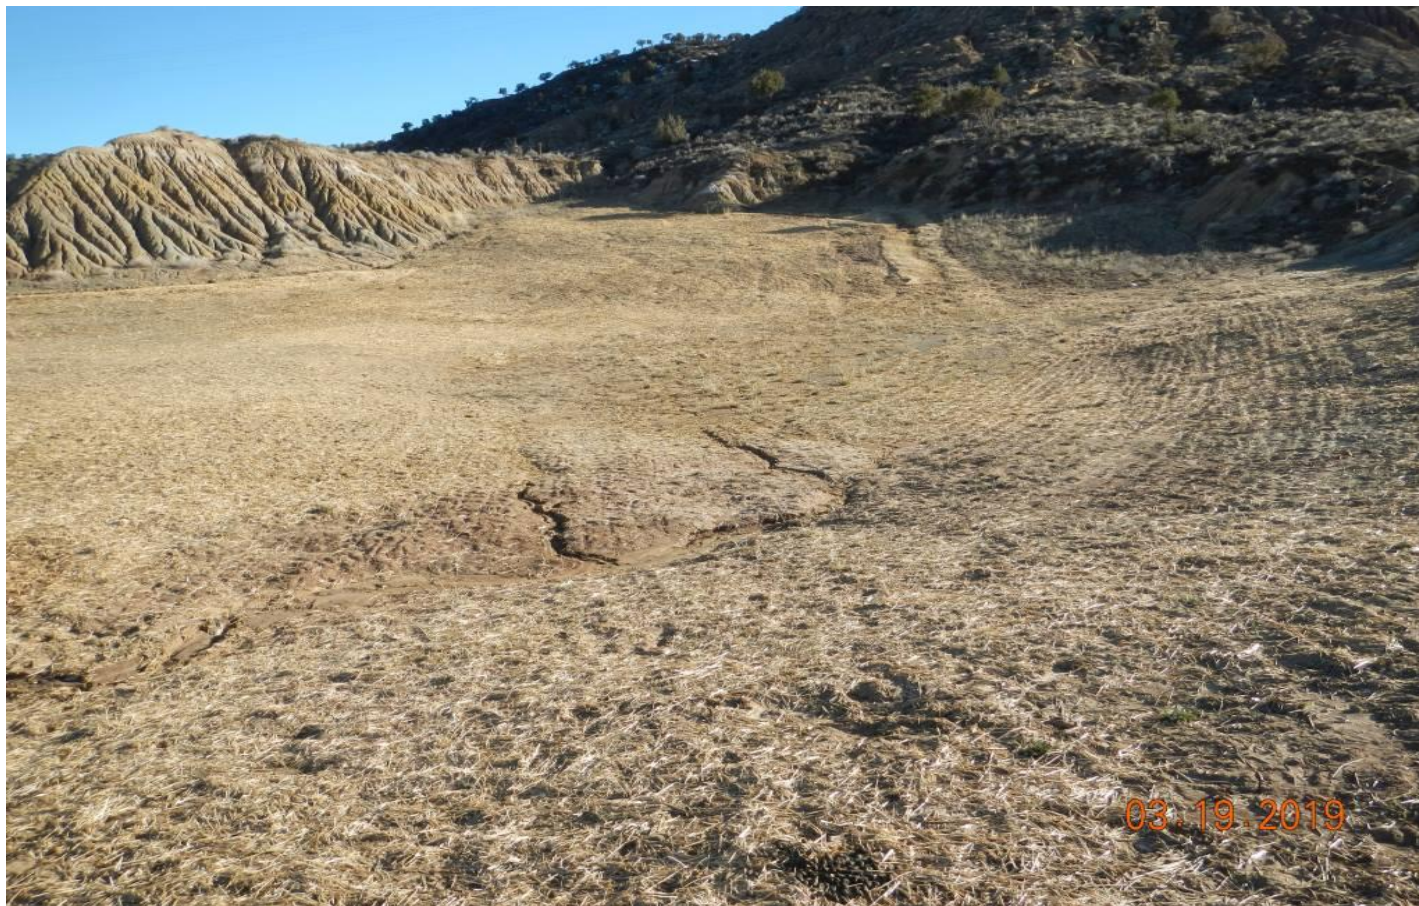
Photo#16:

View over West side of Location; following photos show detail of developing areas of concern.

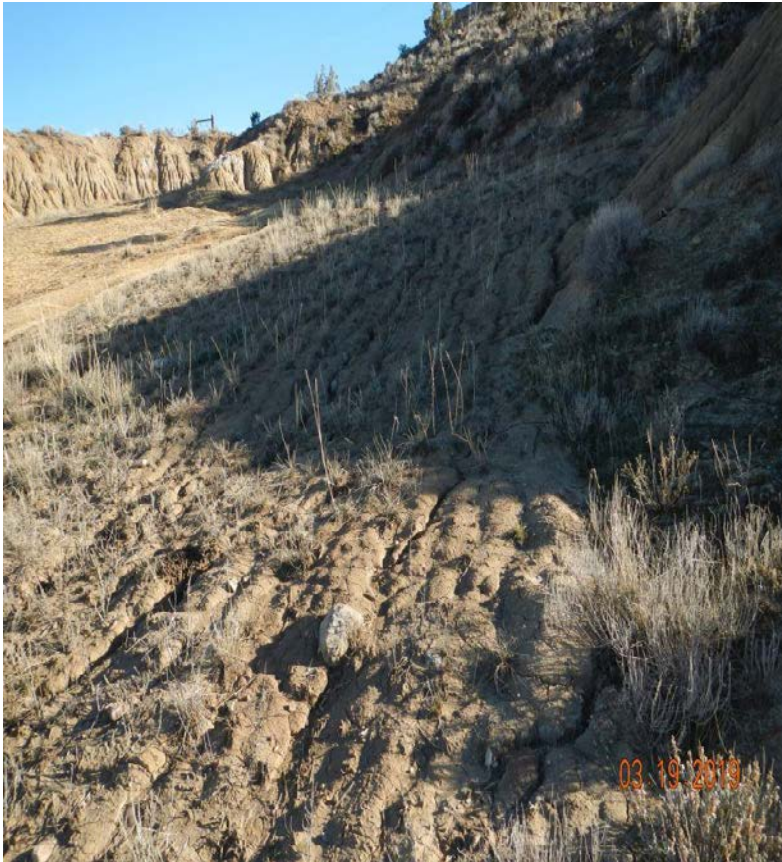
Photo#17:
Area of concern.

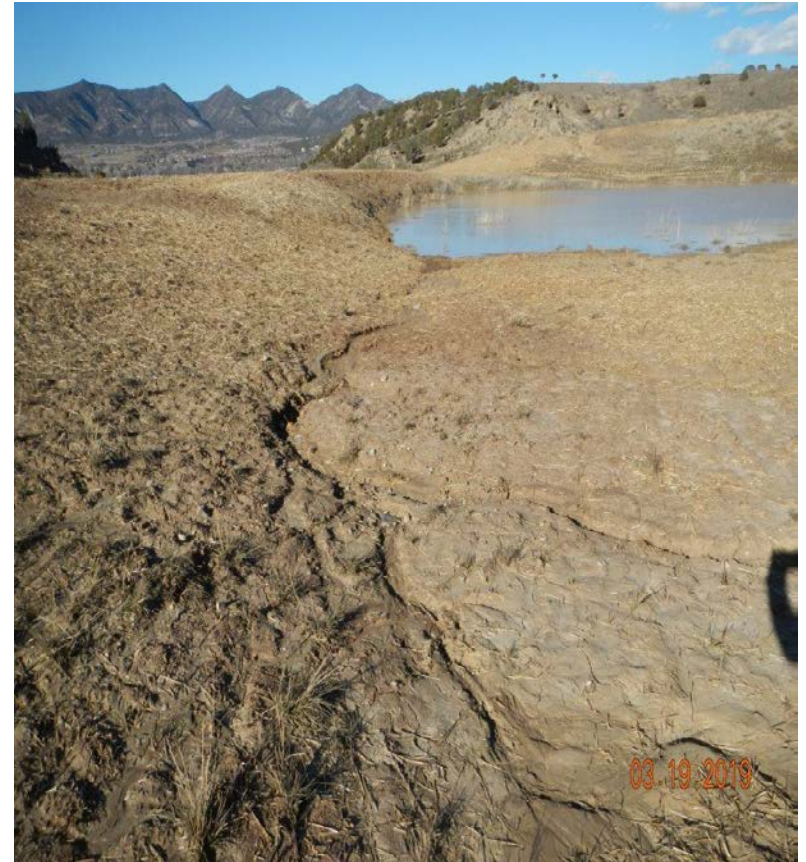
Photo#18:
Area of Concern.
