Inspection Photos
Operator: Hilcorp Energy
Location/API #: 067-06266
Date: 2-18-2019

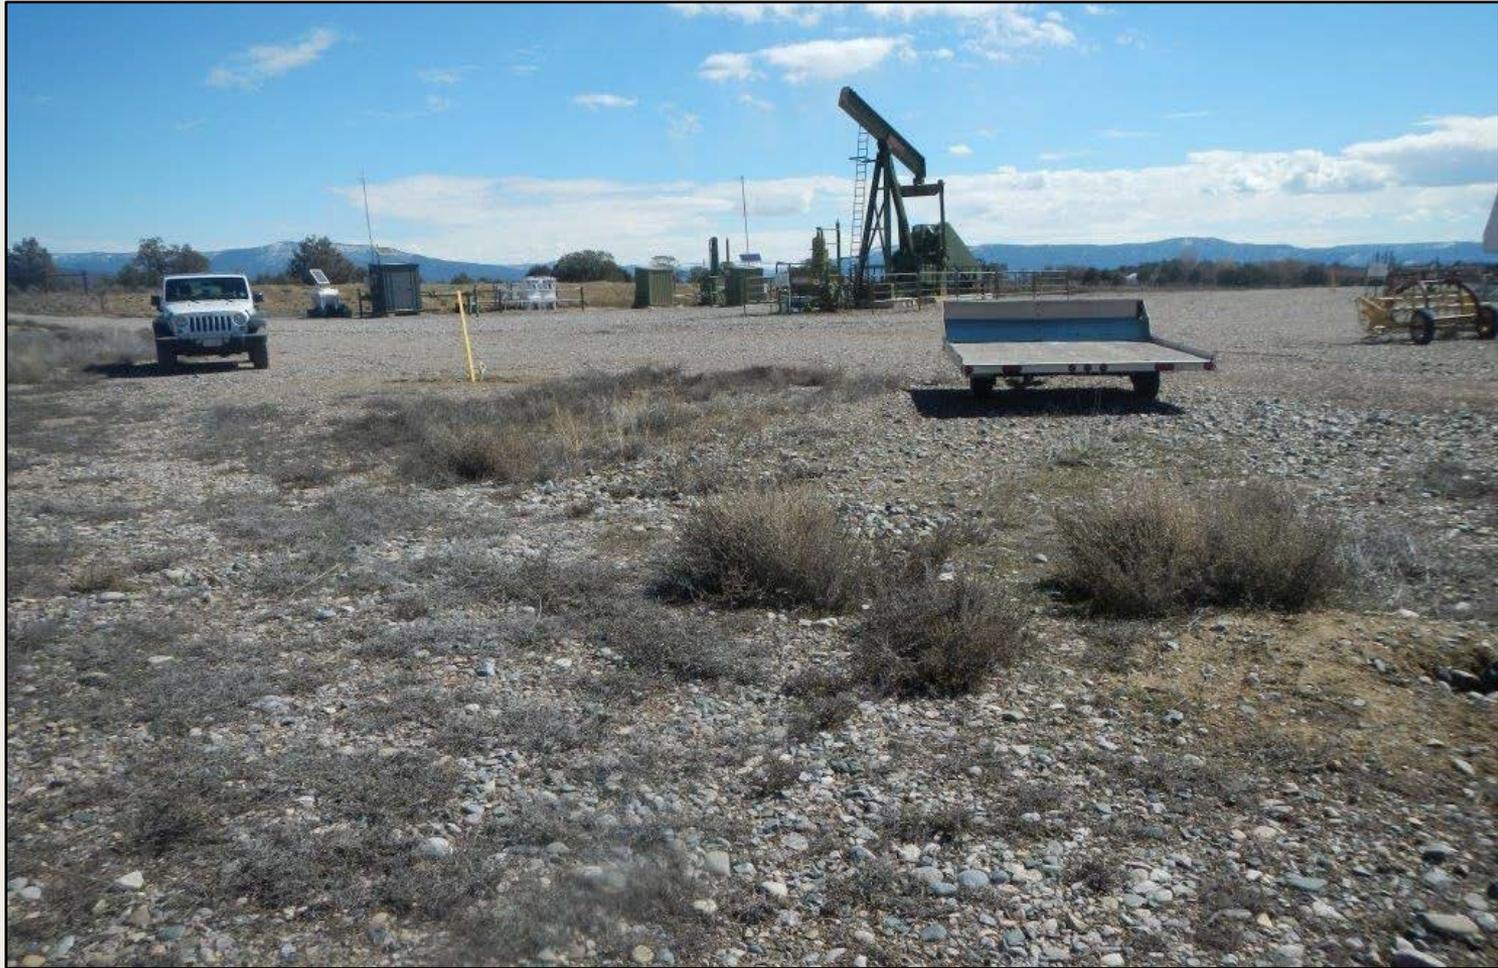
Photo 1. View of the project area from the western corner facing center.

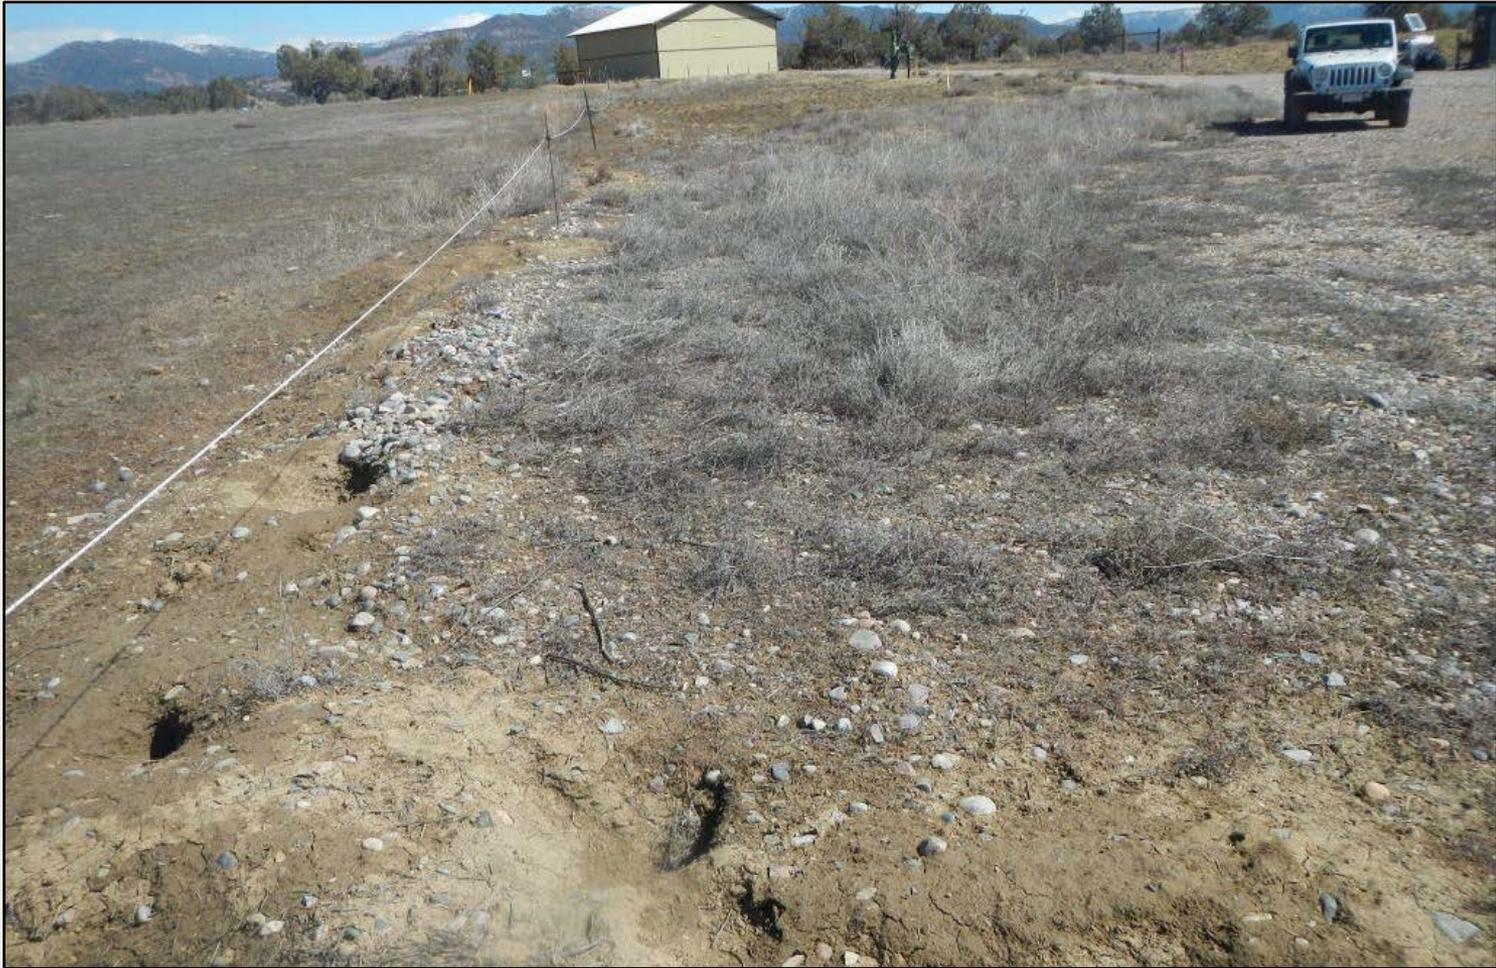
Photo 2. View of the northwestern project area from the eastern corner facing northeastward. Grey vegetation on well pad is comprised of annual weeds such as kochia (*Kochia scoparia*).

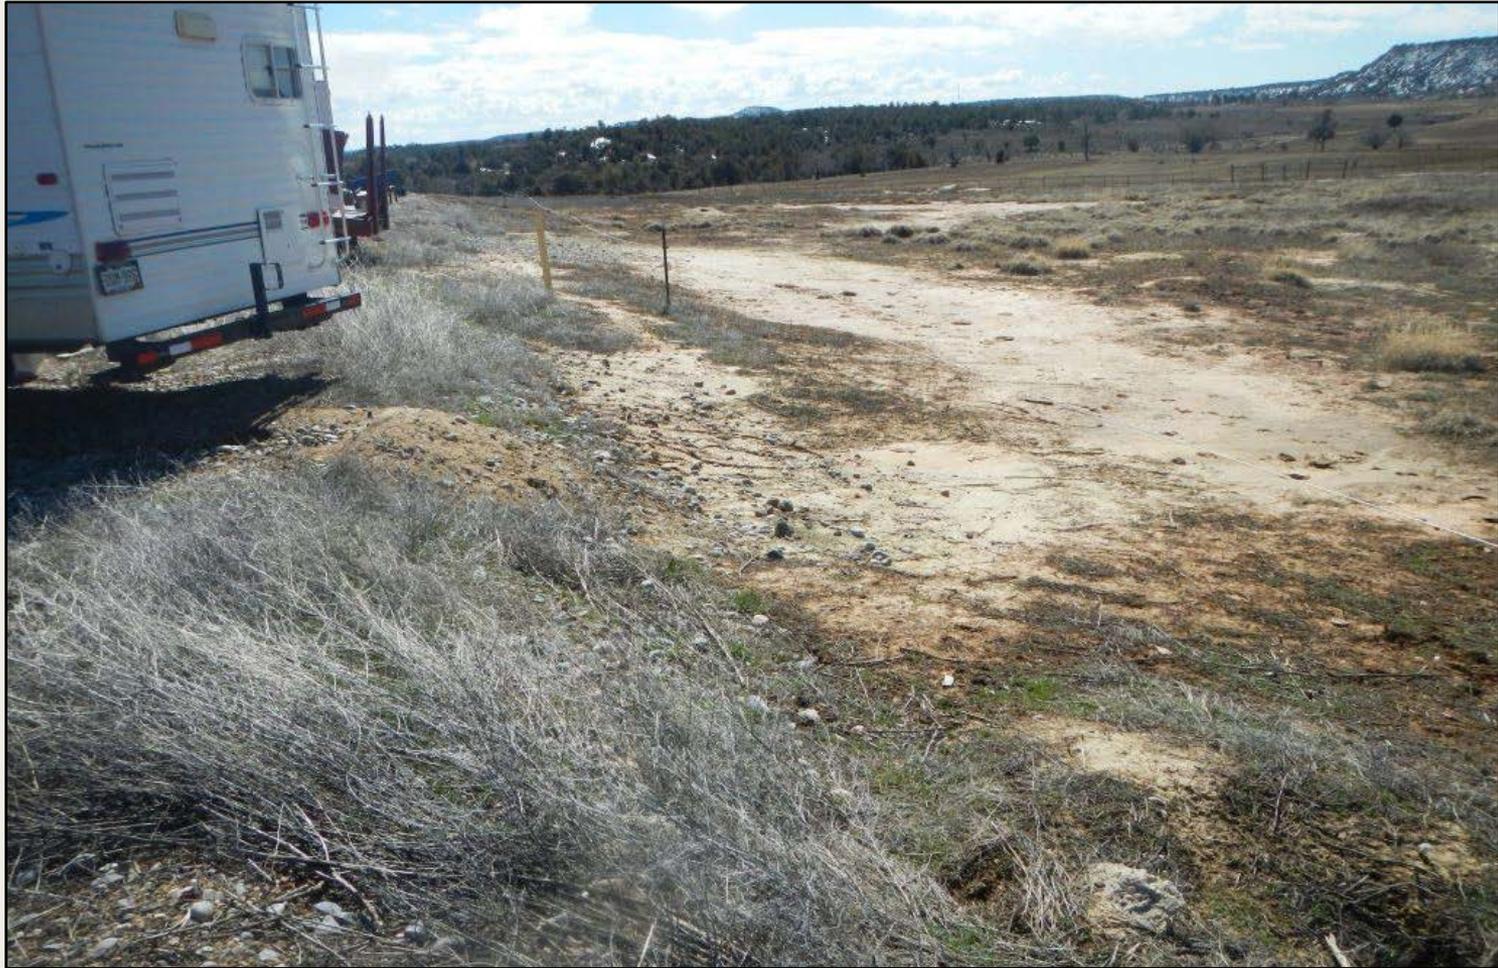
Photo 3. View of area in southwestern project area where there is no vegetation down-slope from the well pad. Aerial imagery indicates there may be a historic release in this area.

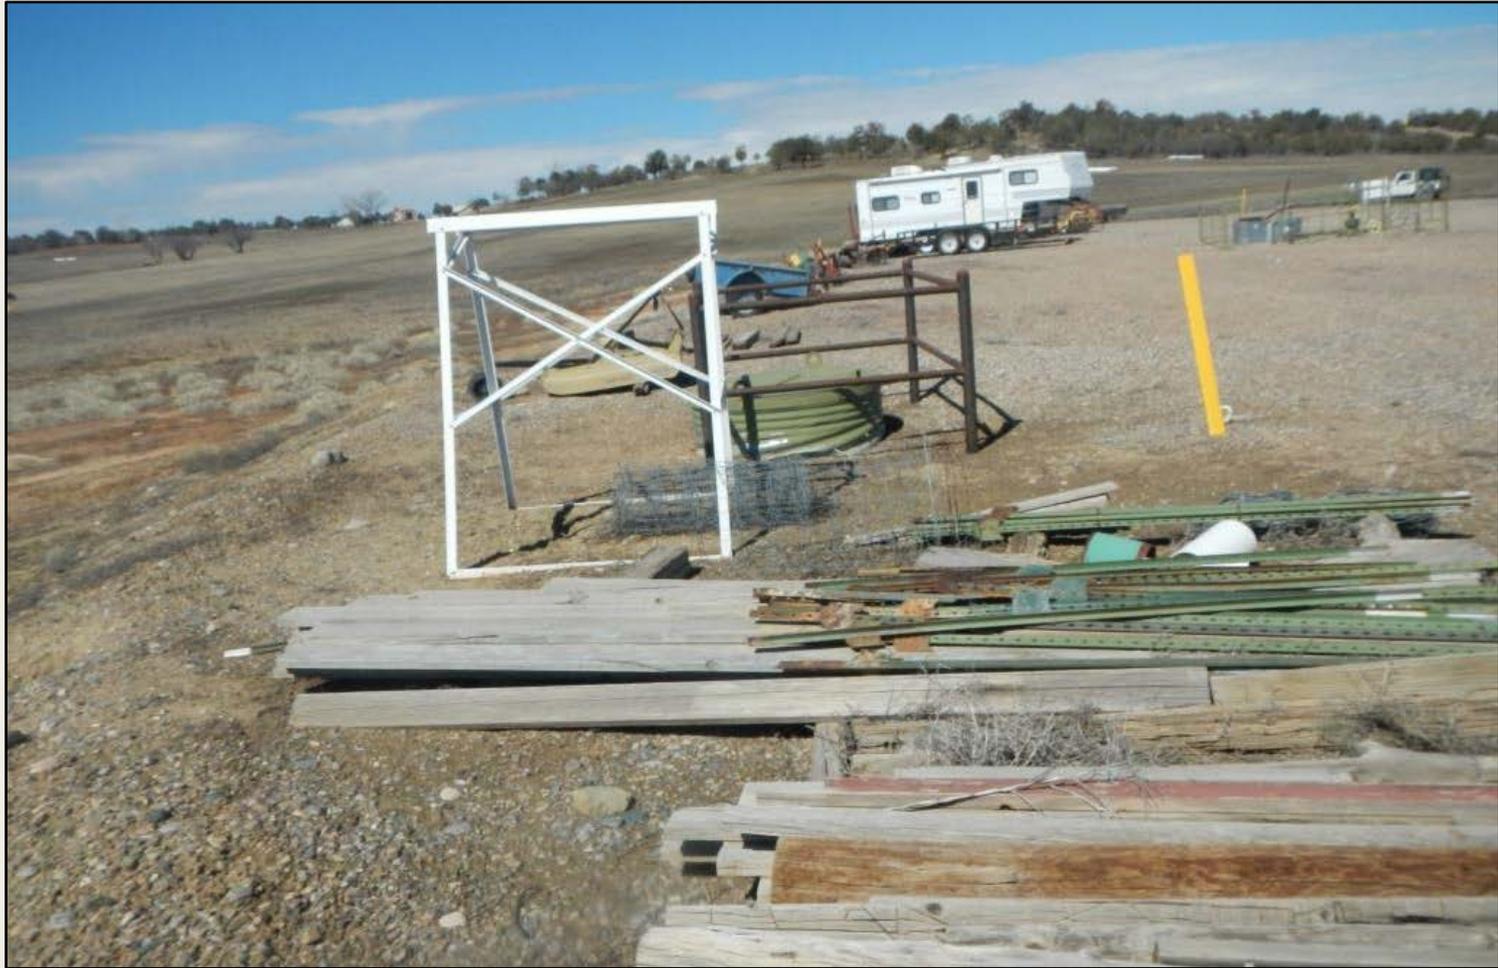
Photo 4. View of the western project area from the southern corner facing northwestward. What appears to be surface owner equipment is stored on the location.

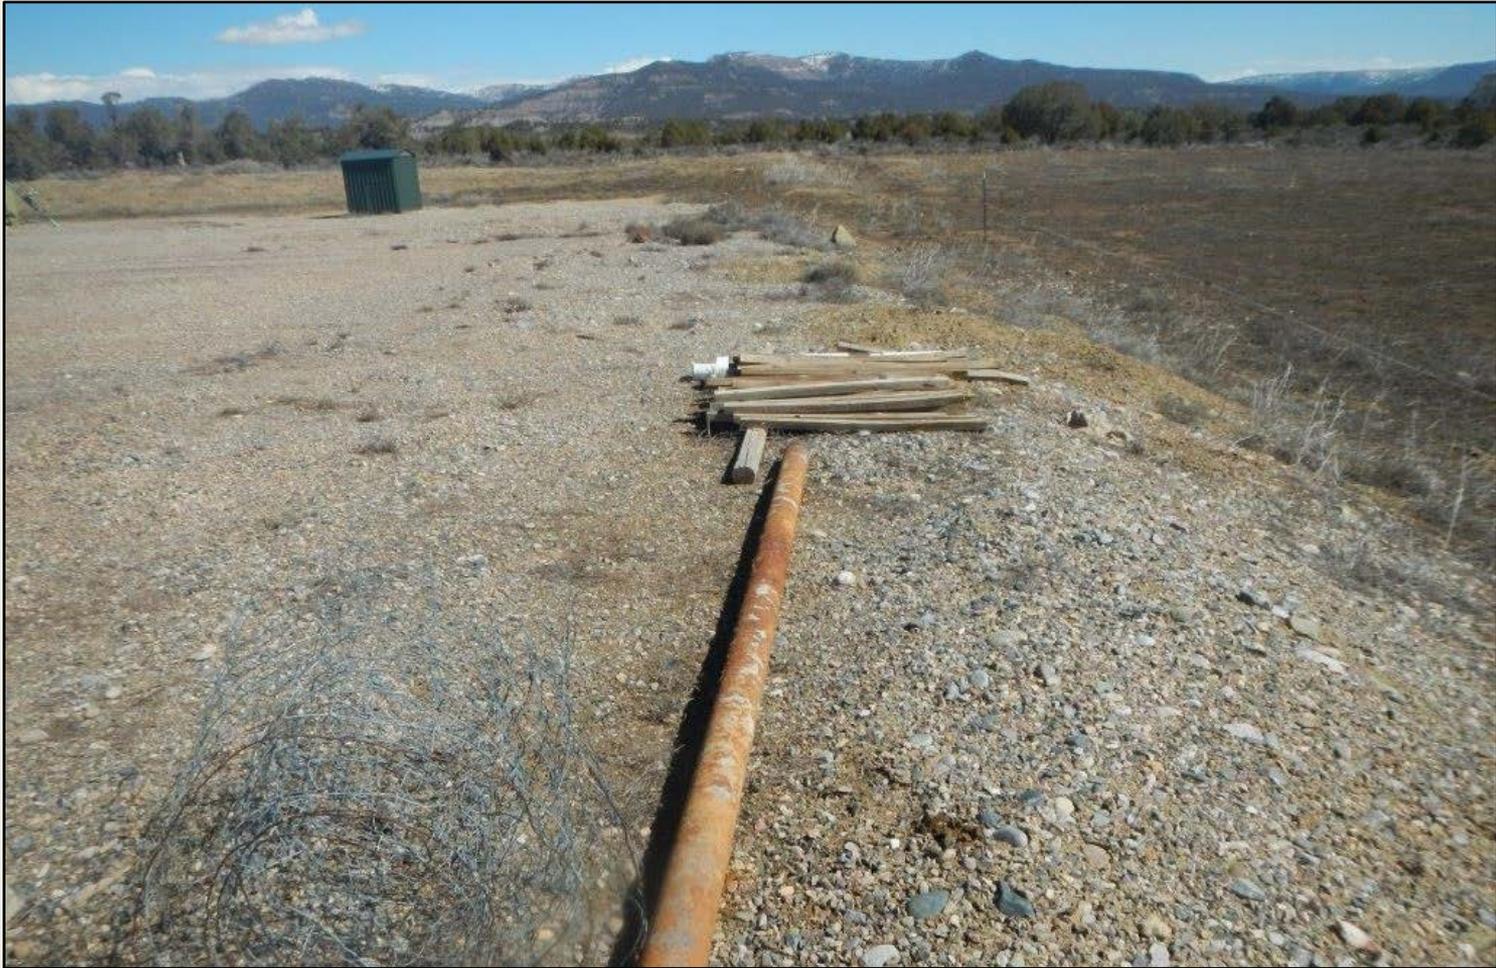
Photo 5. View of the eastern project area from the southern corner facing northeastward.
