Inspection Photos

Operator: Rim Operating
Location/API #: 067-09333
Date: 2-18-2019

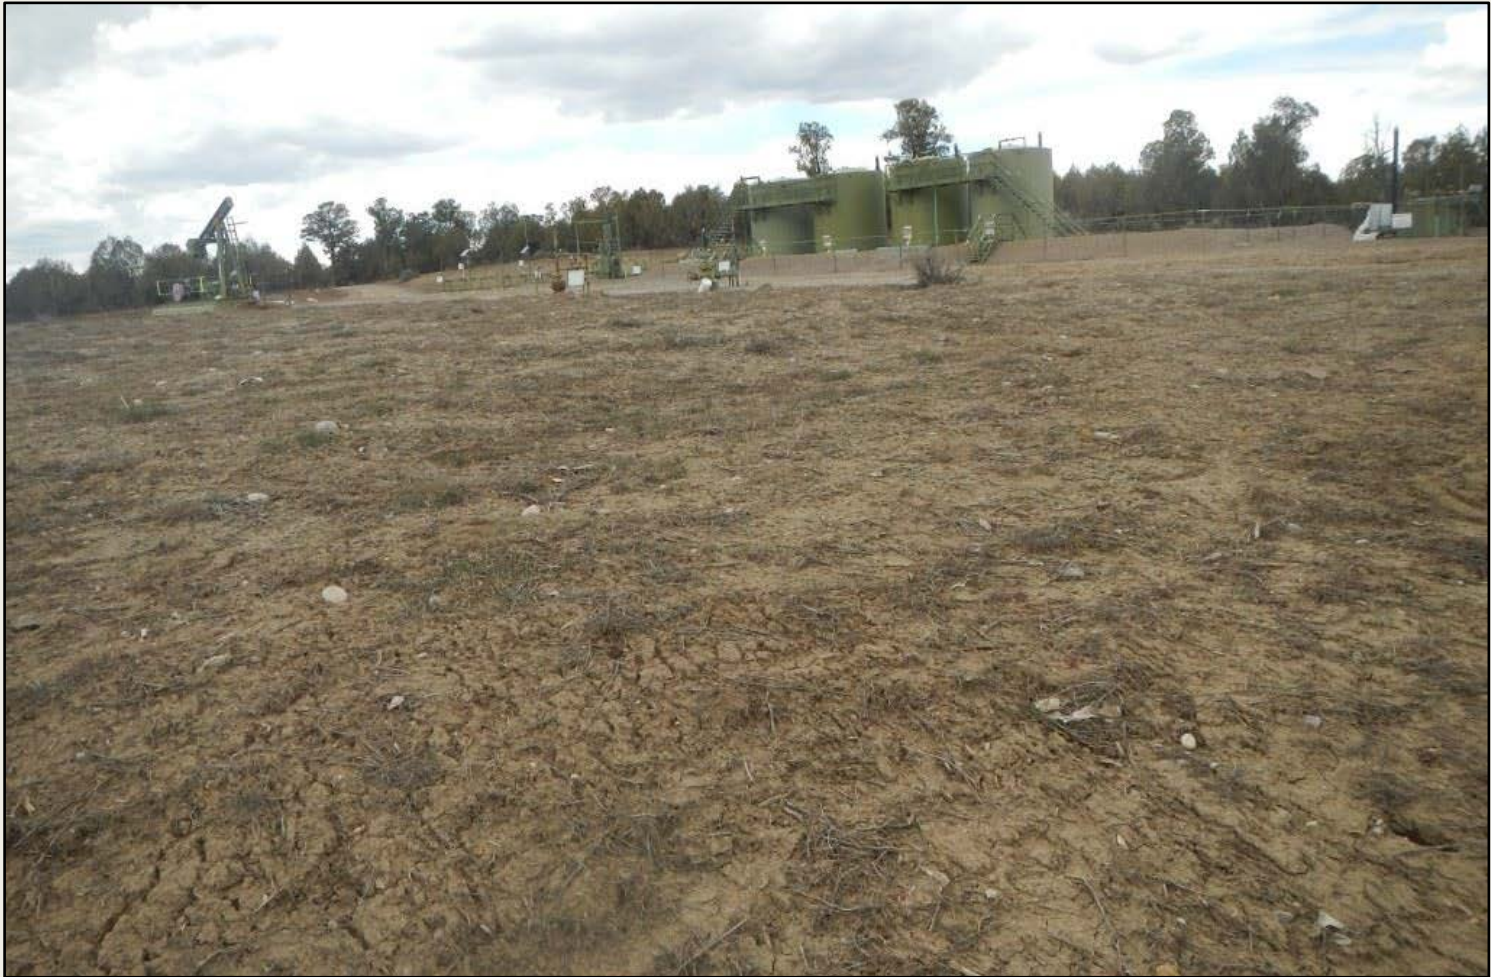
Photo 1. View of project area from the southeastern corner facing center.

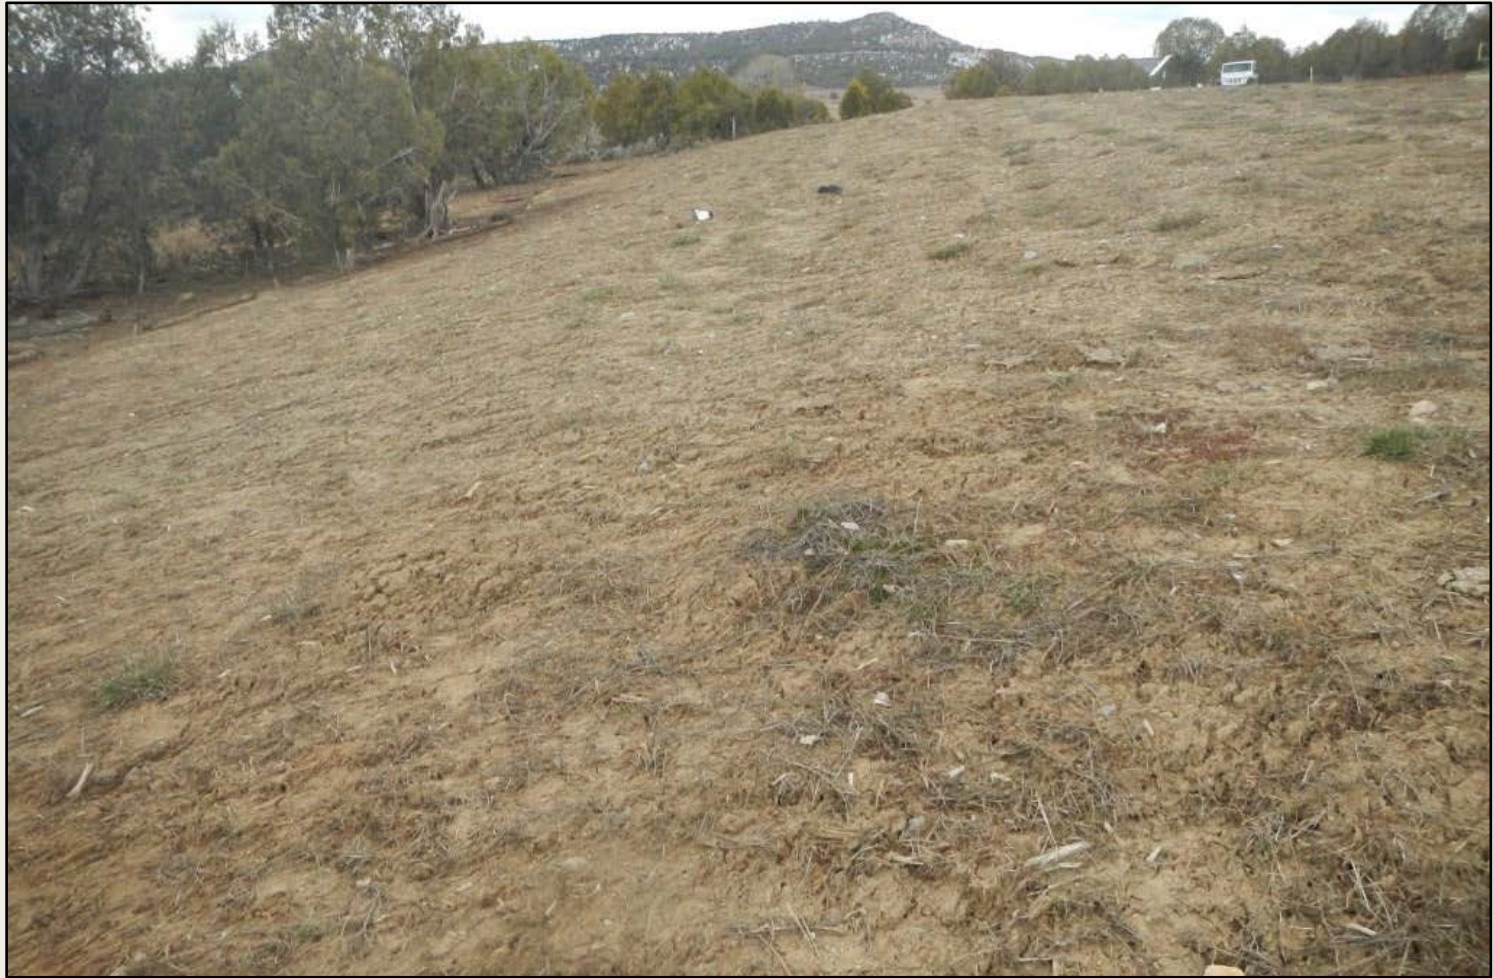
Photo 2. View of the southern project area from the southeastern edge facing westward. Revegetation appears to be progressing, but appears sparse in portions and needs monitoring.

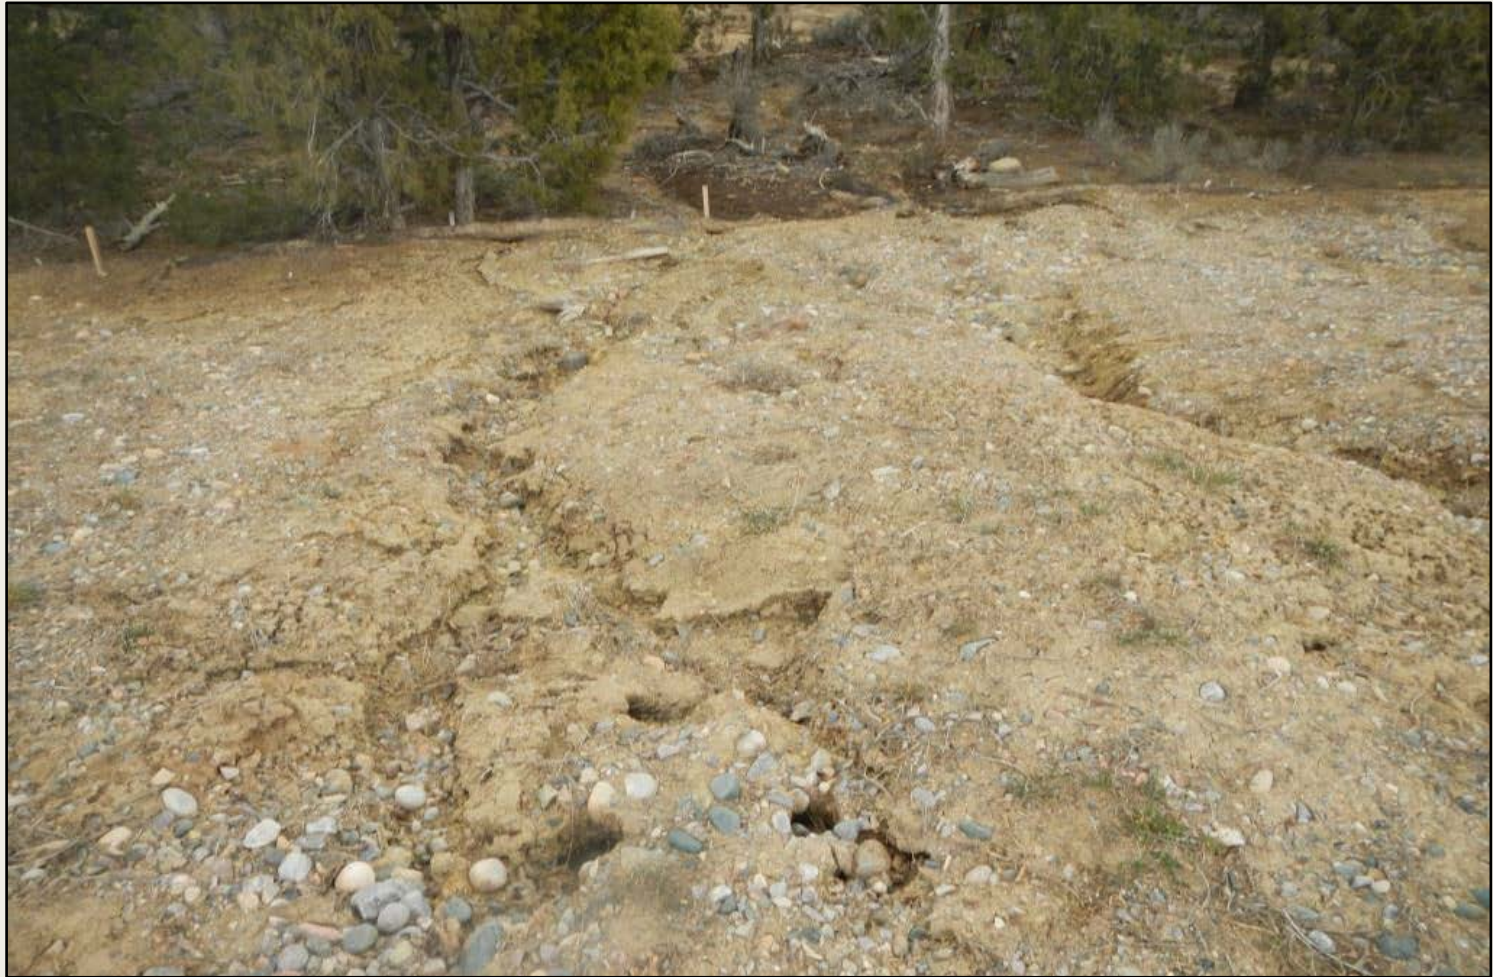
Photo 3. View of erosional channels and failed wattles within the eastern project area.

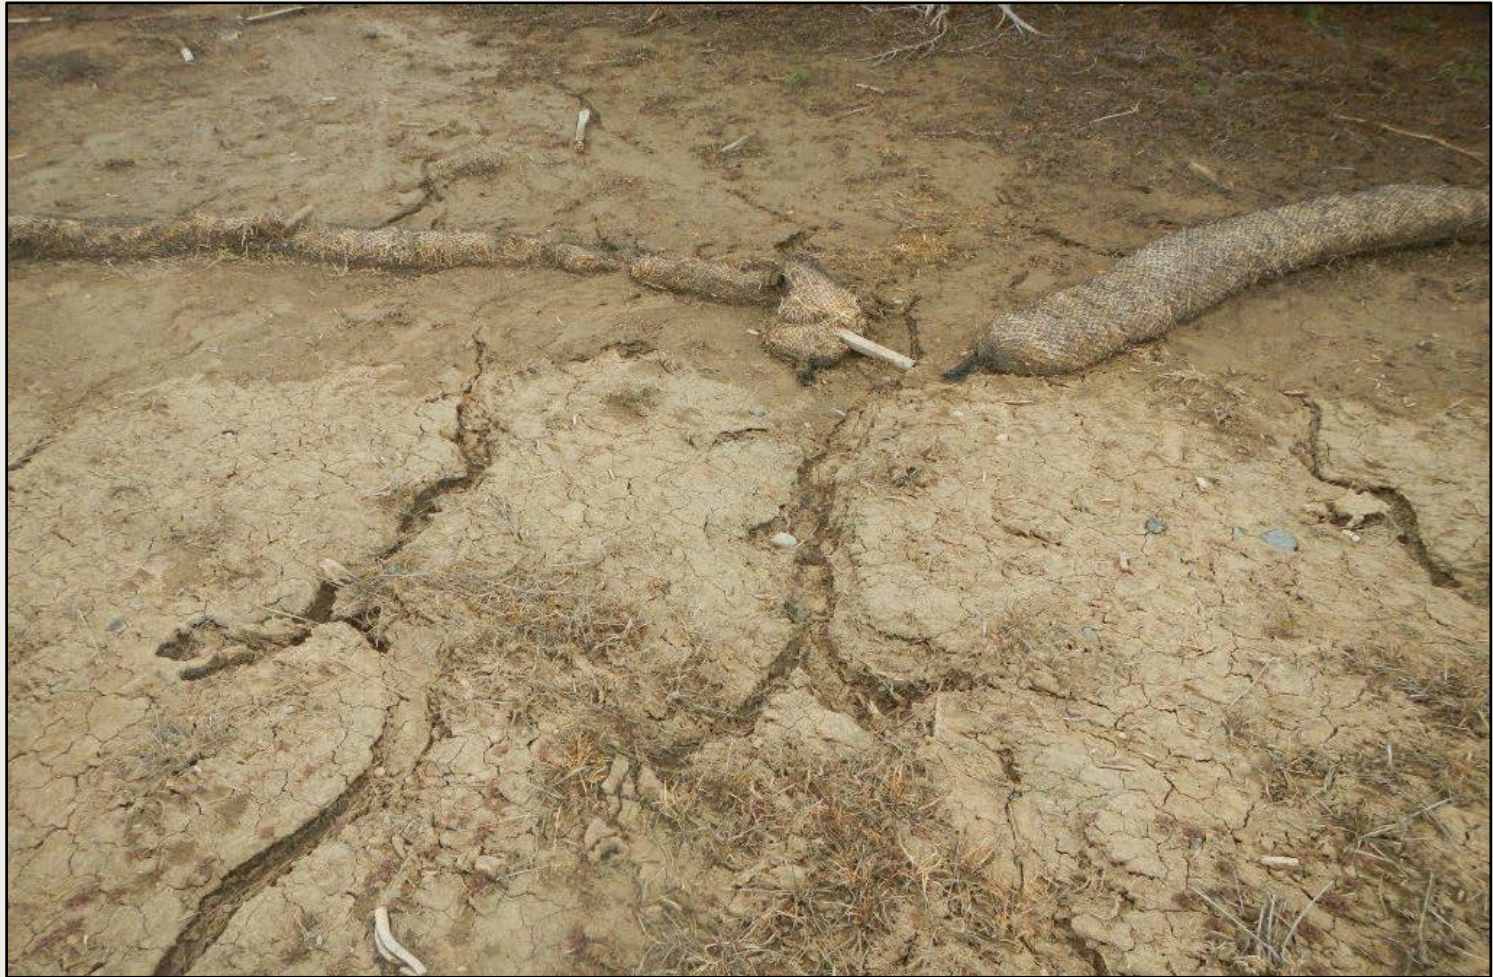
Photo 4. View of more erosional channels showing failed wattles and sediment deposition offsite, within the southern project area.
