**Inspection Photos**  
**Location Name: MV SMITH 31**  
**Location ID: 05-103-05344**  
**Inspection: 679703476**

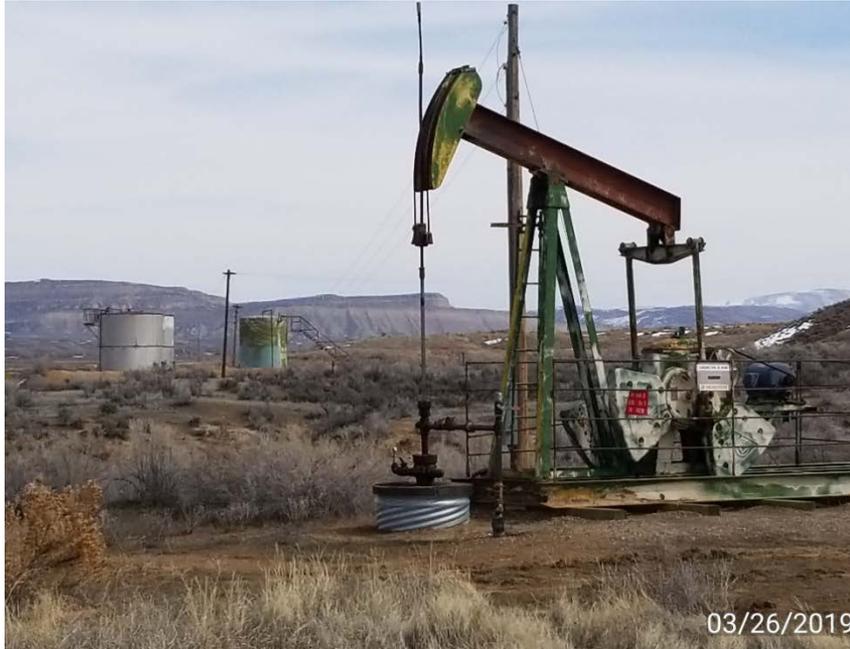
**Photo 1. Location looking northeast.**

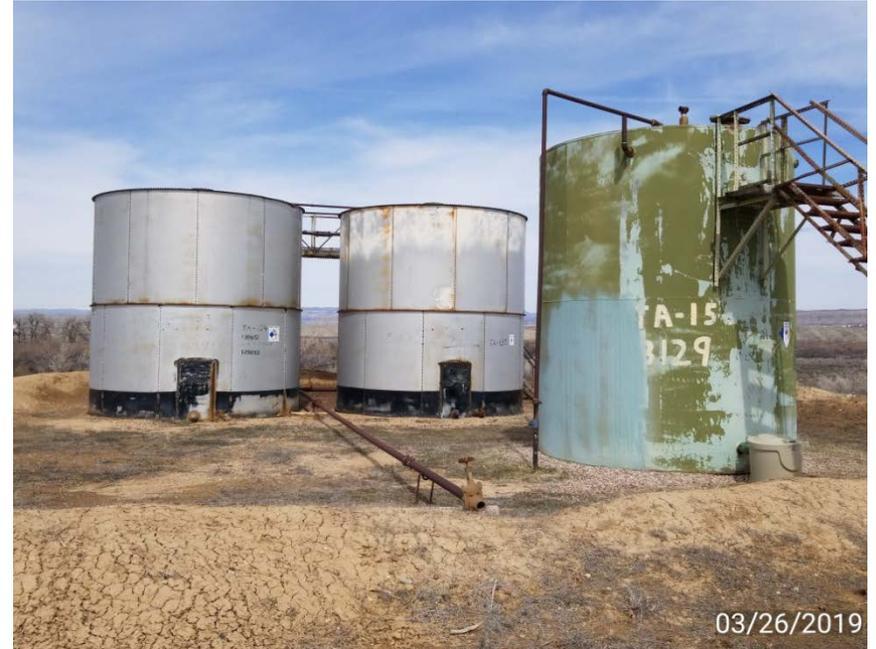
**Photo 2. Tank battery.**

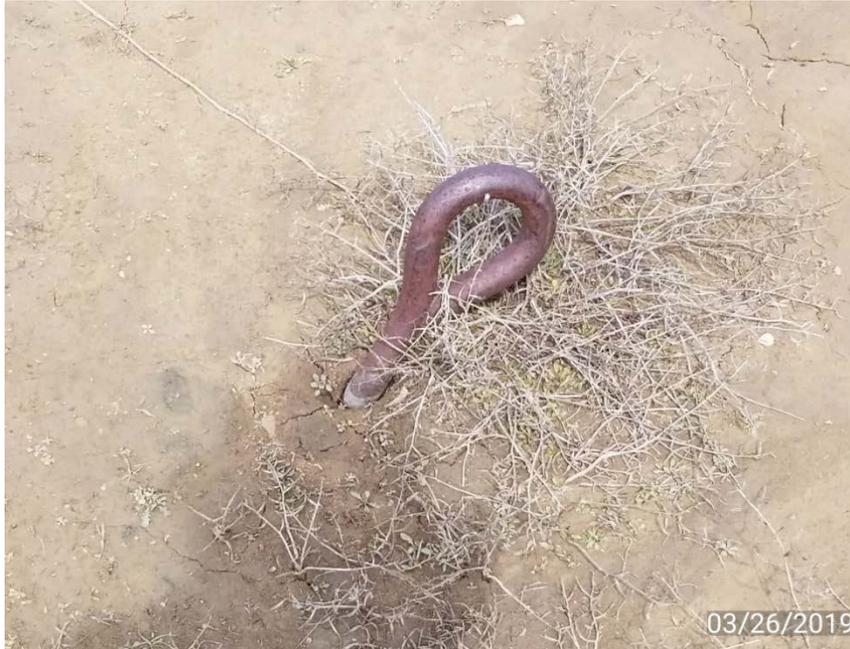
Photo 3. Unmarked deadman

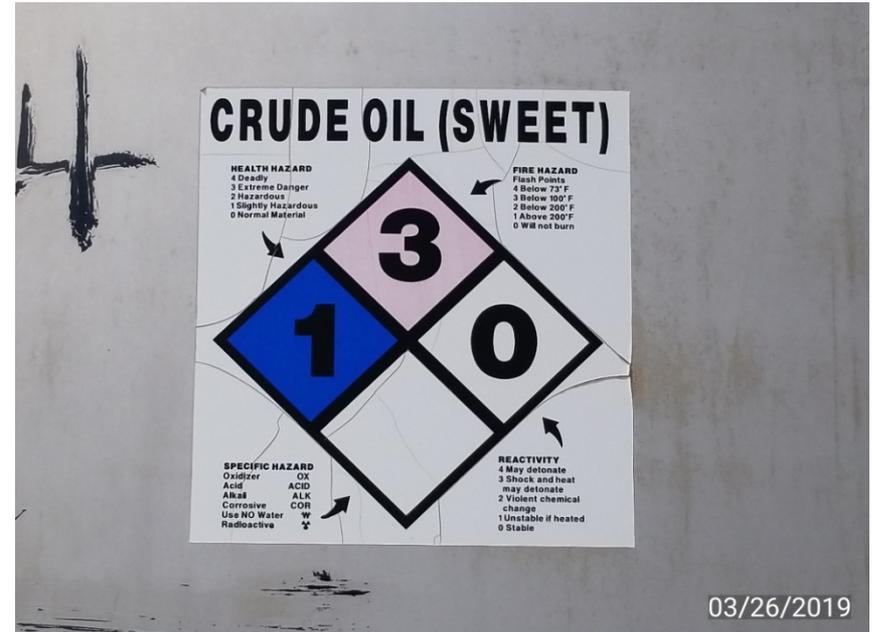
Photo 4. Tank sign missing capacity of 300 bbl.

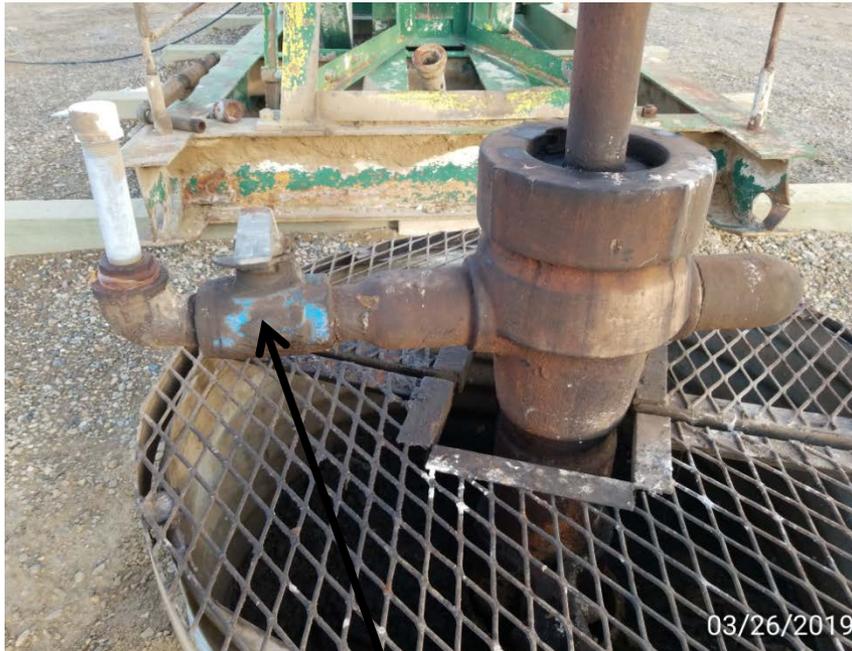
Photo 5. Casing valve leaking gas.

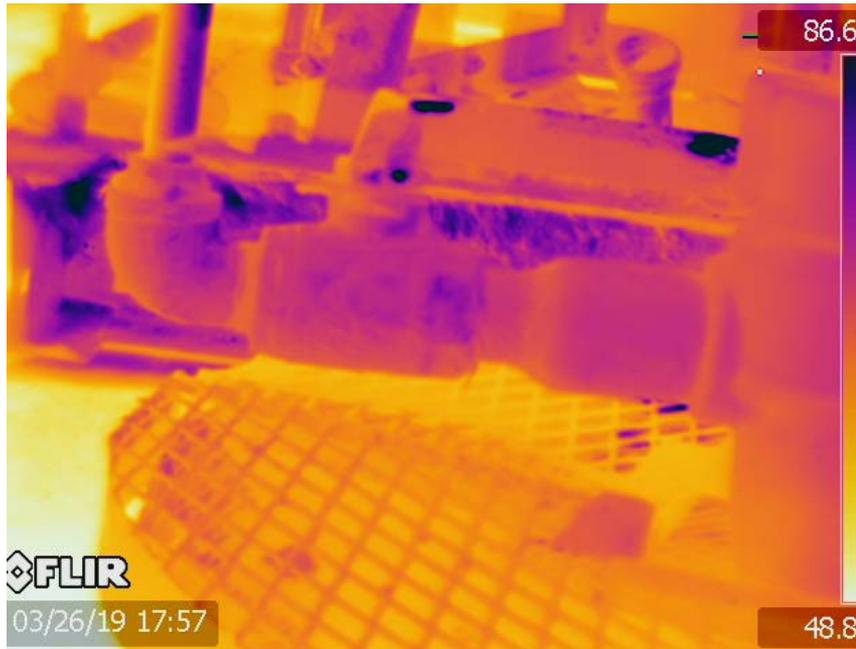
Photo 4. Casing valve in infrared with a FLIR GF320 camera.

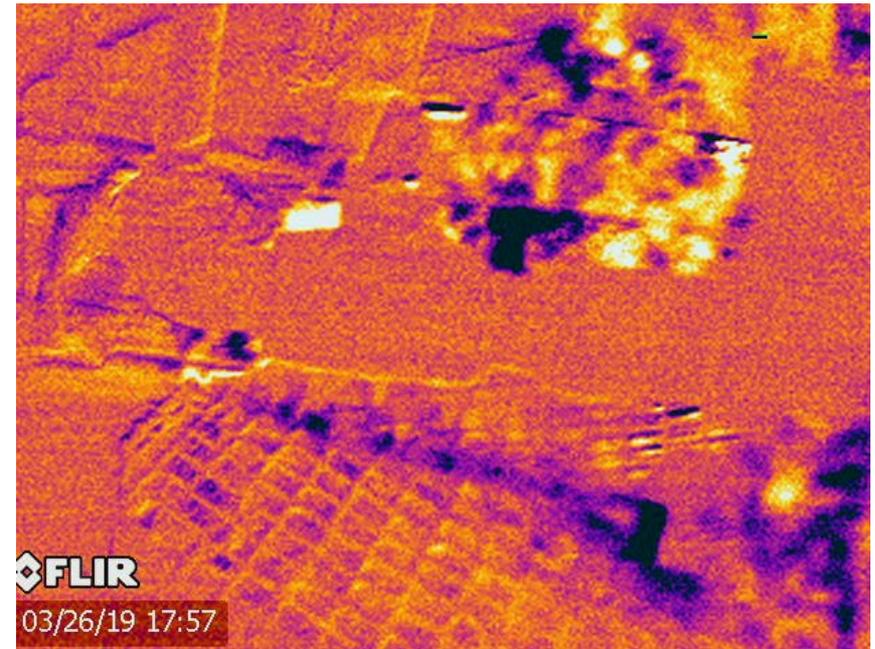
Photo 5. Casing valve in infrared HSM with a FLIR GF320 camera. (Wind blowing left to right)

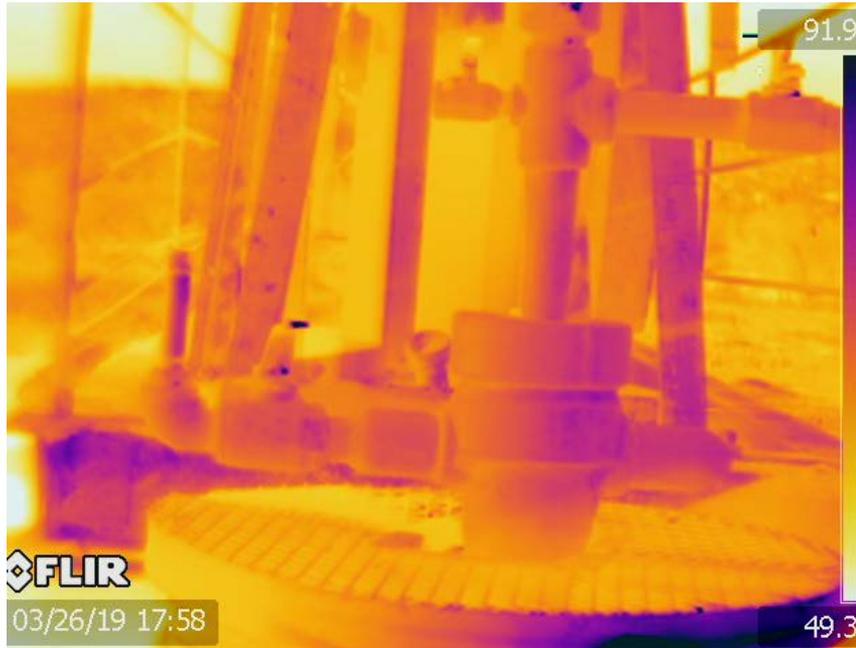
**Photo 6. Well head in infrared with a FLIR GF320 camera.**

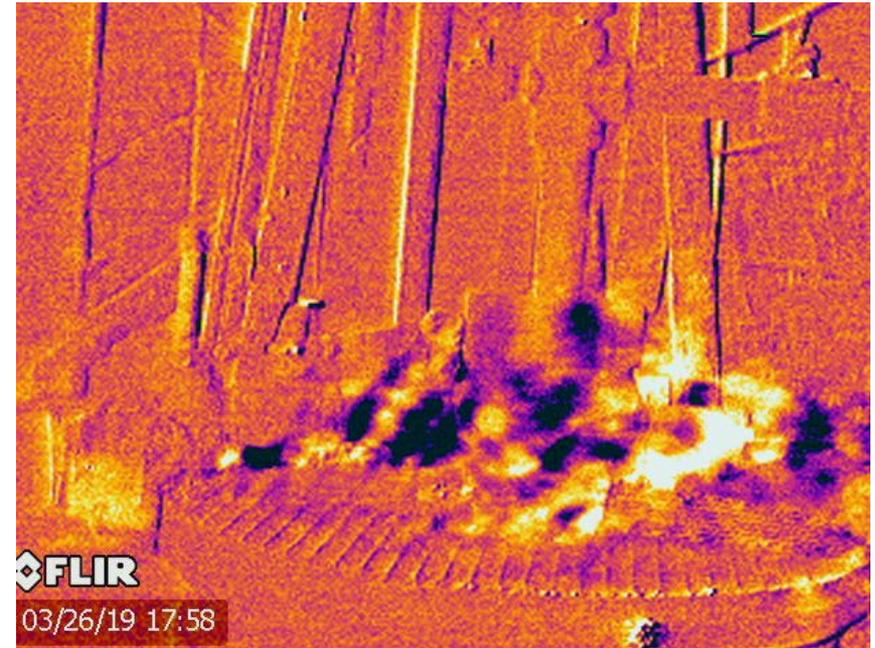
**Photo 7. Well head in infrared HSM with a FLIR GF320 camera. (Wind blowing left to right)**
