Inspection Photos
Location Name: Oxbow 0880 S29
API: 05-057-06618

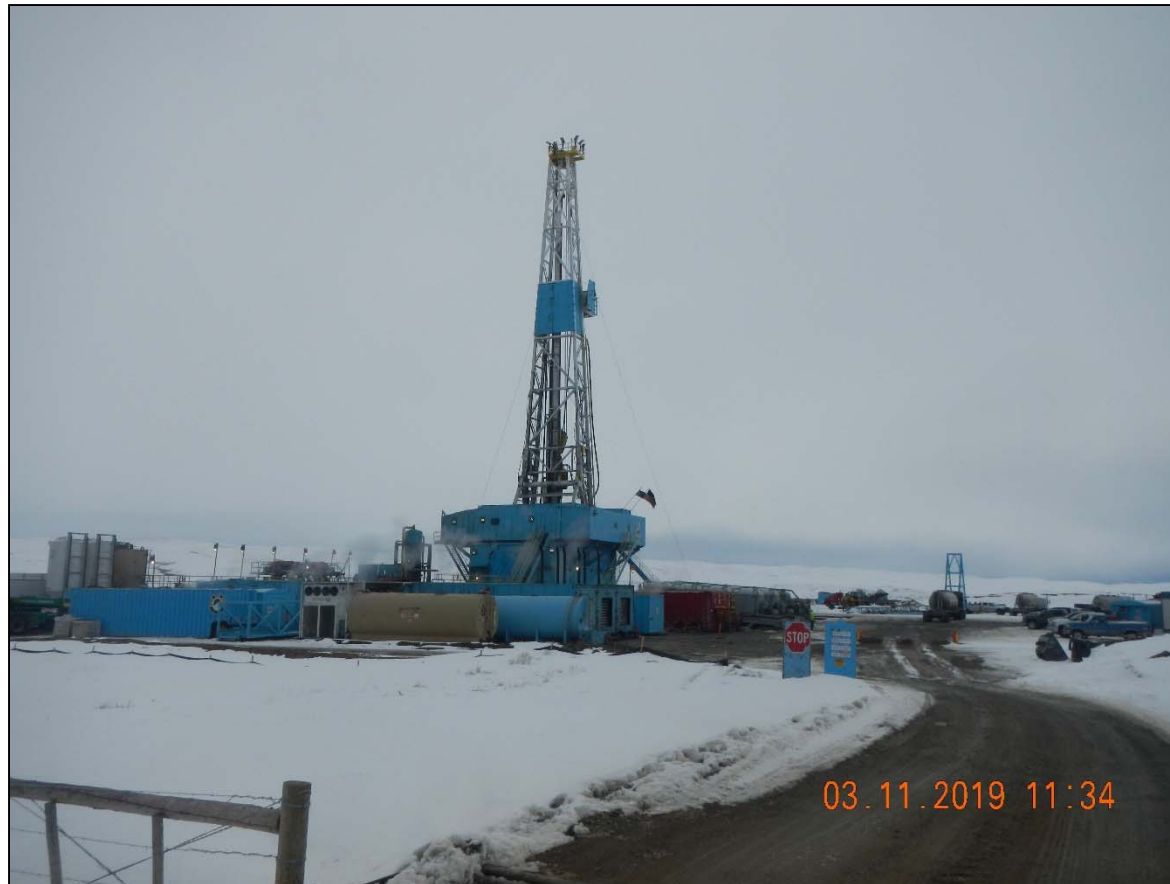
Photo 1. Overview of location taken at entrance facing northeast.

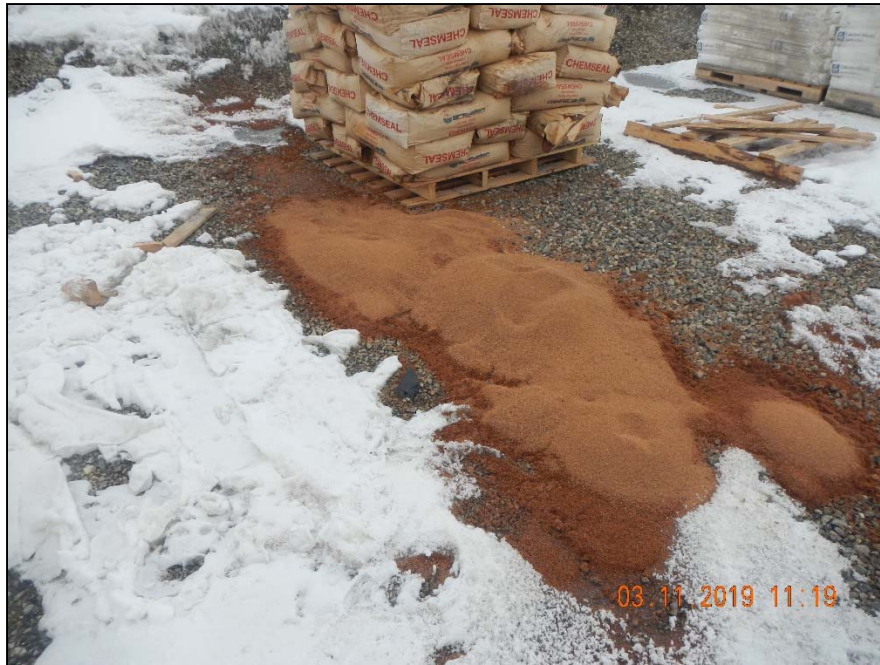
Photo 2. Additive spilled in foreground, improper storage (uncovered) in background.

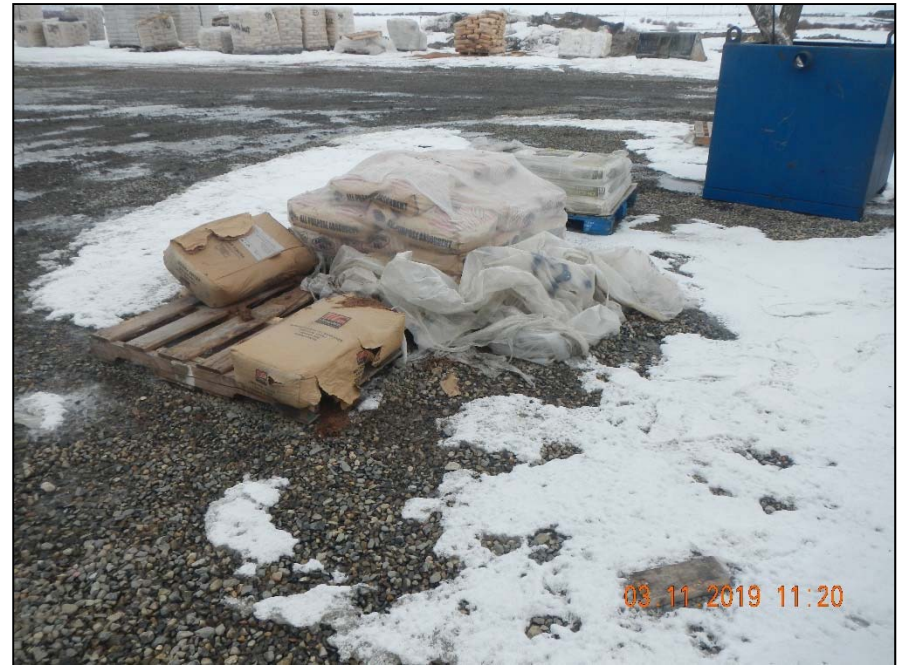
Photo 3. Improper (uncovered) additive storage and spill.

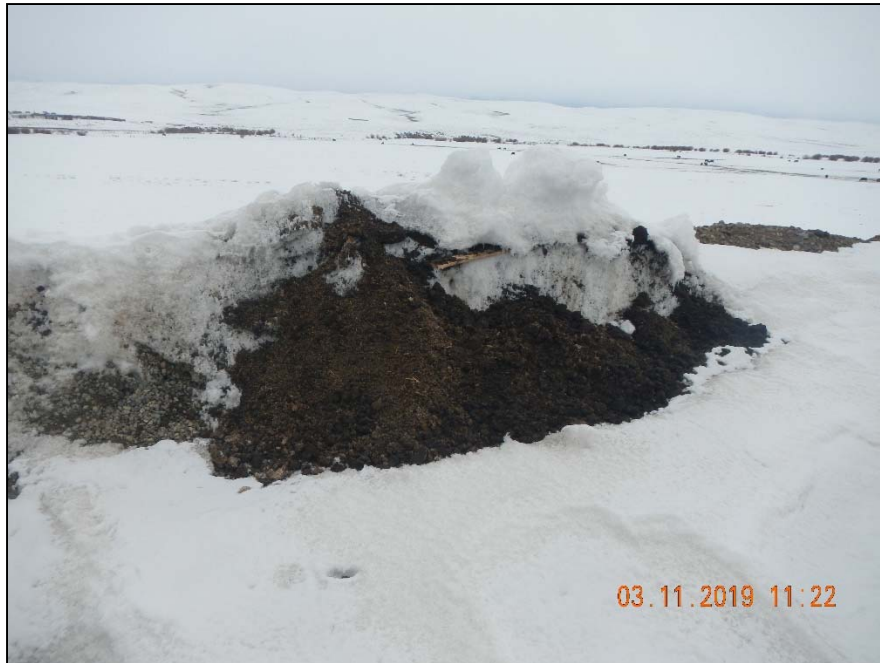
Photo 4. Spilled additive pushed against and into location perimeter berm.

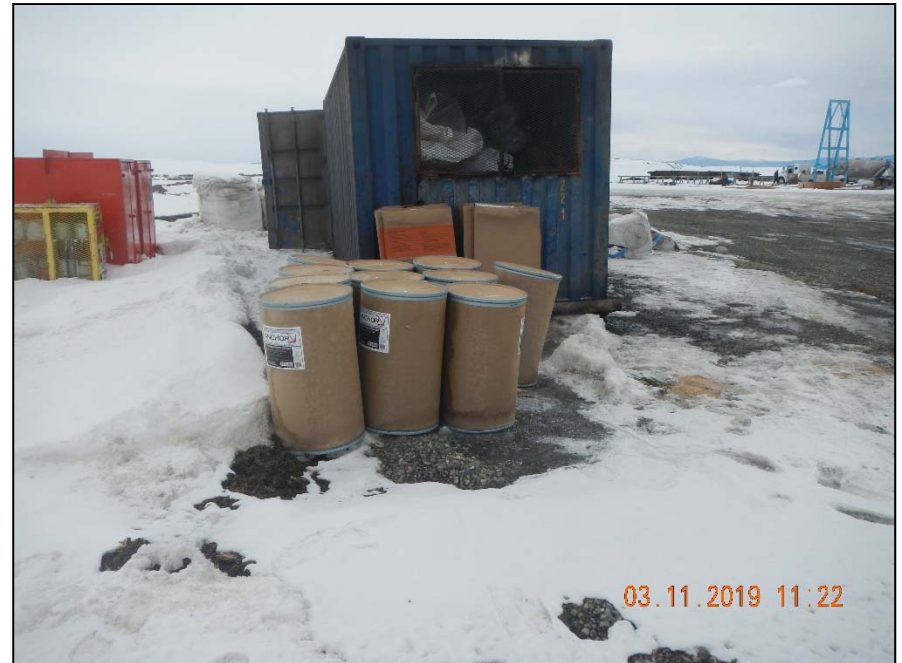
Photo 5. Additives without secondary containment.

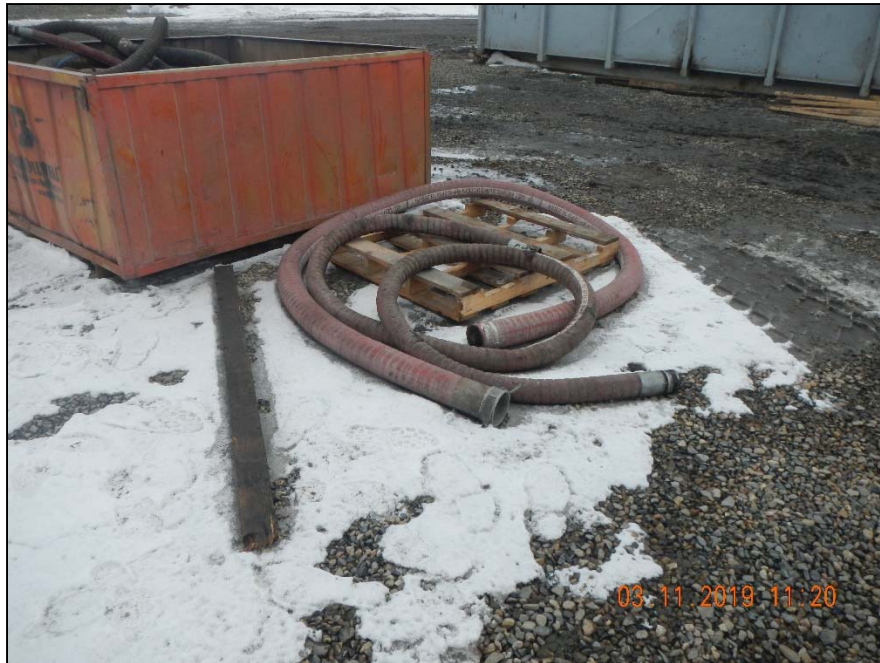
Photo 6. Hoses stored without secondary containment.

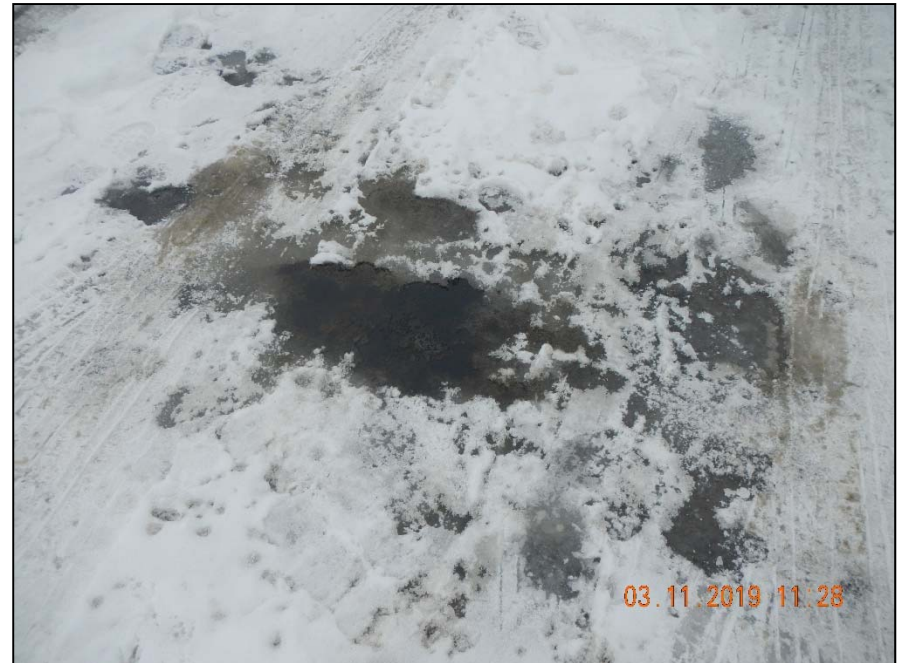
Photo 7. Non-reportable spill.
