Inspection Photos
Location Name: Thomas Jacquez E #1 PW Line
Spill/Release Point ID #458834

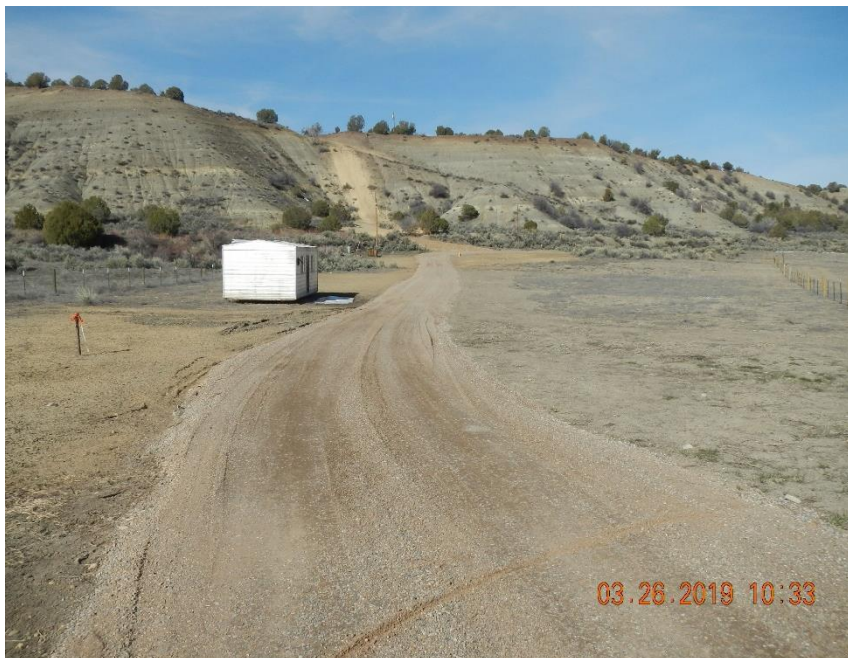
Reclaimed area on hillside near point source of Spill/Release Point ID #458834.

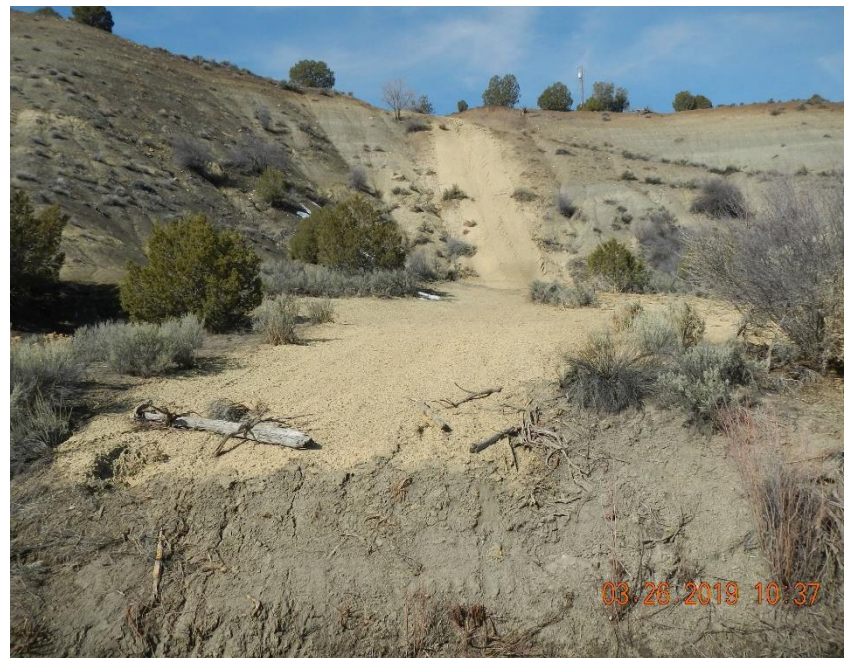
Reclaimed area along flow path of Spill/Release Point ID #458834.

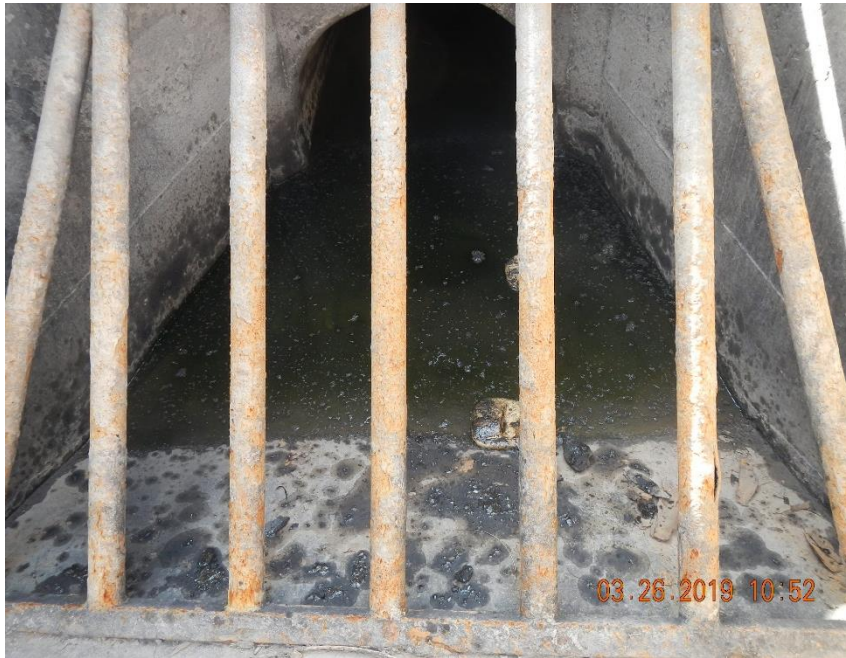
High Flume siphon inlet with residual E and P waste.

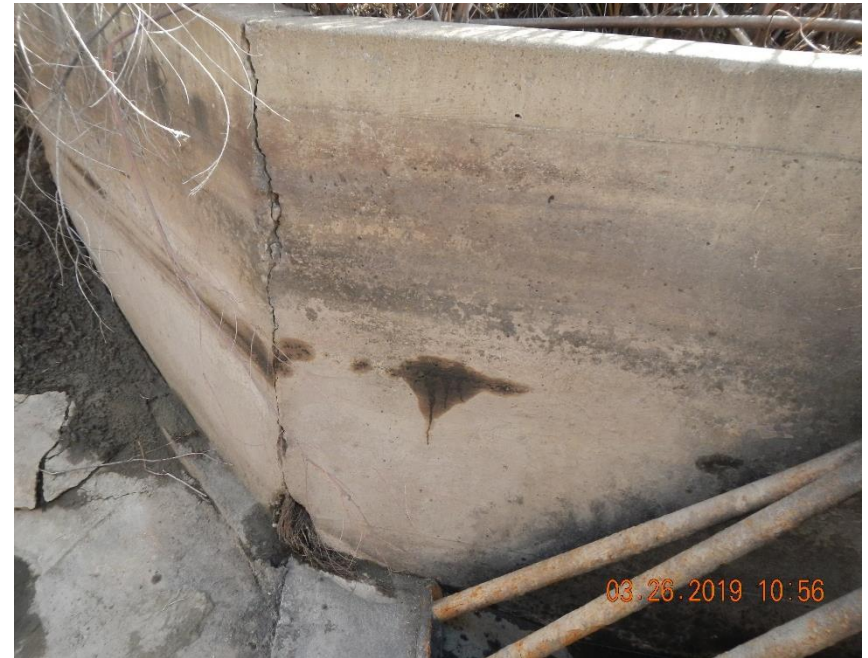
Oil stained concrete at High Flume siphon inlet.

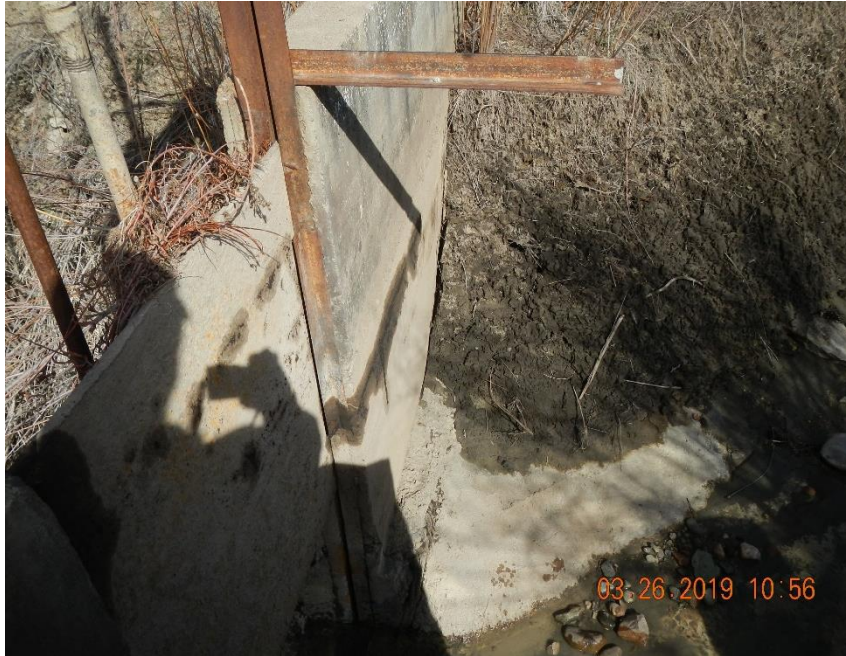
Stained concrete adjacent to High Flume siphon bypass.

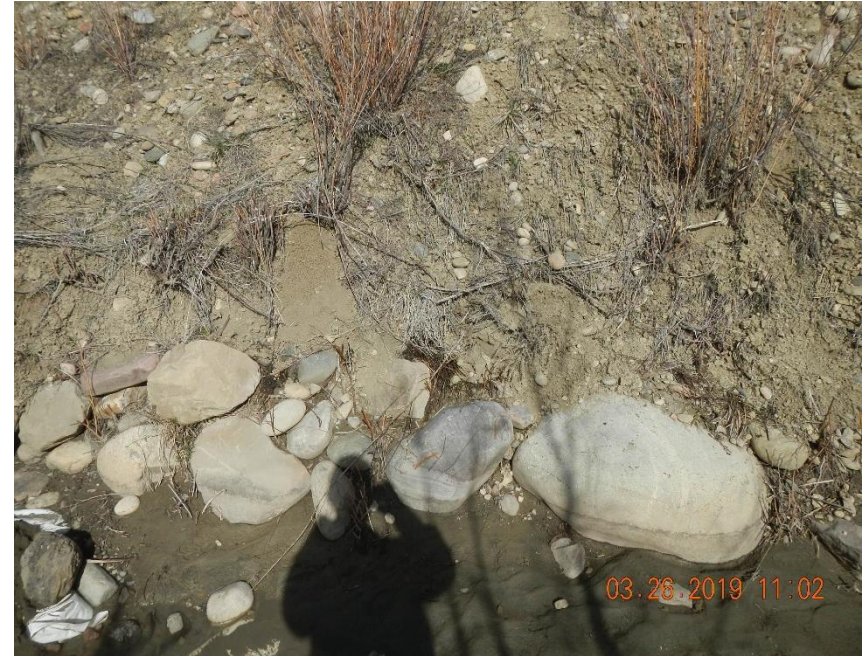
Residual impacts along High Flume siphon bypass.

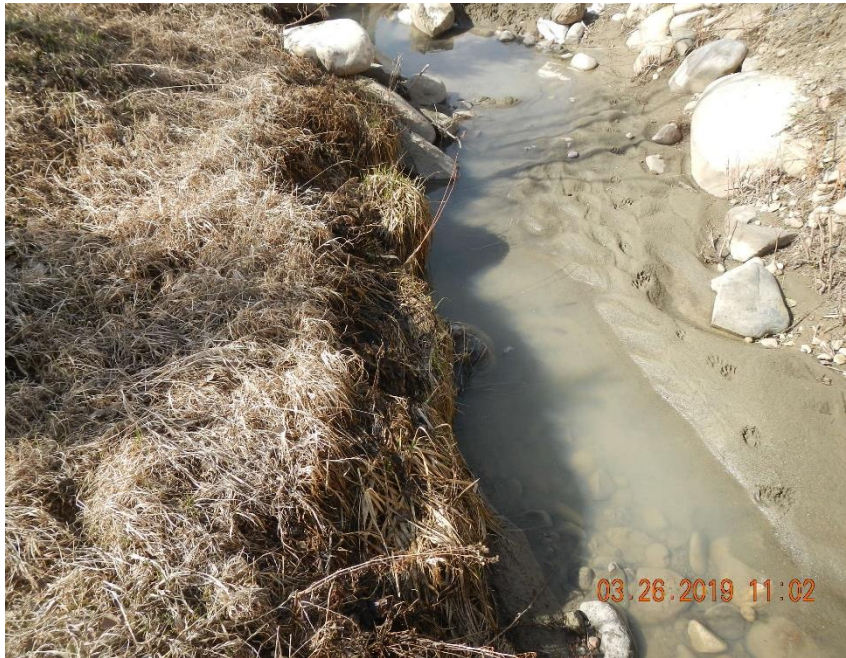
Impacted soil and vegetation along High Flume siphon bypass.

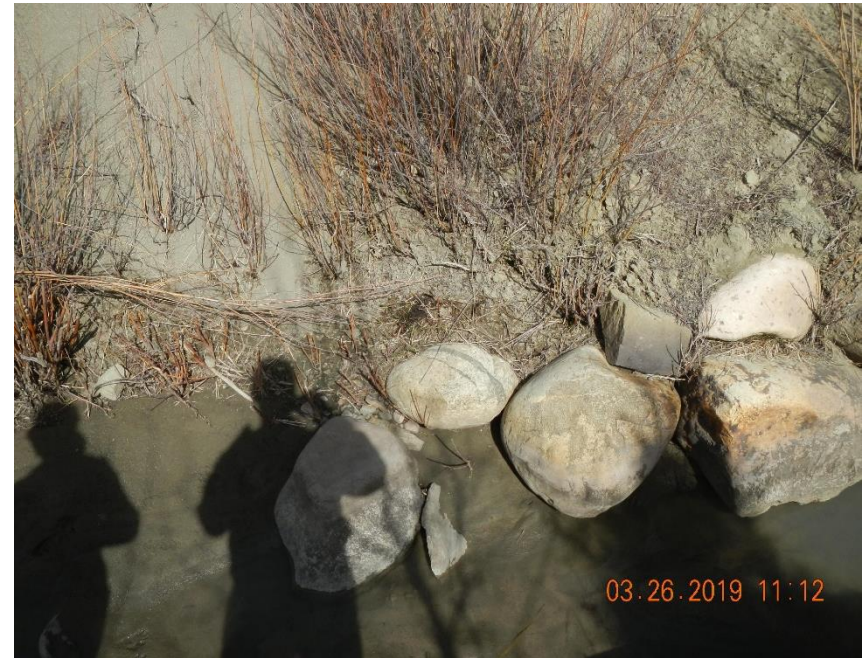
Impacted soil and vegetation remain along High Flume siphon bypass.

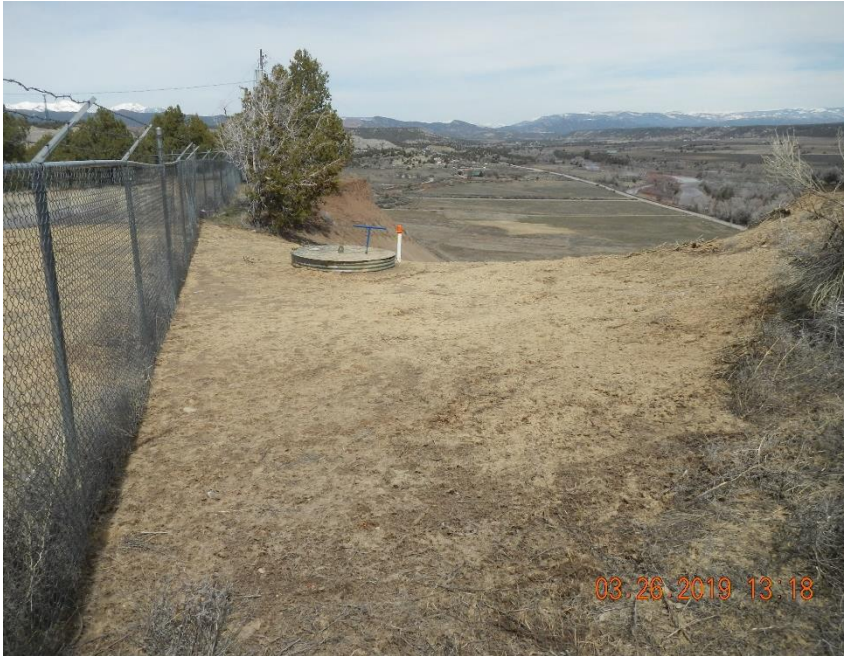
Reclaimed area near point source of release.

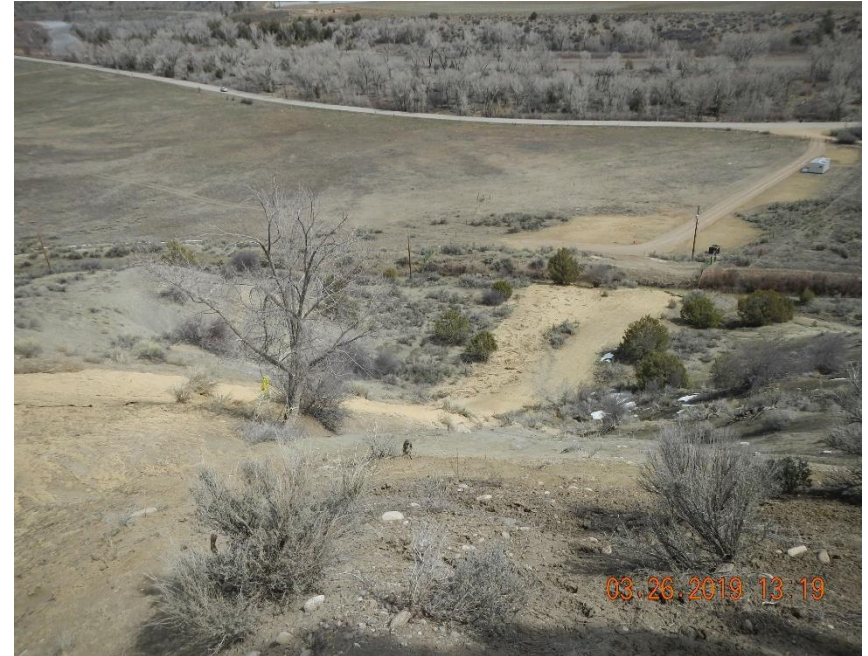
Reclaimed area along flow path of release.
