Construction and Storm Water Inspection

March 22, 2019

Operator: EXTRACTION OIL & GAS INC – 10459

Location ID: 455317

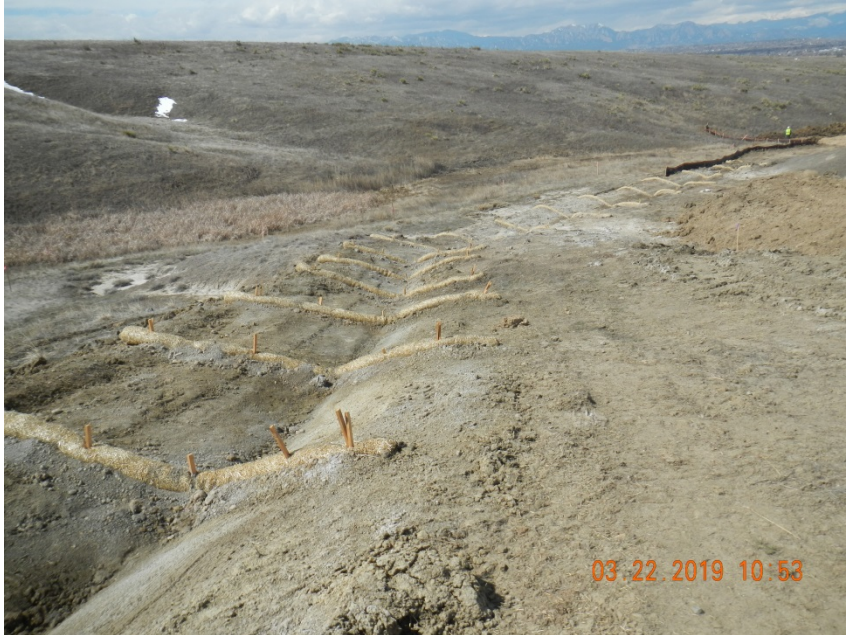
Photo 1. Photo taken from the southern perimeter of the location, facing West. Photo illustrates a ditch and berm BMP that is being installed around the perimeter of the location.

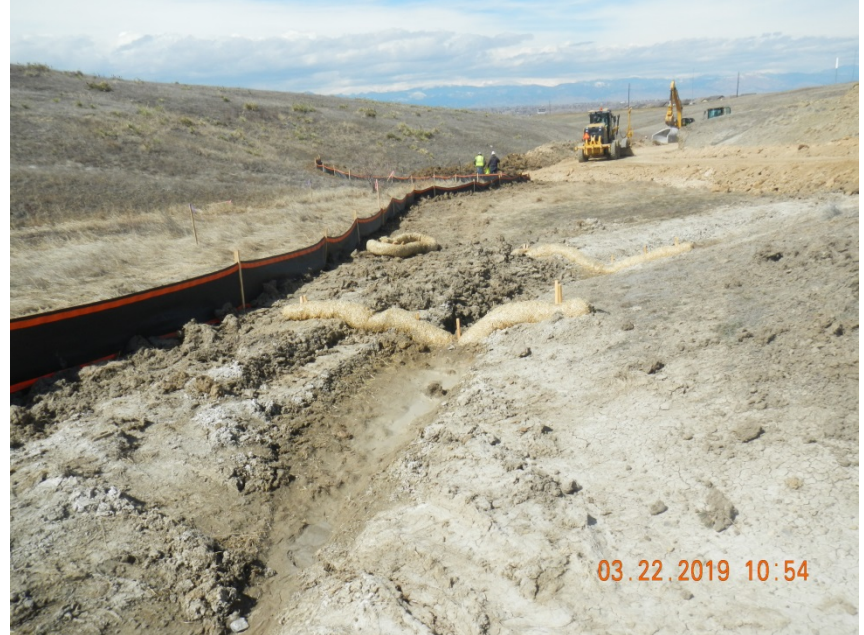
Photo 2. Photo taken from the southern perimeter of the location, facing West. See comments from Photo 1. An additional silt fence BMP is installed on the southern edge of the location.

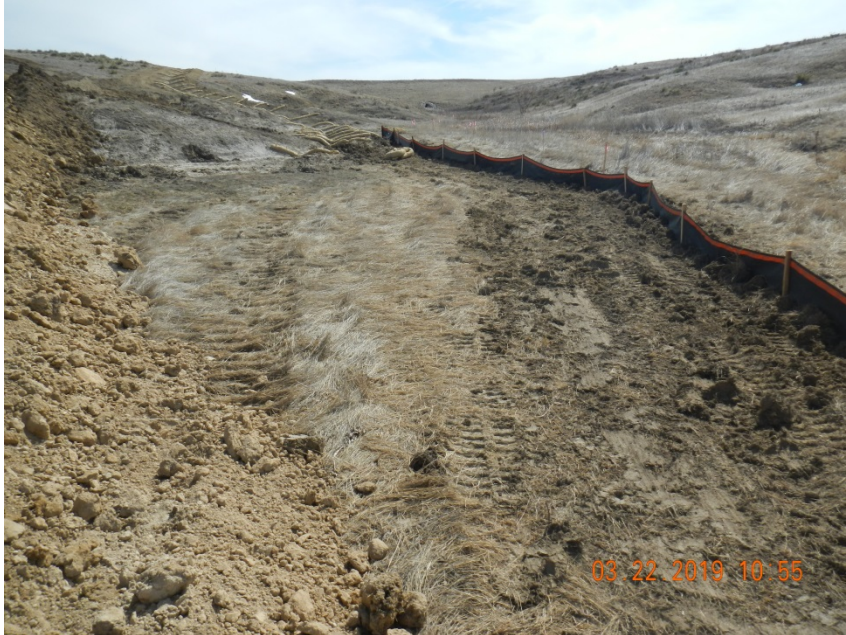
Photo 3. Photo taken from the southern perimeter of the location, facing West. Appears the operator is installing a culvert through the USFWS National Wetlands Inventory mapped Riverine System (R4SBC).

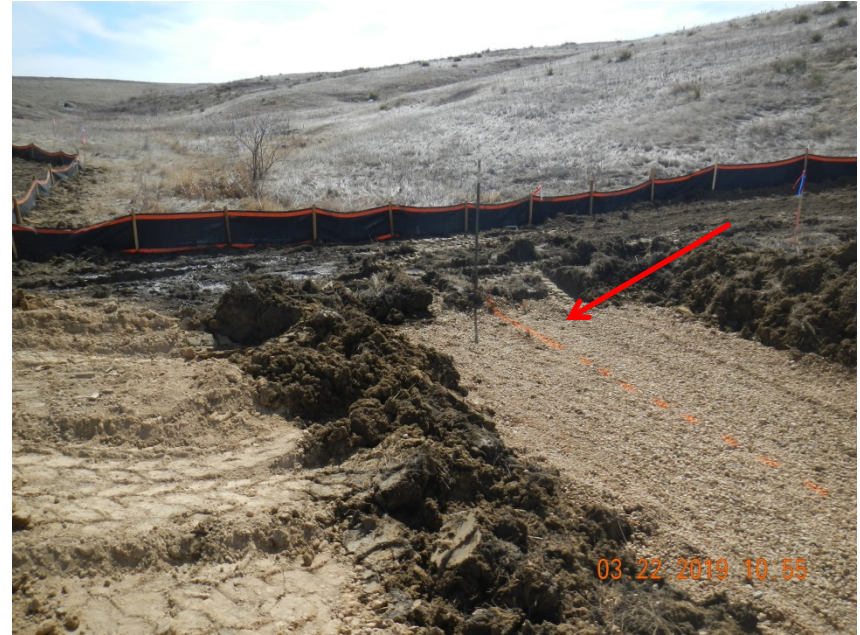
Photo 4. Photo taken from the southern perimeter of the location, facing Southeast. Appears the operator is installing a culvert through the USFWS National Wetlands Inventory mapped Riverine System (R4SBC).

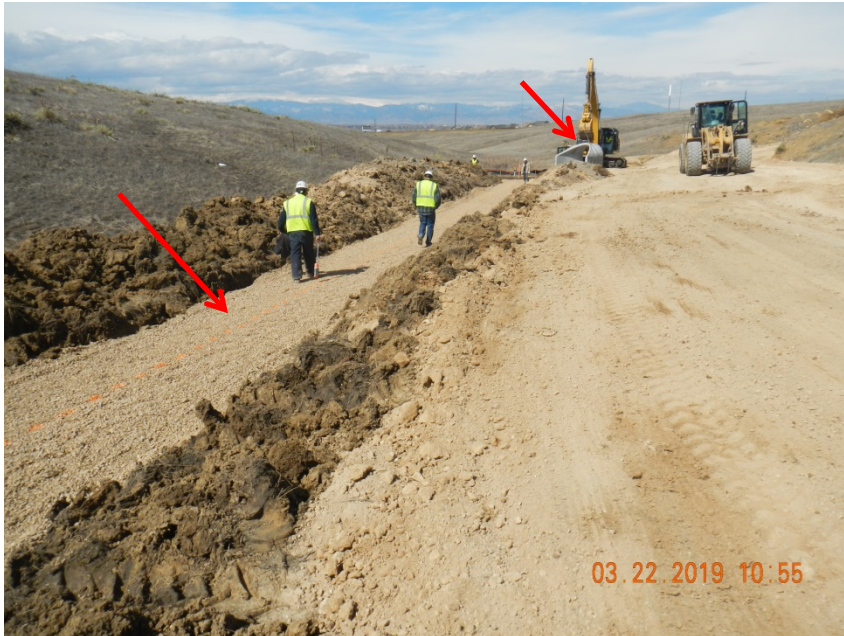
Photo 5. Photo taken from the northwestern perimeter of the location, facing East. See comments from Photo 4.

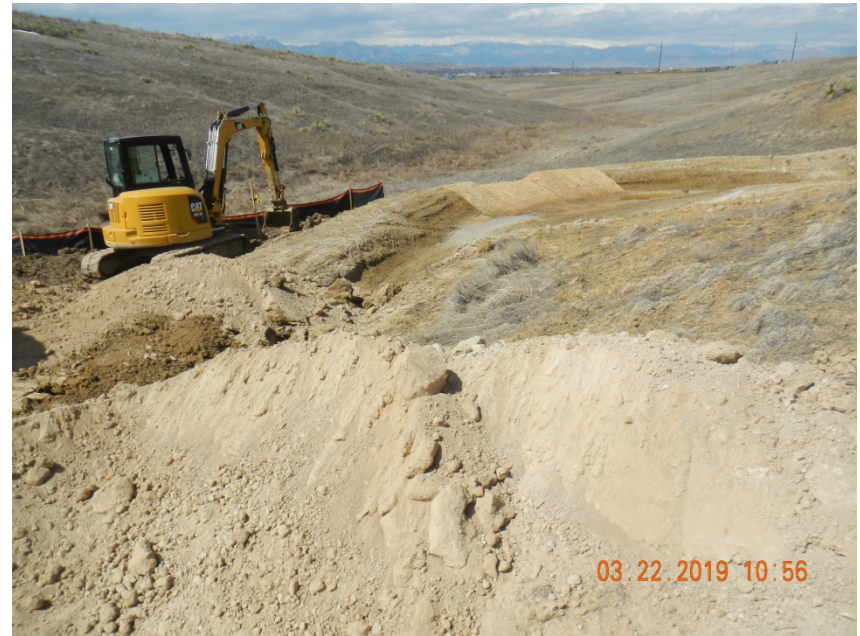
Photo 6. Photo taken from the western perimeter of the location, facing South. Appears the Operator has installed a sediment trap with a temporary stabilized outlet.

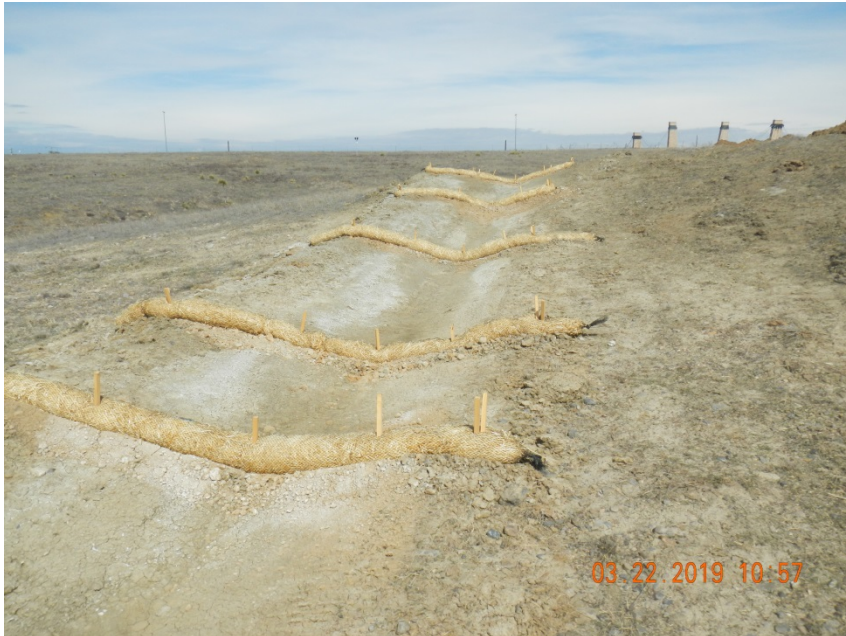
Photo 7. Photo taken from the western perimeter of the location, facing North. See erosion comments from Photo 9.

Photo 9. Photo taken from the western perimeter of the location, facing North. The middle ground of the Photo depicts erosion observed on location with apparent sediment accumulation within the sediment trap. The background of the Photo illustrates the topsoil stockpile has not been temporarily stabilized.

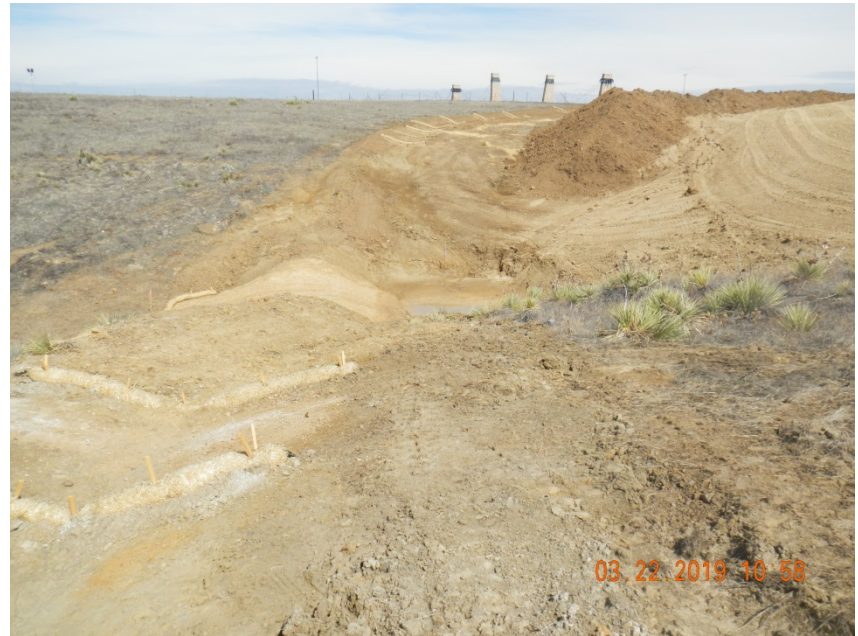
Photo 8. Photo taken from the western perimeter of the location, facing South. See comments from Photos 1 and 6.

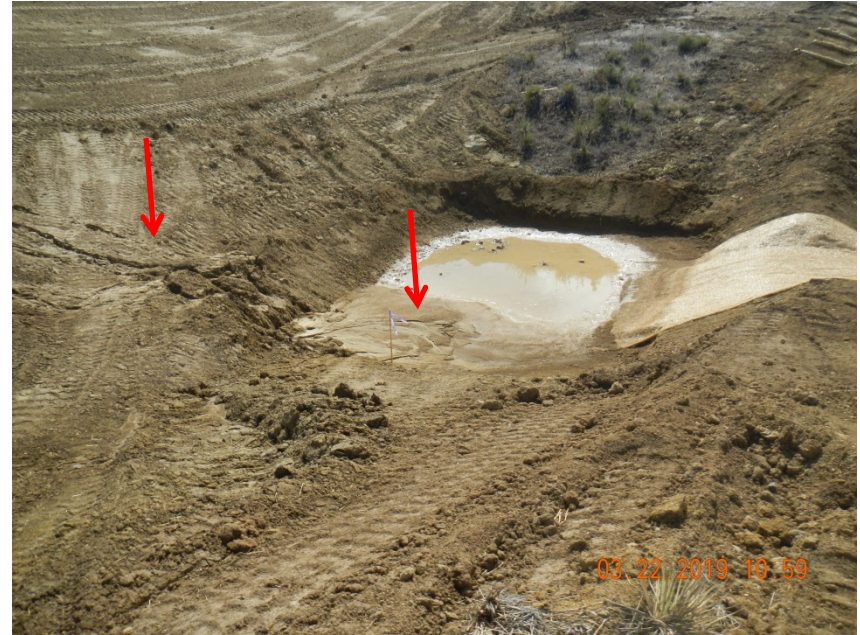
Photo 10. Photo taken from the western perimeter of the location, facing South. See erosion comments from Photo 9.

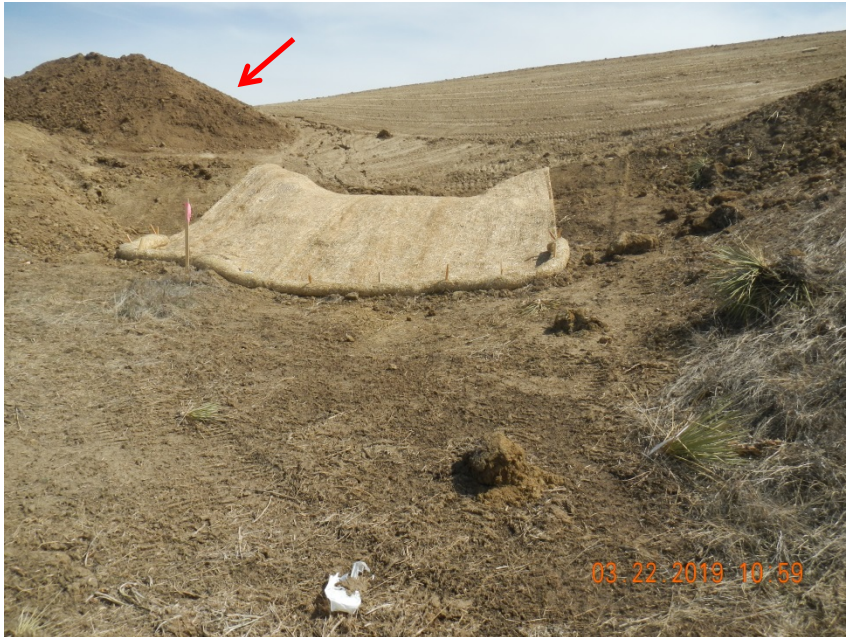
Photo 11. Photo taken from the western perimeter of the location, facing North. See topsoil comments from Photo 9.

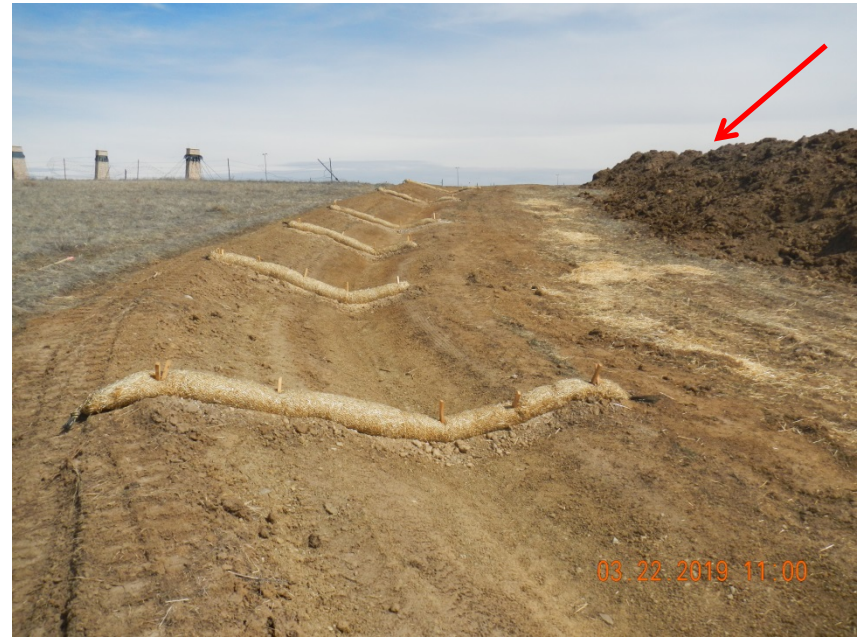
Photo 12. Photo taken from the northwestern perimeter of the location, facing East. See topsoil comments from Photo 9.

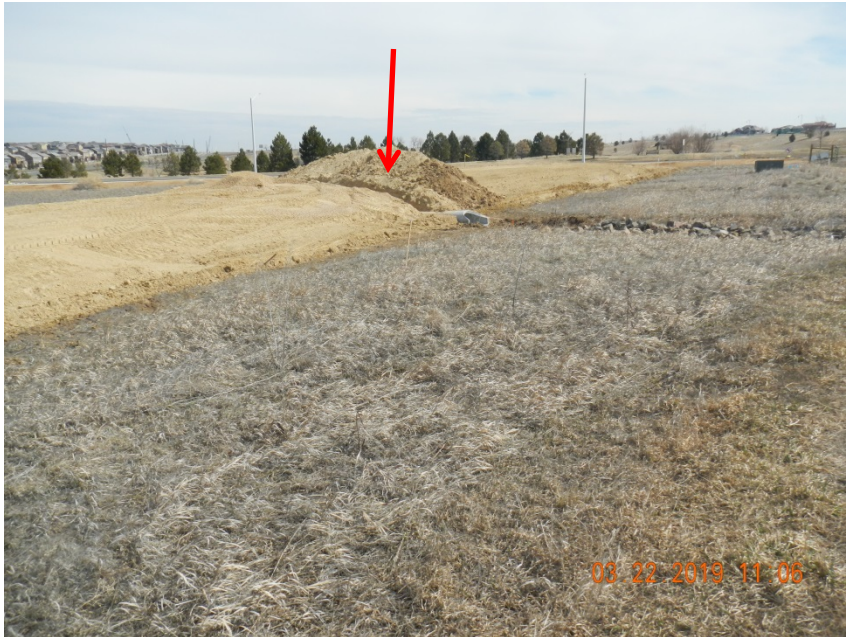
Photo 13. Photo taken looking at the access road on the east end of the location off Lowell Boulevard, facing East. Photo depicts a culvert being installed.

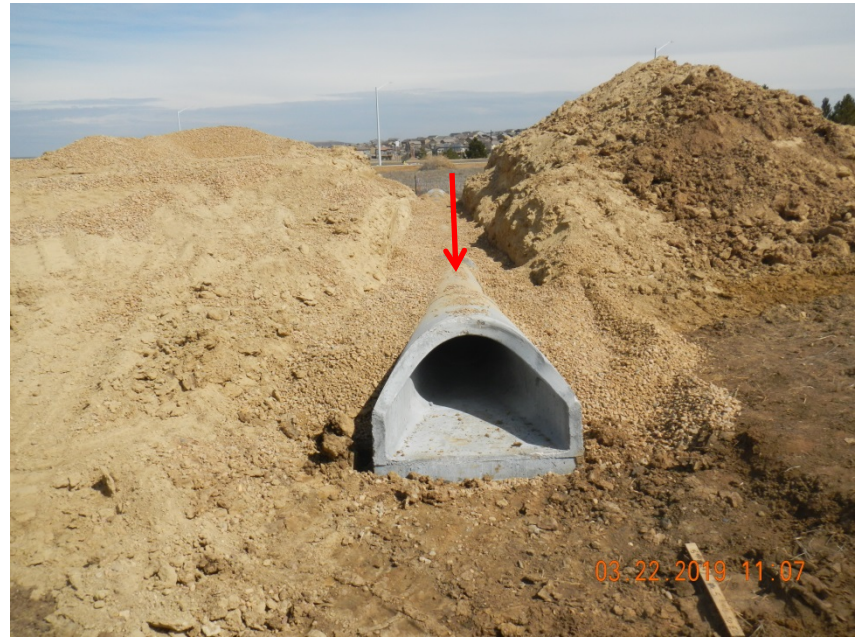
Photo 14. Photo taken from the access road, facing North. See comments from Photos 13.
