Inspection Photos
Location Name: LSWD #1
Facility ID: 159372

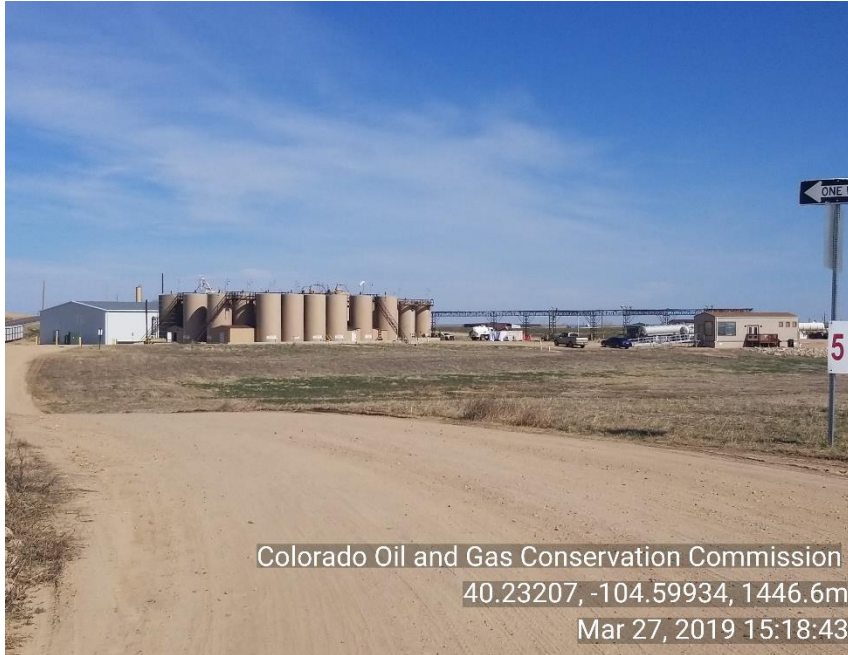
Photo 1 location picture

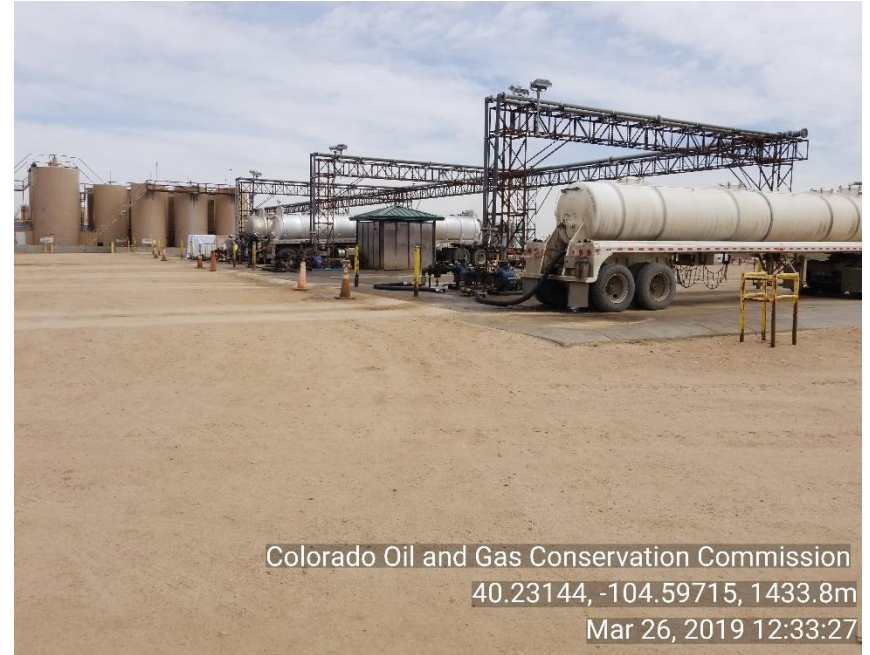
Photo 2 Truck transfer area

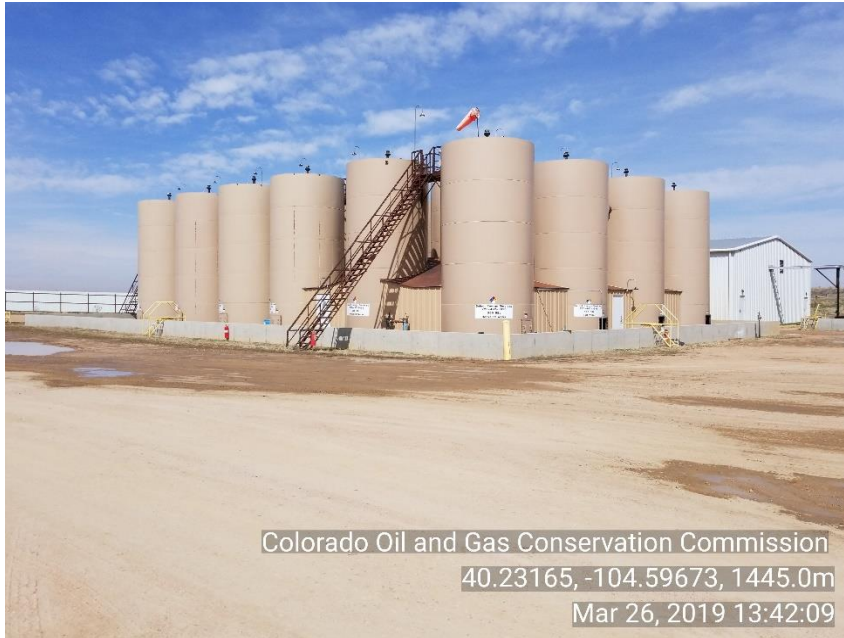
Photo 3 Unused equipment : Recycling battery

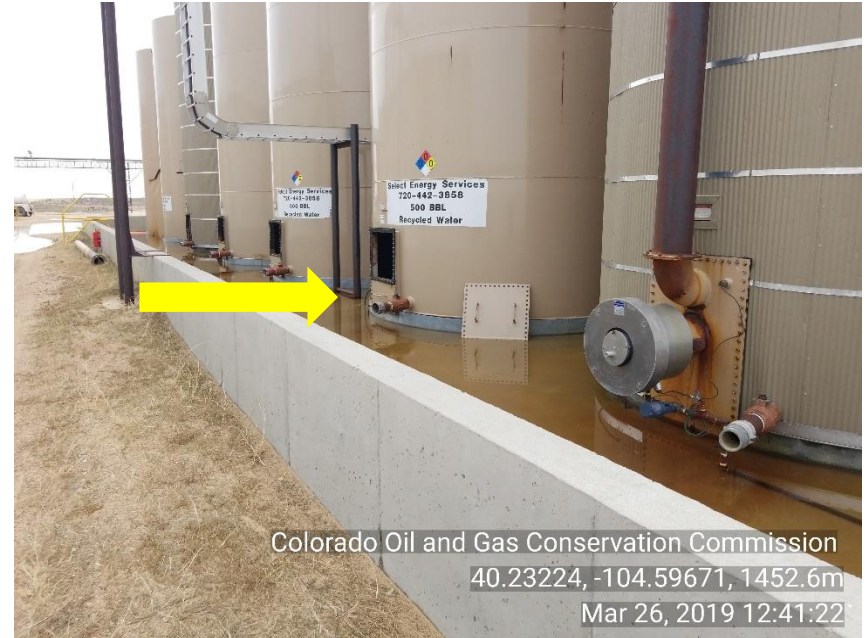
Photo 4 Unused equipment : Recycling battery inspection plates have been removed

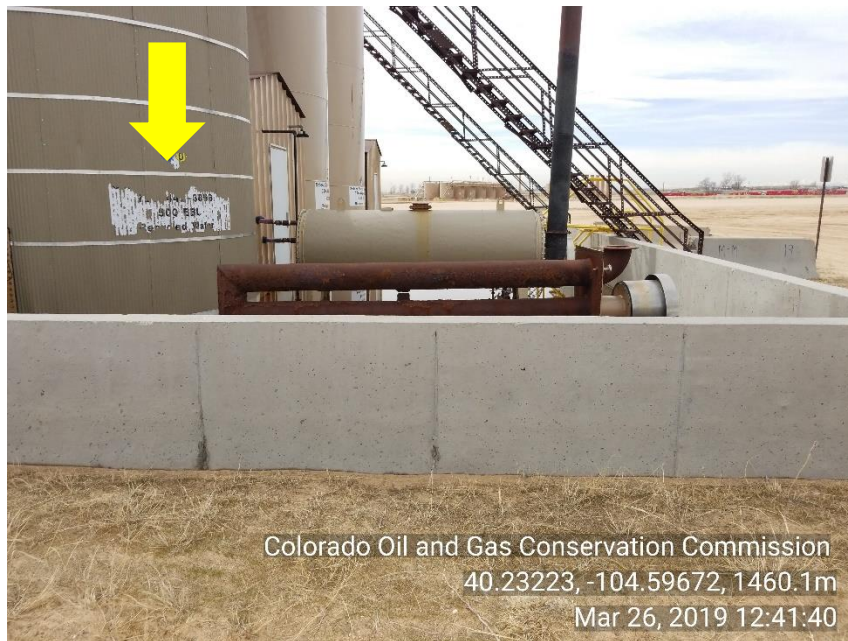
Photo 5 Unused equipment : Recycling battery. Tank sign and NFPA placard unreadable or missing

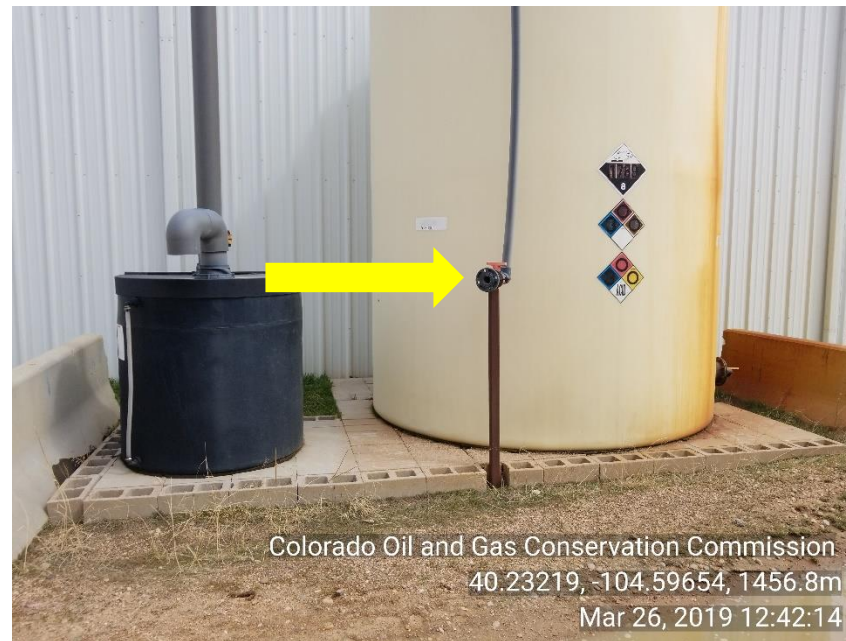
Photo 6 Unused equipment Acid tank, NFPA placards unreadable and faded, no volume sign ,no bull plug on load line, storm water issue with no secondary containment

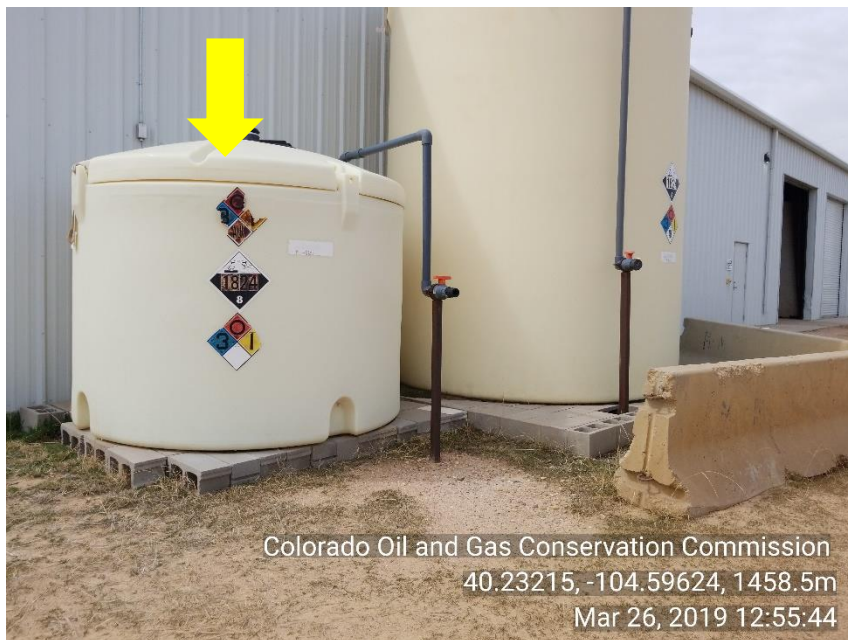
Photo 7 Unused equipment Acid tank, NFPA placards unreadable and faded, no volume sign ,no bull plug on load line, storm water issue with no secondary containment

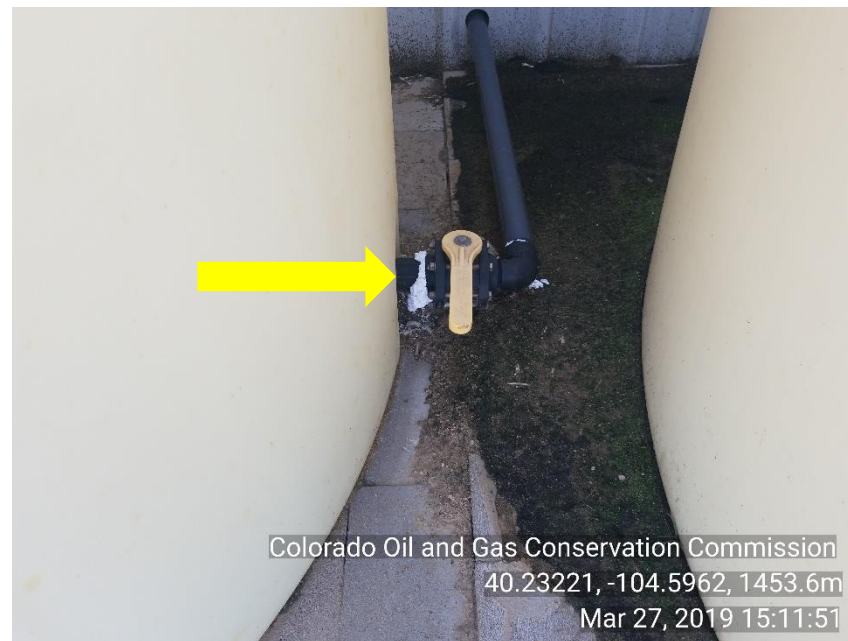
Photo 8 Mechanical issue: Valve appears to be leaking on acid tanks . Storm water issues due to no secondary containment

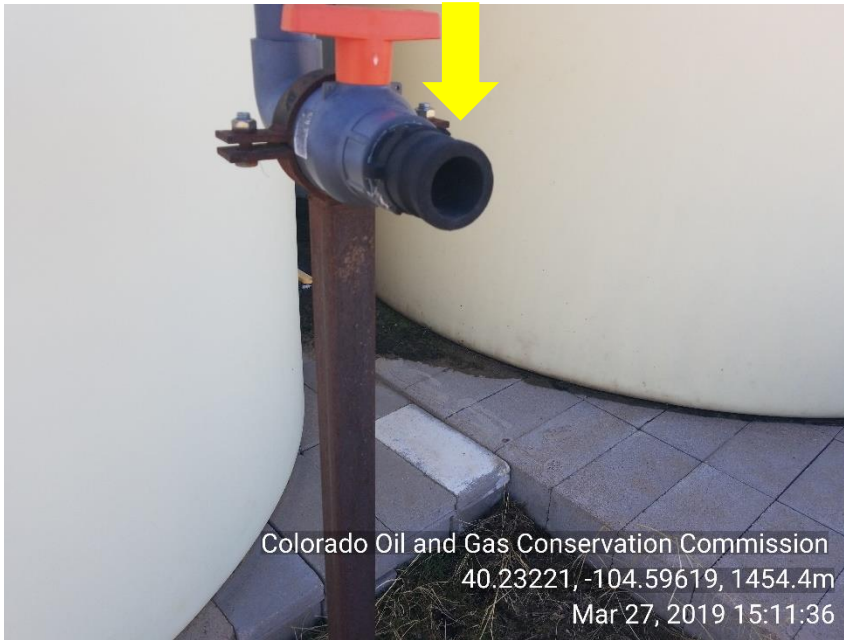
Photo 9 Unused equipment Acid tank, no bull plug on load line, storm water issue with no secondary containment

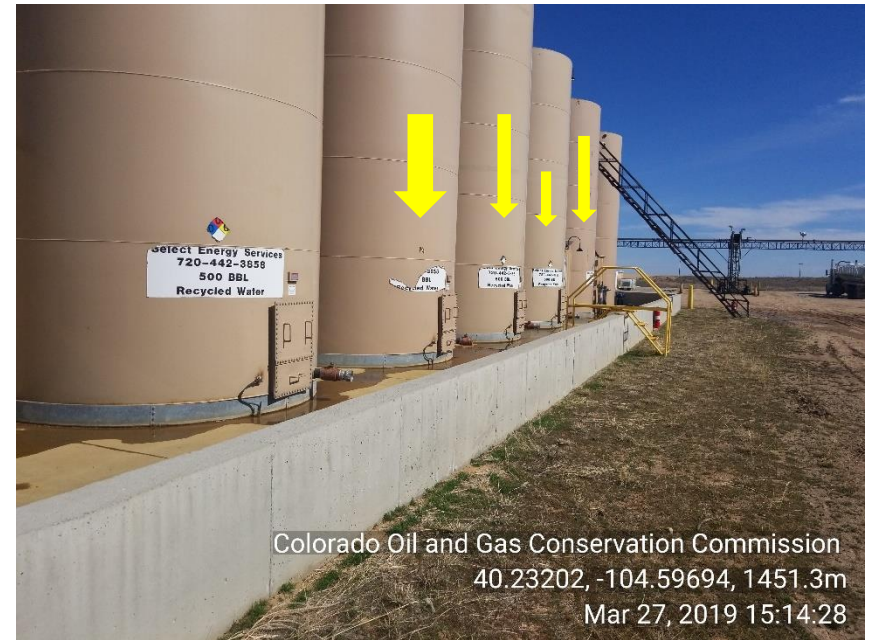
Photo 10 Unused equipment : Recycling battery. Tank sign and NFPA placard unreadable or missing

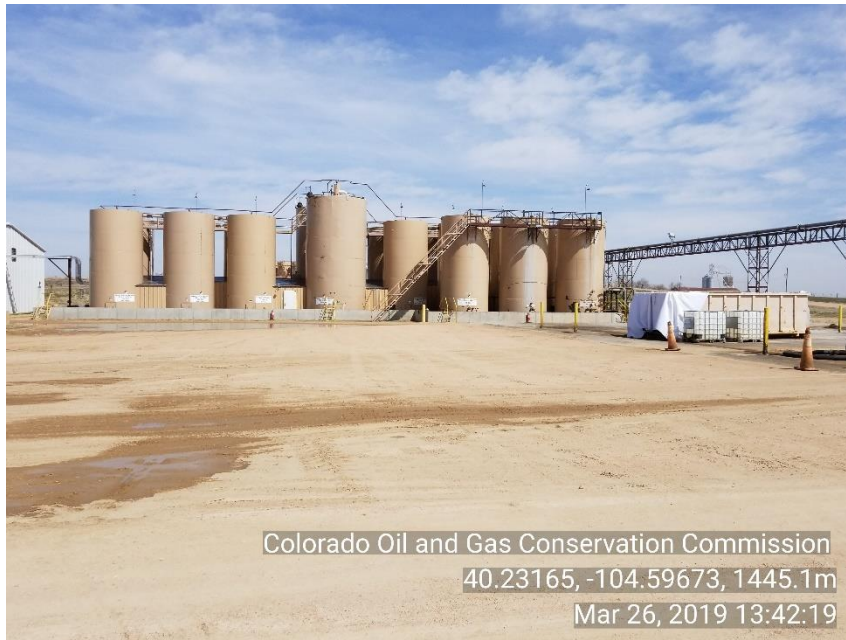
Photo 11 Active injection facility

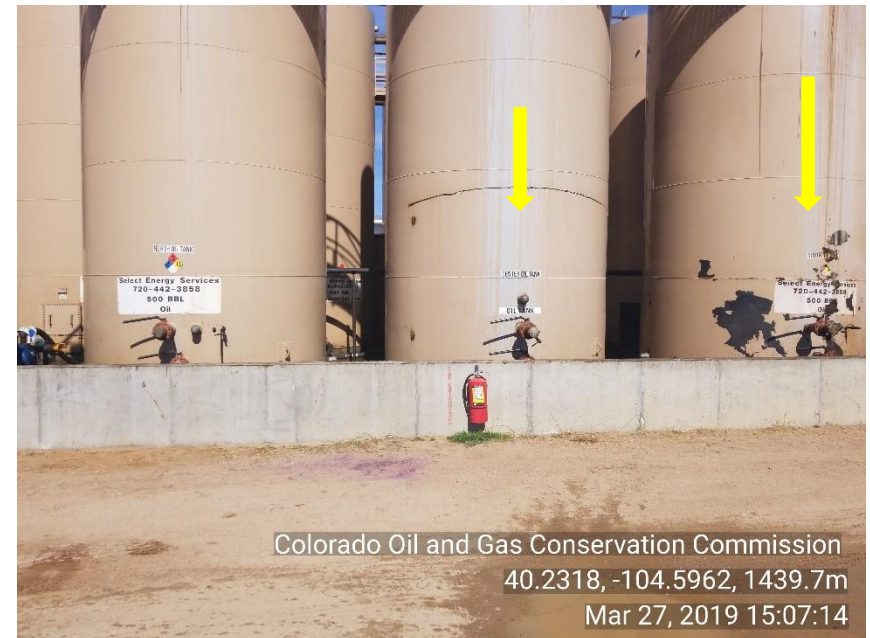
Photo 12 Active Injection facility Tank sign and NFPA placard unreadable or missing

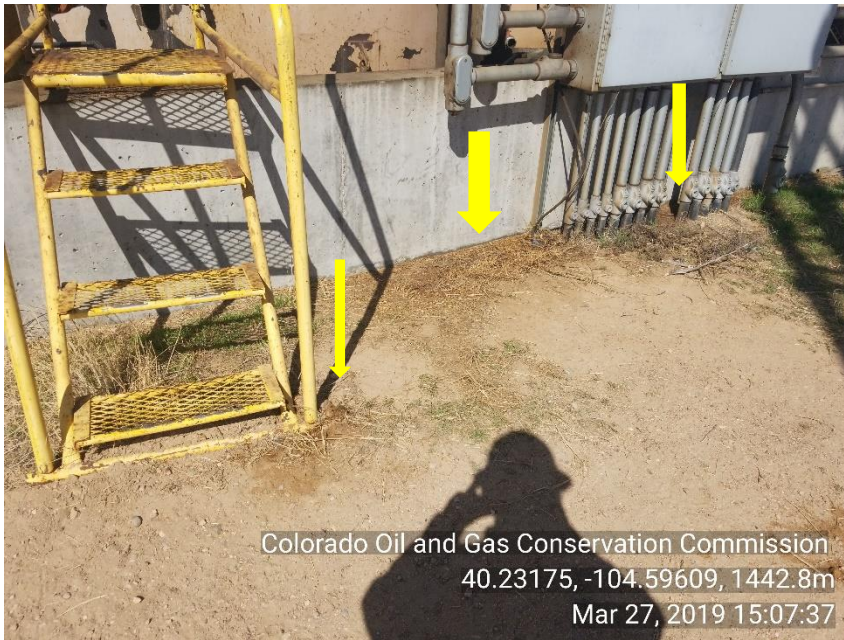
Photo 13 Stained soil around active injection battery

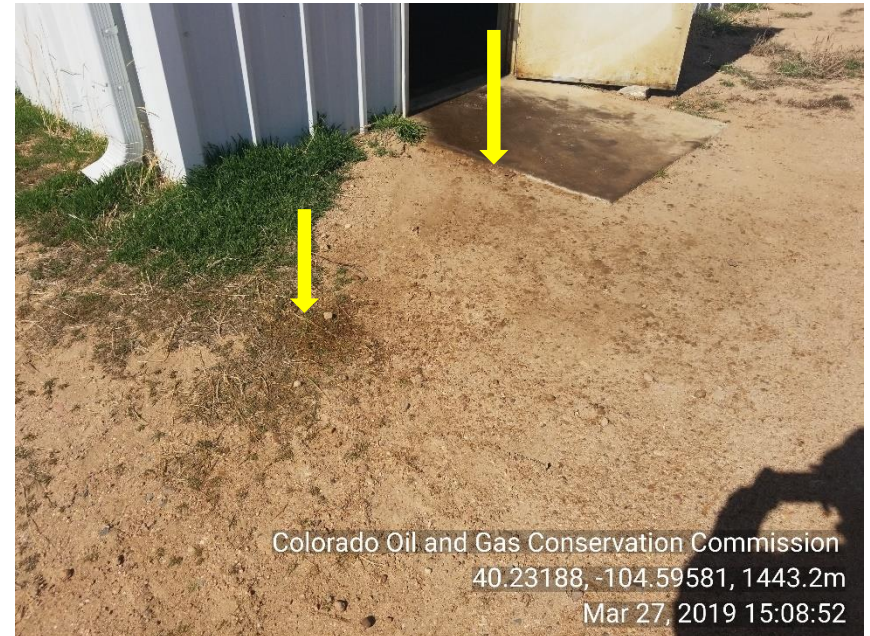
Photo 14 Stained soil outside door of active injection pump building

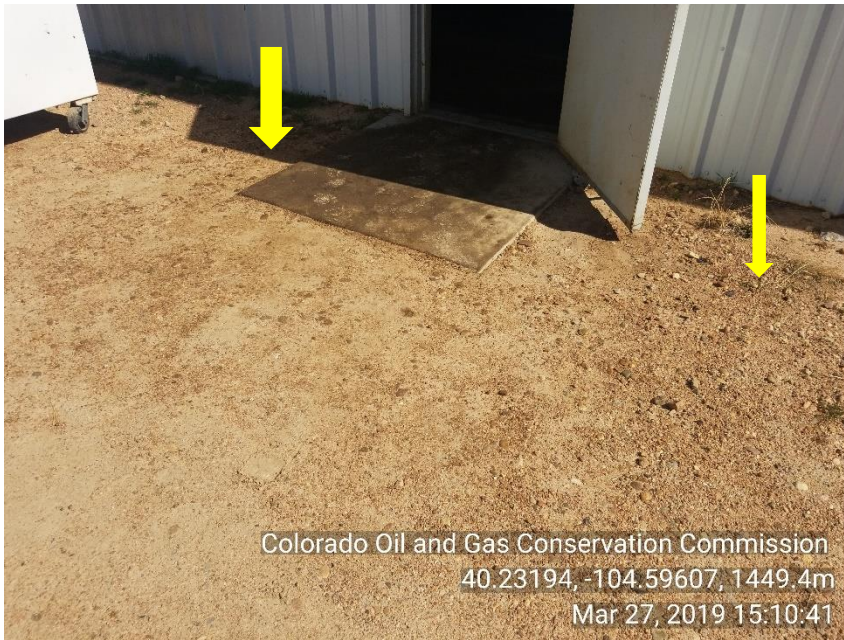
Photo 15 Stained soil outside opposite side of active injection pump building

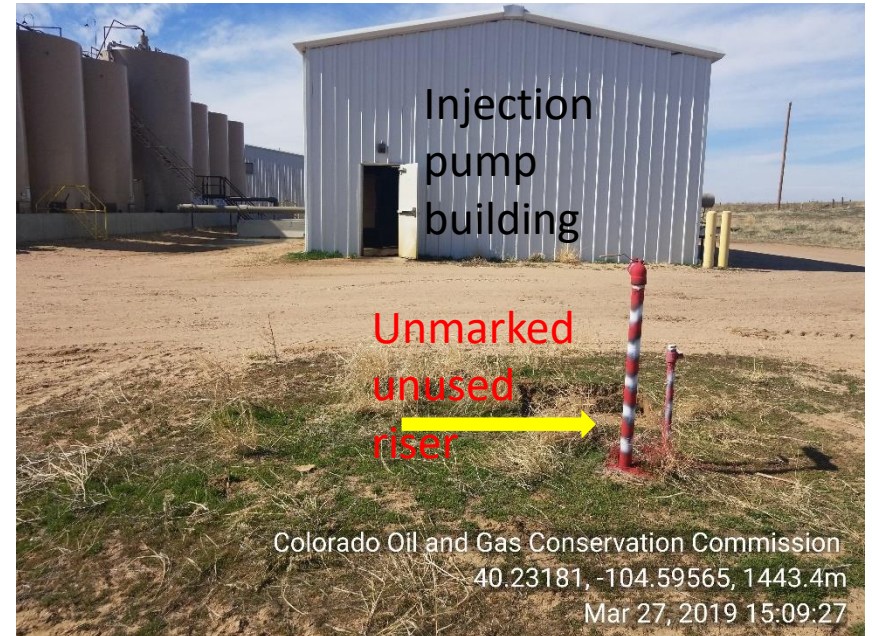
Photo 16 Unused unmarked riser

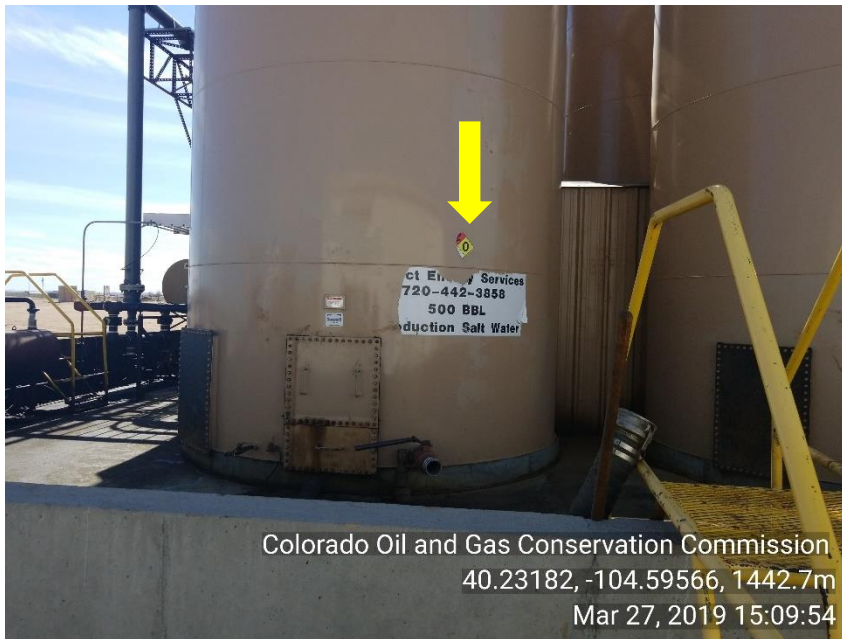
Photo 17 Active Injection facility Tank sign and NFPA placard unreadable or missing

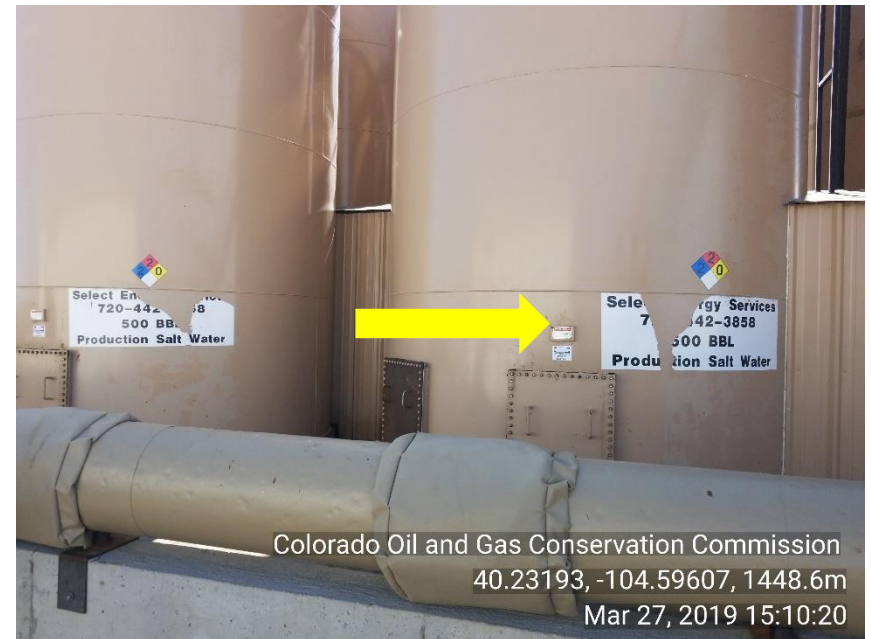
Photo 18 Active Injection facility Tank sign and NFPA placard unreadable or missing

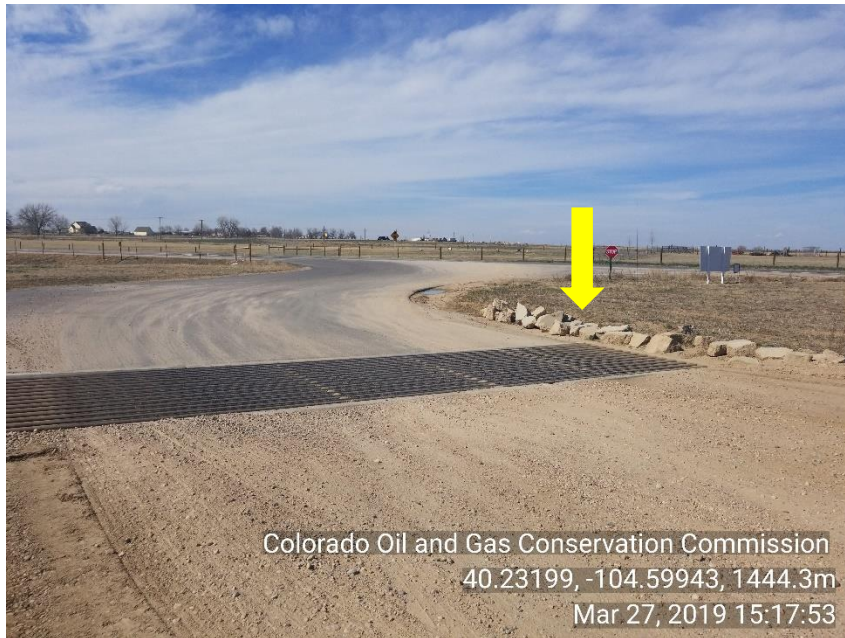
Photo 19 Inadequate tracking pad BMP

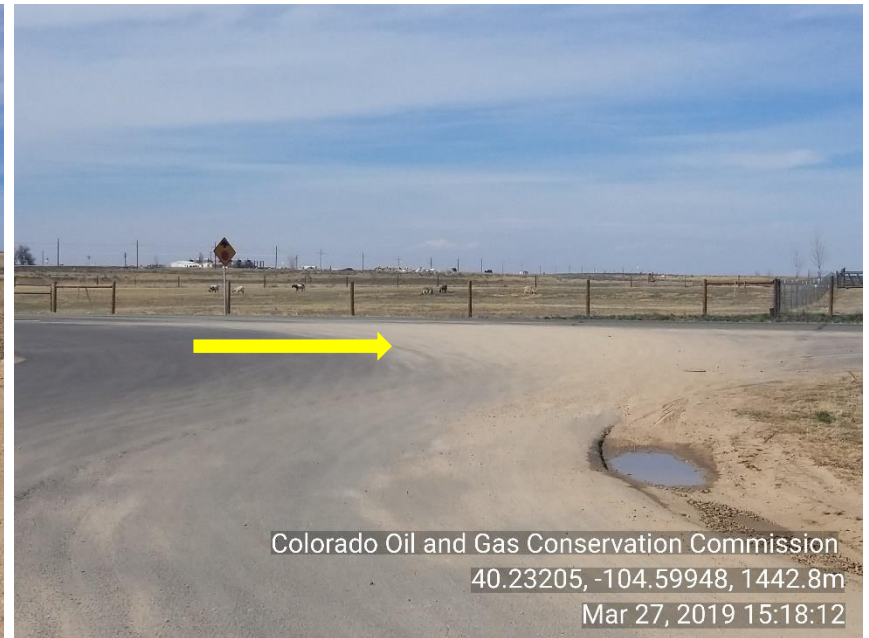
Photo 20 Sediment being carried onto county road 34 from trucks exiting facility
