Inspection Photos
Location Name: Grizzly Hebron 12 0881
Location ID: 448834

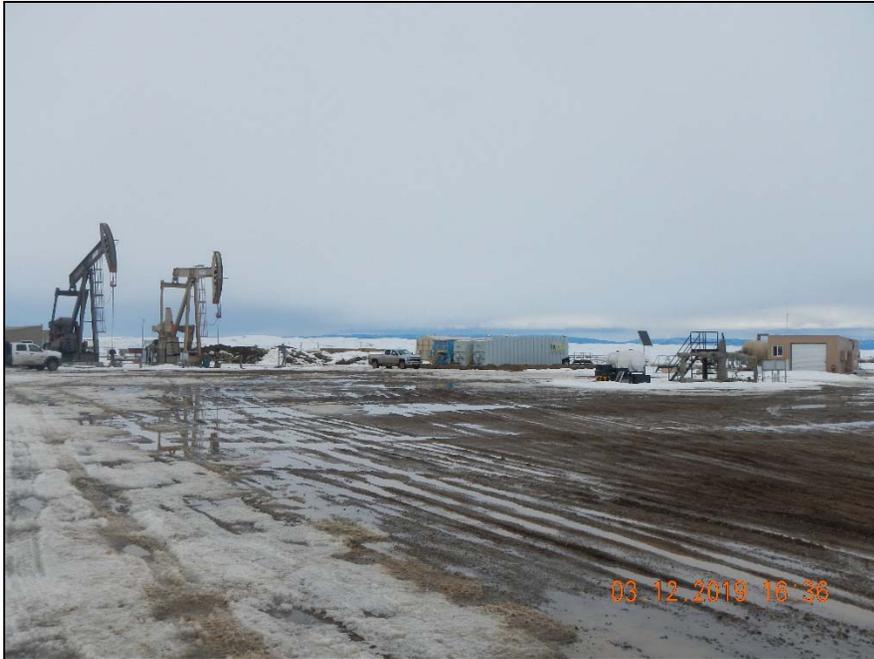
Photo 1. Overview of location taken at entrance facing northeast. Frack tanks stored with improper berm in northeast corner of location.

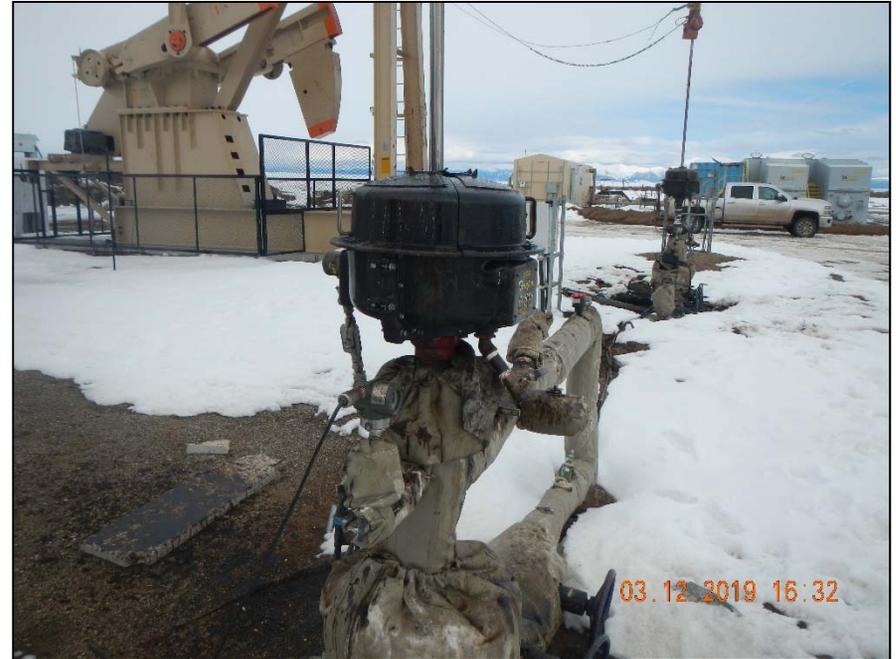
Photo 2. Overview of Grizzly wellheads. Stained soil and boards.

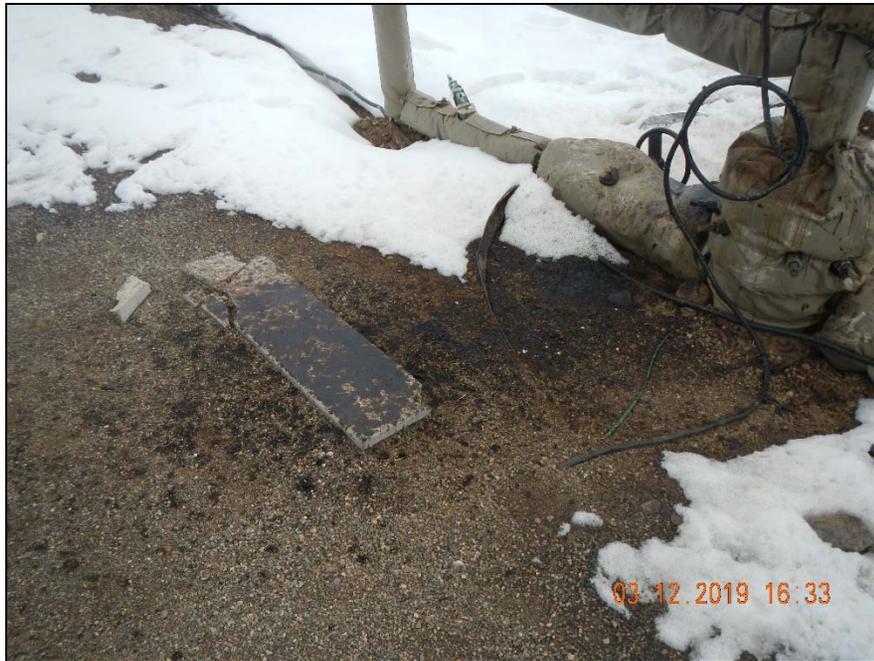
Photo 3. Stained soil and board.

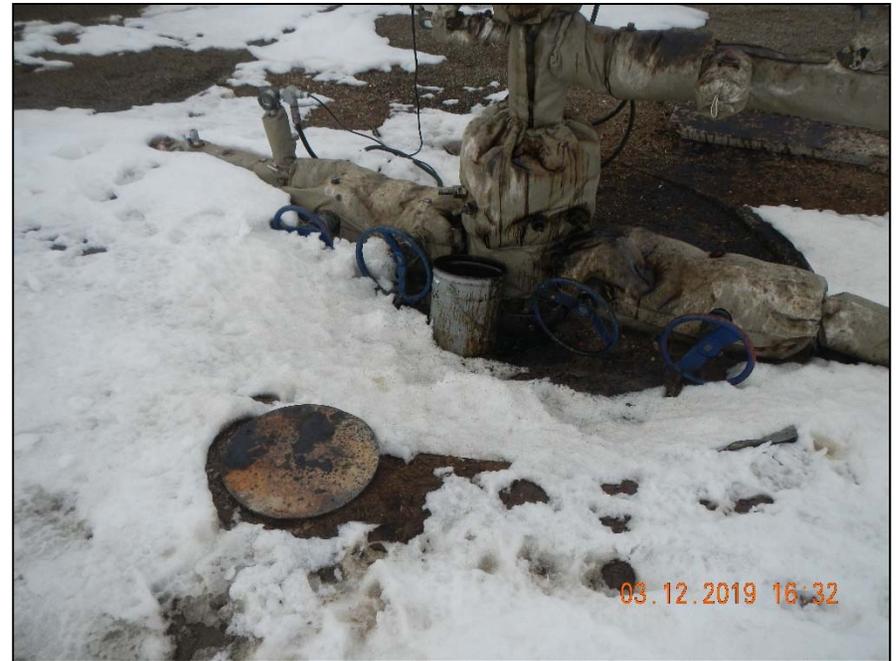
Photo 4. Rathole open, stained soil, bucket full of oily fluid.

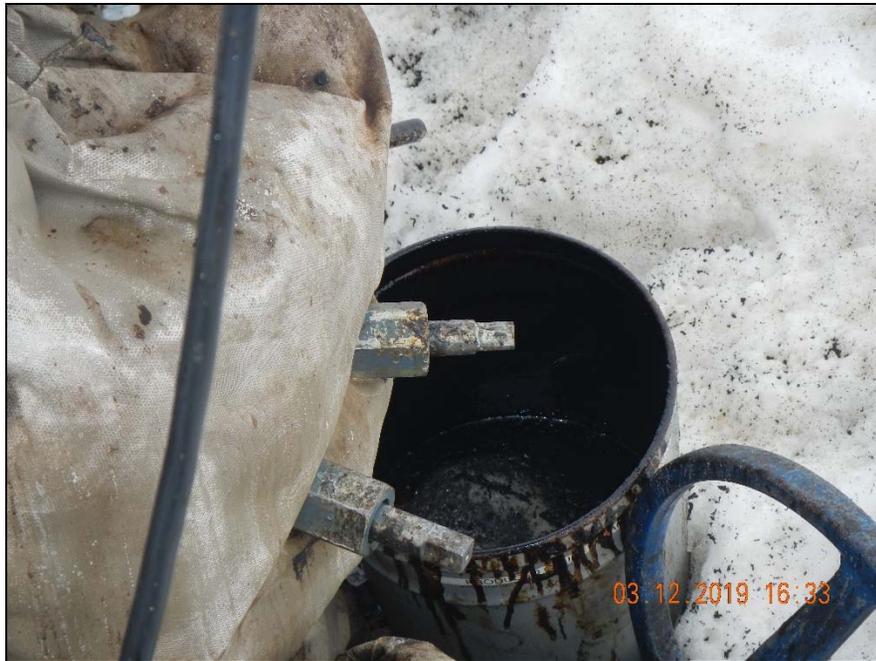
Photo 5. Bucket with oil fluid.

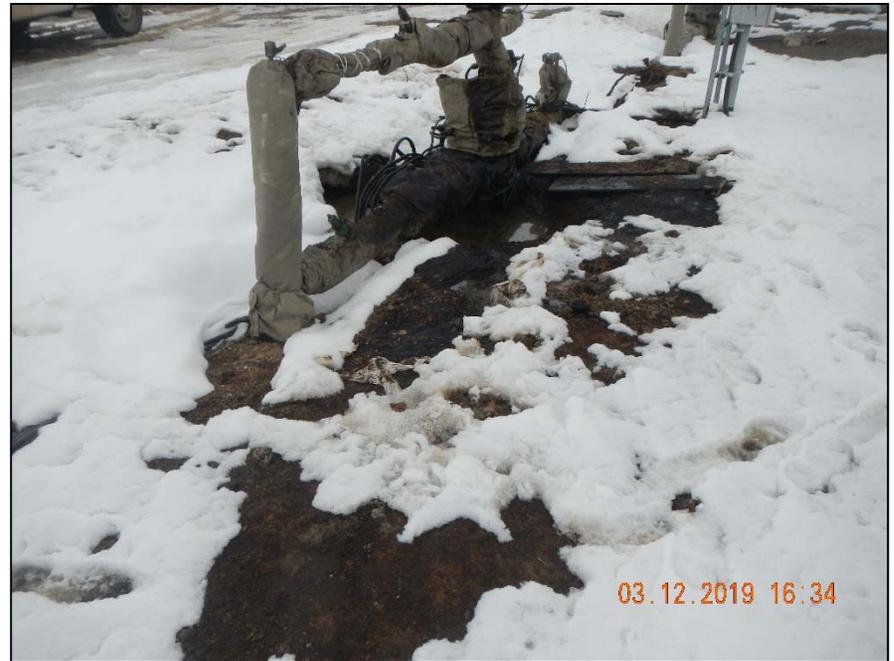
Photo 6. Stained soil, oily debris, cellar full of fluid.

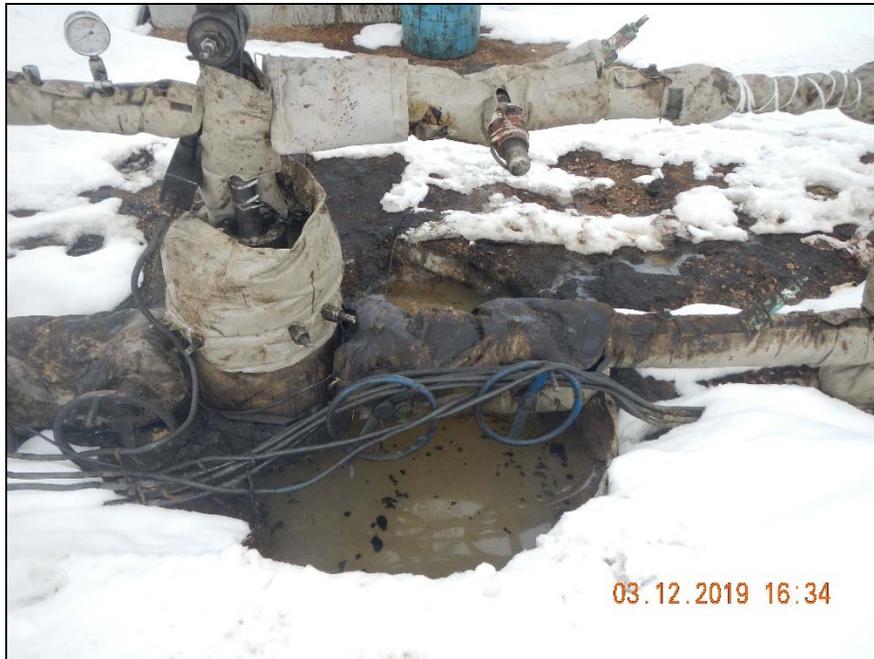
Photo 7. Cellar full of fluid, oil on top, stained soil and oily debris.

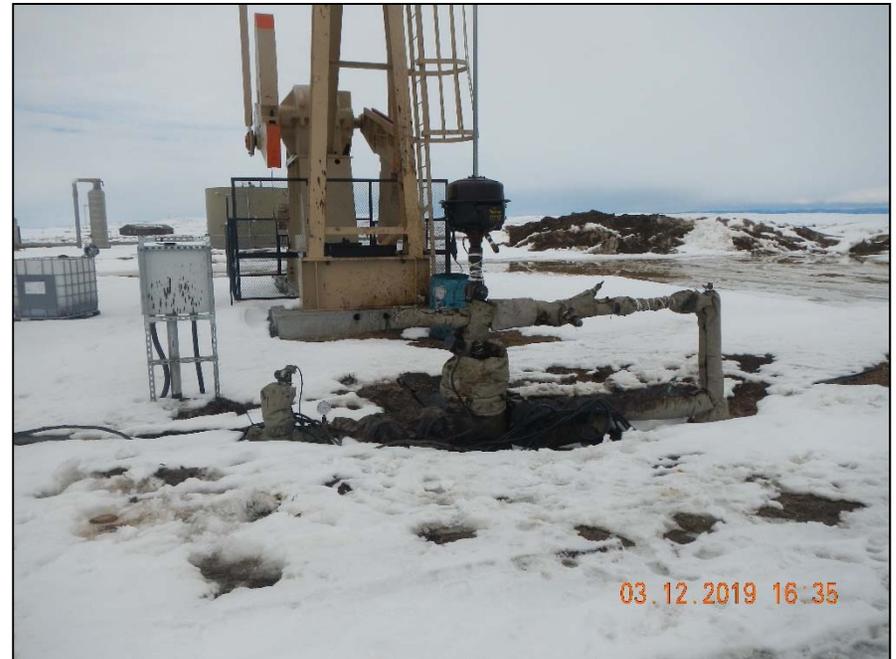
Photo 8. Stained soil, oily debris.
