Inspection Photos

Location Name: Staudinger 1-31H Location ID 424744

Inspection Date: 3/27/2019

COLORADO
Oil & Gas Conservation
Commission
Department of Natural Resources

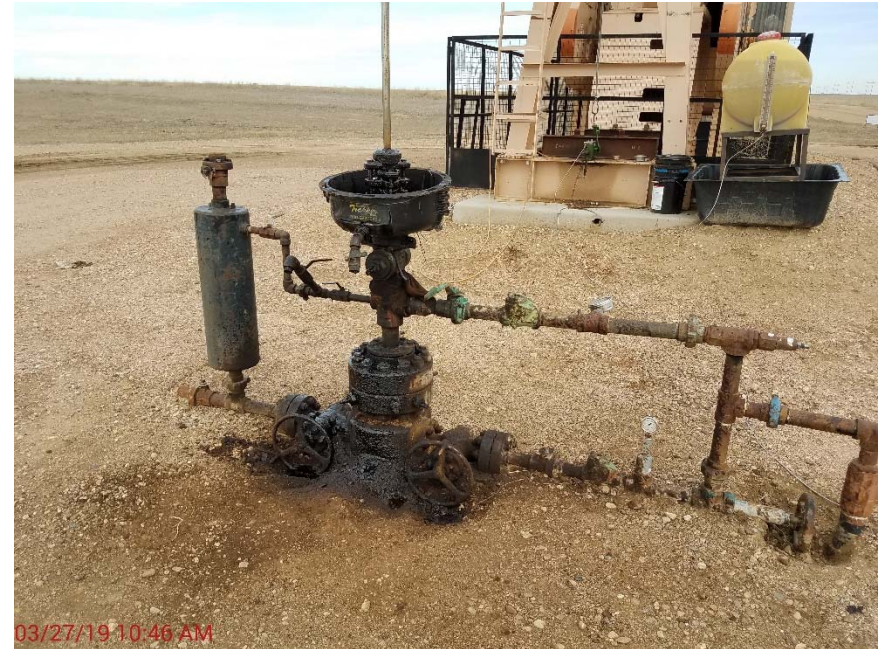
Photo 2 – Leaking wellhead and impacted material/soil.

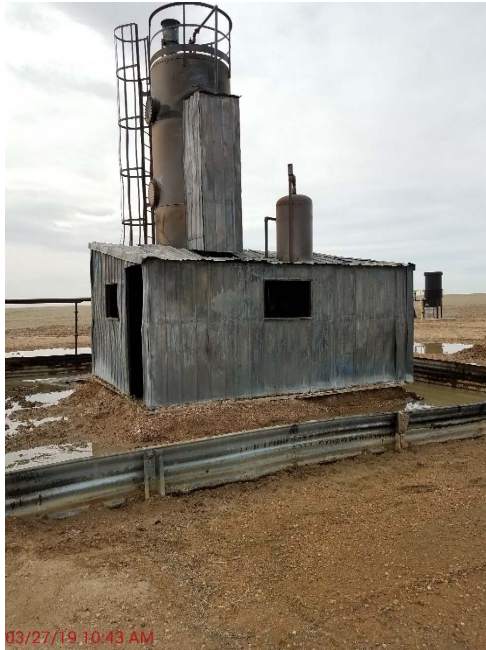
Photo 3 – Northside damaged heater treater.

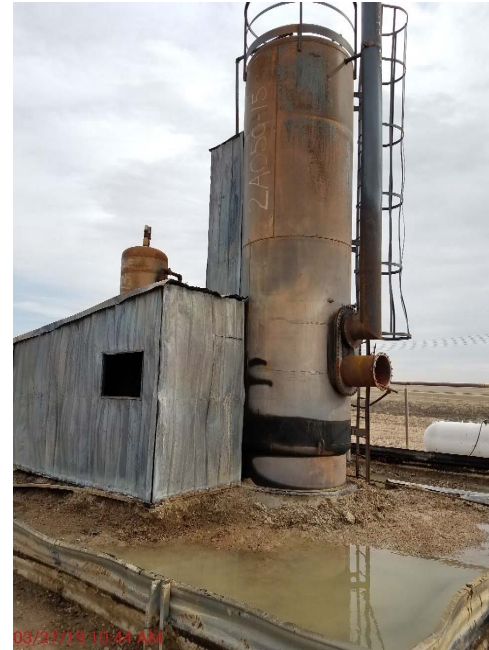
Photo 4 – Southside damaged treater and impacted material removed from within secondary containment.

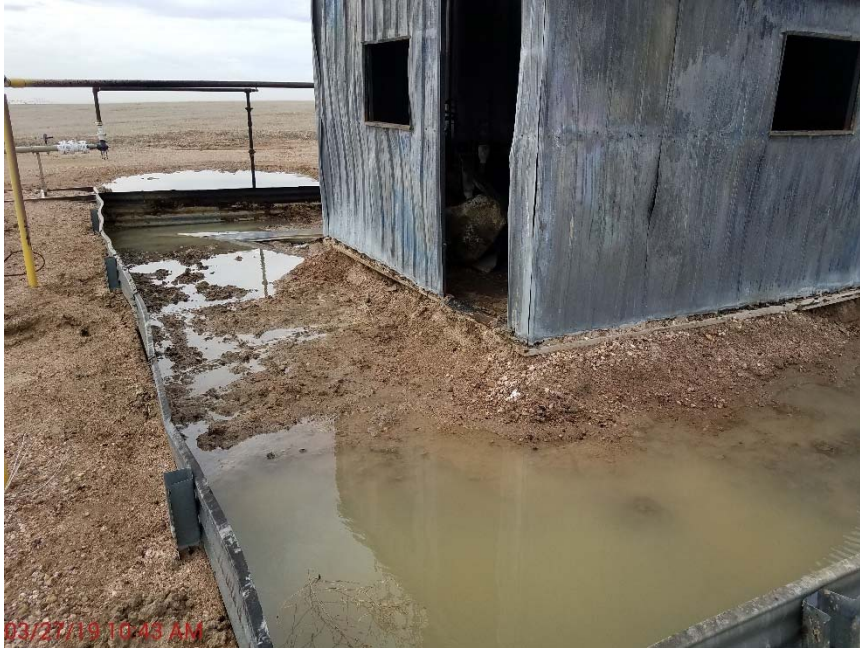
Photo 5 – Inside secondary containment showing impacted material removed from containment area.

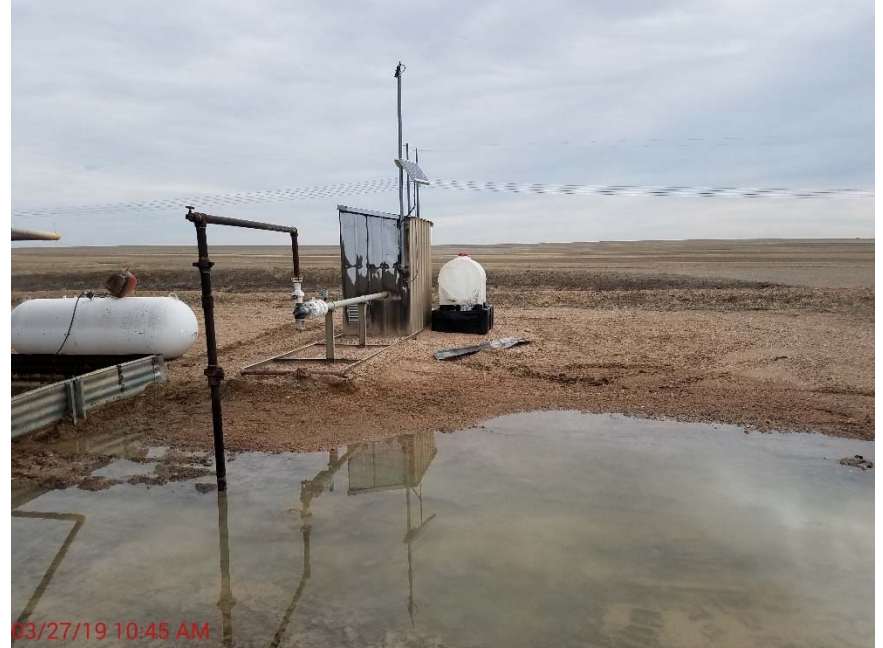
Photo 6 – South side of heater treater showing presumed area impacted by spill and damaged meter shed.

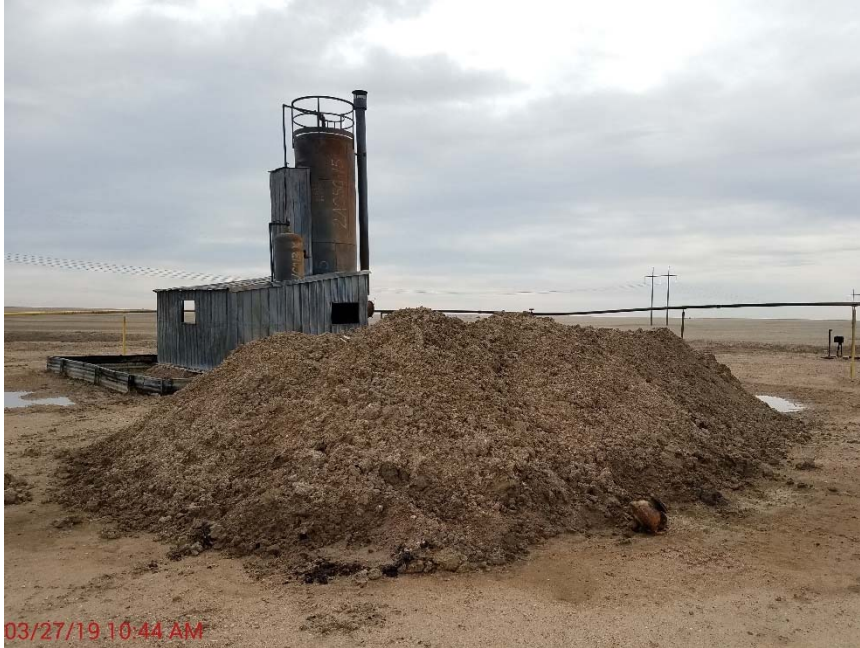
Photo 7 – Impacted material stockpiled on location.

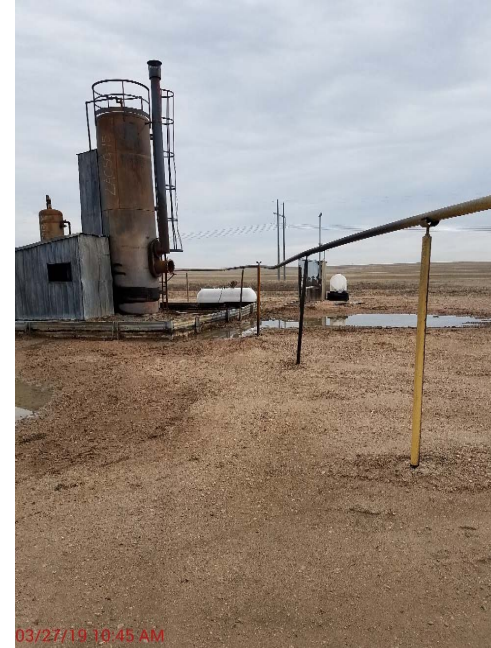
Photo 8 – Piping for ECD warped by heat and coated in oil fro spill.
