W-18-27
Api# 05-045-06542
Inspection # 689702935

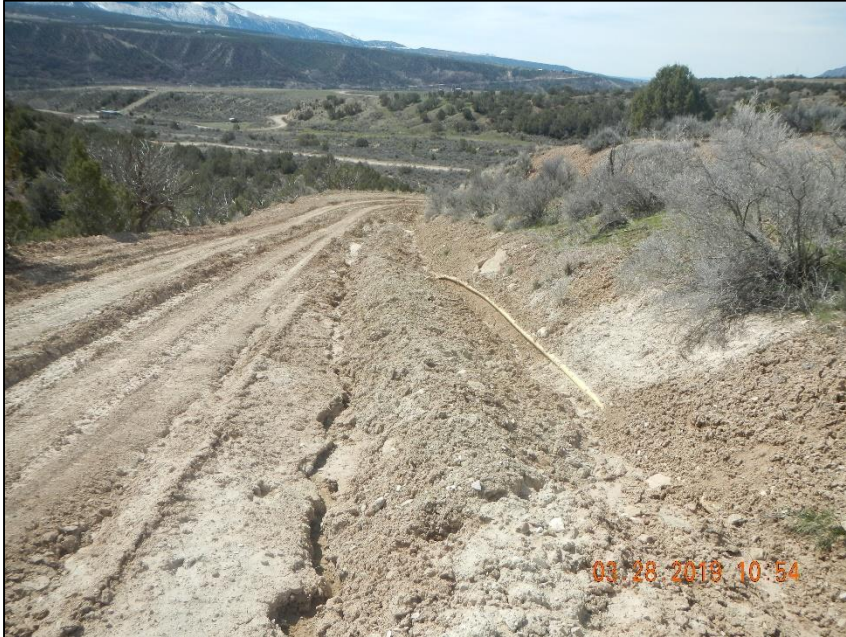
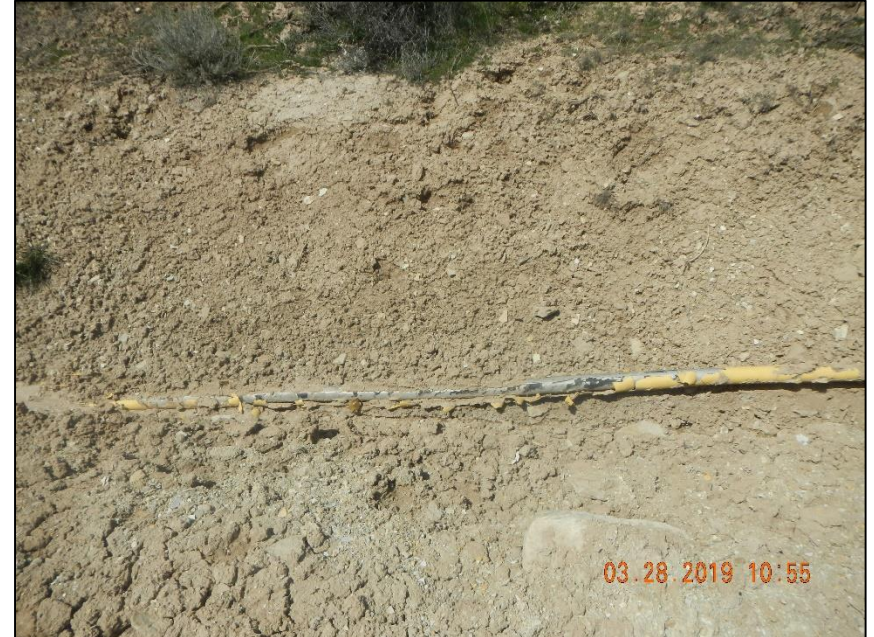
Exposed 2" line along damaged road ditch.

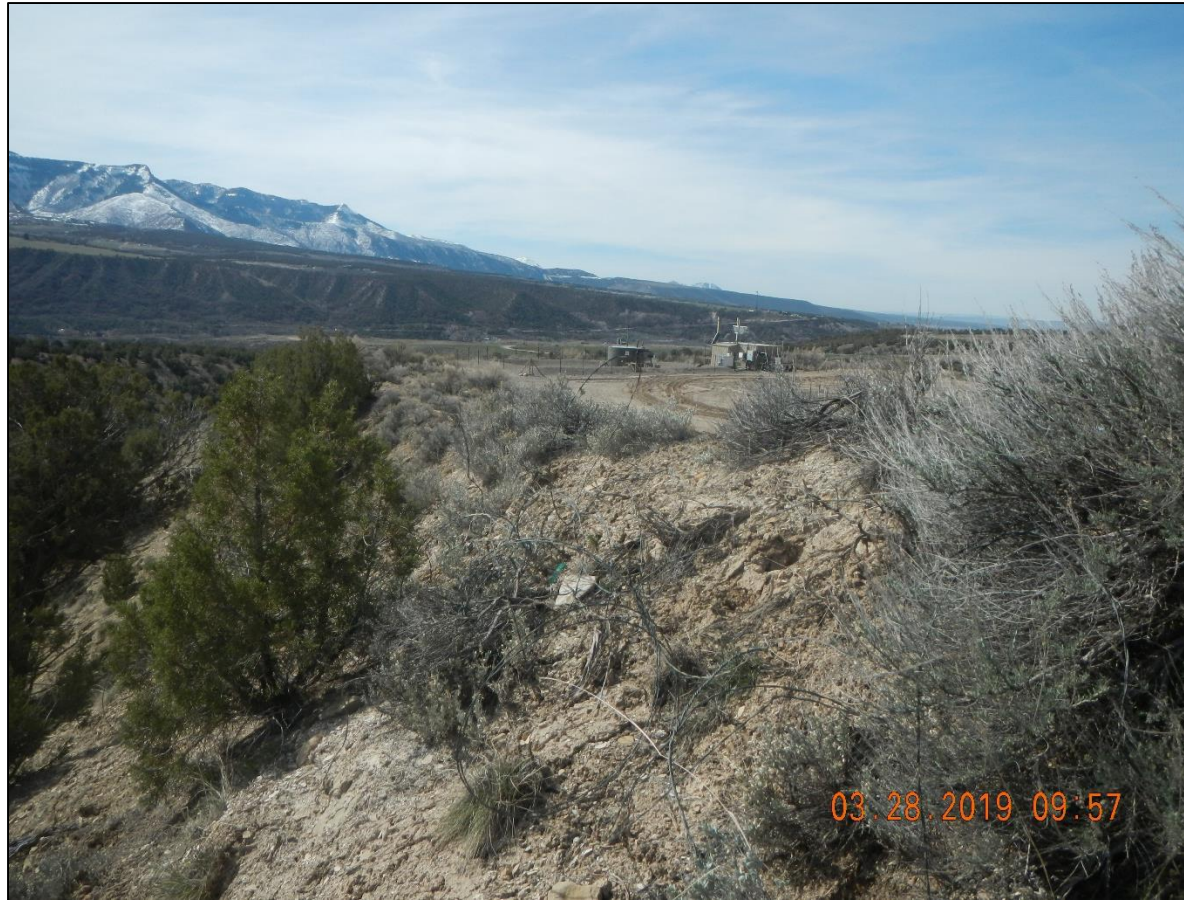
Fencing material off north east edge of location.

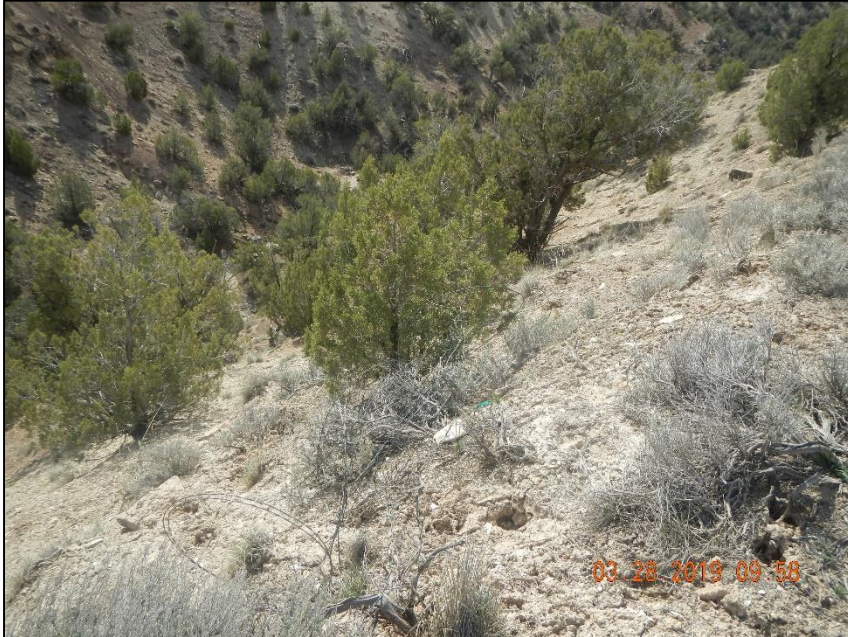
Fencing material off north east edge of location.

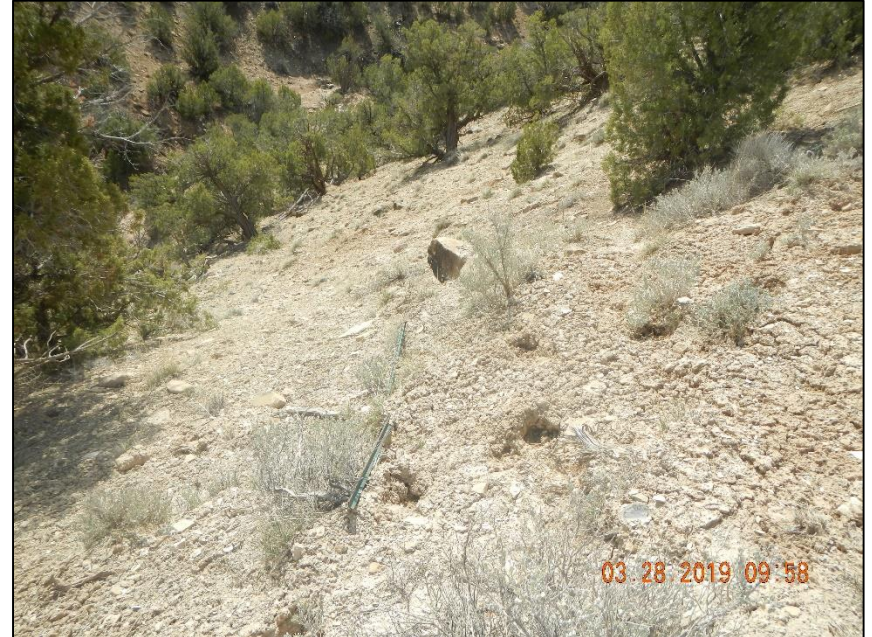
Fencing material off north east edge of location.

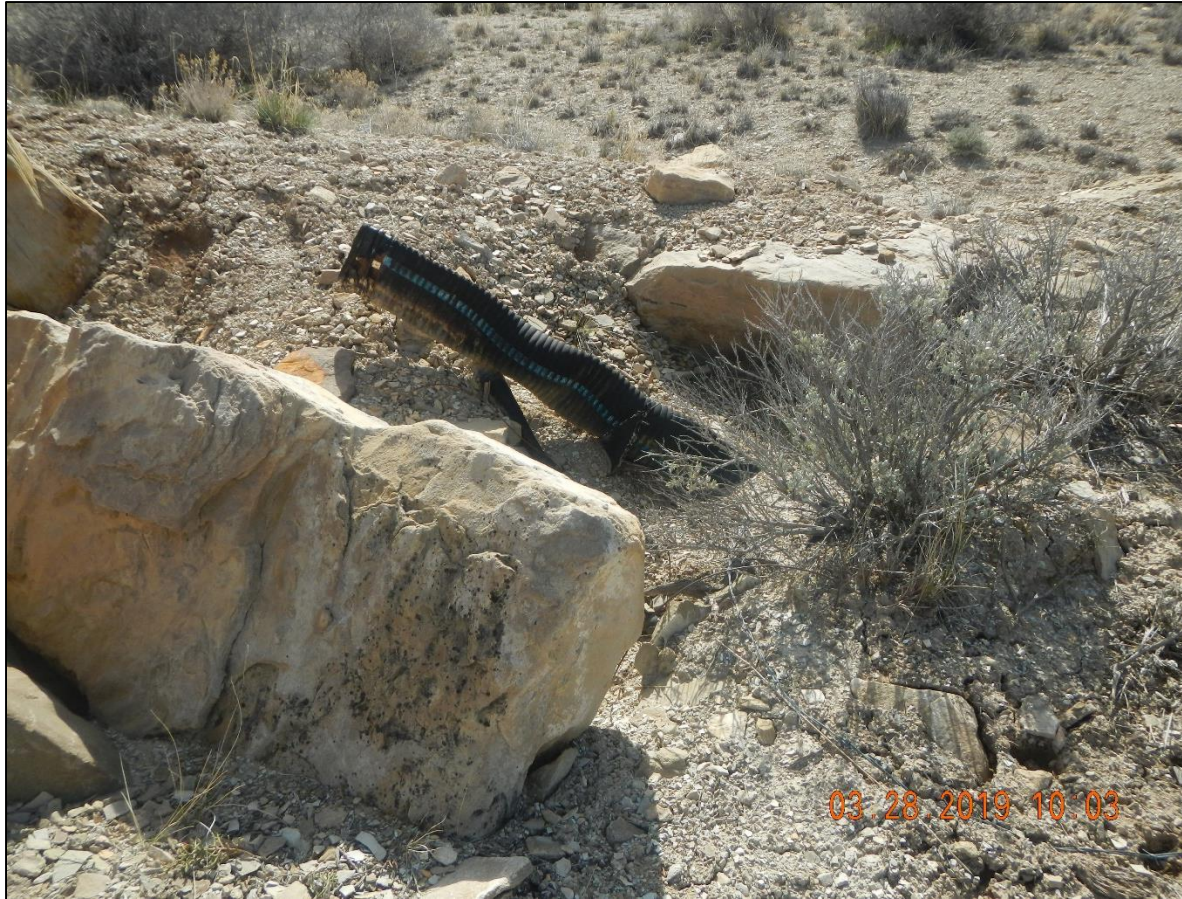
Rubber hose in the north west corner of location.

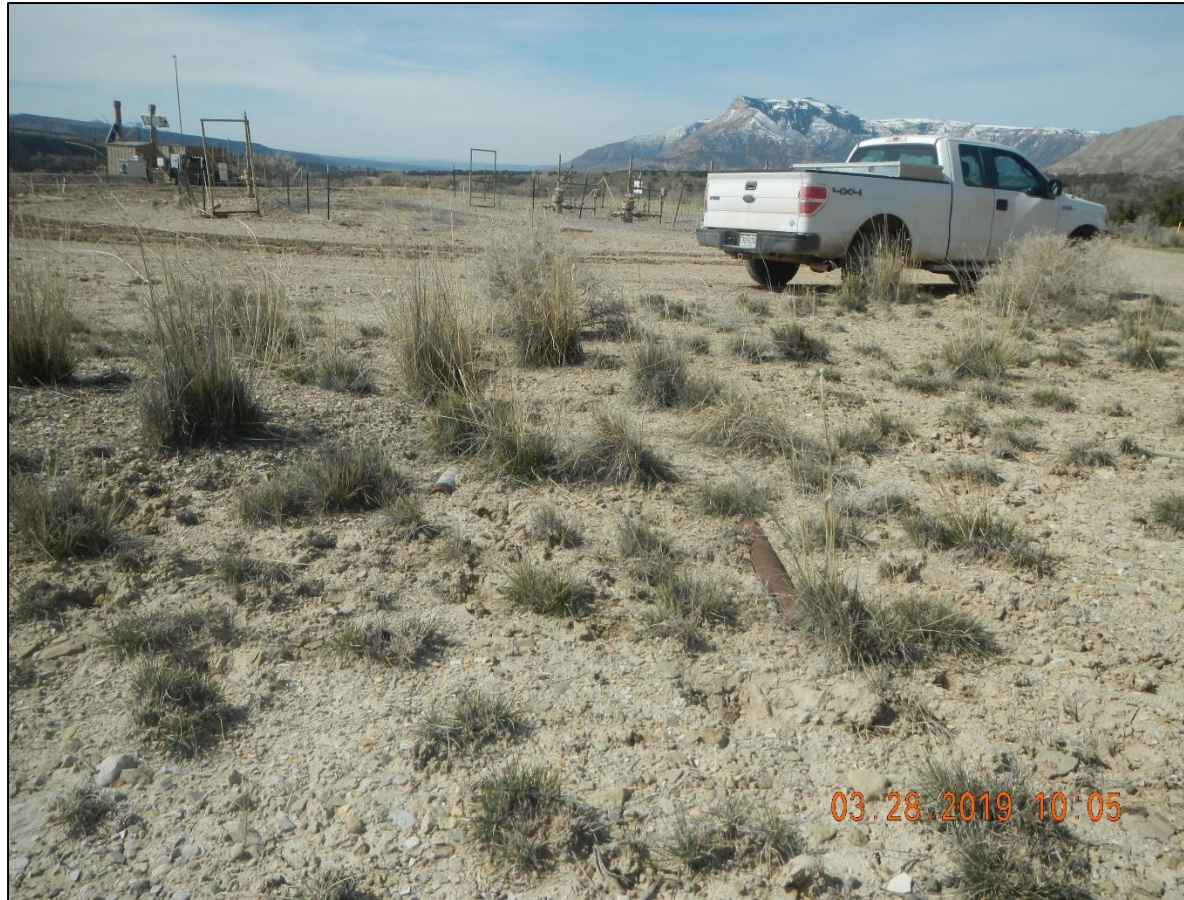
Pieces of 2" pipe in reclaim area north of wells.

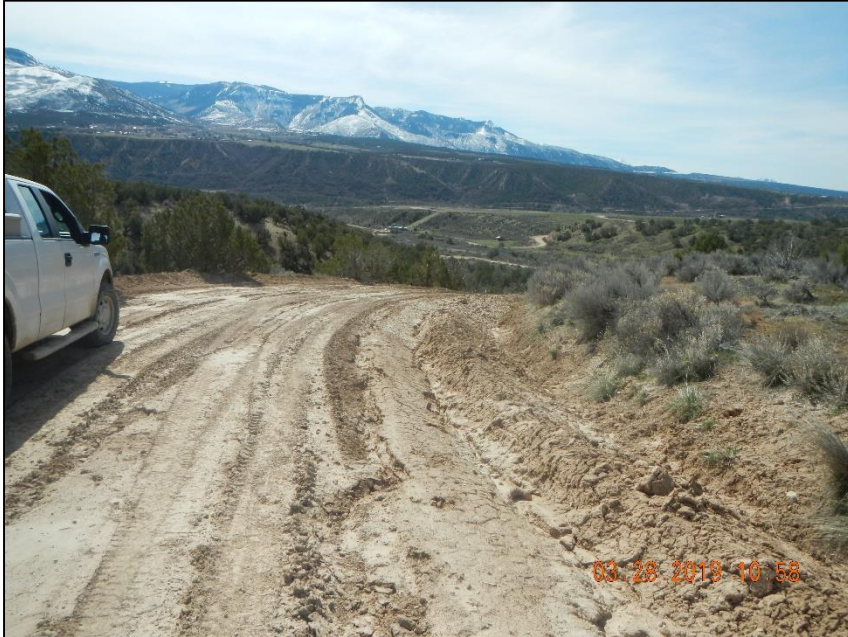
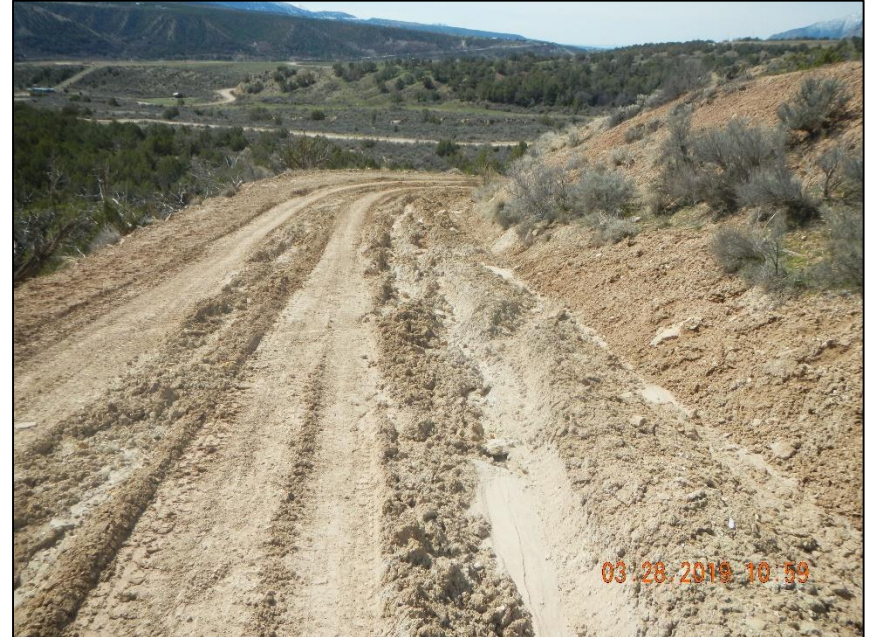
Road ditch damaged by traffic.

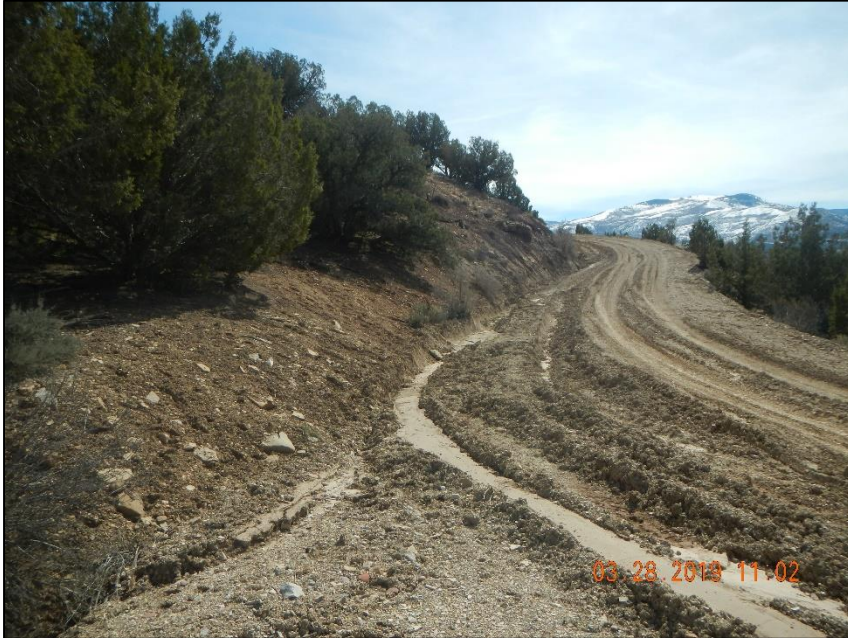
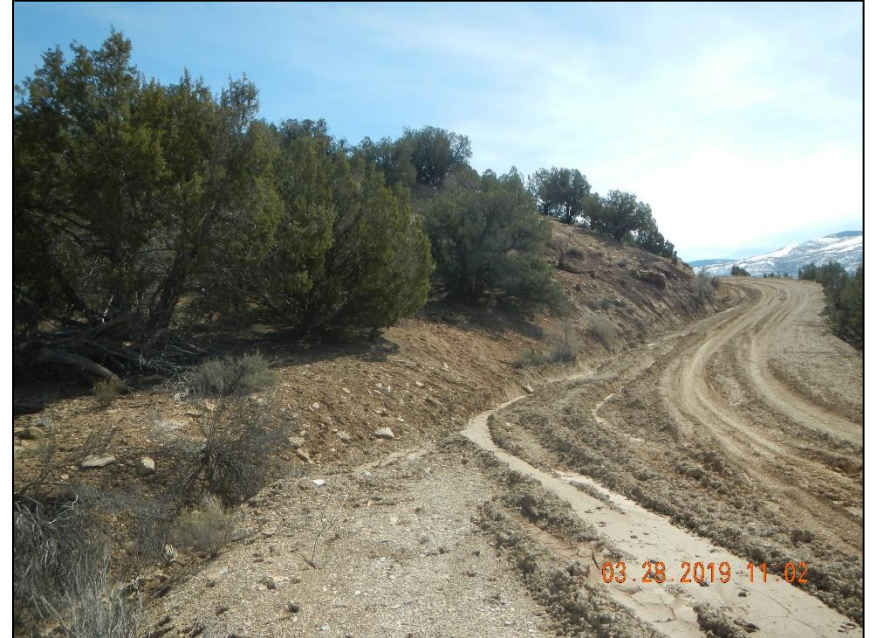
Road ditch damaged by traffic.
