## Inspection Photos

Location Name: [5-MILE RANCH #SG 523-26](#)

Location: 334745

FIR Doc # 692700010

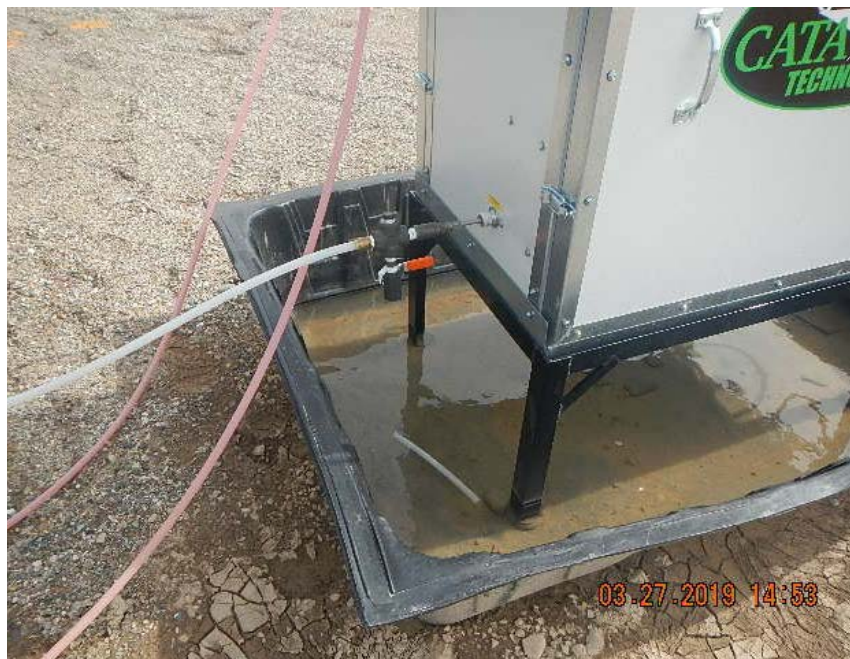
Contents of containment open to wildlife.

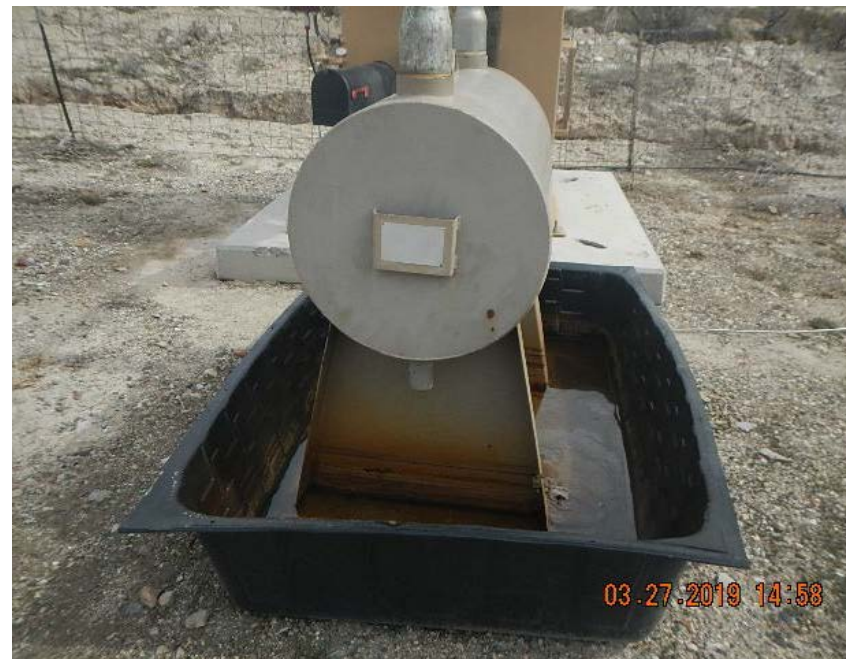
Contents of containment open to wildlife.

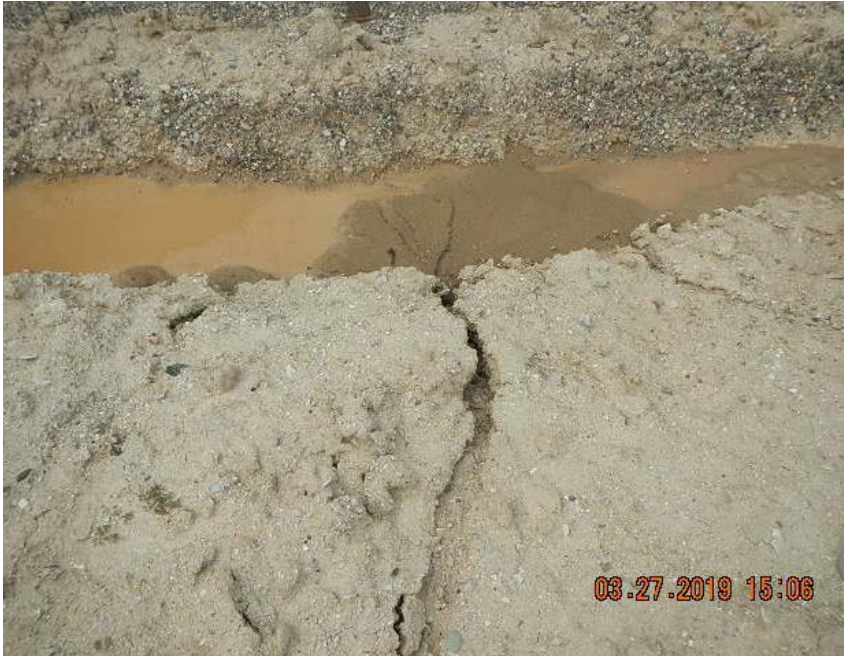
Erosion is evident along unsterilized slope at the east side of location .

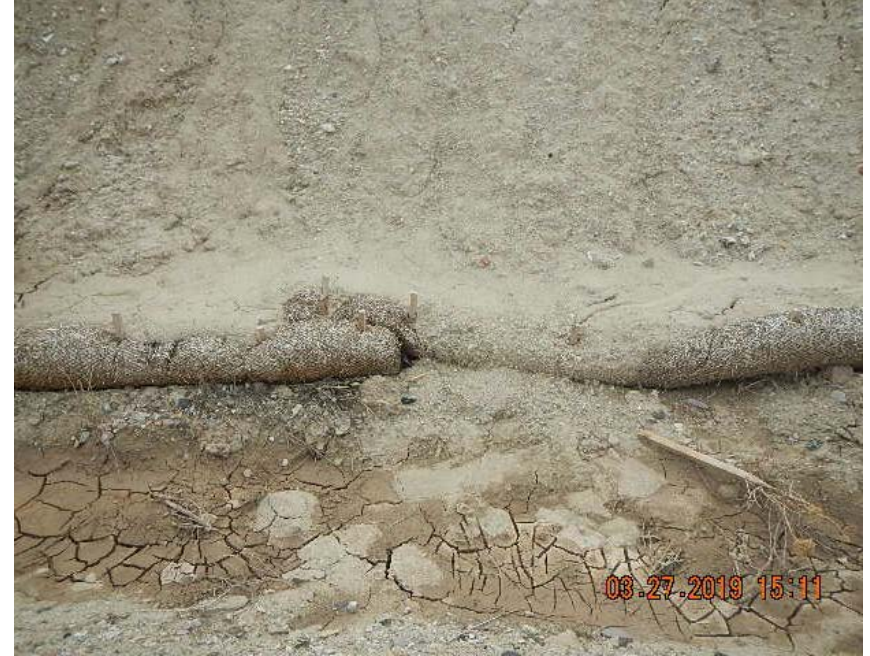
BMP not maintained on NE edge of location.

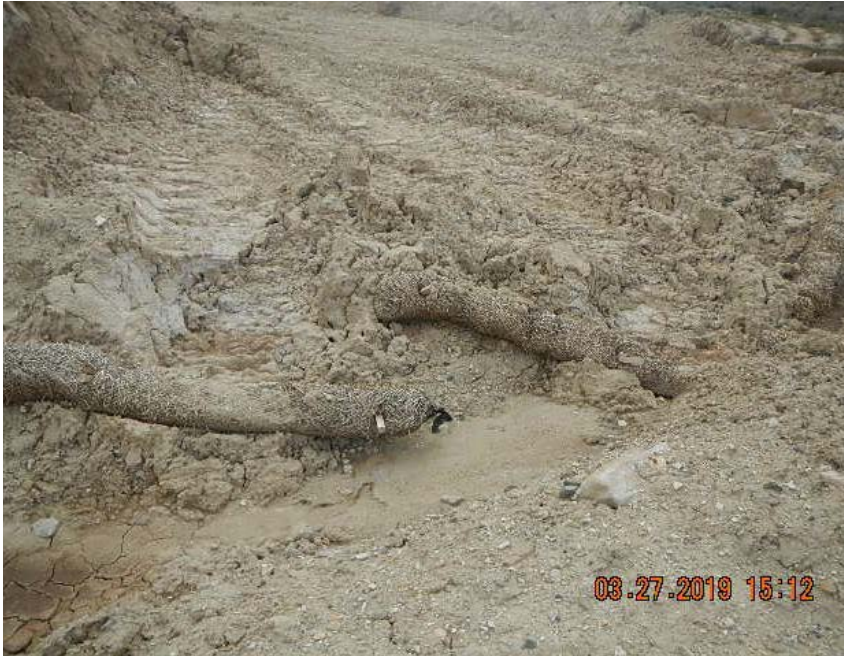
**BMP damaged and not maintained at the NW corner of location.**

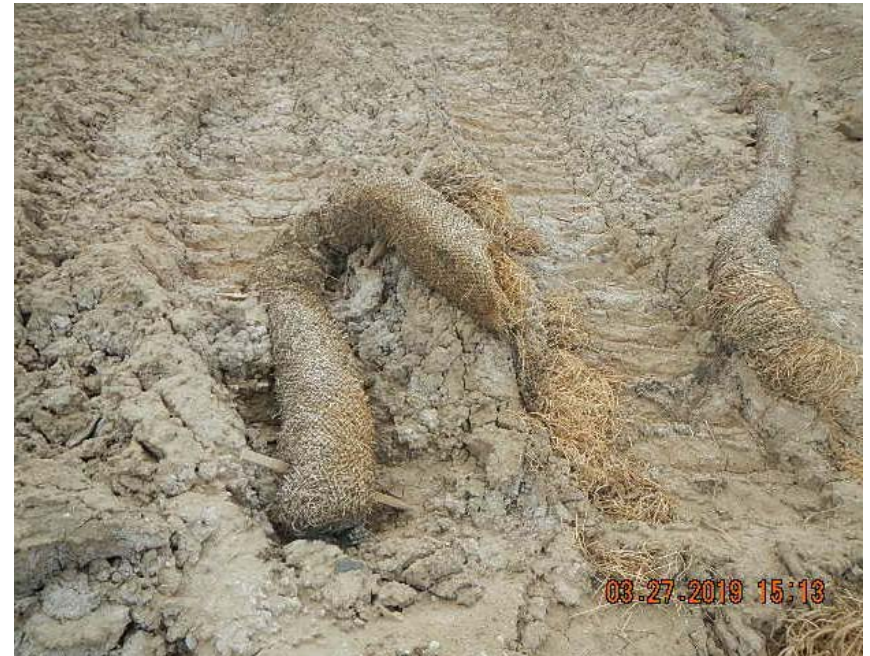
**BMP damaged and not maintained at the NW corner of location.**

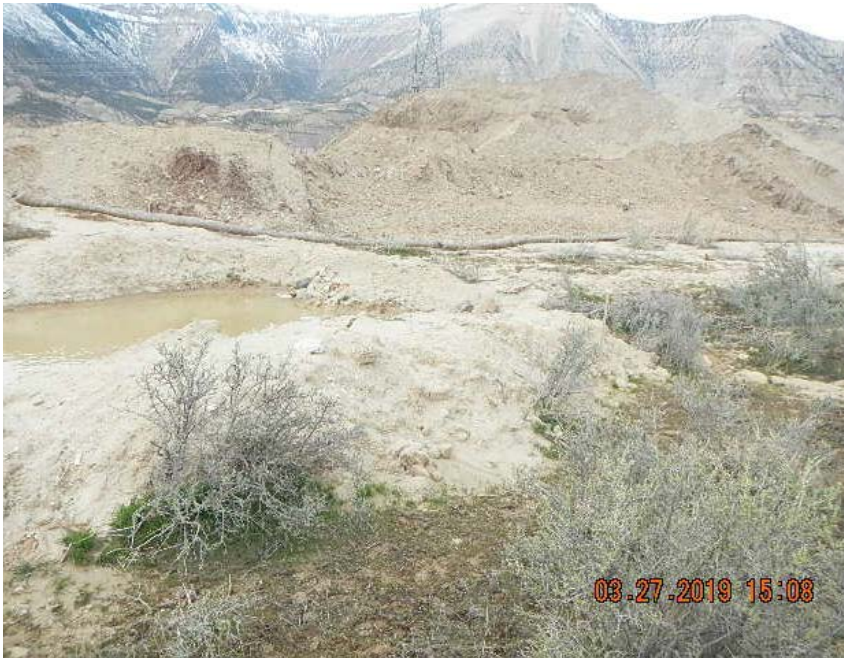
Soil and Debris piled up on the west, North, and east side of location.

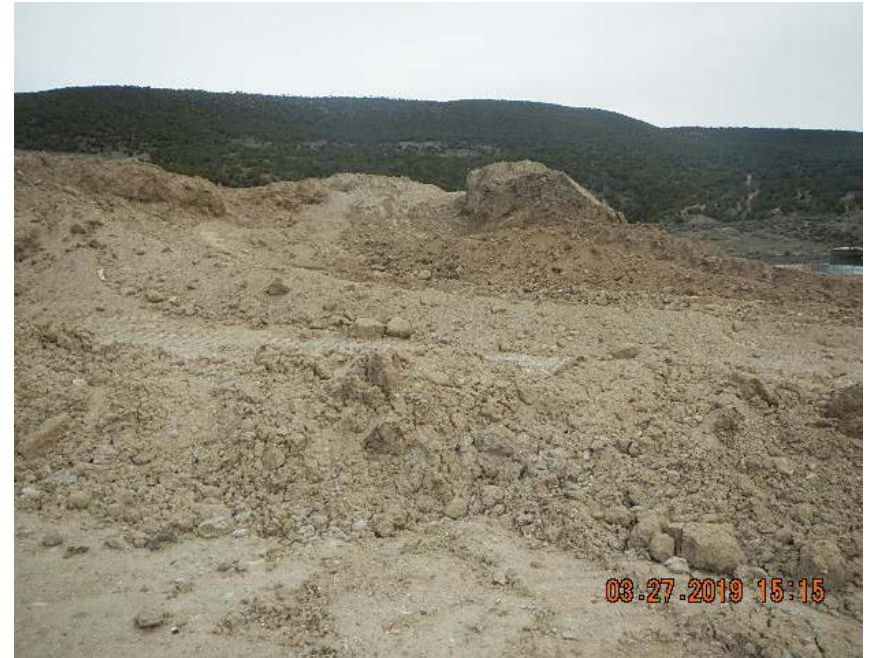
Soil and Debris piled up on the west, North, and east side of location.

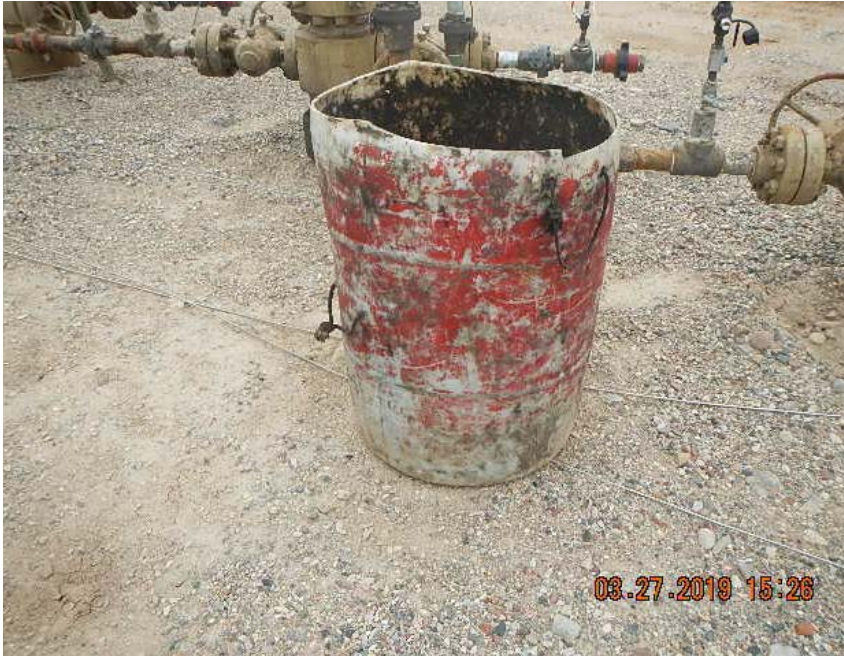
Open trash containers on location.

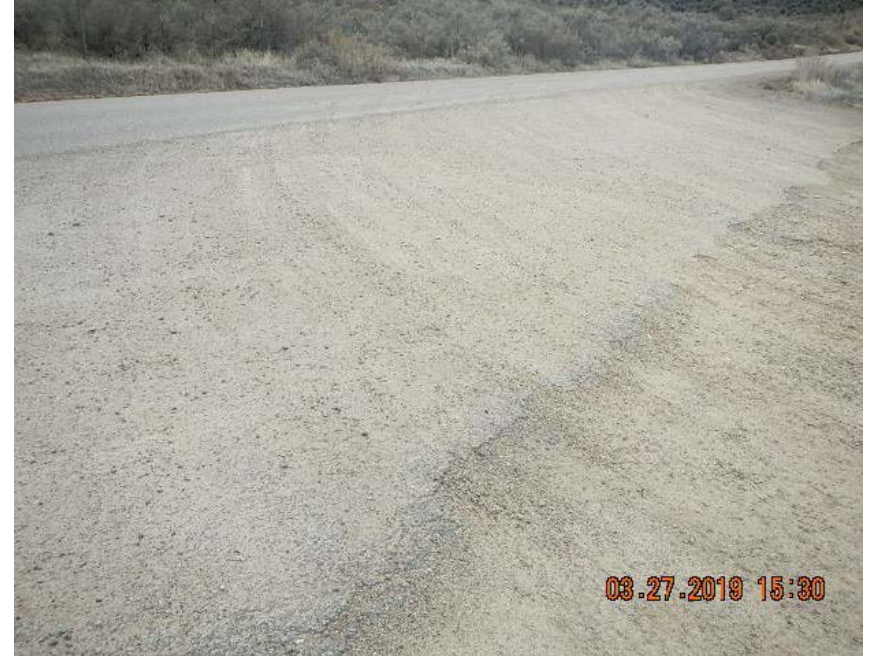
Tracking onto CR 320 from location 334745. No tracking BMP in place.

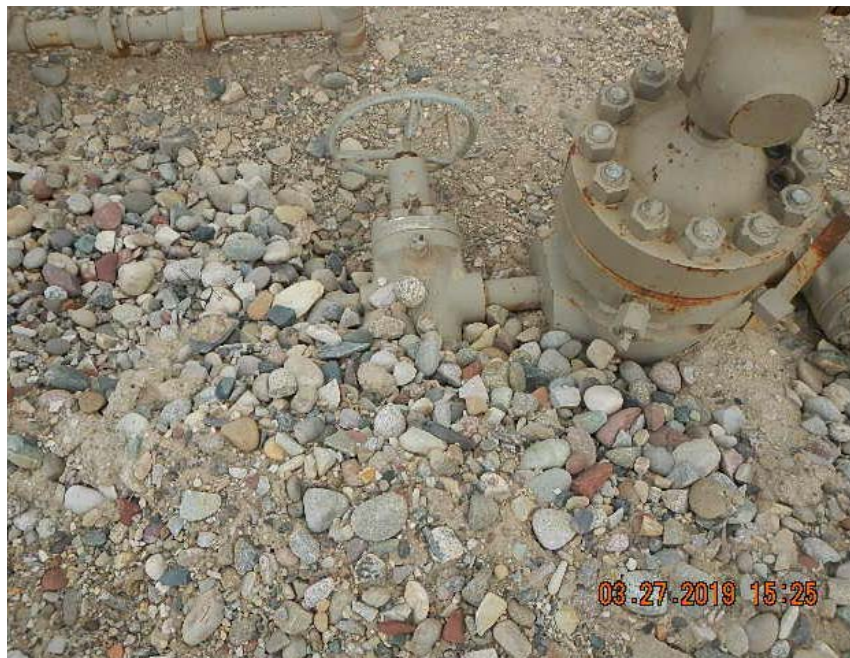
Debris has been pushed over well head equipment

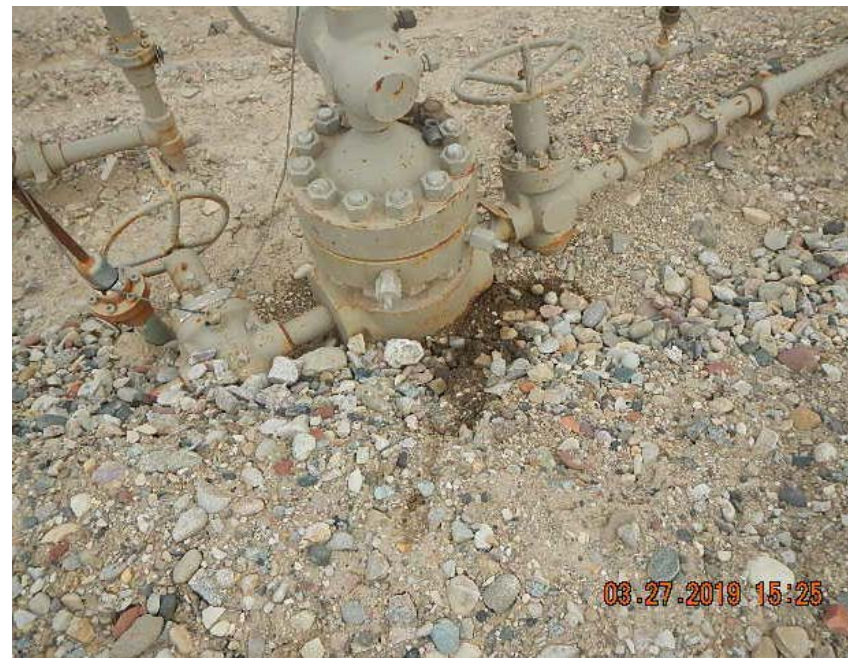
Staining around well head
