Inspection Photos

API: 05-071-09062

Operator: ARP PRODUCTION COMPANY LLC

Inspection Date: 3/25/2019

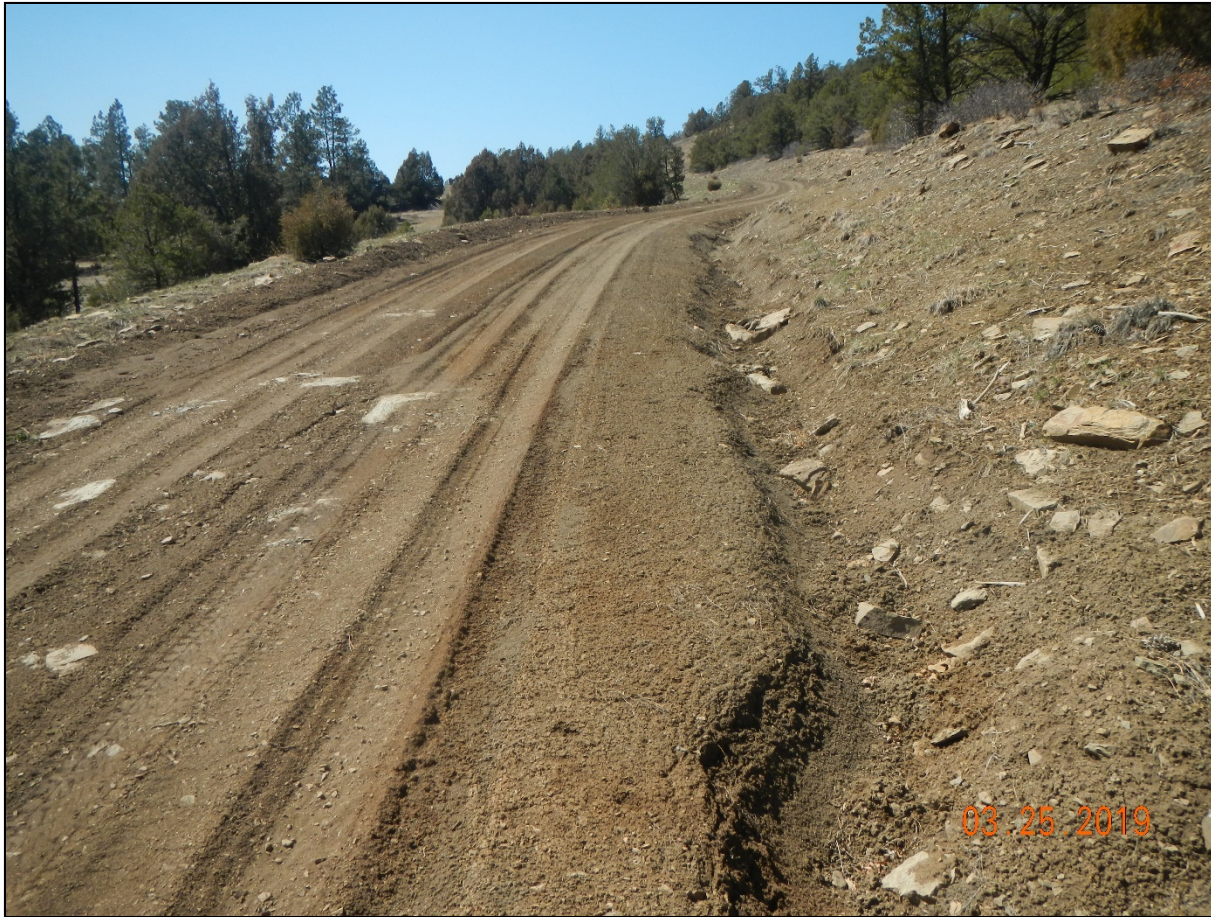
Photo 1. Facing southwest along the access road. No BMP's are installed to prevent erosion along the side of the access road.

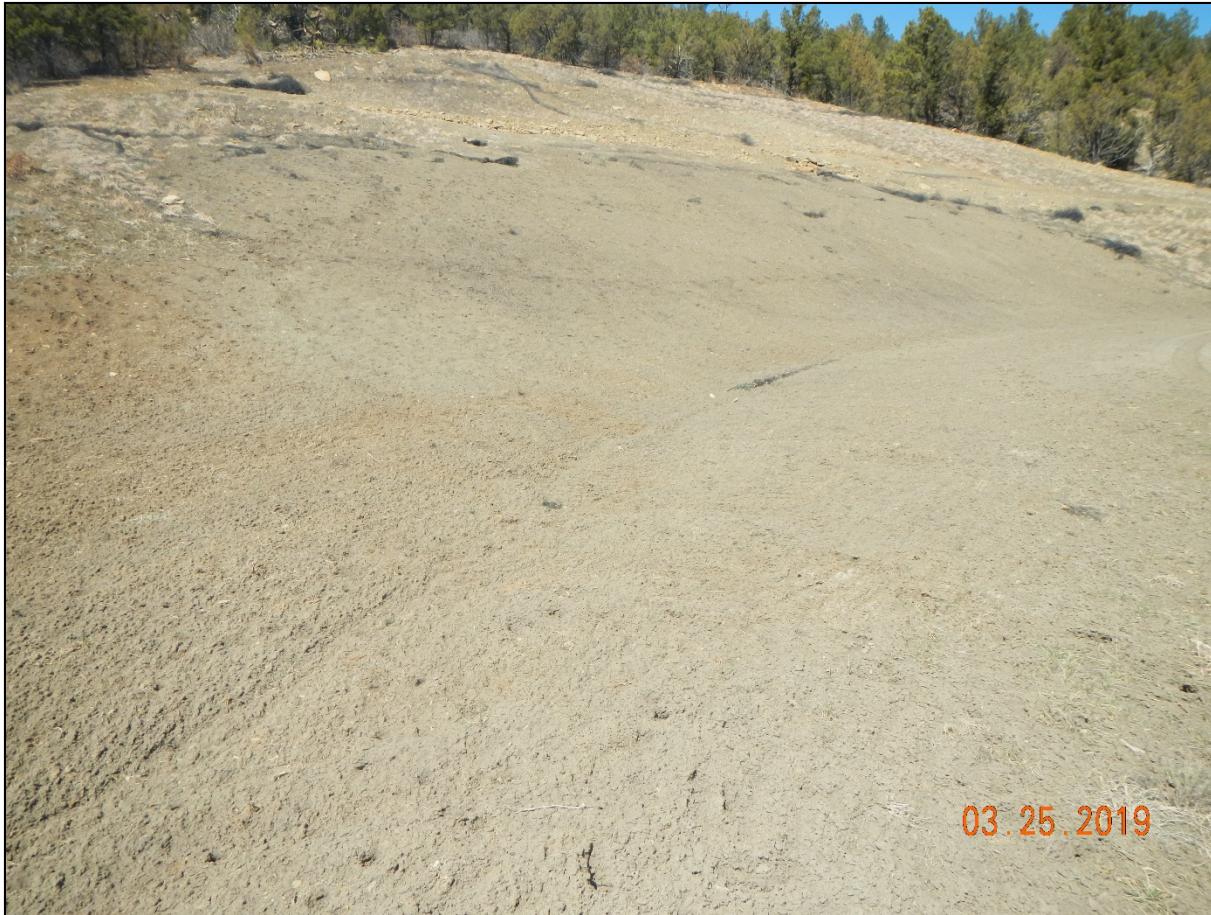
Photo 2. The cut slope is bare of vegetation and susceptible to erosion.

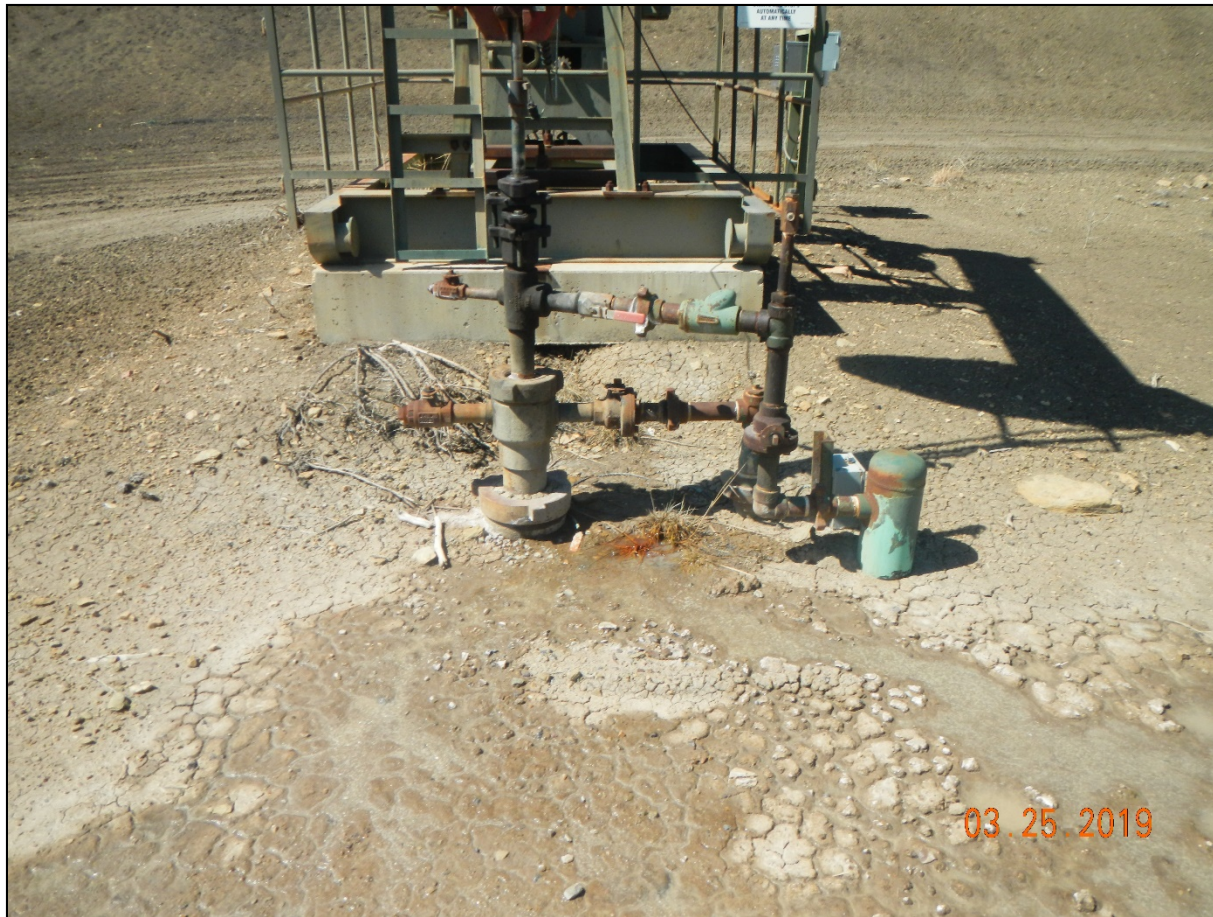
Photo 3. Water is leaking from the wellhead.
